Profile/Photo Observation Report

Date:	03/06/2024	Weather:		Coding:	PACP 7.0
Pipe Length (ft):	264.0	Owner:	City of Hobart	Pre Clean:	Heavy Cleaning
P.O.#:		Surveyor:	S. Bucklin	PSR:	P-405-040-039
Customer:	City of Hobart	Clean Date:	10/24/2023	Shape:	C

Street:	SOFTWOOD DR	Flow Control:	Not Controlled
City:	Hobart, IN	Year Renewed:	
Location:	Easement/Right of Way	Tape/Media #:	
Purpose:	Sewer System Evaluation Survey (SS)	Dia/Height:	8"
Use:	Sanitary Sewage Pipe	Material:	VCP
Drain Area:		Lining:	None
Category:	NA		
Comment:			
Location Details:		Direction of Survey:	Downstream
US MH:	M-405-039	DS MH:	M-405-040
		Total Length Surveyed (ft):	255.6

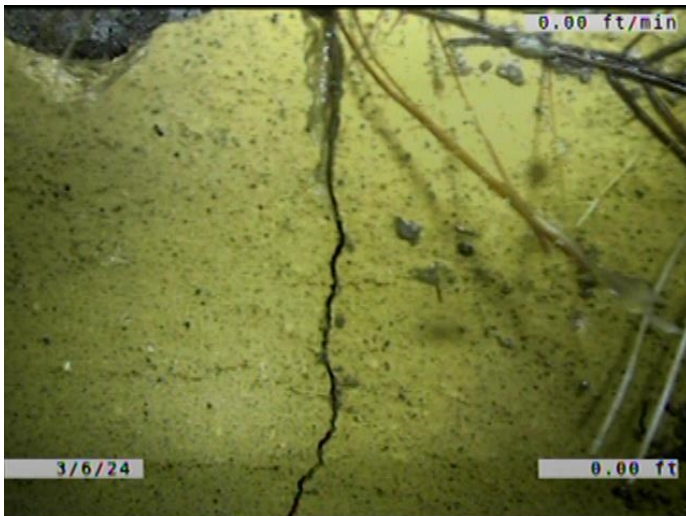
Code: **B**
 Description: **Broken**

Distance (ft): **.0**
 Structural Grade: **4**
 O&M Grade: **0**
 Clock Start/From: **12**
 Clock To: **12**
 1st Value:
 2nd Value:
 Value Percent:
 Continuous Index: **S01**
 Within 8" of Joint: **YES**
 Remarks:

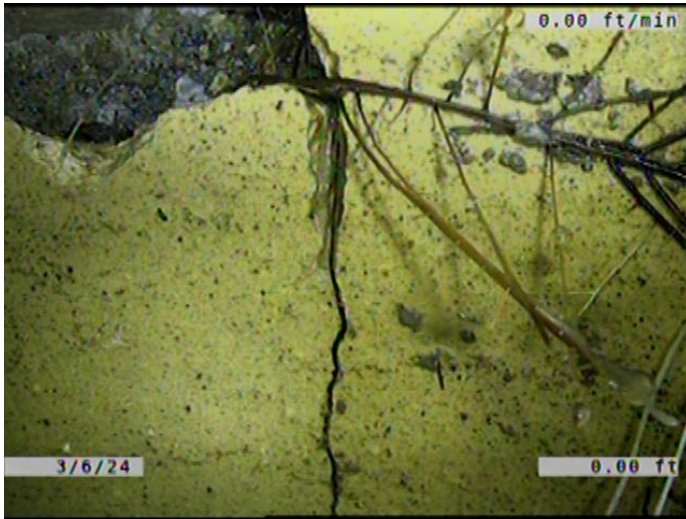
Code: **RFB**
 Description: **Roots Fine Barrel**

Distance (ft): **.0**
 Structural Grade: **0**
 O&M Grade: **2**
 Clock Start/From: **8**
 Clock To: **4**
 1st Value:
 2nd Value:
 Value Percent:
 Continuous Index:
 Within 8" of Joint: **NO**
 Remarks:

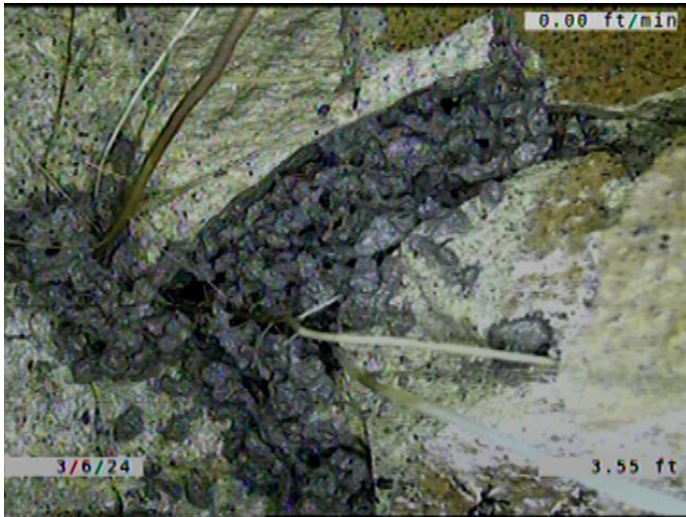
Code: **BSV**
 Description: **Broken Soil Visible**

Distance (ft): **3.6**
 Structural Grade: **5**
 O&M Grade: **0**
 Clock Start/From: **2**
 Clock To: **10**
 1st Value:
 2nd Value:
 Value Percent:
 Continuous Index:
 Within 8" of Joint: **YES**
 Remarks:

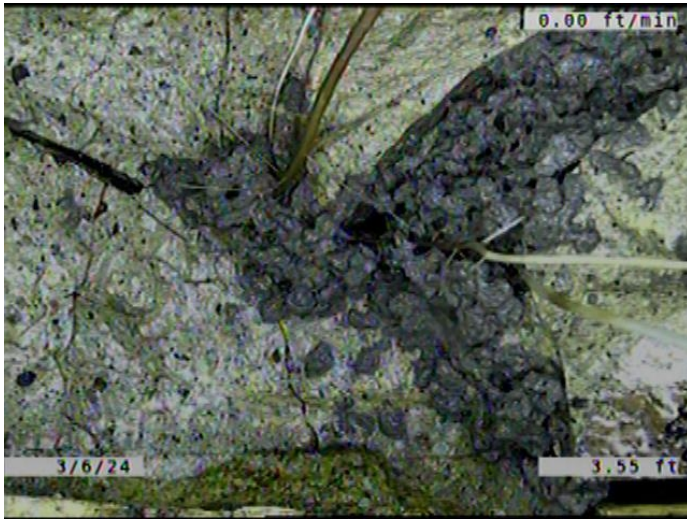
Code: **RFB**
Description: **Roots Fine Barrel**

Distance (ft): **3.6**
Structural Grade: **0**
O&M Grade: **2**
Clock Start/From: **8**
Clock To: **10**
1st Value:
2nd Value:
Value Percent:
Continuous Index:
Within 8" of Joint: **NO**
Remarks:

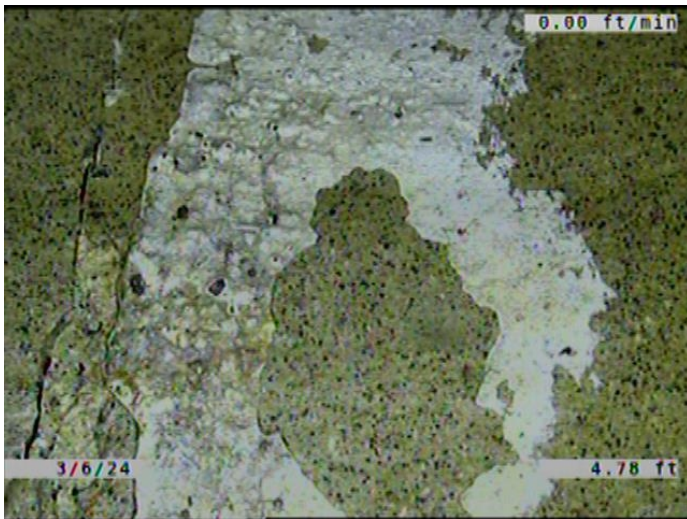
Code: **DAE**
Description: **Deposits Attached Encrustation**

Distance (ft): **4.8**
Structural Grade: **0**
O&M Grade: **2**
Clock Start/From: **7**
Clock To: **5**
1st Value:
2nd Value:
Value Percent: **5.000**
Continuous Index: **S02**
Within 8" of Joint: **YES**
Remarks:

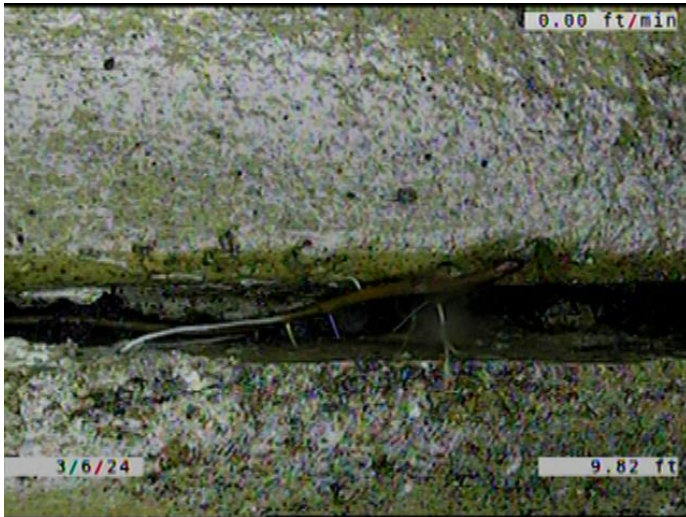
Code: **RFJ**
Description: **Roots Fine Joint**

Distance (ft): **9.8**
Structural Grade: **0**
O&M Grade: **1**
Clock Start/From: **7**
Clock To: **5**
1st Value:
2nd Value:
Value Percent:
Continuous Index: **S03**
Within 8" of Joint: **YES**
Remarks:

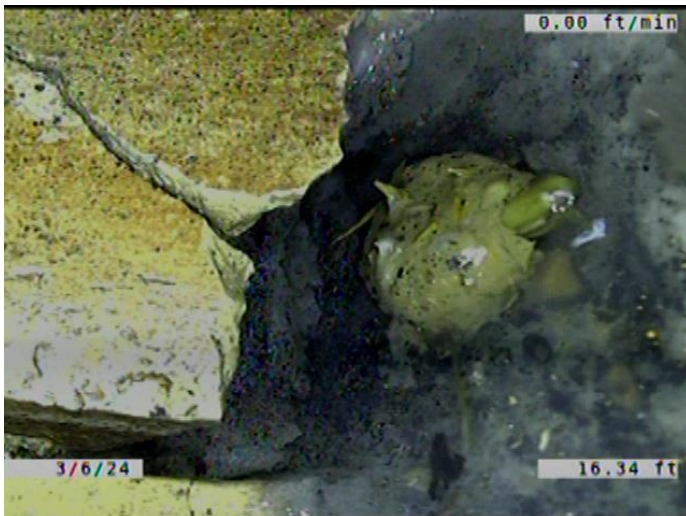
Code: **SMW**
Description: **Surface Damage Missing Wall**

Distance (ft): **16.3**
Structural Grade: **5**
O&M Grade: **0**
Clock Start/From: **7**
Clock To:
1st Value:
2nd Value:
Value Percent:
Continuous Index:
Within 8" of Joint: **YES**
Remarks: **WATER EXITING THE PIPE.**

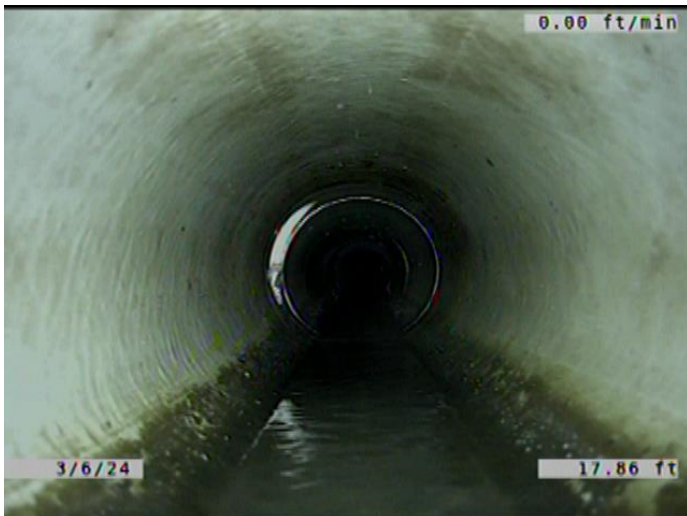
Code: **B**
Description: **Broken**

Distance (ft): **17.4**
Structural Grade: **4**
O&M Grade: **0**
Clock Start/From: **12**
Clock To: **12**
1st Value:
2nd Value:
Value Percent:
Continuous Index: **F01**
Within 8" of Joint: **YES**
Remarks:

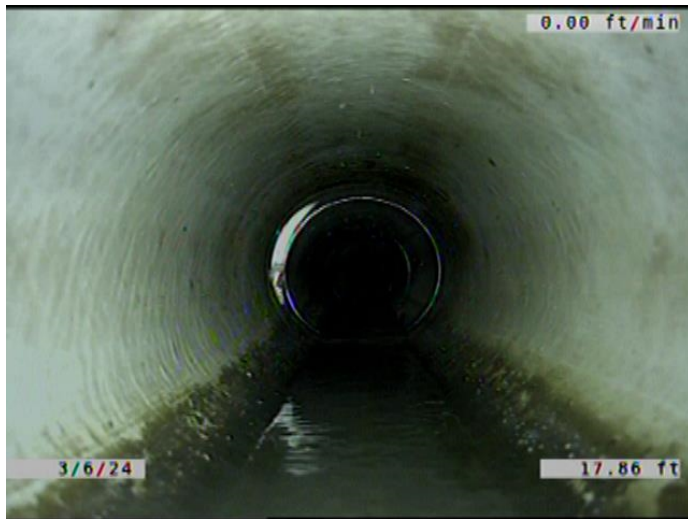
Code: **DAE**
Description: **Deposits Attached Encrustation**

Distance (ft): **17.9**
Structural Grade: **0**
O&M Grade: **2**
Clock Start/From: **7**
Clock To: **5**
1st Value:
2nd Value:
Value Percent: **5.000**
Continuous Index: **F02**
Within 8" of Joint: **YES**
Remarks:

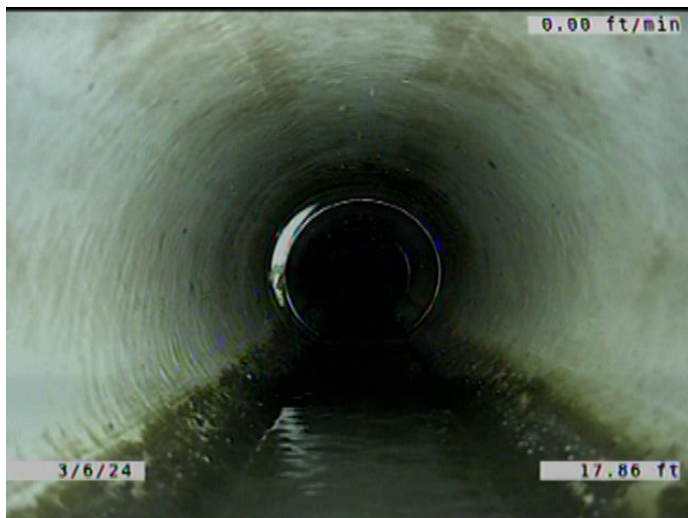
Code: **RFJ**
Description: **Roots Fine Joint**

Distance (ft): **17.9**
Structural Grade: **0**
O&M Grade: **1**
Clock Start/From: **7**
Clock To: **5**
1st Value:
2nd Value:
Value Percent:
Continuous Index: **F03**
Within 8" of Joint: **YES**
Remarks:

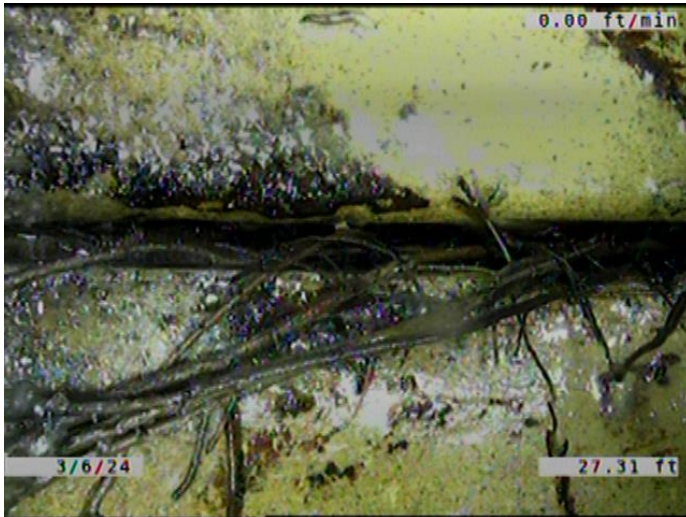
Code: **RFJ**
Description: **Roots Fine Joint**

Distance (ft): **27.3**
Structural Grade: **0**
O&M Grade: **1**
Clock Start/From: **7**
Clock To: **5**
1st Value:
2nd Value:
Value Percent:
Continuous Index: **S05**
Within 8" of Joint: **YES**
Remarks:

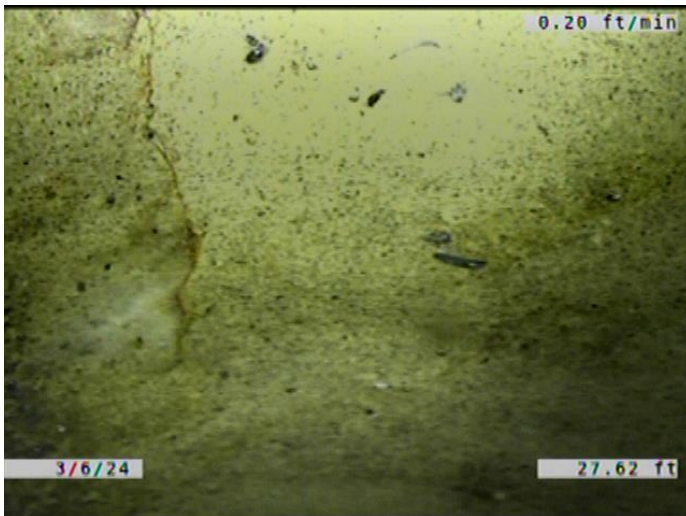
Code: **CM**
Description: **Crack Multiple**

Distance (ft): **27.6**
Structural Grade: **3**
O&M Grade: **0**
Clock Start/From: **8**
Clock To: **11**
1st Value:
2nd Value:
Value Percent:
Continuous Index:
Within 8" of Joint: **YES**
Remarks:

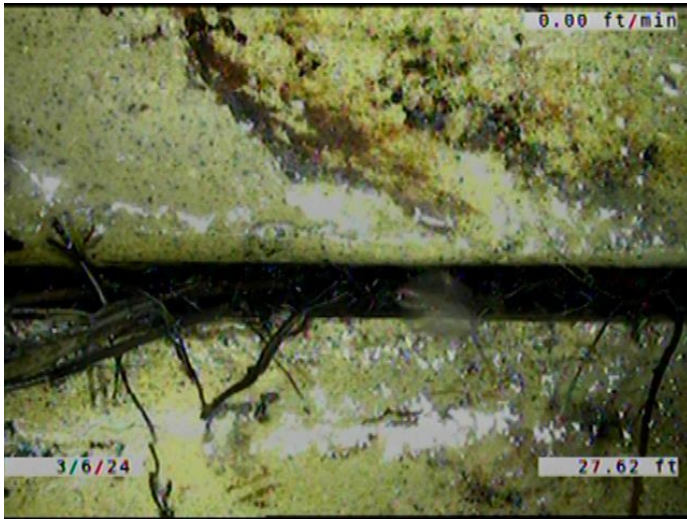
Code: **DAE**
Description: **Deposits Attached Encrustation**

Distance (ft): **27.6**
Structural Grade: **0**
O&M Grade: **2**
Clock Start/From: **7**
Clock To: **5**
1st Value:
2nd Value:
Value Percent: **5.000**
Continuous Index: **S06**
Within 8" of Joint: **YES**
Remarks:

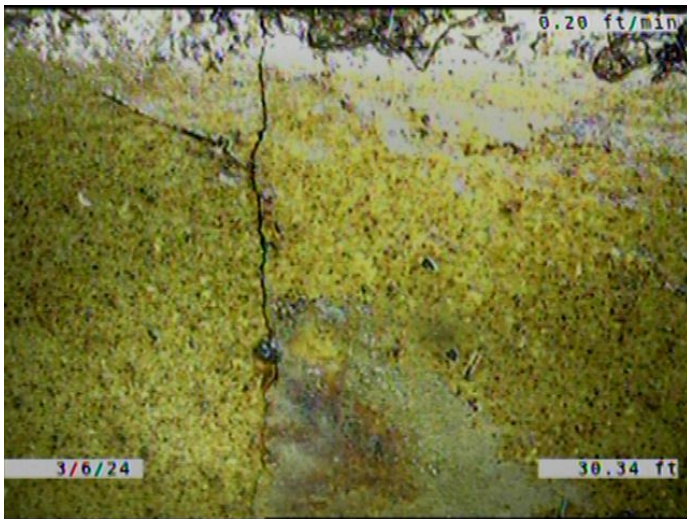
Code: **CM**
Description: **Crack Multiple**

Distance (ft): **30.3**
Structural Grade: **3**
O&M Grade: **0**
Clock Start/From: **2**
Clock To: **4**
1st Value:
2nd Value:
Value Percent:
Continuous Index:
Within 8" of Joint: **YES**
Remarks:

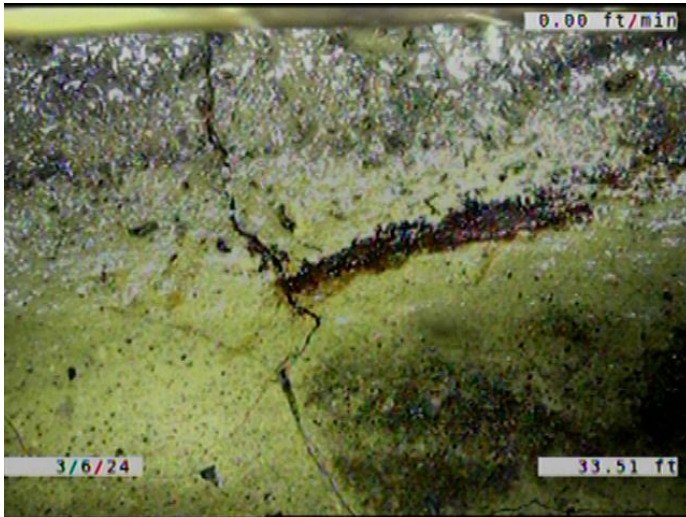
Code: **FM**
 Description: **Fracture Multiple**

Distance (ft): **33.5**
 Structural Grade: **4**
 O&M Grade: **0**
 Clock Start/From: **8**
 Clock To: **3**
 1st Value:
 2nd Value:
 Value Percent:
 Continuous Index:
 Within 8" of Joint: **YES**
 Remarks:

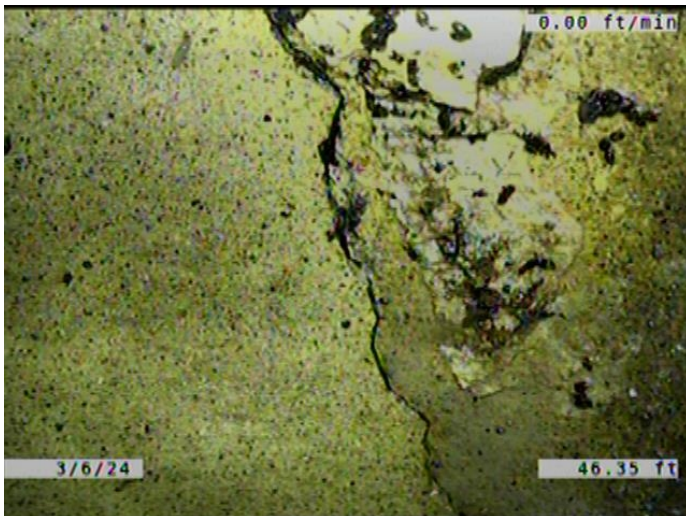
Code: **B**
 Description: **Broken**

Distance (ft): **46.4**
 Structural Grade: **4**
 O&M Grade: **0**
 Clock Start/From: **2**
 Clock To: **4**
 1st Value:
 2nd Value:
 Value Percent:
 Continuous Index:
 Within 8" of Joint: **YES**
 Remarks:

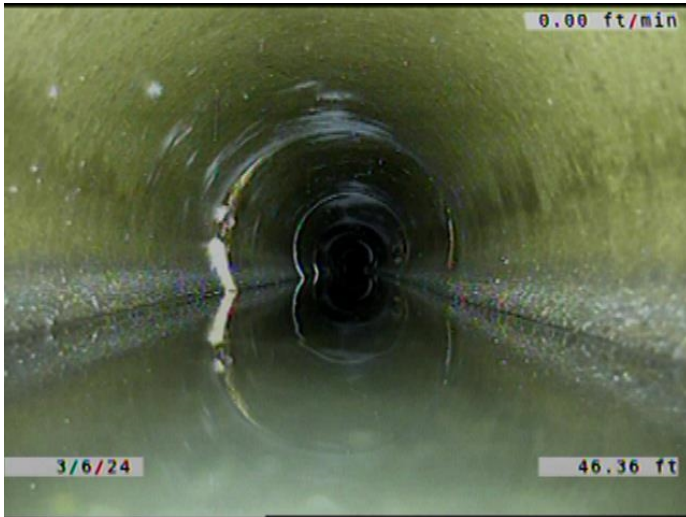
Code: **MWLS**
Description: **Miscellaneous Water Level Sag**

Distance (ft): **46.4**
Structural Grade: **2**
O&M Grade: **0**
Clock Start/From:
Clock To:
1st Value:
2nd Value:
Value Percent: **15.000**
Continuous Index: **S07**
Within 8" of Joint: **NO**
Remarks:

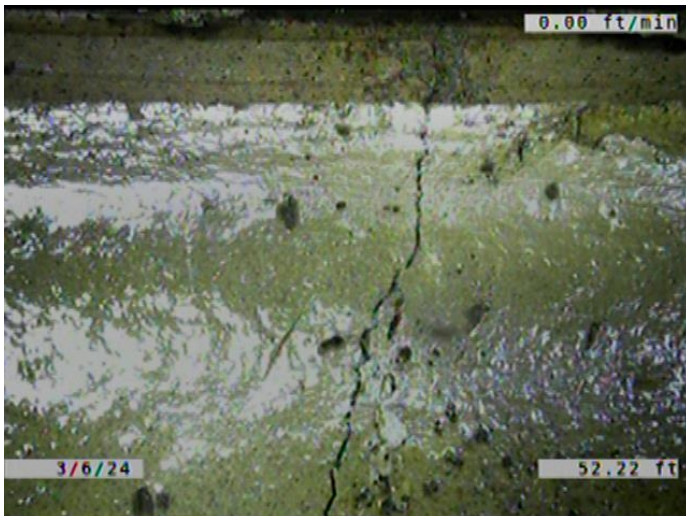
Code: **FM**
Description: **Fracture Multiple**

Distance (ft): **52.2**
Structural Grade: **4**
O&M Grade: **0**
Clock Start/From: **8**
Clock To: **4**
1st Value:
2nd Value:
Value Percent:
Continuous Index:
Within 8" of Joint: **YES**
Remarks:

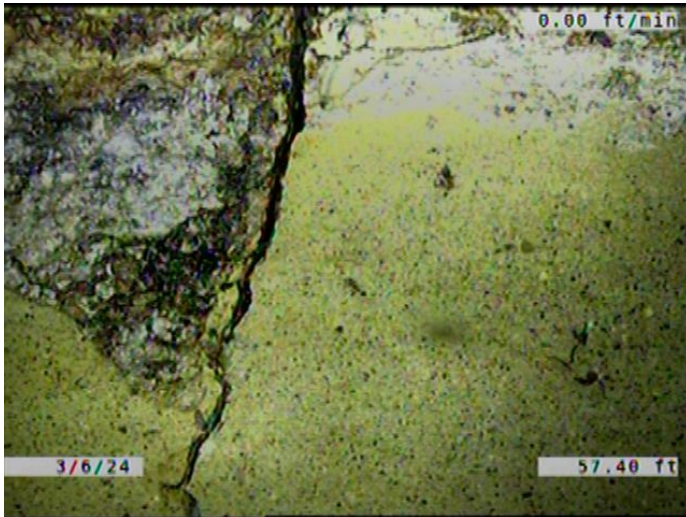
Code: **B**
Description: **Broken**

Distance (ft): **57.4**
Structural Grade: **4**
O&M Grade: **0**
Clock Start/From: **12**
Clock To: **12**
1st Value:
2nd Value:
Value Percent:
Continuous Index: **S09**
Within 8" of Joint: **YES**
Remarks:

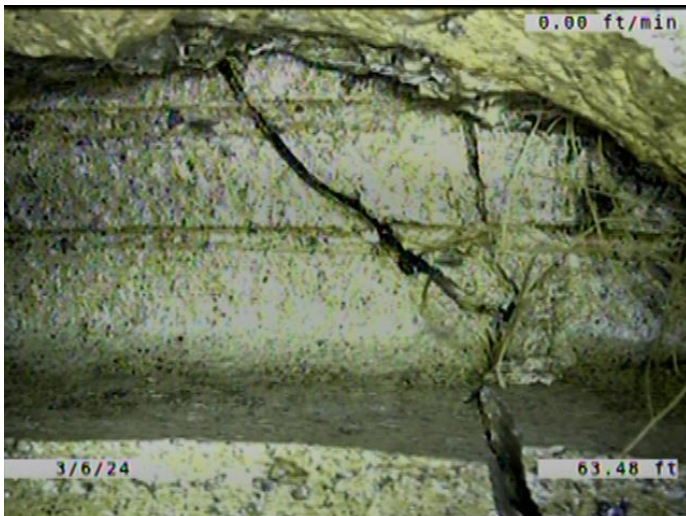
Code: **SMW**
Description: **Surface Damage Missing Wall**

Distance (ft): **63.5**
Structural Grade: **5**
O&M Grade: **0**
Clock Start/From: **11**
Clock To: **3**
1st Value:
2nd Value:
Value Percent:
Continuous Index:
Within 8" of Joint: **YES**
Remarks: **THE INSIDE OF THE JOINT.**

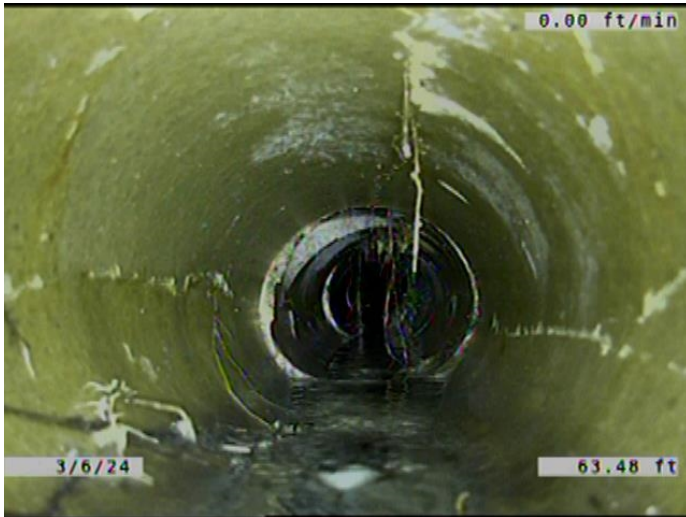
Code: **MWLS**
Description: **Miscellaneous Water Level Sag**

Distance (ft): **63.5**
Structural Grade: **2**
O&M Grade: **0**
Clock Start/From:
Clock To:
1st Value:
2nd Value:
Value Percent: **15.000**
Continuous Index: **F07**
Within 8" of Joint: **NO**
Remarks:

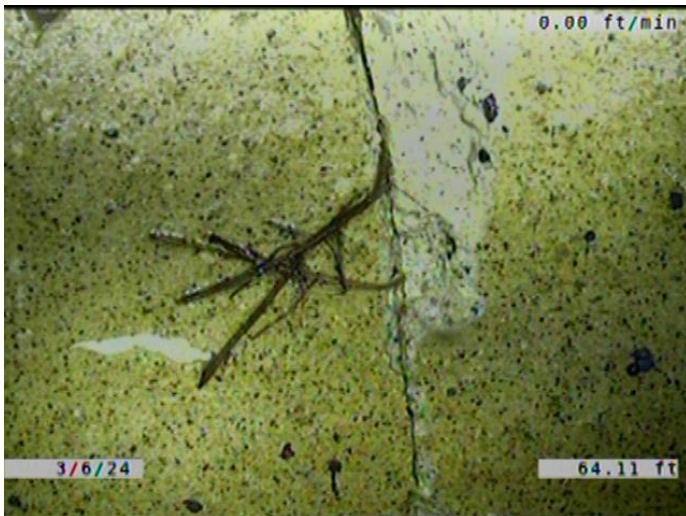
Code: **RFB**
Description: **Roots Fine Barrel**

Distance (ft): **64.1**
Structural Grade: **0**
O&M Grade: **2**
Clock Start/From: **8**
Clock To: **4**
1st Value:
2nd Value:
Value Percent:
Continuous Index: **S10**
Within 8" of Joint: **NO**
Remarks:

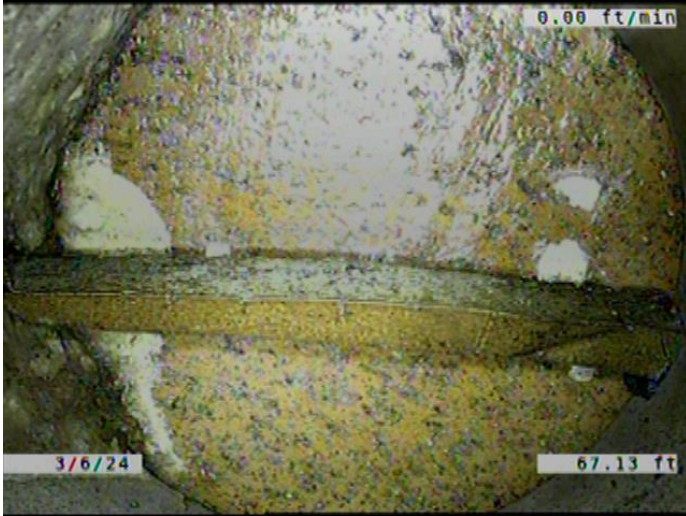
Code:	TFD
Description:	Tap Factory Defective
Distance (ft):	67.1
Structural Grade:	0
O&M Grade:	3
Clock Start/From:	11
Clock To:	
1st Value:	6.000
2nd Value:	
Value Percent:	
Continuous Index:	
Within 8" of Joint:	YES
Remarks:	CAPPED. TAP BROKEN. ENCrustATION COMING AROUND T

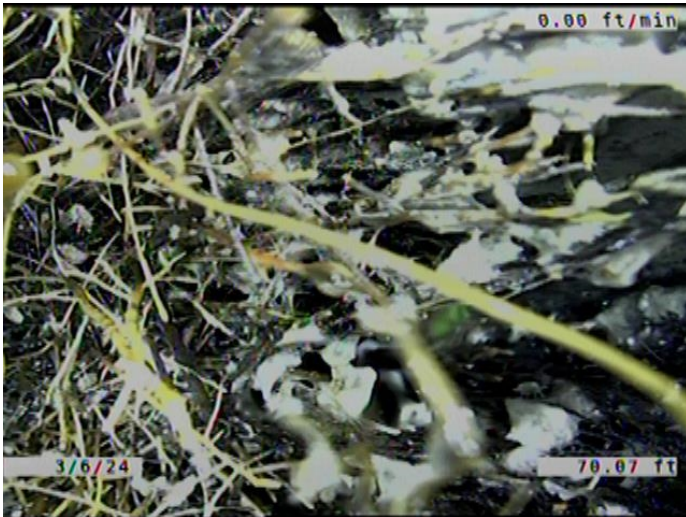
Code:	RML
Description:	Roots Medium Lateral
Distance (ft):	70.1
Structural Grade:	0
O&M Grade:	3
Clock Start/From:	1
Clock To:	3
1st Value:	
2nd Value:	
Value Percent:	10.000
Continuous Index:	
Within 8" of Joint:	NO
Remarks:	ROOTS GROWING DOWN THE SERVICE INTO THE MAIN.

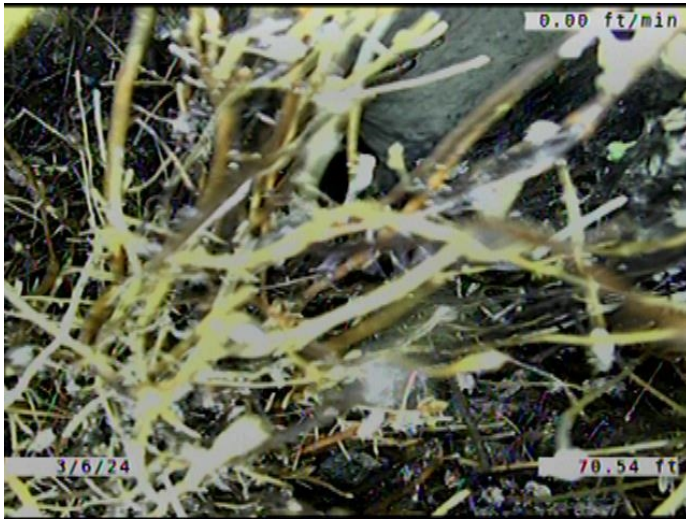
Code:	TFD
Description:	Tap Factory Defective
Distance (ft):	70.5
Structural Grade:	0
O&M Grade:	3
Clock Start/From:	2
Clock To:	
1st Value:	6.000
2nd Value:	
Value Percent:	
Continuous Index:	
Within 8" of Joint:	YES
Remarks:	TAP BROKEN. CONSTANTLY RUNNING WATER. 95% PLUGGED WI

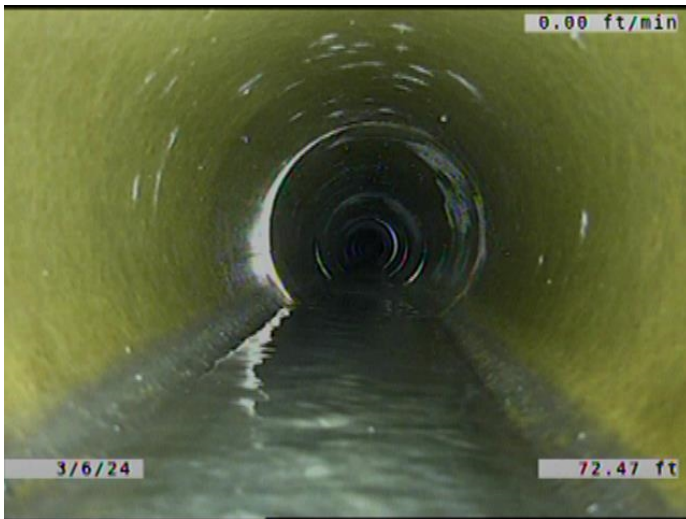
Code:	RFB
Description:	Roots Fine Barrel
Distance (ft):	72.4
Structural Grade:	0
O&M Grade:	2
Clock Start/From:	8
Clock To:	4
1st Value:	
2nd Value:	
Value Percent:	
Continuous Index:	F10
Within 8" of Joint:	NO
Remarks:

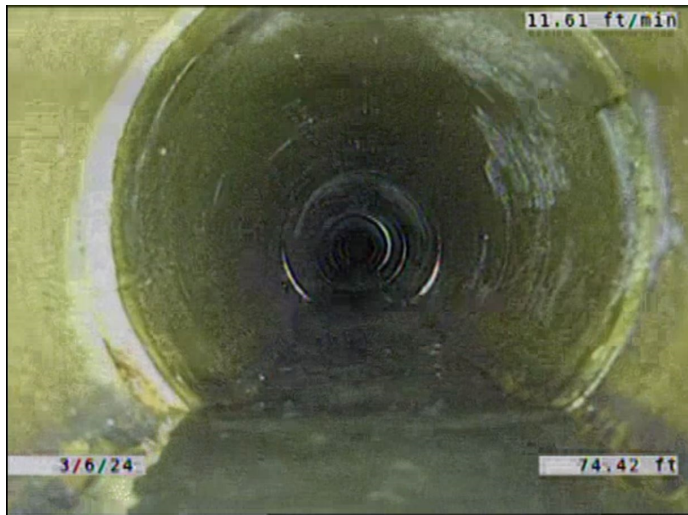
Code: **B**
Description: **Broken**

Distance (ft): **74.4**
Structural Grade: **4**
O&M Grade: **0**
Clock Start/From: **12**
Clock To: **12**
1st Value:
2nd Value:
Value Percent:
Continuous Index: **F09**
Within 8" of Joint: **YES**
Remarks:

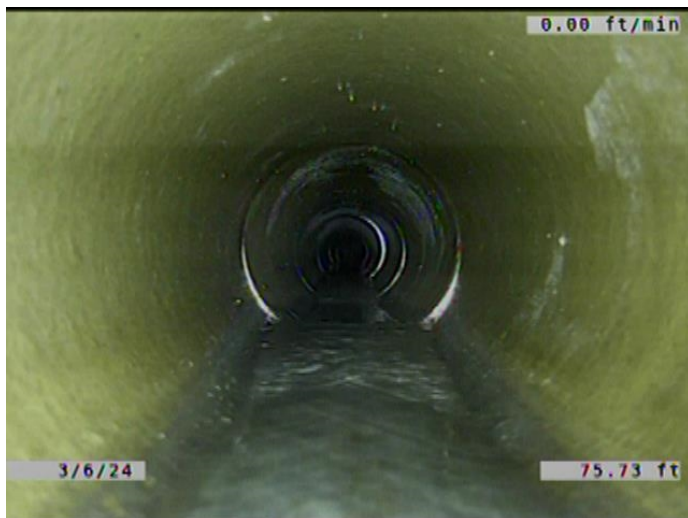
Code: **RFJ**
Description: **Roots Fine Joint**

Distance (ft): **75.7**
Structural Grade: **0**
O&M Grade: **1**
Clock Start/From: **7**
Clock To: **5**
1st Value:
2nd Value:
Value Percent:
Continuous Index: **F05**
Within 8" of Joint: **YES**
Remarks:

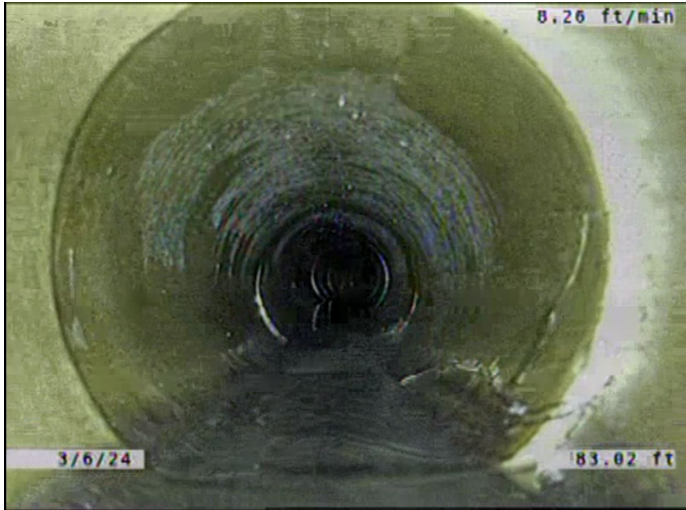
Code: **FM**
Description: **Fracture Multiple**

Distance (ft): **83.0**
Structural Grade: **4**
O&M Grade: **0**
Clock Start/From: **8**
Clock To: **4**
1st Value:
2nd Value:
Value Percent:
Continuous Index: **S08**
Within 8" of Joint: **YES**
Remarks:

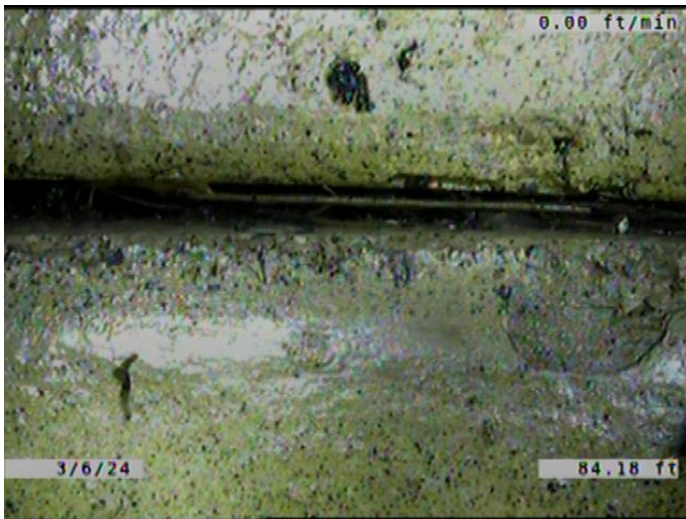
Code: **RFJ**
Description: **Roots Fine Joint**

Distance (ft): **84.2**
Structural Grade: **0**
O&M Grade: **1**
Clock Start/From: **7**
Clock To: **5**
1st Value:
2nd Value:
Value Percent:
Continuous Index: **S11**
Within 8" of Joint: **YES**
Remarks:

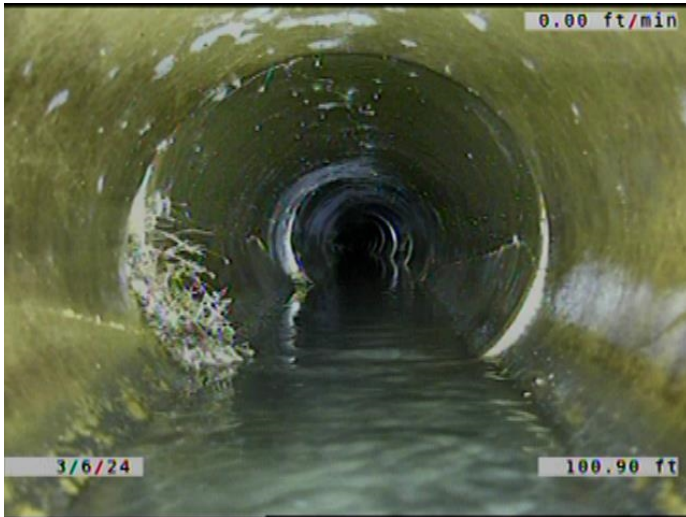
Code:	MWLS
Description:	Miscellaneous Water Level Sag
Distance (ft):	100.9
Structural Grade:	2
O&M Grade:	0
Clock Start/From:	
Clock To:	
1st Value:	
2nd Value:	
Value Percent:	15.000
Continuous Index:	S12
Within 8" of Joint:	NO
Remarks:

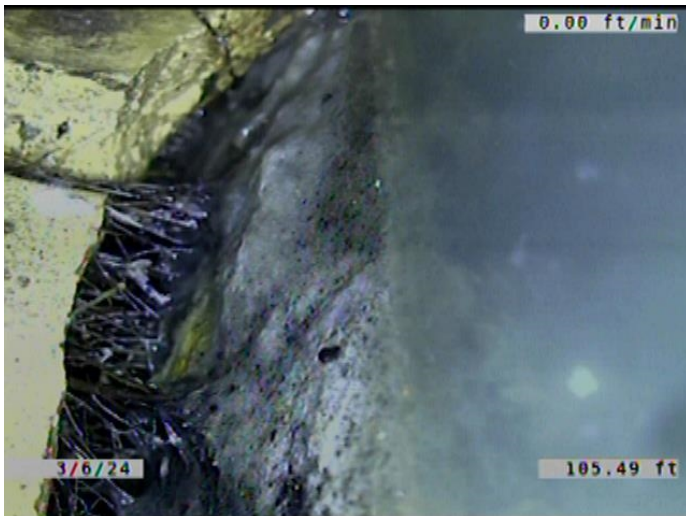
Code:	HVV
Description:	Hole Void Visible
Distance (ft):	105.5
Structural Grade:	5
O&M Grade:	0
Clock Start/From:	6
Clock To:	8
1st Value:	
2nd Value:	
Value Percent:	
Continuous Index:	
Within 8" of Joint:	YES
Remarks:	VOID AND SOIL VISIBLE. WATER EXITING THE PIPE.

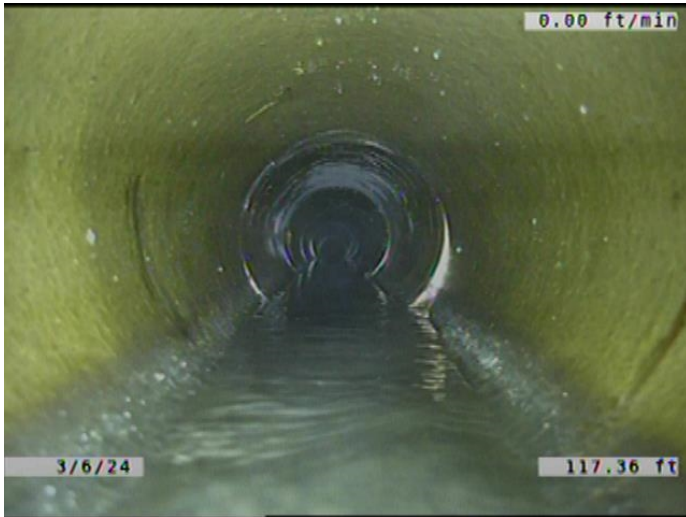
Code: **MWLS**
Description: **Miscellaneous Water Level Sag**

Distance (ft): **117.3**
Structural Grade: **2**
O&M Grade: **0**
Clock Start/From:
Clock To:
1st Value:
2nd Value:
Value Percent: **15.000**
Continuous Index: **F12**
Within 8" of Joint: **NO**
Remarks:

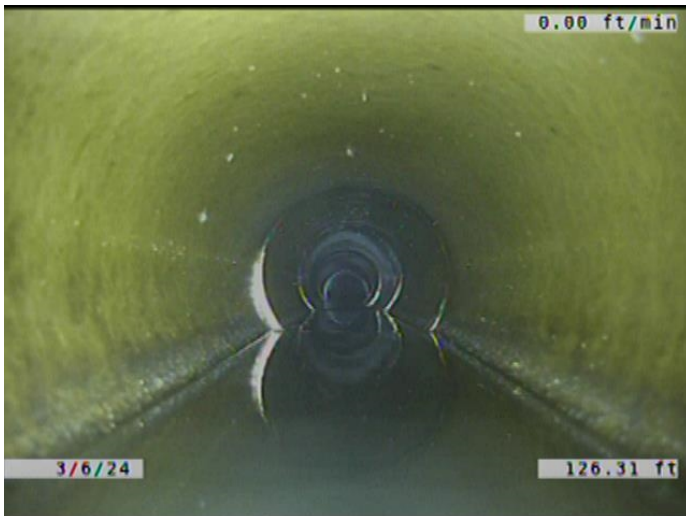
Code: **RFJ**
Description: **Roots Fine Joint**

Distance (ft): **126.3**
Structural Grade: **0**
O&M Grade: **1**
Clock Start/From: **7**
Clock To: **5**
1st Value:
2nd Value:
Value Percent:
Continuous Index: **F11**
Within 8" of Joint: **YES**
Remarks:

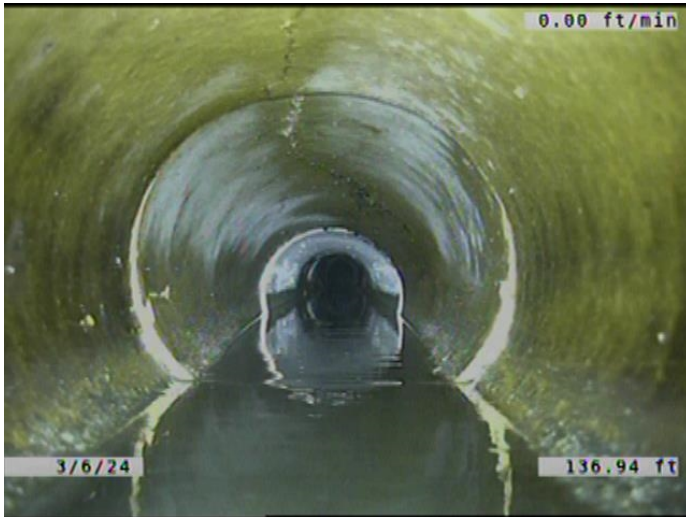
Code: **MWLS**
Description: **Miscellaneous Water Level Sag**

Distance (ft): **136.9**
Structural Grade: **2**
O&M Grade: **0**
Clock Start/From:
Clock To:
1st Value:
2nd Value:
Value Percent: **20.000**
Continuous Index: **S13**
Within 8" of Joint: **NO**
Remarks:

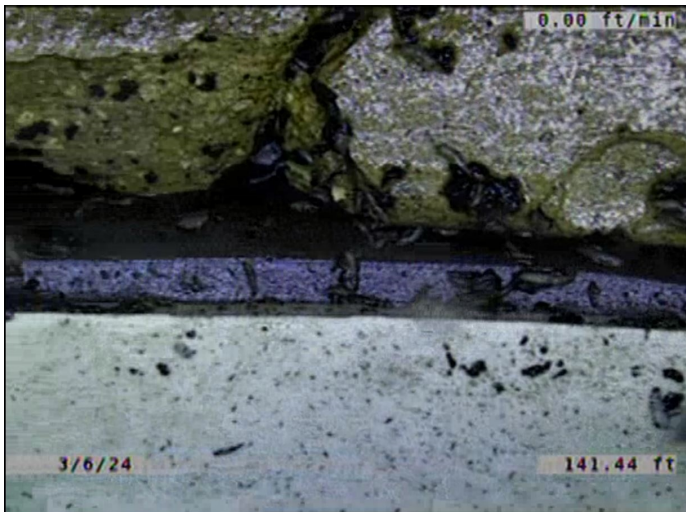
Code: **FM**
Description: **Fracture Multiple**

Distance (ft): **141.4**
Structural Grade: **4**
O&M Grade: **0**
Clock Start/From: **8**
Clock To: **4**
1st Value:
2nd Value:
Value Percent:
Continuous Index: **F08**
Within 8" of Joint: **YES**
Remarks:

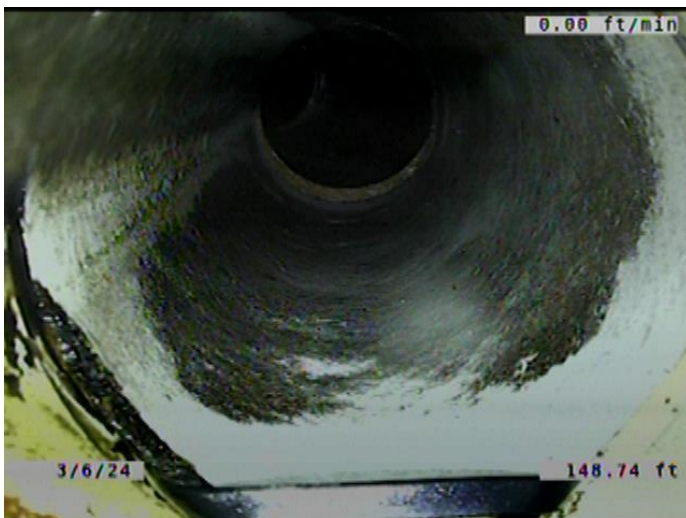
Code: **TFD**
Description: **Tap Factory Defective**

Distance (ft): **148.7**
Structural Grade: **0**
O&M Grade: **3**
Clock Start/From: **10**
Clock To:
1st Value: **6.000**
2nd Value:
Value Percent:
Continuous Index:
Within 8" of Joint: **YES**
Remarks: **TAP PVC. JOINT SEAL ROLLED AND STICKING OUT OF THE JOINT. CONST**

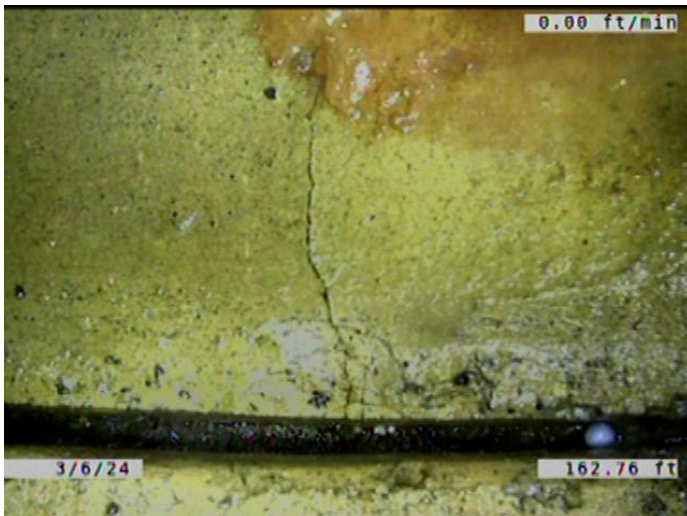
Code: **CL**
 Description: **Crack Longitudinal**

Distance (ft): **162.8**
 Structural Grade: **2**
 O&M Grade: **0**
 Clock Start/From: **8**
 Clock To:
 1st Value:
 2nd Value:
 Value Percent:
 Continuous Index:
 Within 8" of Joint: **YES**
 Remarks:

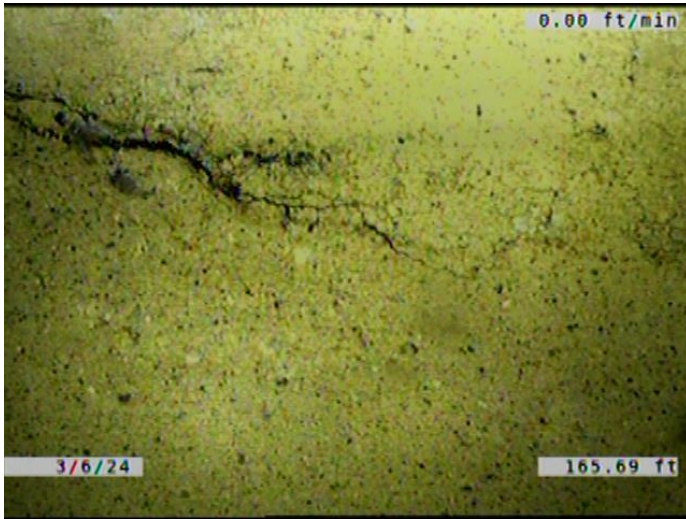
Code: **CM**
Description: **Crack Multiple**

Distance (ft): **165.7**
Structural Grade: **3**
O&M Grade: **0**
Clock Start/From: **1**
Clock To: **6**
1st Value:
2nd Value:
Value Percent:
Continuous Index:
Within 8" of Joint: **YES**
Remarks:

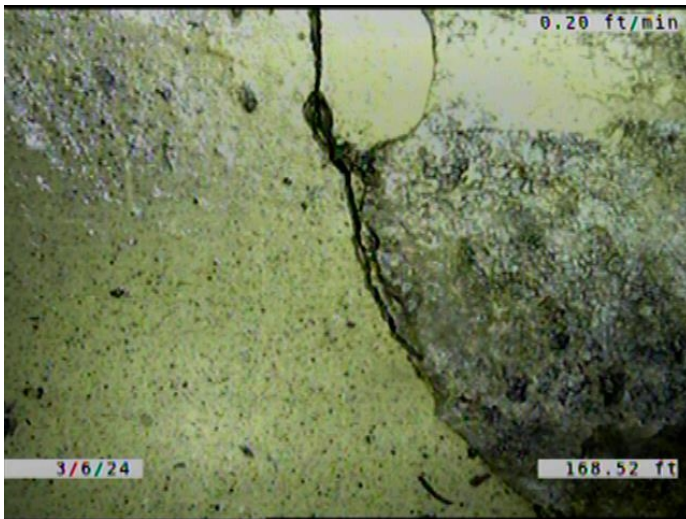
Code: **FM**
Description: **Fracture Multiple**

Distance (ft): **168.5**
Structural Grade: **4**
O&M Grade: **0**
Clock Start/From: **12**
Clock To: **12**
1st Value:
2nd Value:
Value Percent:
Continuous Index: **S16**
Within 8" of Joint: **YES**
Remarks:

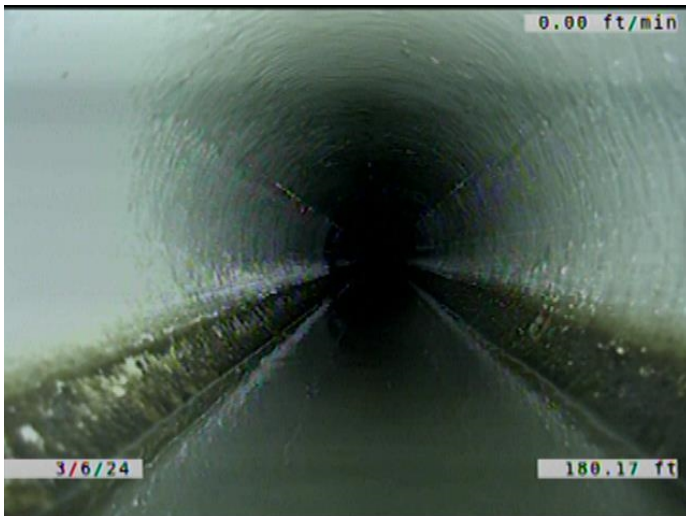
Code: **DAE**
Description: **Deposits Attached Encrustation**

Distance (ft): **180.2**
Structural Grade: **0**
O&M Grade: **2**
Clock Start/From: **7**
Clock To: **5**
1st Value:
2nd Value:
Value Percent: **5.000**
Continuous Index: **F15**
Within 8" of Joint: **YES**
Remarks:

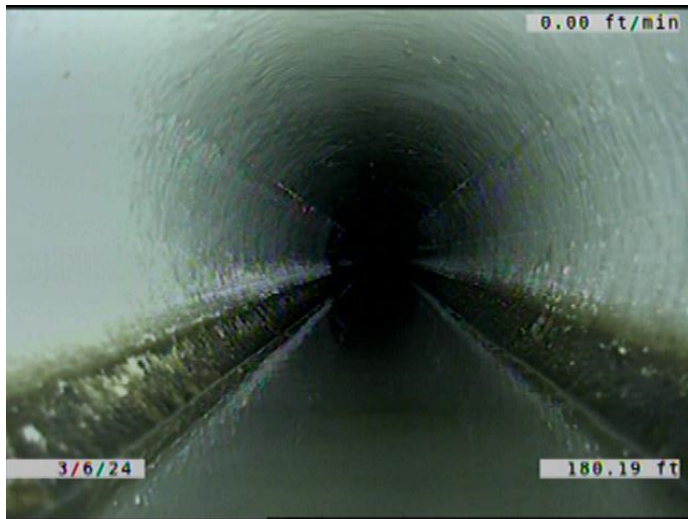
Code: **FM**
Description: **Fracture Multiple**

Distance (ft): **180.2**
Structural Grade: **4**
O&M Grade: **0**
Clock Start/From: **12**
Clock To: **12**
1st Value:
2nd Value:
Value Percent:
Continuous Index: **F16**
Within 8" of Joint: **YES**
Remarks:

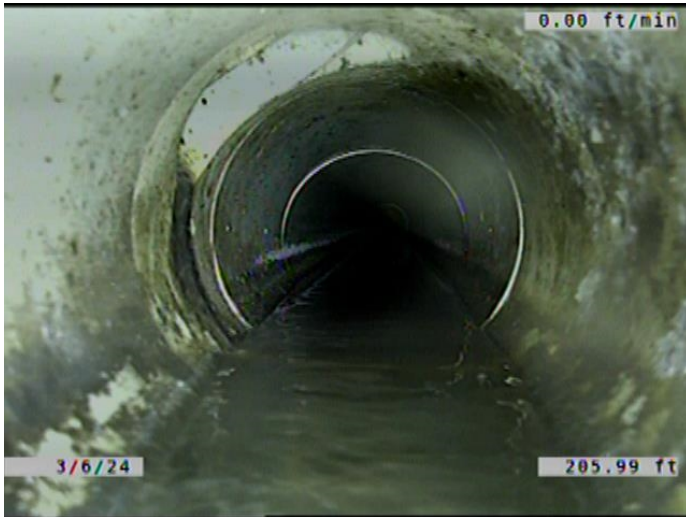
Code: **MWLS**
Description: **Miscellaneous Water Level Sag**

Distance (ft): **206.0**
Structural Grade: **2**
O&M Grade: **0**
Clock Start/From:
Clock To:
1st Value:
2nd Value:
Value Percent: **15.000**
Continuous Index: **S18**
Within 8" of Joint: **NO**
Remarks:

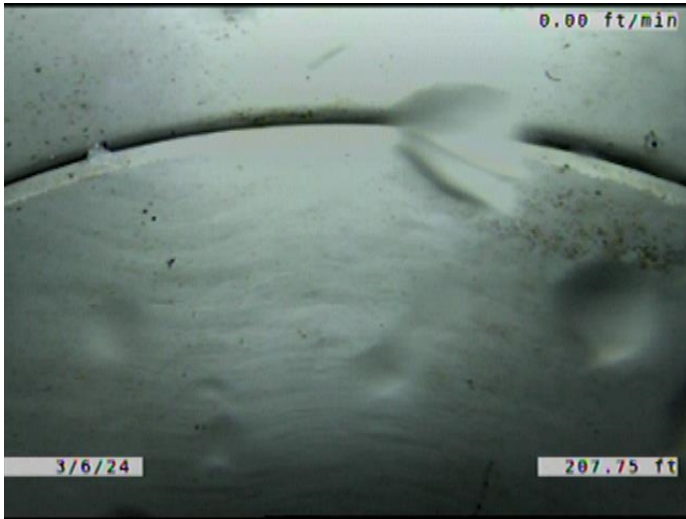
Code: **JOM**
Description: **Joint Offset Medium**

Distance (ft): **207.7**
Structural Grade: **3**
O&M Grade: **0**
Clock Start/From:
Clock To:
1st Value:
2nd Value:
Value Percent:
Continuous Index:
Within 8" of Joint: **NO**
Remarks:

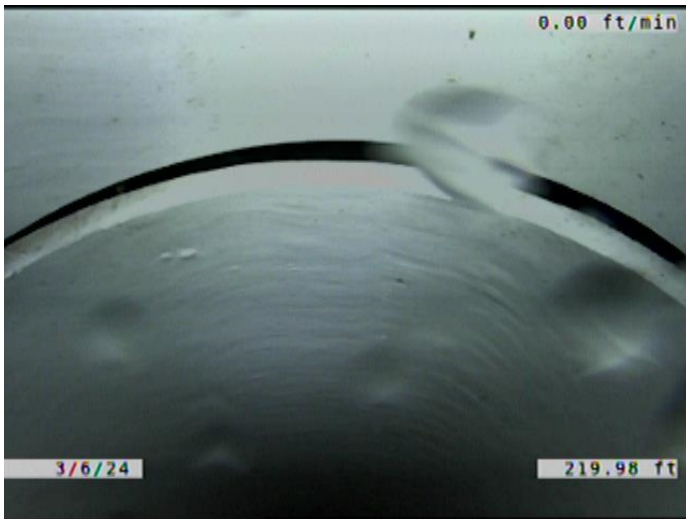
Code: **JOM**
Description: **Joint Offset Medium**

Distance (ft): **220.0**
Structural Grade: **3**
O&M Grade: **0**
Clock Start/From:
Clock To:
1st Value:
2nd Value:
Value Percent:
Continuous Index:
Within 8" of Joint: **NO**
Remarks:

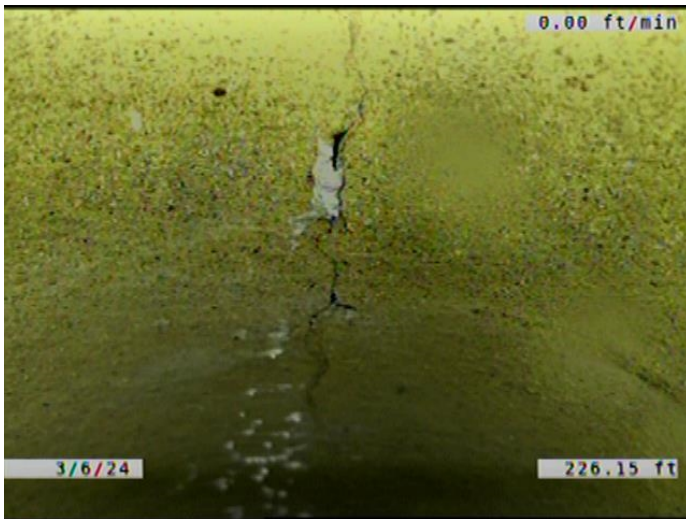
Code: **CM**
Description: **Crack Multiple**

Distance (ft): **226.1**
Structural Grade: **3**
O&M Grade: **0**
Clock Start/From: **11**
Clock To: **2**
1st Value:
2nd Value:
Value Percent:
Continuous Index:
Within 8" of Joint: **YES**
Remarks:

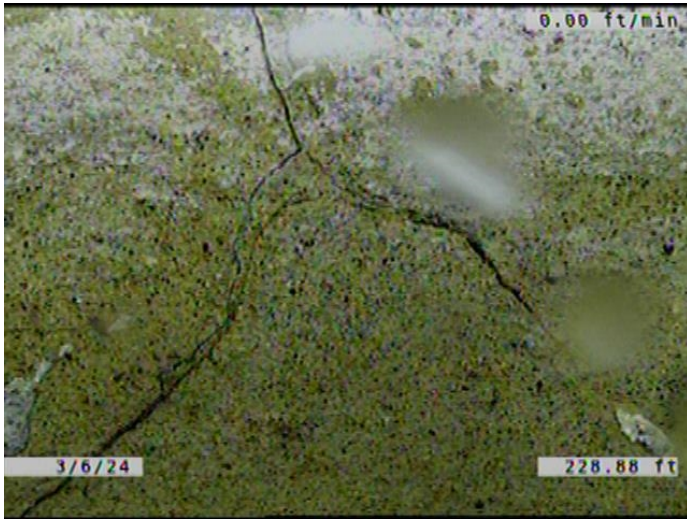
Code: **CM**
Description: **Crack Multiple**

Distance (ft): **228.9**
Structural Grade: **3**
O&M Grade: **0**
Clock Start/From: **10**
Clock To: **4**
1st Value:
2nd Value:
Value Percent:
Continuous Index:
Within 8" of Joint: **YES**
Remarks:

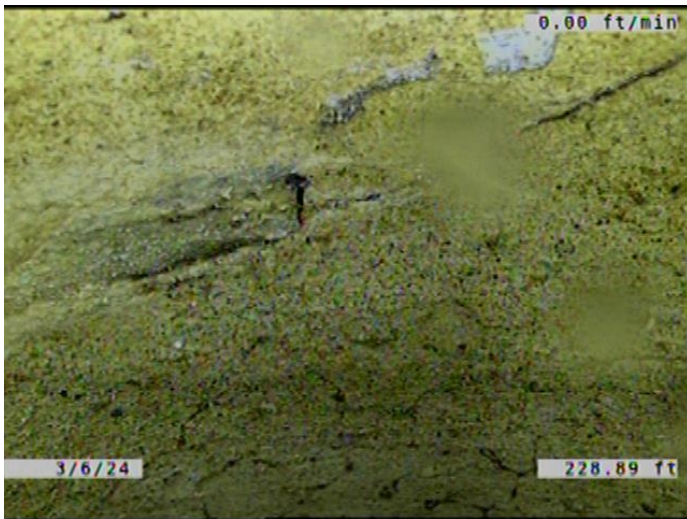
Code: **DAE**
Description: **Deposits Attached Encrustation**

Distance (ft): **228.9**
Structural Grade: **0**
O&M Grade: **2**
Clock Start/From: **7**
Clock To: **5**
1st Value:
2nd Value:
Value Percent: **5.000**
Continuous Index: **S19**
Within 8" of Joint: **YES**
Remarks:

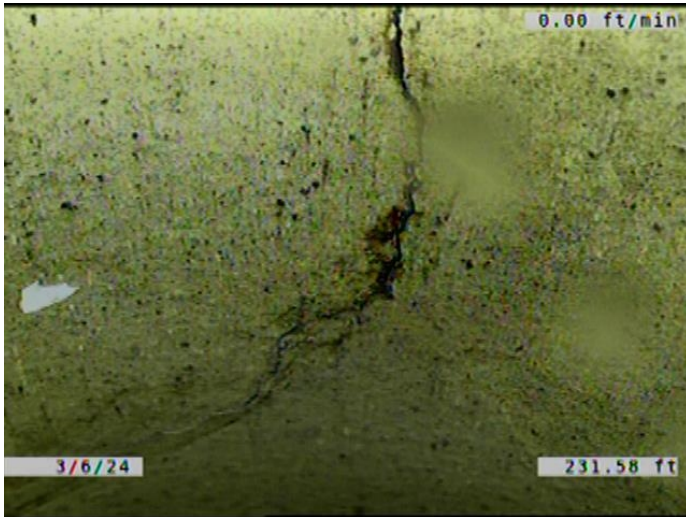
Code: **FM**
Description: **Fracture Multiple**

Distance (ft): **231.6**
Structural Grade: **4**
O&M Grade: **0**
Clock Start/From: **8**
Clock To: **3**
1st Value:
2nd Value:
Value Percent:
Continuous Index:
Within 8" of Joint: **YES**
Remarks:

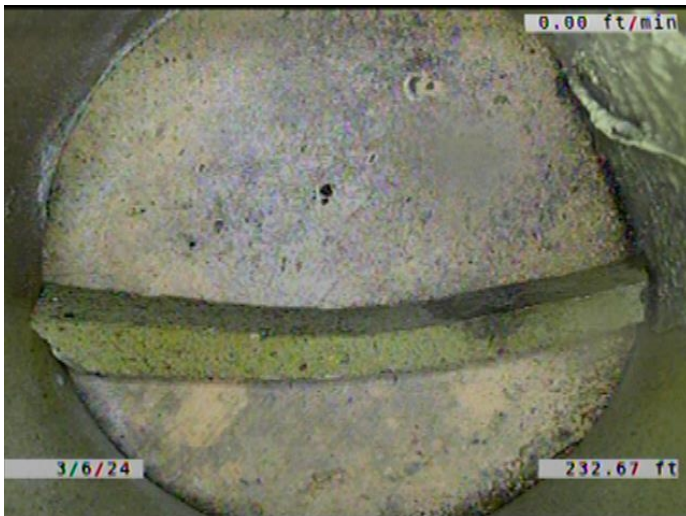
Code: **TFD**
Description: **Tap Factory Defective**

Distance (ft): **232.7**
Structural Grade: **0**
O&M Grade: **3**
Clock Start/From: **2**
Clock To:
1st Value: **6.000**
2nd Value:
Value Percent:
Continuous Index:
Within 8" of Joint: **YES**
Remarks: **CAPPED. TAP FRACTURED.
ENCrustation COMING AROUND T**

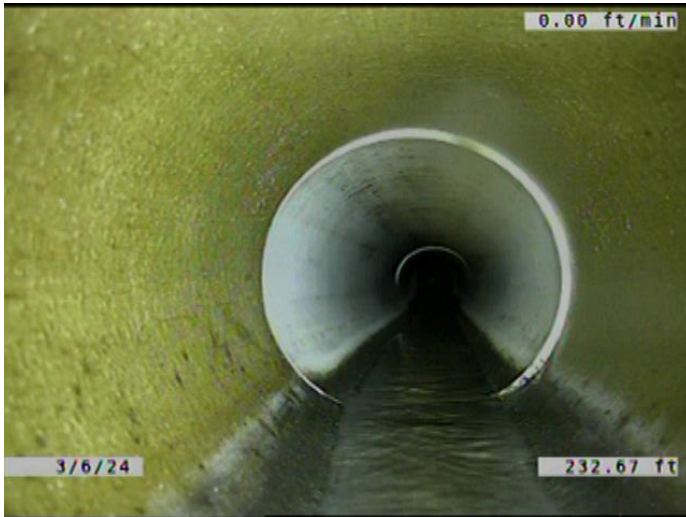
Code: **MWLS**
Description: **Miscellaneous Water Level Sag**

Distance (ft): **232.7**
Structural Grade: **2**
O&M Grade: **0**
Clock Start/From:
Clock To:
1st Value:
2nd Value:
Value Percent: **15.000**
Continuous Index: **F18**
Within 8" of Joint: **NO**
Remarks:

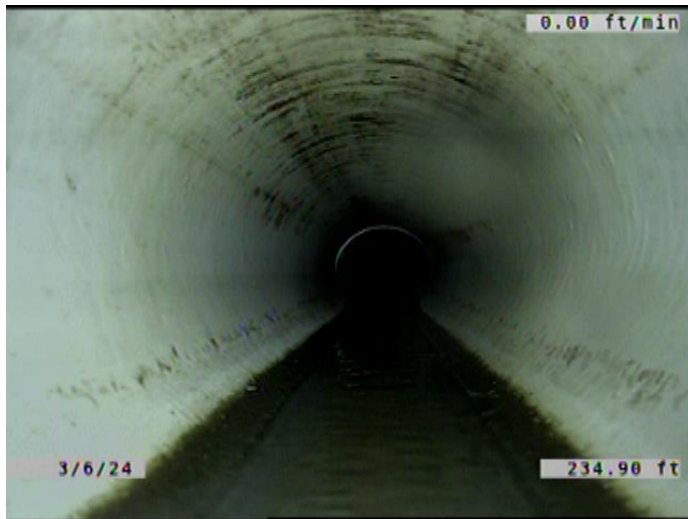
Code: **DAE**
Description: **Deposits Attached Encrustation**

Distance (ft): **234.9**
Structural Grade: **0**
O&M Grade: **2**
Clock Start/From: **7**
Clock To: **5**
1st Value:
2nd Value:
Value Percent: **5.000**
Continuous Index: **F19**
Within 8" of Joint: **YES**
Remarks:

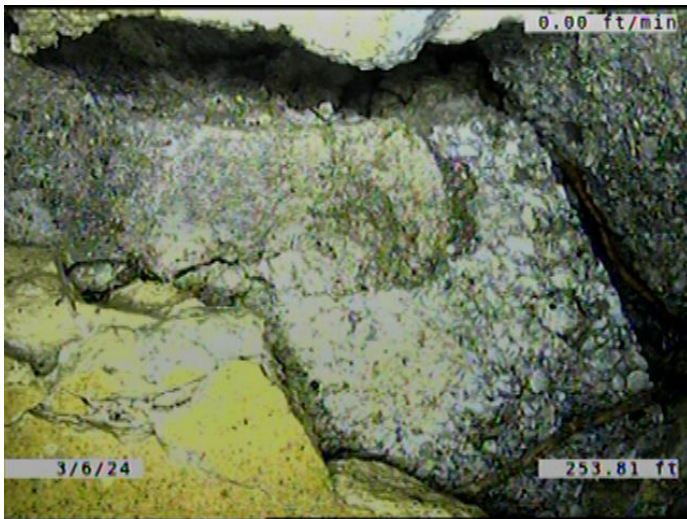
Code: **BSV**
Description: **Broken Soil Visible**

Distance (ft): **253.8**
Structural Grade: **5**
O&M Grade: **0**
Clock Start/From: **9**
Clock To: **2**
1st Value:
2nd Value:
Value Percent:
Continuous Index:
Within 8" of Joint: **YES**
Remarks: **VOID AND SOIL VISIBLE.**
