## Profile/Photo Observation Report

Date:	<b>04/20/2018</b>	Weather:		Coding:	<b>PACP 6.0</b>
Pipe Length (ft):	<b>305.1</b>	Owner:	<b>NA</b>	Pre Clean:	<b>No Pre-Cleaning</b>
P.O.#:		Surveyor:	<b>Byrd Fitzgerald</b>	PSR:	<b>P-405-041-040</b>
Customer:		Clean Date:	<b>01/01/1900</b>	Shape:	<b>C</b>

Street:	<b>ALLEY BETWEEN SOFTWOOD DR &amp; 3</b>	Flow Control:	<b>Not Controlled</b>
City:	<b>Hobart, IN</b>	Year Renewed:	
Location:	<b>Yard</b>	Tape/Media #:	
Purpose:	<b>Routine Assessment</b>	Dia/Height:	<b>8"</b>
Use:	<b>Sanitary</b>	Material:	<b>PVC</b>
Drain Area:	<b>NA</b>	Lining:	
Category:	<b>NA</b>		
Comment:	<b>P_C at 142 ft roots Flow direction wrong</b>		
Location Details:		Direction of Survey:	<b>Upstream</b>
US MH:	<b>M-405-040</b>	DS MH:	<b>M-405-041</b>
		Total Length Surveyed (ft):	<b>143.4</b>

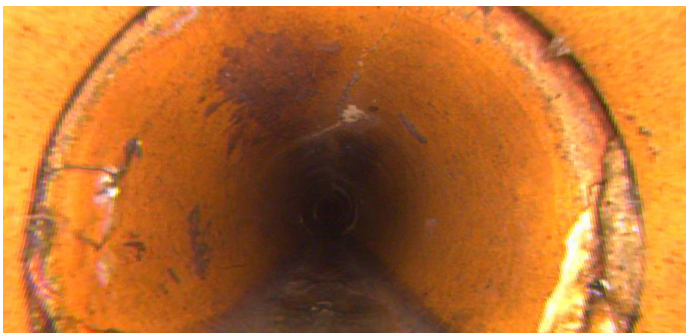
Code: **RFJ**  
Description: **Roots Fine Joint**

Distance (ft): **12.3**  
Structural Grade: **0**  
O&M Grade: **1**  
Clock Start/From: **7**  
Clock To: **5**  
1st Value:  
2nd Value:  
Value Percent:  
Continuous Index: **S01**  
Within 8" of Joint: **YES**  
Remarks: **wandering**

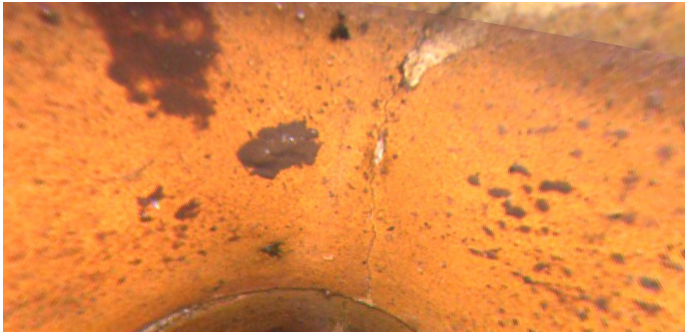
Code: **CL**  
Description: **Crack Longitudinal**

Distance (ft): **15.1**  
Structural Grade: **2**  
O&M Grade: **0**  
Clock Start/From: **12**  
Clock To:  
1st Value:  
2nd Value:  
Value Percent:  
Continuous Index: **S02**  
Within 8" of Joint: **YES**  
Remarks:

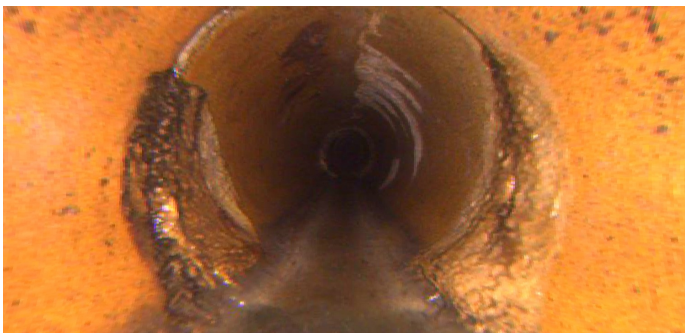
Code: **DAZ**  
Description: **Deposits Attached Other**

Distance (ft): **15.1**  
Structural Grade: **0**  
O&M Grade: **2**  
Clock Start/From: **7**  
Clock To: **5**  
1st Value:  
2nd Value:  
Value Percent: **5.000**  
Continuous Index: **S03**  
Within 8" of Joint: **YES**  
Remarks: **wandering at joint and in barrel**

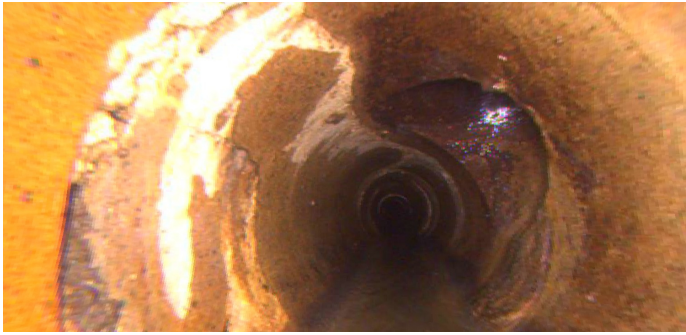
Code: **CM**  
Description: **Crack Multiple**

Distance (ft): **21.3**  
Structural Grade: **3**  
O&M Grade: **0**  
Clock Start/From: **9**  
Clock To: **12**  
1st Value:  
2nd Value:  
Value Percent:  
Continuous Index: **S04**  
Within 8" of Joint: **YES**  
Remarks: **wandering**

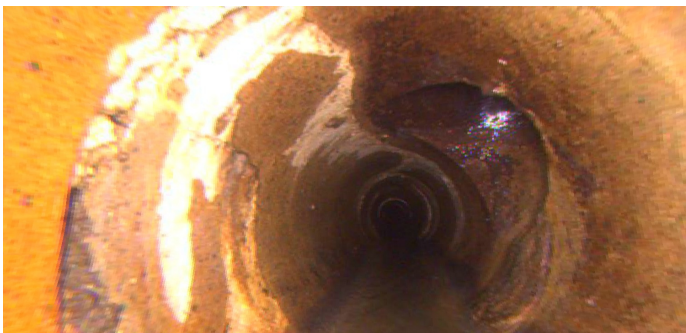
Code: **CL**  
Description: **Crack Longitudinal**

Distance (ft): **21.3**  
Structural Grade: **2**  
O&M Grade: **0**  
Clock Start/From: **12**  
Clock To:  
1st Value:  
2nd Value:  
Value Percent:  
Continuous Index: **F02**  
Within 8" of Joint: **YES**  
Remarks:

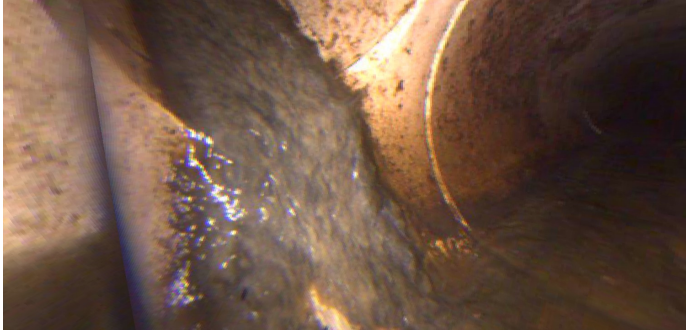
Code: **DAGS**  
Description: **Deposits Attached Grease**

Distance (ft): **53.6**  
Structural Grade: **0**  
O&M Grade: **2**  
Clock Start/From: **7**  
Clock To: **9**  
1st Value:  
2nd Value:  
Value Percent: **5.000**  
Continuous Index:  
Within 8" of Joint: **NO**  
Remarks:

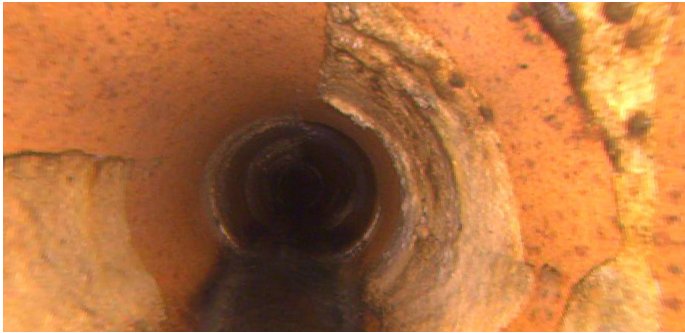
Code: **CH3**  
Description: **Crack Longitudinal Hinge, 3**

Distance (ft): **64.8**  
Structural Grade: **5**  
O&M Grade: **0**  
Clock Start/From: **9**  
Clock To: **3**  
1st Value:  
2nd Value:  
Value Percent:  
Continuous Index: **S05**  
Within 8" of Joint:  
Remarks:

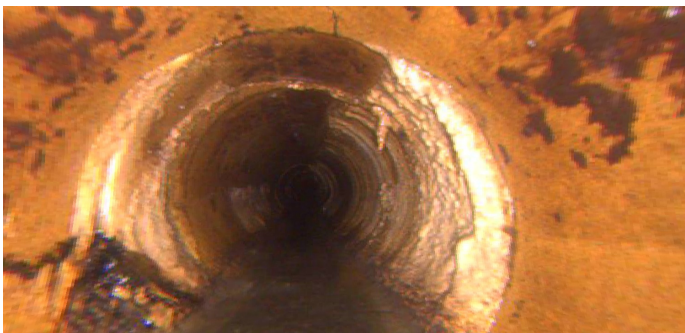
Code: **CH3**  
Description: **Crack Longitudinal Hinge, 3**

Distance (ft): **71.4**  
Structural Grade: **5**  
O&M Grade: **0**  
Clock Start/From: **9**  
Clock To: **3**  
1st Value:  
2nd Value:  
Value Percent:  
Continuous Index: **F05**  
Within 8" of Joint:  
Remarks:

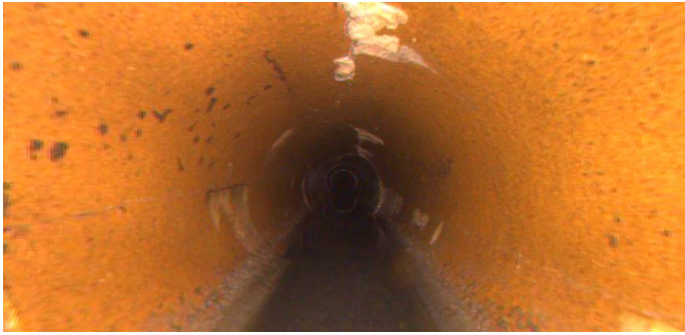
Code: **CH3**  
Description: **Crack Longitudinal Hinge, 3**

Distance (ft): **93.1**  
Structural Grade: **5**  
O&M Grade: **0**  
Clock Start/From: **9**  
Clock To: **3**  
1st Value:  
2nd Value:  
Value Percent:  
Continuous Index: **S06**  
Within 8" of Joint:  
Remarks:

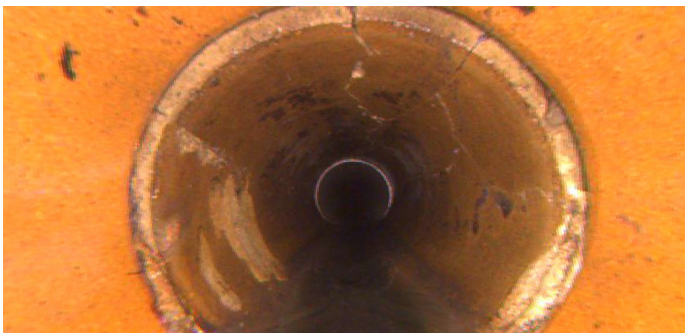
Code: **CH3**  
Description: **Crack Longitudinal Hinge, 3**

Distance (ft): **98.0**  
Structural Grade: **5**  
O&M Grade: **0**  
Clock Start/From: **9**  
Clock To: **3**  
1st Value:  
2nd Value:  
Value Percent:  
Continuous Index: **F06**  
Within 8" of Joint:  
Remarks:

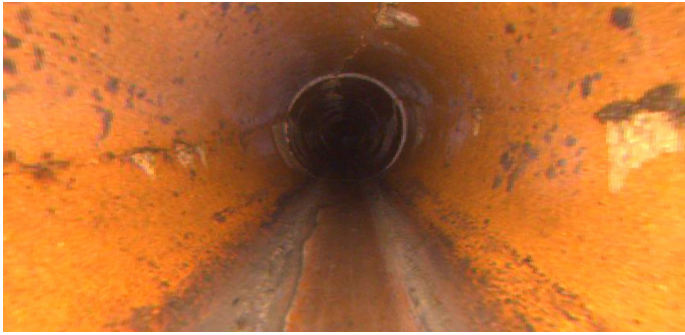
Code: **CH3**  
Description: **Crack Longitudinal Hinge, 3**

Distance (ft): **111.6**  
Structural Grade: **5**  
O&M Grade: **0**  
Clock Start/From: **9**  
Clock To: **3**  
1st Value:  
2nd Value:  
Value Percent:  
Continuous Index: **S07**  
Within 8" of Joint:  
Remarks:

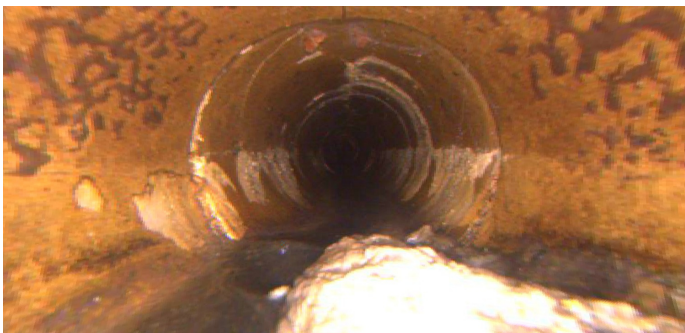
Code: **DSZ**  
Description: **Deposits Settled Other**

Distance (ft): **118.6**  
Structural Grade: **0**  
O&M Grade: **3**  
Clock Start/From: **6**  
Clock To:  
1st Value:  
2nd Value:  
Value Percent: **15.000**  
Continuous Index:  
Within 8" of Joint: **NO**  
Remarks: **tissue/rag**

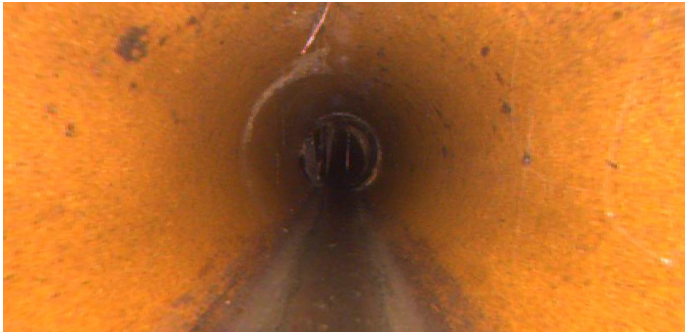
Code: **CH3**  
Description: **Crack Longitudinal Hinge, 3**

Distance (ft): **122.9**  
Structural Grade: **5**  
O&M Grade: **0**  
Clock Start/From: **9**  
Clock To: **3**  
1st Value:  
2nd Value:  
Value Percent:  
Continuous Index: **F07**  
Within 8" of Joint:  
Remarks:

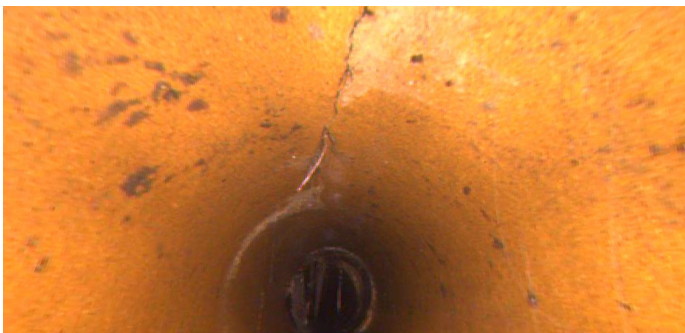
Code: **RFB**  
Description: **Roots Fine Barrel**

Distance (ft): **122.9**  
Structural Grade: **0**  
O&M Grade: **2**  
Clock Start/From: **12**  
Clock To:  
1st Value:  
2nd Value:  
Value Percent:  
Continuous Index:  
Within 8" of Joint: **NO**  
Remarks:

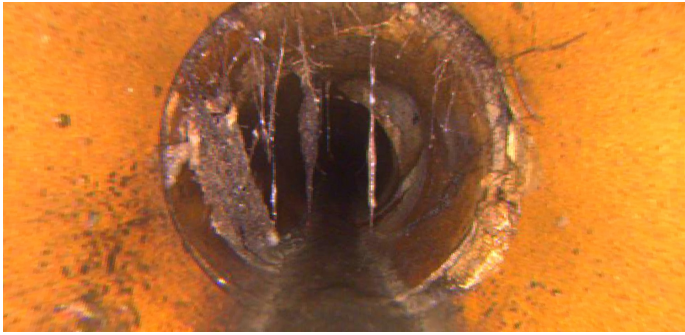
Code: **RMJ**  
Description: **Roots Medium Joint**

Distance (ft): **124.7**  
Structural Grade: **0**  
O&M Grade: **3**  
Clock Start/From: **7**  
Clock To: **5**  
1st Value:  
2nd Value:  
Value Percent: **5.000**  
Continuous Index:  
Within 8" of Joint: **YES**  
Remarks:

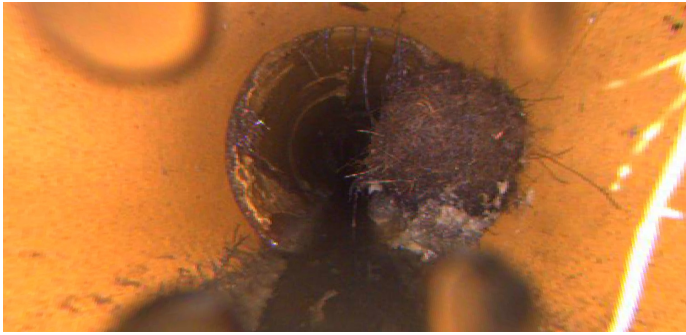
Code: **RBJ**  
Description: **Roots Ball Joint**

Distance (ft): **142.4**  
Structural Grade: **0**  
O&M Grade: **4**  
Clock Start/From: **2**  
Clock To: **5**  
1st Value:  
2nd Value:  
Value Percent: **55.000**  
Continuous Index:  
Within 8" of Joint: **YES**  
Remarks:

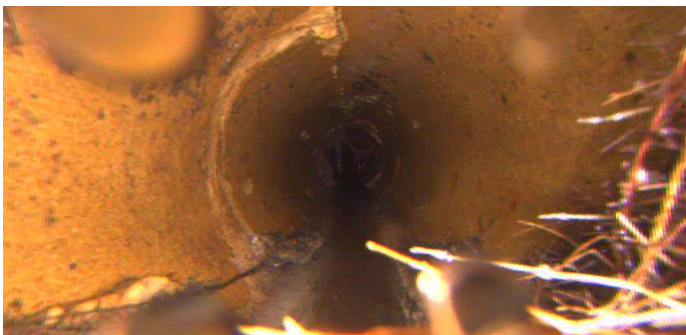
Code: **CM**  
Description: **Crack Multiple**

Distance (ft): **143.4**  
Structural Grade: **3**  
O&M Grade: **0**  
Clock Start/From: **9**  
Clock To: **12**  
1st Value:  
2nd Value:  
Value Percent:  
Continuous Index: **F04**  
Within 8" of Joint: **YES**  
Remarks: **wandering**

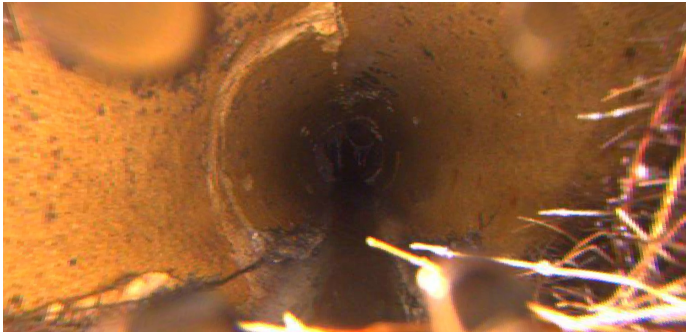
Code: **DAZ**  
Description: **Deposits Attached Other**

Distance (ft): **143.4**  
Structural Grade: **0**  
O&M Grade: **2**  
Clock Start/From: **7**  
Clock To: **5**  
1st Value:  
2nd Value:  
Value Percent: **5.000**  
Continuous Index: **F03**  
Within 8" of Joint: **YES**  
Remarks: **wandering at joint and in barrel**

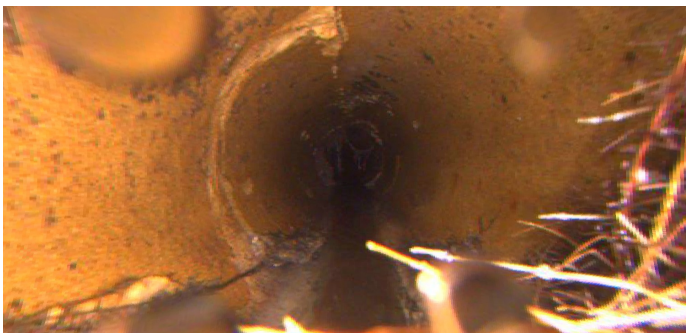
Code: **RFJ**  
Description: **Roots Fine Joint**

Distance (ft): **143.4**  
Structural Grade: **0**  
O&M Grade: **1**  
Clock Start/From: **7**  
Clock To: **5**  
1st Value:  
2nd Value:  
Value Percent:  
Continuous Index: **F01**  
Within 8" of Joint: **YES**  
Remarks: **wandering**

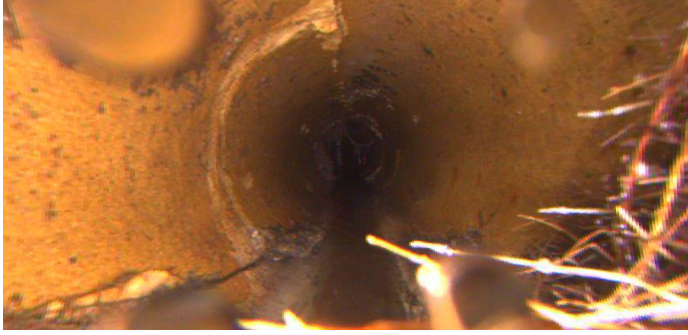
Code:	<b>MSA</b>
Description:	<b>Abandoned Survey</b>
Distance (ft):	<b>143.4</b>
Structural Grade:	<b>0</b>
O&M Grade:	<b>0</b>
Clock Start/From:	
Clock To:	
1st Value:	
2nd Value:	
Value Percent:	
Continuous Index:	
Within 8" of Joint:	<b>NO</b>
Remarks:	<b>rbj</b>
