Profile/Photo Observation Report

Date:	04/20/2018	Weather:		Coding:	PACP 6.0
Pipe Length (ft):	305.1	Owner:	NA	Pre Clean:	No Pre-Cleaning
P.O.#:		Surveyor:	Byrd Fitzgerald	PSR:	P-405-041-040
Customer:		Clean Date:	01/01/1900	Shape:	C

Street:	FOXCROFT STREET	Flow Control:	Not Controlled
City:	Hobart, IN	Year Renewed:	
Location:	Yard	Tape/Media #:	
Purpose:	Routine Assessment	Dia/Height:	8"
Use:	Sanitary	Material:	PVC
Drain Area:	NA	Lining:	
Category:	NA		
Comment:	P_C at 142 ft roots Flow direction wrong		
Location Details:		Direction of Survey:	Upstream
US MH:	M-405-040	DS MH:	M-405-041
		Total Length Surveyed (ft):	143.4

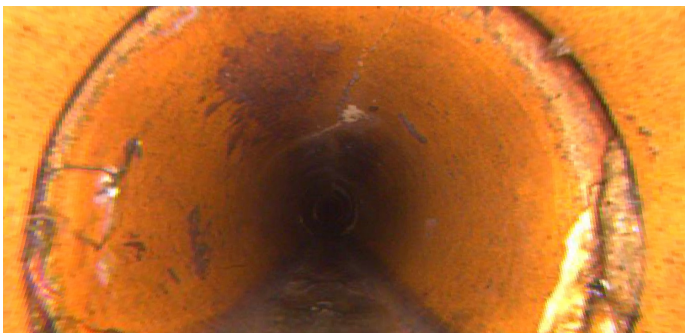
Code: **RFJ**
Description: **Roots Fine Joint**

Distance (ft): **12.3**
Structural Grade: **0**
O&M Grade: **1**
Clock Start/From: **7**
Clock To: **5**
1st Value:
2nd Value:
Value Percent:
Continuous Index: **S01**
Within 8" of Joint: **YES**
Remarks: **wandering**

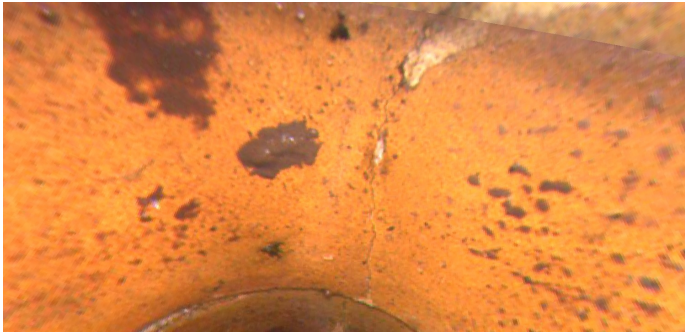
Code: **CL**
Description: **Crack Longitudinal**

Distance (ft): **15.1**
Structural Grade: **2**
O&M Grade: **0**
Clock Start/From: **12**
Clock To:
1st Value:
2nd Value:
Value Percent:
Continuous Index: **S02**
Within 8" of Joint: **YES**
Remarks:

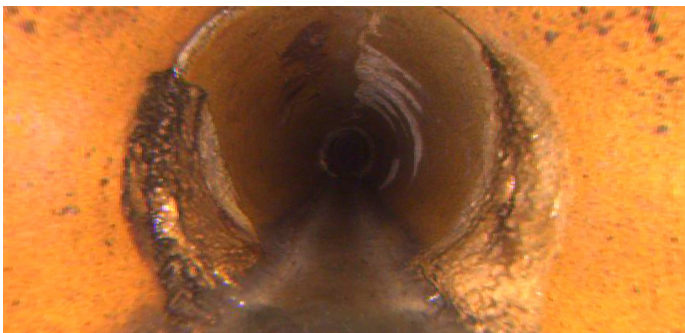
Code: **DAZ**
Description: **Deposits Attached Other**

Distance (ft): **15.1**
Structural Grade: **0**
O&M Grade: **2**
Clock Start/From: **7**
Clock To: **5**
1st Value:
2nd Value:
Value Percent: **5.000**
Continuous Index: **S03**
Within 8" of Joint: **YES**
Remarks: **wandering at joint and in barrel**

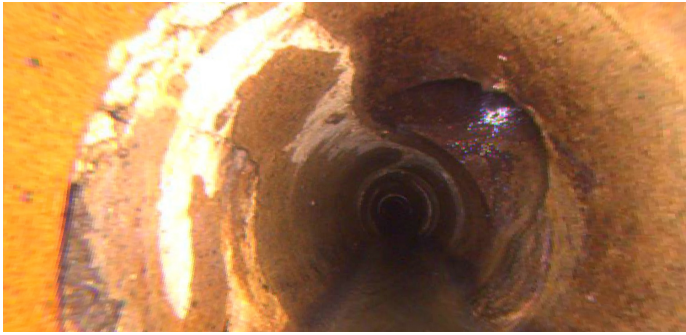
Code: **CM**
Description: **Crack Multiple**

Distance (ft): **21.3**
Structural Grade: **3**
O&M Grade: **0**
Clock Start/From: **9**
Clock To: **12**
1st Value:
2nd Value:
Value Percent:
Continuous Index: **S04**
Within 8" of Joint: **YES**
Remarks: **wandering**

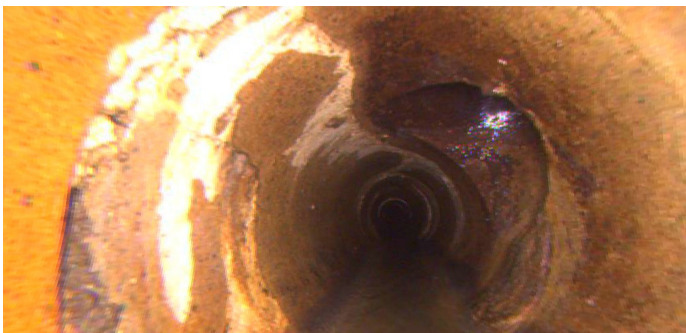
Code: **CL**
Description: **Crack Longitudinal**

Distance (ft): **21.3**
Structural Grade: **2**
O&M Grade: **0**
Clock Start/From: **12**
Clock To:
1st Value:
2nd Value:
Value Percent:
Continuous Index: **F02**
Within 8" of Joint: **YES**
Remarks:

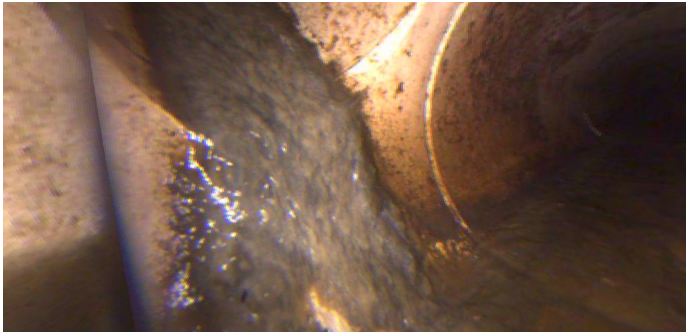
Code: **DAGS**
Description: **Deposits Attached Grease**

Distance (ft): **53.6**
Structural Grade: **0**
O&M Grade: **2**
Clock Start/From: **7**
Clock To: **9**
1st Value:
2nd Value:
Value Percent: **5.000**
Continuous Index:
Within 8" of Joint: **NO**
Remarks:

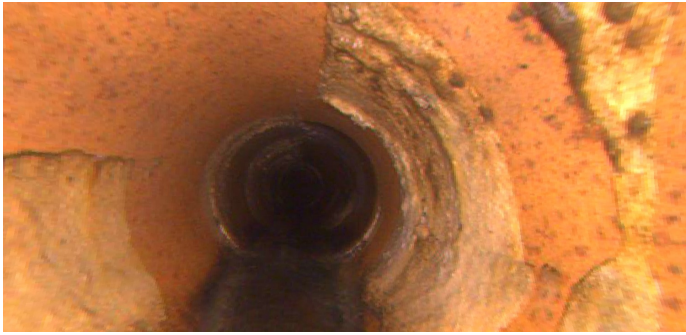
Code: **CH3**
Description: **Crack Longitudinal Hinge, 3**

Distance (ft): **64.8**
Structural Grade: **5**
O&M Grade: **0**
Clock Start/From: **9**
Clock To: **3**
1st Value:
2nd Value:
Value Percent:
Continuous Index: **S05**
Within 8" of Joint:
Remarks:

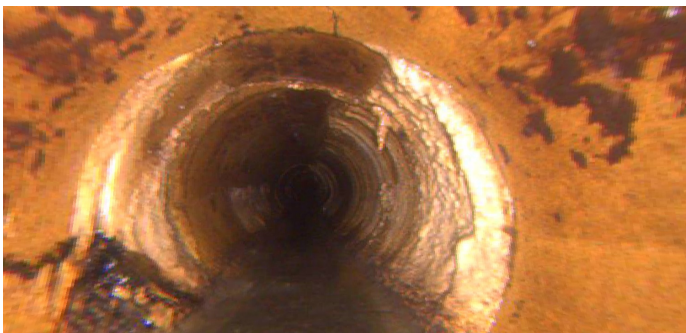
Code: **CH3**
Description: **Crack Longitudinal Hinge, 3**

Distance (ft): **71.4**
Structural Grade: **5**
O&M Grade: **0**
Clock Start/From: **9**
Clock To: **3**
1st Value:
2nd Value:
Value Percent:
Continuous Index: **F05**
Within 8" of Joint:
Remarks:

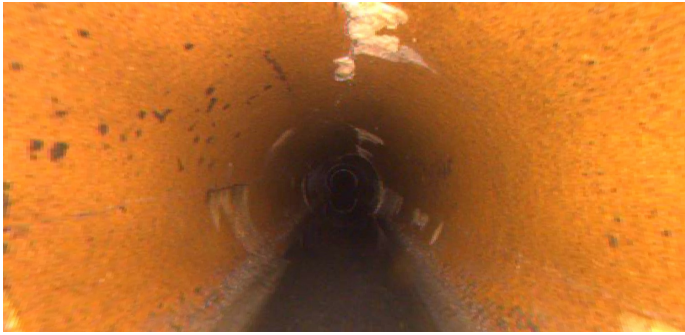
Code: **CH3**
Description: **Crack Longitudinal Hinge, 3**

Distance (ft): **93.1**
Structural Grade: **5**
O&M Grade: **0**
Clock Start/From: **9**
Clock To: **3**
1st Value:
2nd Value:
Value Percent:
Continuous Index: **S06**
Within 8" of Joint:
Remarks:

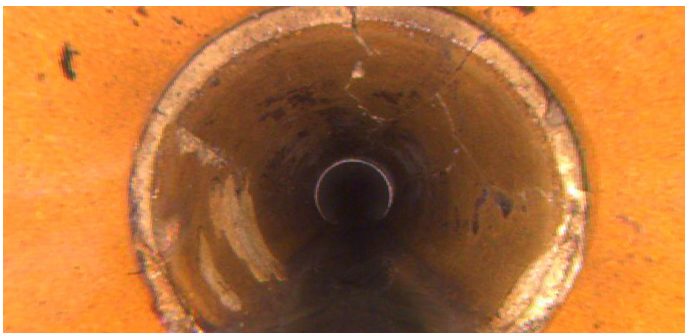
Code: **CH3**
Description: **Crack Longitudinal Hinge, 3**

Distance (ft): **98.0**
Structural Grade: **5**
O&M Grade: **0**
Clock Start/From: **9**
Clock To: **3**
1st Value:
2nd Value:
Value Percent:
Continuous Index: **F06**
Within 8" of Joint:
Remarks:

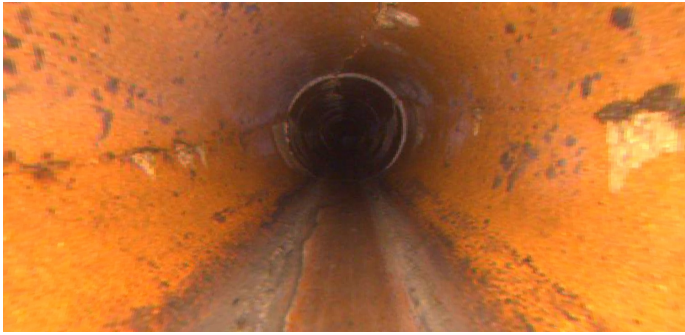
Code: **CH3**
Description: **Crack Longitudinal Hinge, 3**

Distance (ft): **111.6**
Structural Grade: **5**
O&M Grade: **0**
Clock Start/From: **9**
Clock To: **3**
1st Value:
2nd Value:
Value Percent:
Continuous Index: **S07**
Within 8" of Joint:
Remarks:

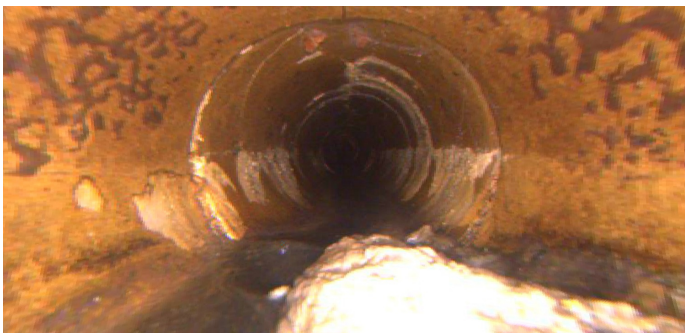
Code: **DSZ**
Description: **Deposits Settled Other**

Distance (ft): **118.6**
Structural Grade: **0**
O&M Grade: **3**
Clock Start/From: **6**
Clock To:
1st Value:
2nd Value:
Value Percent: **15.000**
Continuous Index:
Within 8" of Joint: **NO**
Remarks: **tissue/rag**

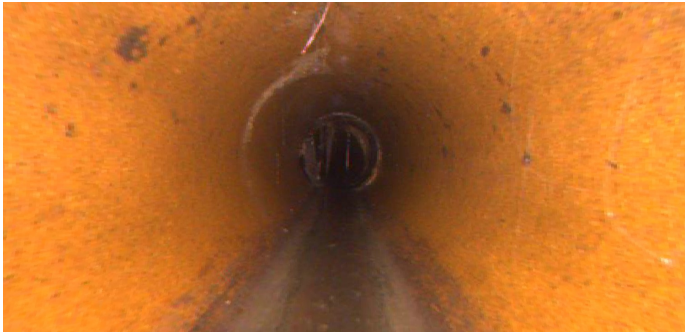
Code: **CH3**
Description: **Crack Longitudinal Hinge, 3**

Distance (ft): **122.9**
Structural Grade: **5**
O&M Grade: **0**
Clock Start/From: **9**
Clock To: **3**
1st Value:
2nd Value:
Value Percent:
Continuous Index: **F07**
Within 8" of Joint:
Remarks:

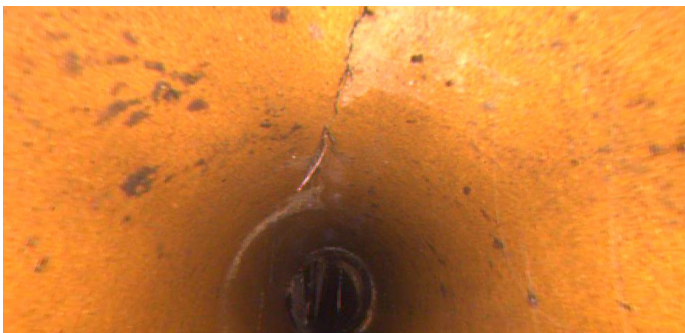
Code: **RFB**
Description: **Roots Fine Barrel**

Distance (ft): **122.9**
Structural Grade: **0**
O&M Grade: **2**
Clock Start/From: **12**
Clock To:
1st Value:
2nd Value:
Value Percent:
Continuous Index:
Within 8" of Joint: **NO**
Remarks:

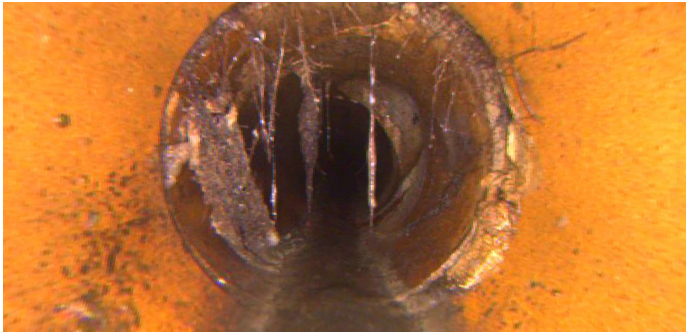
Code: **RMJ**
Description: **Roots Medium Joint**

Distance (ft): **124.7**
Structural Grade: **0**
O&M Grade: **3**
Clock Start/From: **7**
Clock To: **5**
1st Value:
2nd Value:
Value Percent: **5.000**
Continuous Index:
Within 8" of Joint: **YES**
Remarks:

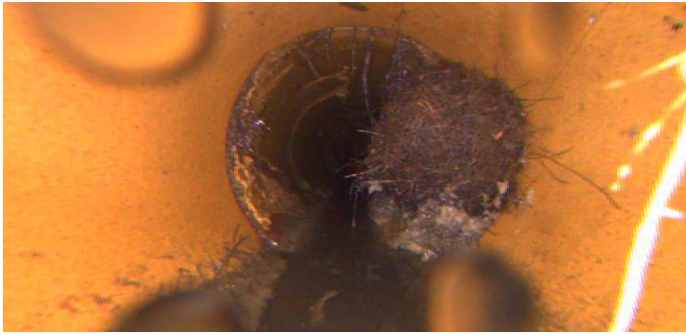
Code: **RBJ**
Description: **Roots Ball Joint**

Distance (ft): **142.4**
Structural Grade: **0**
O&M Grade: **4**
Clock Start/From: **2**
Clock To: **5**
1st Value:
2nd Value:
Value Percent: **55.000**
Continuous Index:
Within 8" of Joint: **YES**
Remarks:

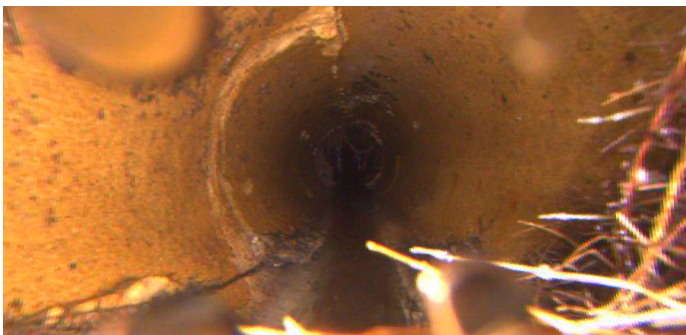
Code: **CM**
Description: **Crack Multiple**

Distance (ft): **143.4**
Structural Grade: **3**
O&M Grade: **0**
Clock Start/From: **9**
Clock To: **12**
1st Value:
2nd Value:
Value Percent:
Continuous Index: **F04**
Within 8" of Joint: **YES**
Remarks: **wandering**

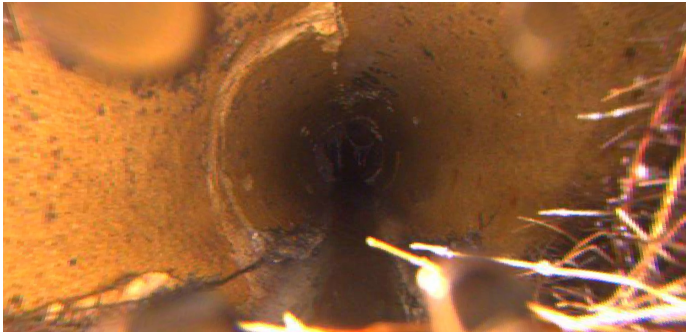
Code: **DAZ**
Description: **Deposits Attached Other**

Distance (ft): **143.4**
Structural Grade: **0**
O&M Grade: **2**
Clock Start/From: **7**
Clock To: **5**
1st Value:
2nd Value:
Value Percent: **5.000**
Continuous Index: **F03**
Within 8" of Joint: **YES**
Remarks: **wandering at joint and in barrel**

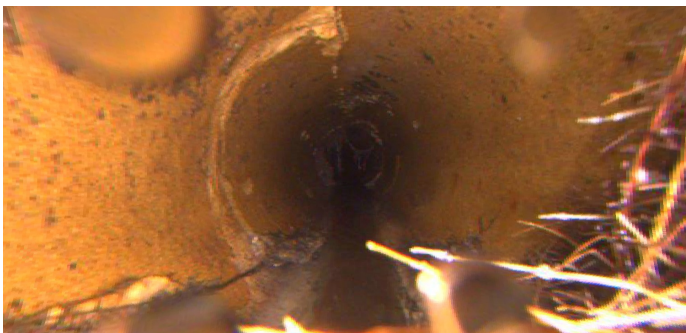
Code: **RFJ**
Description: **Roots Fine Joint**

Distance (ft): **143.4**
Structural Grade: **0**
O&M Grade: **1**
Clock Start/From: **7**
Clock To: **5**
1st Value:
2nd Value:
Value Percent:
Continuous Index: **F01**
Within 8" of Joint: **YES**
Remarks: **wandering**

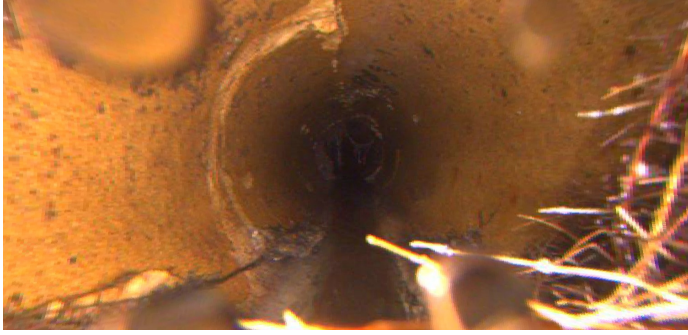
Code:	MSA
Description:	Abandoned Survey
Distance (ft):	143.4
Structural Grade:	0
O&M Grade:	0
Clock Start/From:	
Clock To:	
1st Value:	
2nd Value:	
Value Percent:	
Continuous Index:	
Within 8" of Joint:	NO
Remarks:	rbj
