Profile/Photo Observation Report

| Pipe Length (ft): | 305.0 | Owner: | City of Hobart | Pre Clean: | Heavy Cleaning |

| Street: | SOFTWOOD DR | Flow Control: | Not Controlled |
| US MH: | M-405-040 | DS MH: | M-405-041 |

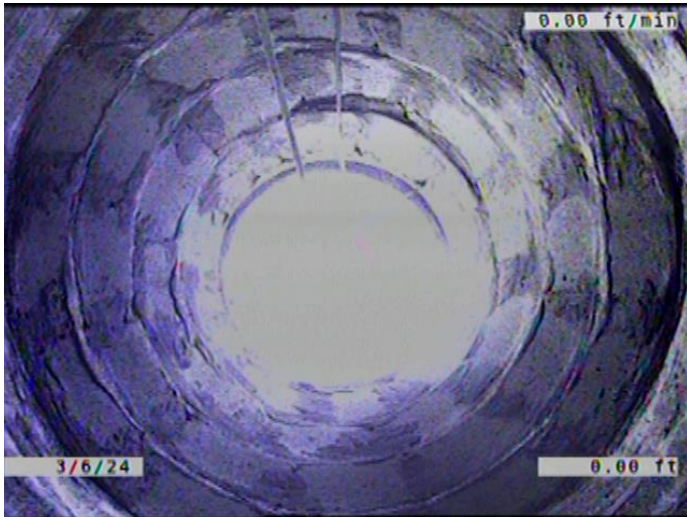
Code: **AMH**
Description: **Manhole**

Distance (ft): **.0**
Structural Grade: **0**
O&M Grade: **0**
Clock Start/From:
Clock To:
1st Value:
2nd Value:
Value Percent:
Continuous Index:
Within 8" of Joint: **NO**
Remarks: **M-405-040**

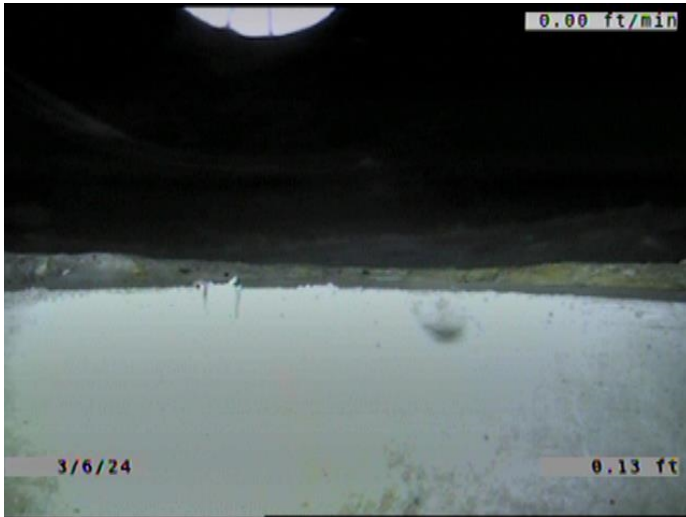
Code: **RPR**
Description: **Point Repair Replacement**

Distance (ft): **.1**
Structural Grade: **0**
O&M Grade: **0**
Clock Start/From:
Clock To:
1st Value:
2nd Value:
Value Percent:
Continuous Index: **S01**
Within 8" of Joint: **YES**
Remarks: **REPLACED WITH PVC.**

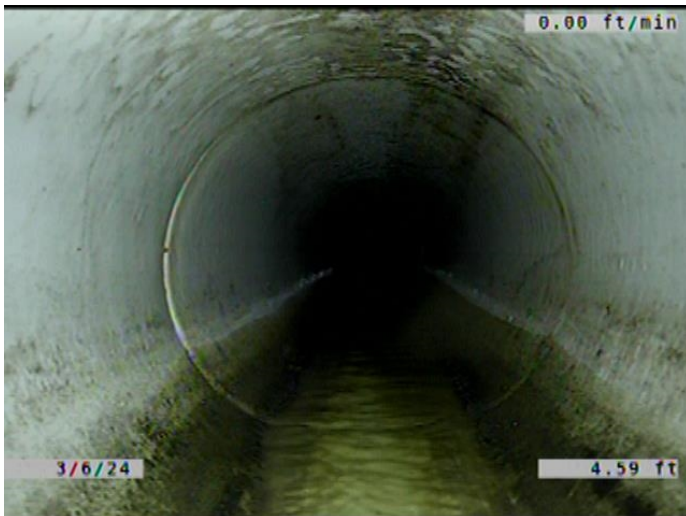
Code: **MWLS**
Description: **Miscellaneous Water Level Sag**

Distance (ft): **4.6**
Structural Grade: **2**
O&M Grade: **0**
Clock Start/From:
Clock To:
1st Value:
2nd Value:
Value Percent: **5.000**
Continuous Index: **S02**
Within 8" of Joint: **NO**
Remarks:

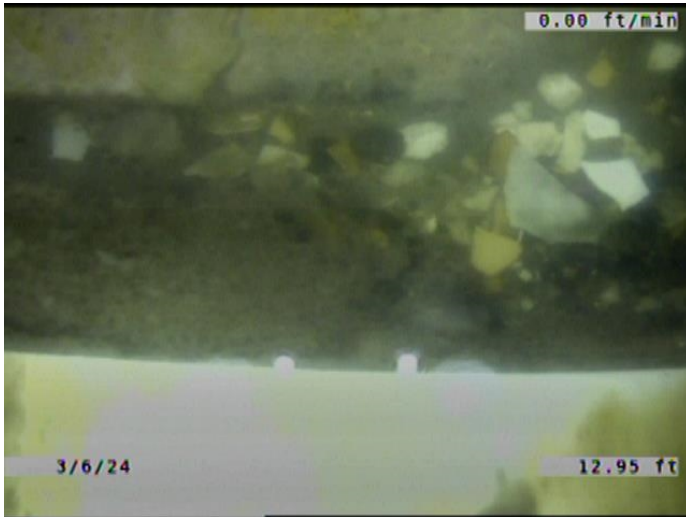
Code: **RPR**
Description: **Point Repair Replacement**

Distance (ft): **13.0**
Structural Grade: **0**
O&M Grade: **0**
Clock Start/From:
Clock To:
1st Value:
2nd Value:
Value Percent:
Continuous Index: **F01**
Within 8" of Joint: **YES**
Remarks: **REPLACED WITH PVC.**

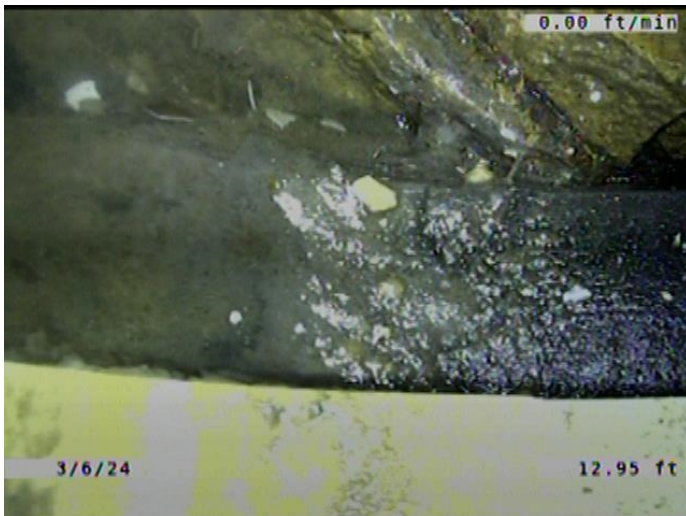
Code: **JAM**
Description: **Joint Angular Medium**

Distance (ft): **13.0**
Structural Grade: **3**
O&M Grade: **0**
Clock Start/From:
Clock To:
1st Value:
2nd Value:
Value Percent:
Continuous Index:
Within 8" of Joint: **NO**
Remarks:

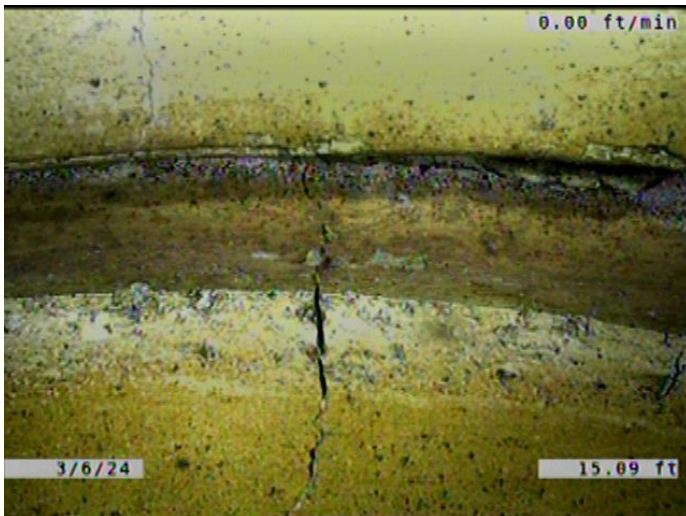
Code: **FM**
Description: **Fracture Multiple**

Distance (ft): **15.1**
Structural Grade: **4**
O&M Grade: **0**
Clock Start/From: **12**
Clock To: **12**
1st Value:
2nd Value:
Value Percent:
Continuous Index: **S03**
Within 8" of Joint: **YES**
Remarks:

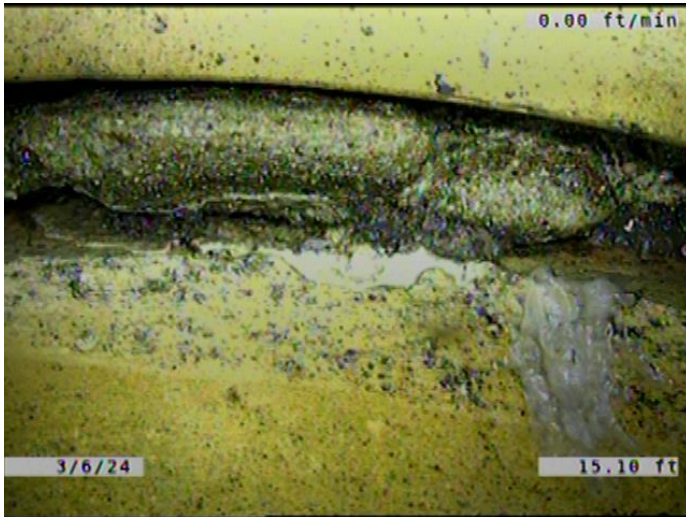
Code: **DAE**
Description: **Deposits Attached Encrustation**

Distance (ft): **15.1**
Structural Grade: **0**
O&M Grade: **2**
Clock Start/From: **7**
Clock To: **5**
1st Value:
2nd Value:
Value Percent: **5.000**
Continuous Index: **S04**
Within 8" of Joint: **YES**
Remarks:

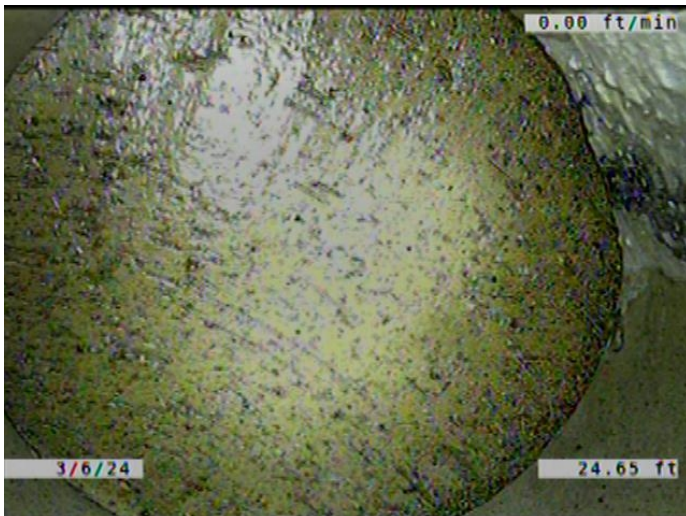
Code: **TFD**
Description: **Tap Factory Defective**

Distance (ft): **24.6**
Structural Grade: **0**
O&M Grade: **3**
Clock Start/From: **2**
Clock To:
1st Value: **6.000**
2nd Value:
Value Percent:
Continuous Index:
Within 8" of Joint: **YES**
Remarks: **CAPPED. TAP FRACTURED.
ENCrustation COMING AROUND T**

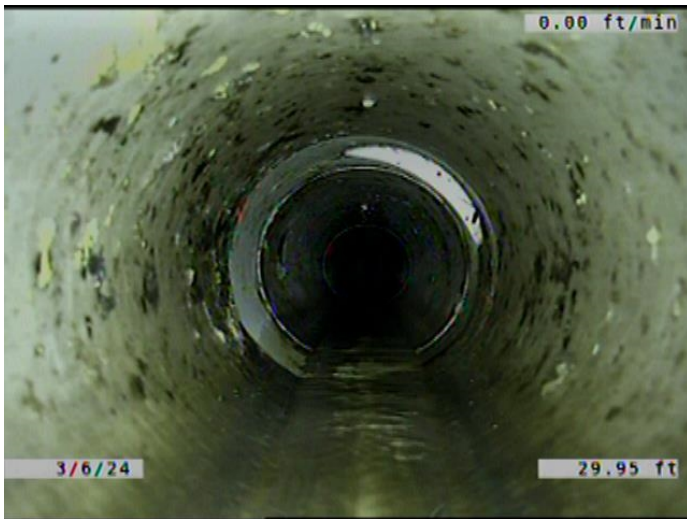
Code: **FM**
Description: **Fracture Multiple**

Distance (ft): **30.0**
Structural Grade: **4**
O&M Grade: **0**
Clock Start/From: **12**
Clock To: **12**
1st Value:
2nd Value:
Value Percent:
Continuous Index: **F03**
Within 8" of Joint: **YES**
Remarks:

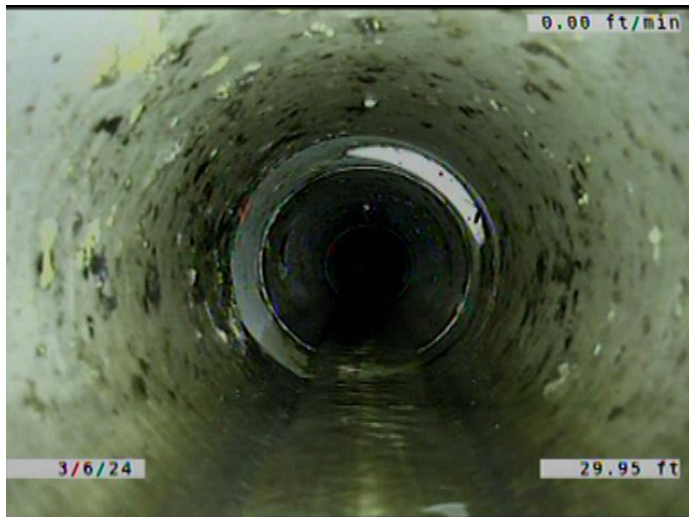
Code: **DAE**
Description: **Deposits Attached Encrustation**

Distance (ft): **30.0**
Structural Grade: **0**
O&M Grade: **2**
Clock Start/From: **7**
Clock To: **5**
1st Value:
2nd Value:
Value Percent: **5.000**
Continuous Index: **F04**
Within 8" of Joint: **YES**
Remarks:

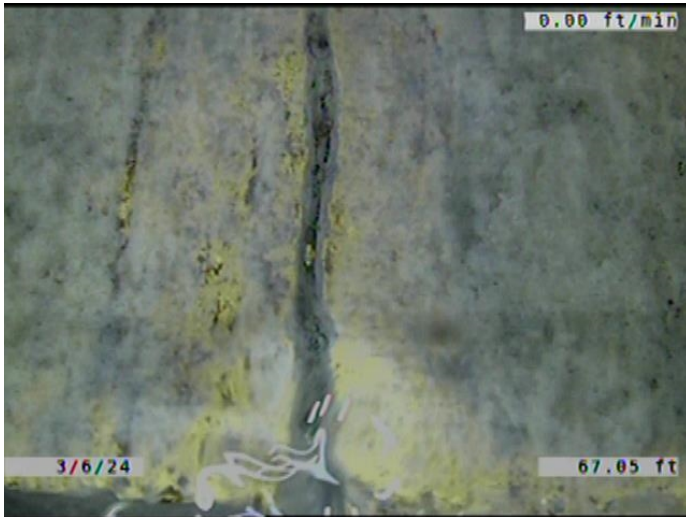
Code: **FH4**
Description: **Fracture Longitudinal Hinge, 4**

Distance (ft): **67.0**
Structural Grade: **4**
O&M Grade: **0**
Clock Start/From: **12**
Clock To: **12**
1st Value:
2nd Value:
Value Percent:
Continuous Index: **S06**
Within 8" of Joint: **YES**
Remarks:

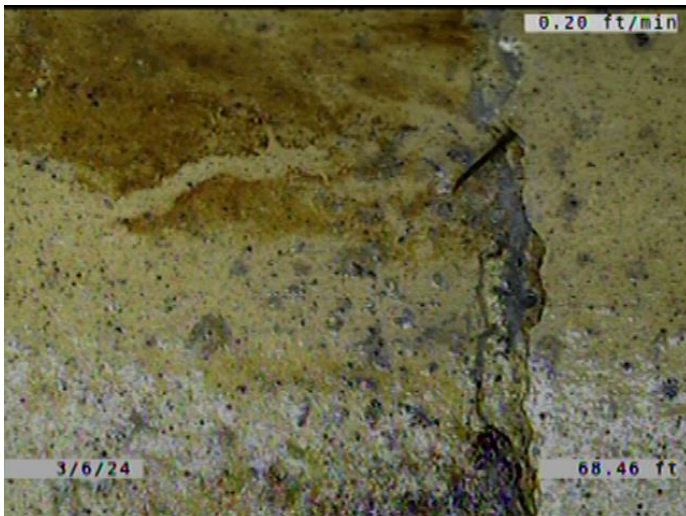
Code: **ISB**
Description: **Infiltration Stain Barrel**

Distance (ft): **68.4**
Structural Grade: **0**
O&M Grade: **1**
Clock Start/From: **3**
Clock To: **5**
1st Value:
2nd Value:
Value Percent:
Continuous Index:
Within 8" of Joint: **YES**
Remarks:

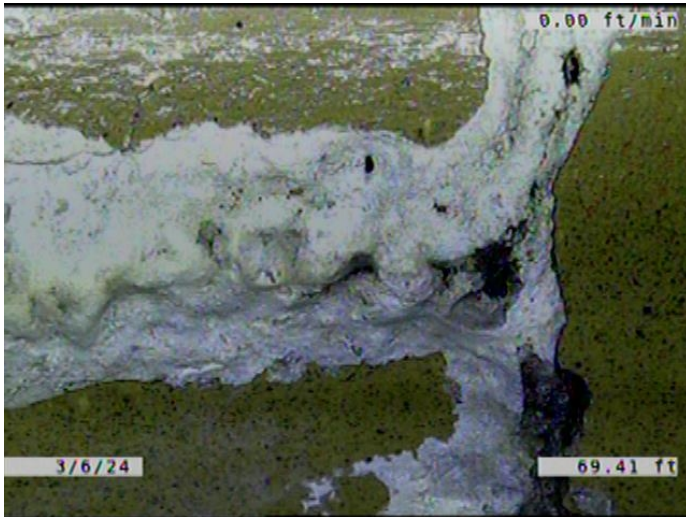
Code: **DAE**
 Description: **Deposits Attached Encrustation**

Distance (ft): **69.4**
 Structural Grade: **0**
 O&M Grade: **2**
 Clock Start/From: **7**
 Clock To: **5**
 1st Value:
 2nd Value:
 Value Percent: **5.000**
 Continuous Index: **S07**
 Within 8" of Joint: **YES**
 Remarks:

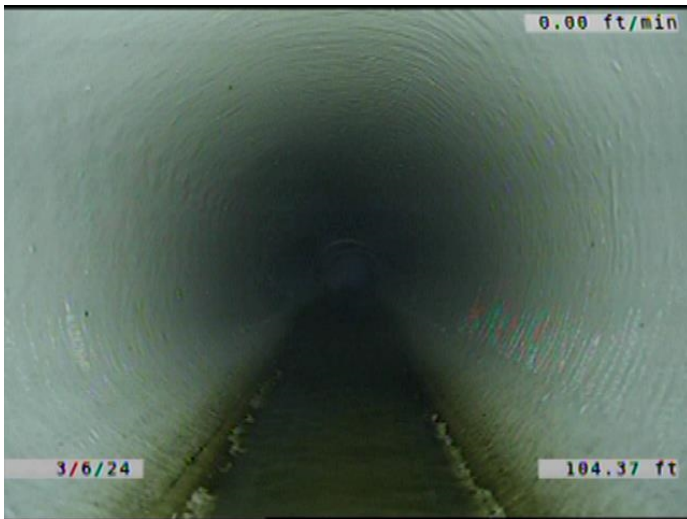
Code: **FH4**
Description: **Fracture Longitudinal Hinge, 4**

Distance (ft): **104.4**
Structural Grade: **4**
O&M Grade: **0**
Clock Start/From: **12**
Clock To: **12**
1st Value:
2nd Value:
Value Percent:
Continuous Index: **F06**
Within 8" of Joint: **YES**
Remarks:

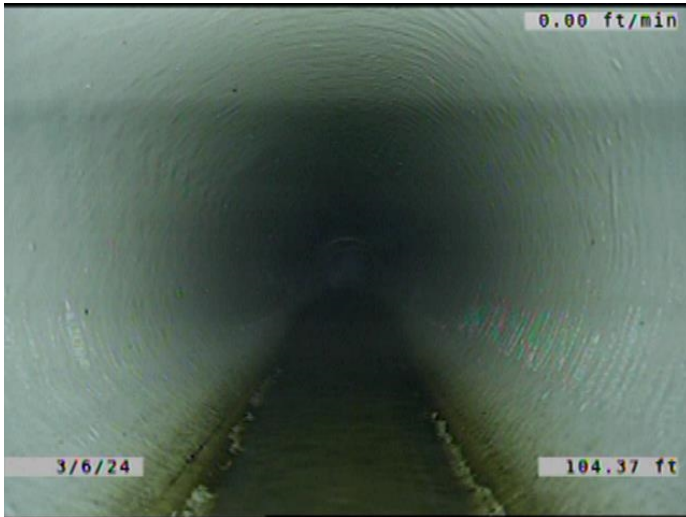
Code: **DAE**
Description: **Deposits Attached Encrustation**

Distance (ft): **104.4**
Structural Grade: **0**
O&M Grade: **2**
Clock Start/From: **7**
Clock To: **5**
1st Value:
2nd Value:
Value Percent: **5.000**
Continuous Index: **F07**
Within 8" of Joint: **YES**
Remarks:

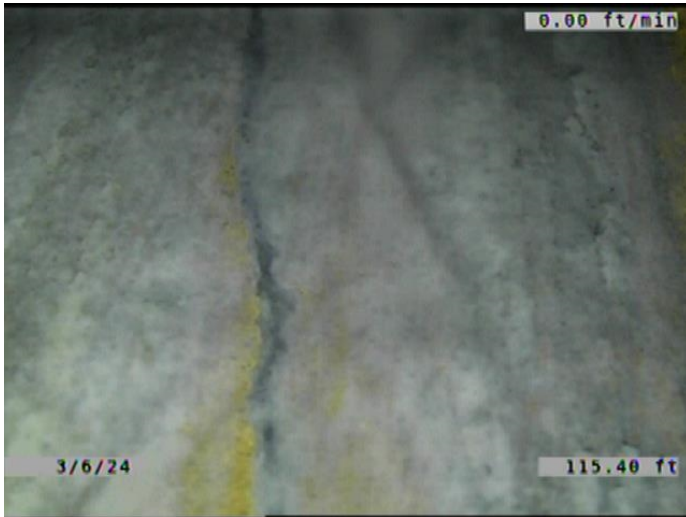
Code: **FH4**
Description: **Fracture Longitudinal Hinge, 4**

Distance (ft): **115.4**
Structural Grade: **4**
O&M Grade: **0**
Clock Start/From: **12**
Clock To: **12**
1st Value:
2nd Value:
Value Percent:
Continuous Index: **S11**
Within 8" of Joint: **YES**
Remarks:

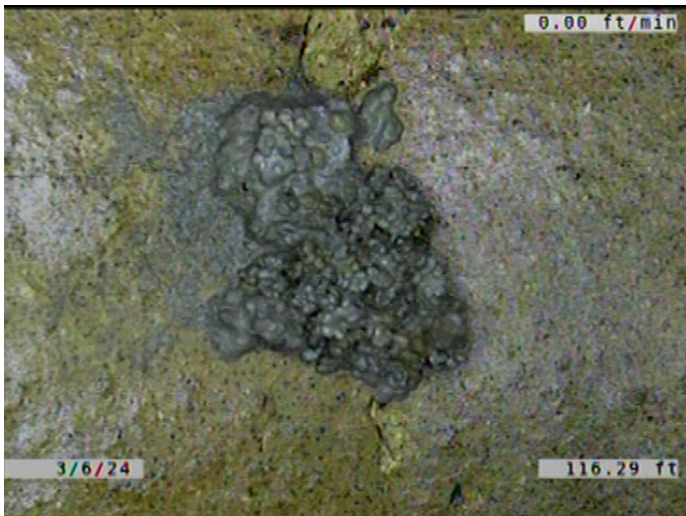
Code: **DAE**
Description: **Deposits Attached Encrustation**

Distance (ft): **116.3**
Structural Grade: **0**
O&M Grade: **2**
Clock Start/From: **8**
Clock To: **9**
1st Value:
2nd Value:
Value Percent: **5.000**
Continuous Index:
Within 8" of Joint: **YES**
Remarks:

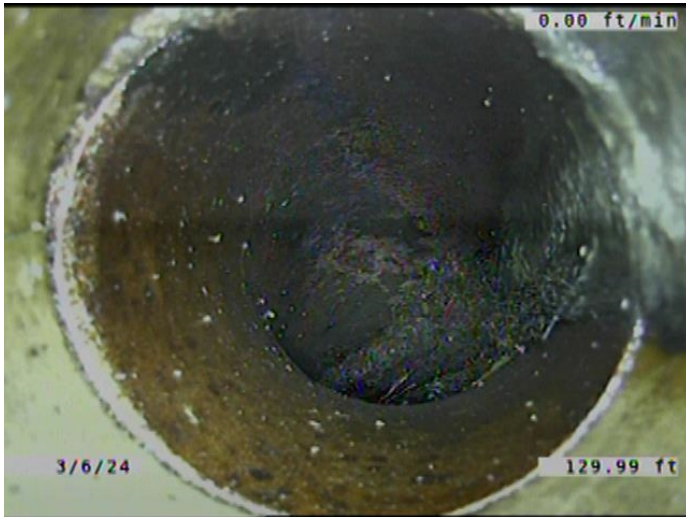
| Code: | TFD |
| Description: | Tap Factory Defective |
| Distance (ft): | 130.0 |
| Remarks: | TAP BROKEN. ROOTS GROWING IN THE JOINTS. CONSTANTLY RUNNING |

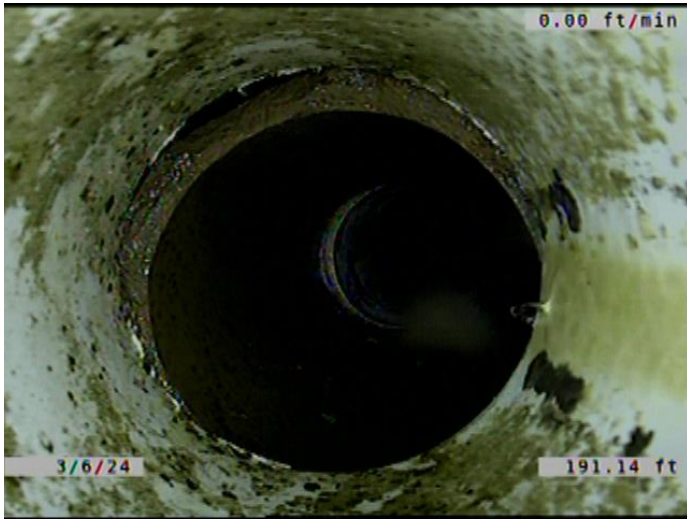
Code: **IRL**
Description: **Infiltration Runner Lateral**

Distance (ft): **191.1**
Structural Grade: **0**
O&M Grade: **4**
Clock Start/From: **2**
Clock To:
1st Value:
2nd Value:
Value Percent:
Continuous Index:
Within 8" of Joint: **YES**
Remarks:

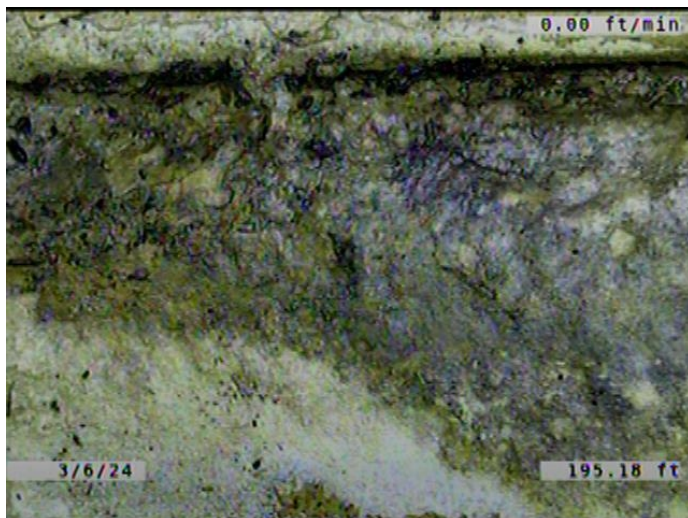
Code: **DAE**
Description: **Deposits Attached Encrustation**

Distance (ft): **195.2**
Structural Grade: **0**
O&M Grade: **2**
Clock Start/From: **7**
Clock To: **5**
1st Value:
2nd Value:
Value Percent: **5.000**
Continuous Index: **S16**
Within 8" of Joint: **YES**
Remarks:

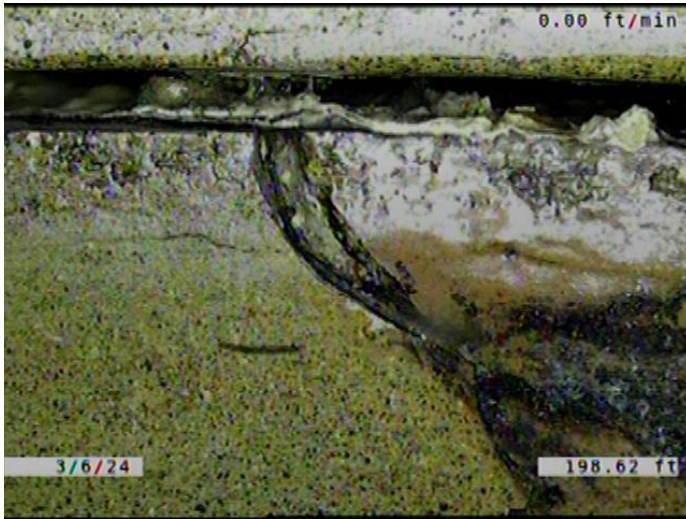
Code: **B**
 Description: **Broken**

Distance (ft): **198.6**
 Structural Grade: **4**
 O&M Grade: **0**
 Clock Start/From: **3**
 Clock To: **5**
 1st Value:
 2nd Value:
 Value Percent:
 Continuous Index:
 Within 8" of Joint: **YES**
 Remarks:

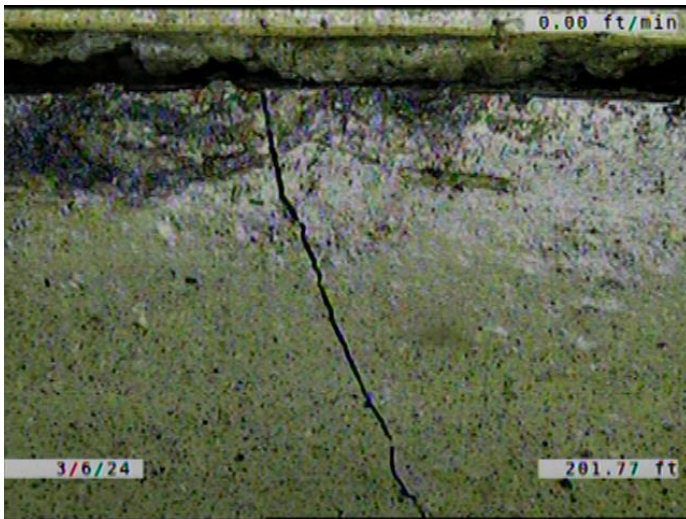
Code: **FM**
 Description: **Fracture Multiple**

Distance (ft): **201.8**
 Structural Grade: **4**
 O&M Grade: **0**
 Clock Start/From: **2**
 Clock To: **8**
 1st Value:
 2nd Value:
 Value Percent:
 Continuous Index:
 Within 8" of Joint: **YES**
 Remarks:

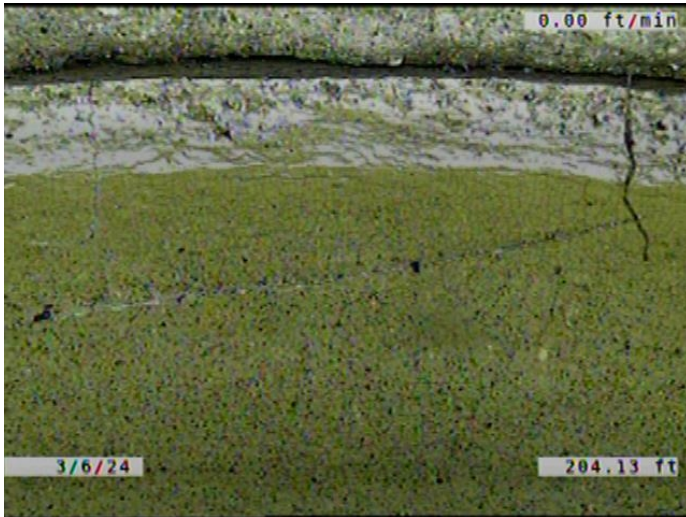
Code: **CM**
Description: **Crack Multiple**

Distance (ft): **204.1**
Structural Grade: **3**
O&M Grade: **0**
Clock Start/From: **10**
Clock To: **2**
1st Value:
2nd Value:
Value Percent:
Continuous Index:
Within 8" of Joint: **YES**
Remarks:

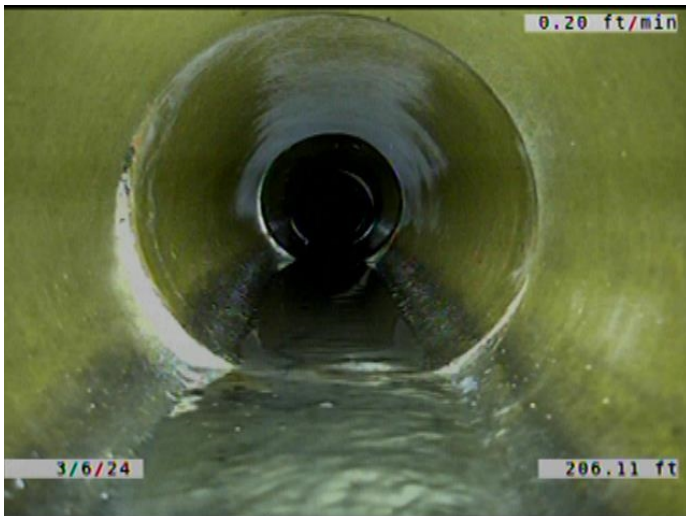
Code: **MWLS**
Description: **Miscellaneous Water Level Sag**

Distance (ft): **206.1**
Structural Grade: **2**
O&M Grade: **0**
Clock Start/From:
Clock To:
1st Value:
2nd Value:
Value Percent: **10.000**
Continuous Index: **S17**
Within 8" of Joint: **NO**
Remarks:

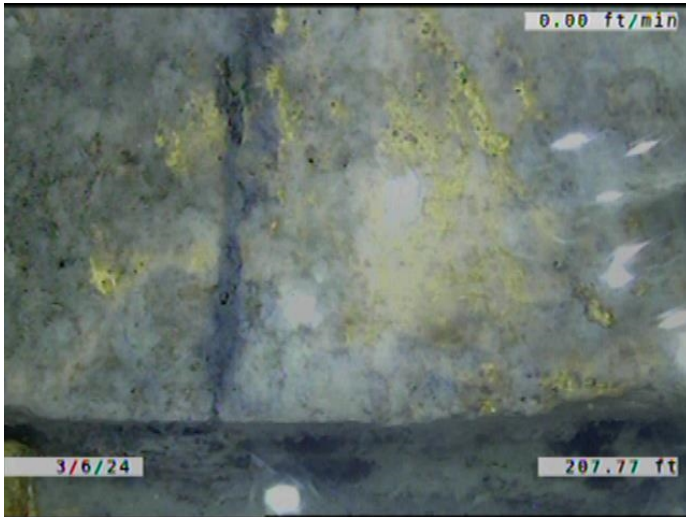
Code: **FS**
Description: **Fracture Spiral**

Distance (ft): **207.8**
Structural Grade: **3**
O&M Grade: **0**
Clock Start/From: **6**
Clock To: **7**
1st Value:
2nd Value:
Value Percent:
Continuous Index:
Within 8" of Joint: **YES**
Remarks:

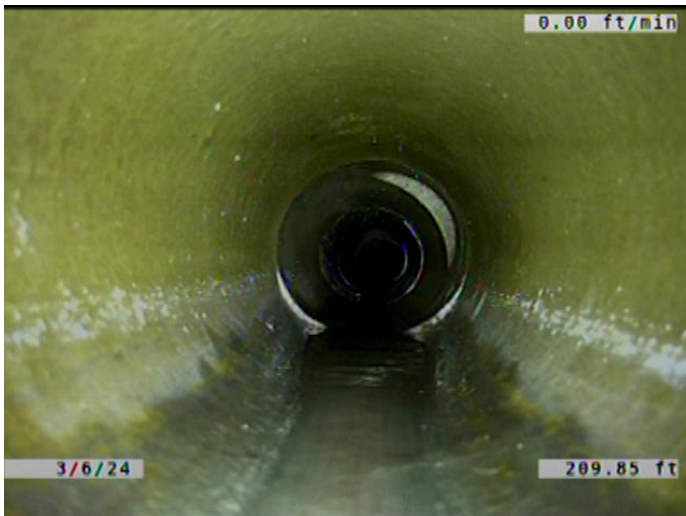
Code: **MWLS**
Description: **Miscellaneous Water Level Sag**

Distance (ft): **209.8**
Structural Grade: **2**
O&M Grade: **0**
Clock Start/From:
Clock To:
1st Value:
2nd Value:
Value Percent: **10.000**
Continuous Index: **F17**
Within 8" of Joint: **NO**
Remarks:

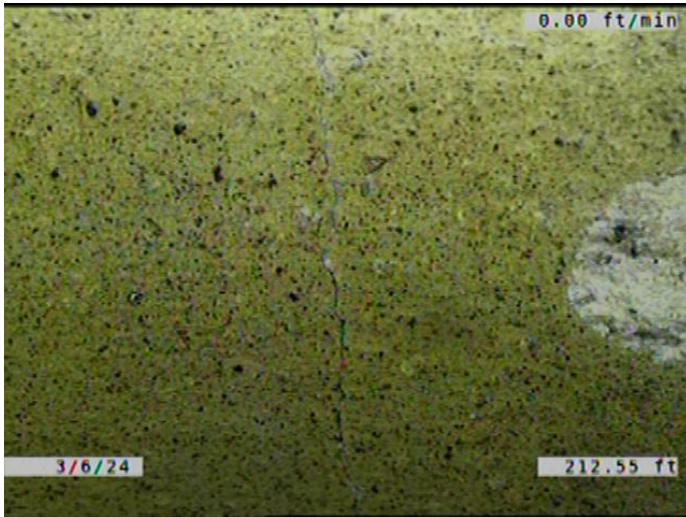
Code: **FS**
Description: **Fracture Spiral**

Distance (ft): **212.5**
Structural Grade: **3**
O&M Grade: **0**
Clock Start/From: **3**
Clock To: **4**
1st Value:
2nd Value:
Value Percent:
Continuous Index:
Within 8" of Joint: **YES**
Remarks:

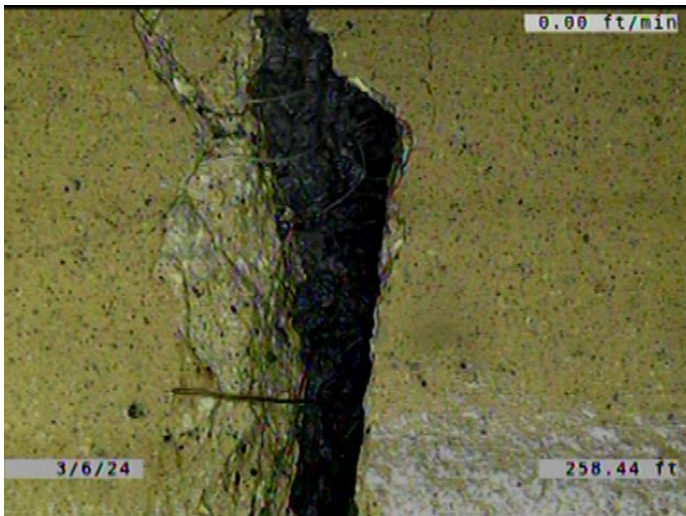
Code: **BVV**
Description: **Broken Void Visible**

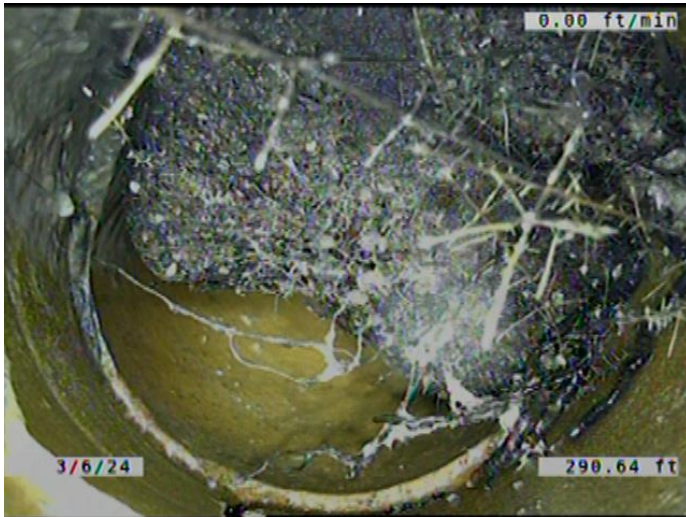
Code: **TFD**
Description: **Tap Factory Defective**

Distance (ft): **290.6**
Structural Grade: **0**
O&M Grade: **3**
Clock Start/From: **10**
Clock To:
1st Value: **6.000**
2nd Value:
Value Percent:
Continuous Index:
Within 8" of Joint: **YES**
Remarks: **TAP BROKEN. PART MISSING. 85% PLUGGED WITH ROOTS. CONSTANTL**

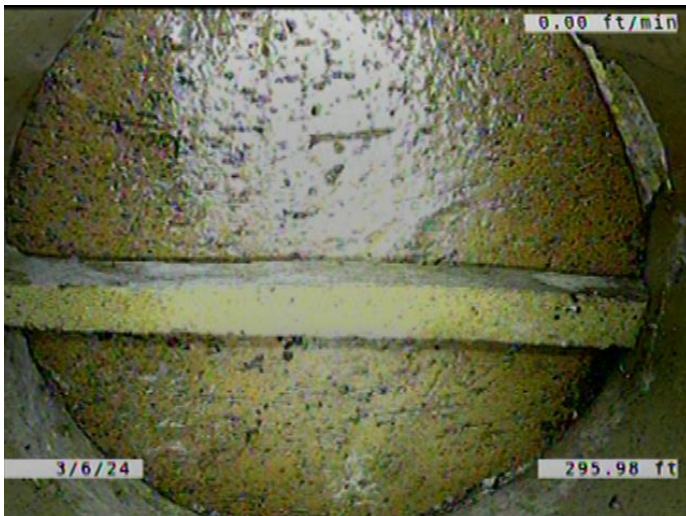
Code: **TFD**
Description: **Tap Factory Defective**

Distance (ft): **296.0**
Structural Grade: **0**
O&M Grade: **3**
Clock Start/From: **2**
Clock To:
1st Value: **6.000**
2nd Value:
Value Percent:
Continuous Index:
Within 8" of Joint: **YES**
Remarks: **CAPPED. TAP CRACKED. ENCRUSTATION COMING IN AROUN**

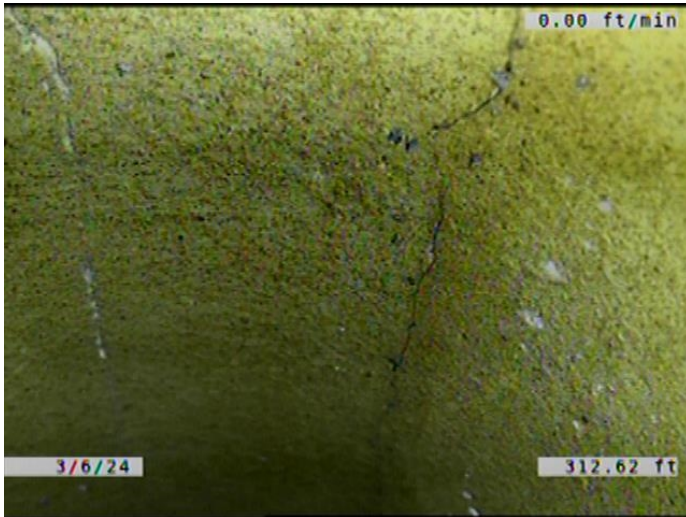
Code: **BVV**
Description: **Broken Void Visible**
