Profile/Photo Observation Report

Street:	FOXCROFT STREET	Flow Control:	Not Controlled
City:	Hobart, IN	Year Renewed:	
Location:	Yard	Tape/Media #:	
Purpose:	Routine Assessment	Dia/Height:	8"
Use:	Sanitary	Material:	VCP
Drain Area:	NA	Lining:	
Category:	NA		
Comment:	P_C at 12 ft debris		
Location Details:		Direction of Survey:	Upstream
US MH:	M-405-041	DS MH:	M-405-042
		Total Length Surveyed (ft):	12.9

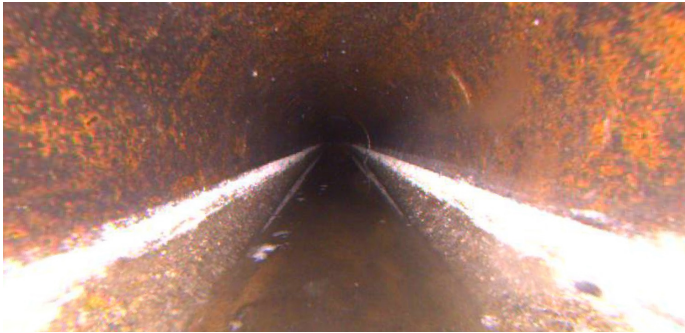
Code:	MWL
Description:	Water Level

Distance (ft):	.0
Structural Grade:	0
O&M Grade:	0
Clock Start/From:	
Clock To:	
1st Value:	
2nd Value:	
Value Percent:	5.000
Continuous Index:	
Within 8" of Joint:	NO
Remarks:

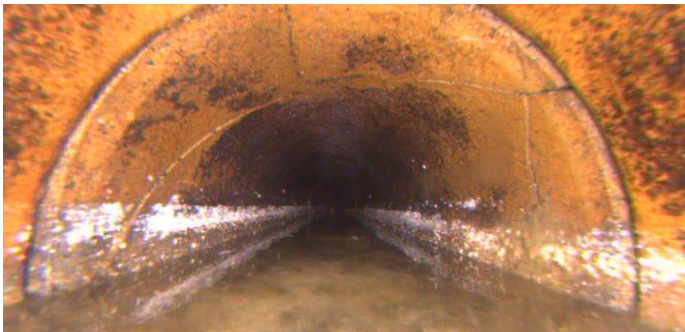
Code:	FM
Description:	Fracture Multiple

Distance (ft):	6.6
Structural Grade:	4
O&M Grade:	0
Clock Start/From:	8
Clock To:	4
1st Value:	
2nd Value:	
Value Percent:	
Continuous Index:	
Within 8" of Joint:	YES
Remarks:

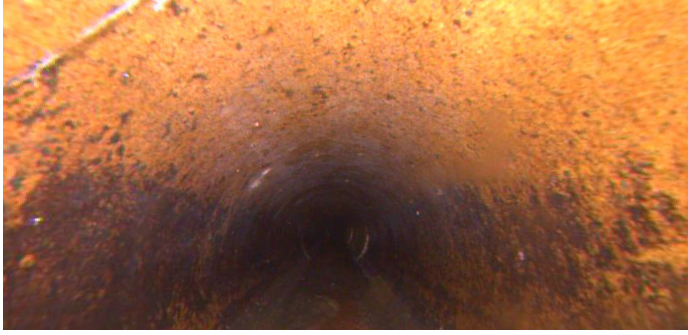
Code:	MSA
Description:	Abandoned Survey
Distance (ft):	12.9
Structural Grade:	0
O&M Grade:	0
Clock Start/From:	
Clock To:	
1st Value:	
2nd Value:	
Value Percent:	
Continuous Index:	
Within 8" of Joint:	NO
Remarks:	debris under water
