Profile/Photo Observation Report

Date:	04/20/2018	Weather:		Coding:	PACP 6.0
Pipe Length (ft):	338.0	Owner:	NA	Pre Clean:	No Pre-Cleaning
P.O.#:		Surveyor:	Byrd Fitzgerald	PSR:	P-405-042-041
Customer:		Clean Date:	01/01/1900	Shape:	C

Street:	OFF W 3RD ST	Flow Control:	Not Controlled
City:	Hobart, IN	Year Renewed:	
Location:	Yard	Tape/Media #:	
Purpose:	Routine Assessment	Dia/Height:	8"
Use:	Sanitary	Material:	PVC
Drain Area:	NA	Lining:	
Category:	NA		
Comment:	P_C at 49 ft debris		
Location Details:		Direction of Survey:	Downstream
US MH:	M-405-041	DS MH:	M-405-042
		Total Length Surveyed (ft):	50.7

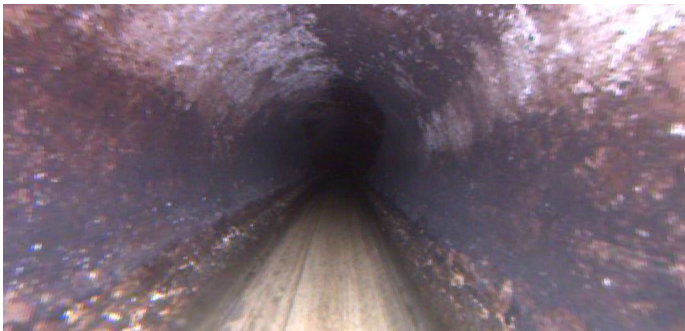
Code: **AMH**
Description: **Manhole**

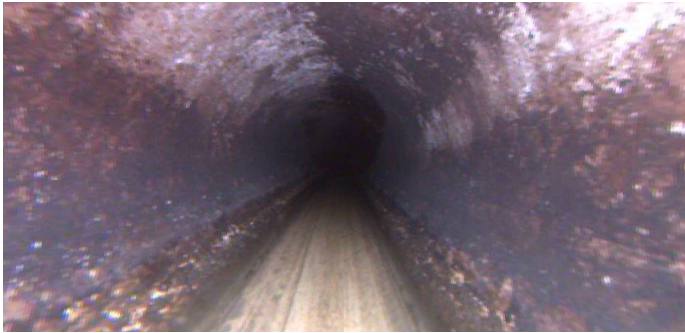
Code:	MWL
Description:	Water Level

Distance (ft):	.0
Structural Grade:	0
O&M Grade:	0
Clock Start/From:	
Clock To:	
1st Value:	
2nd Value:	
Value Percent:	5.000
Continuous Index:	
Within 8" of Joint:	NO
Remarks:

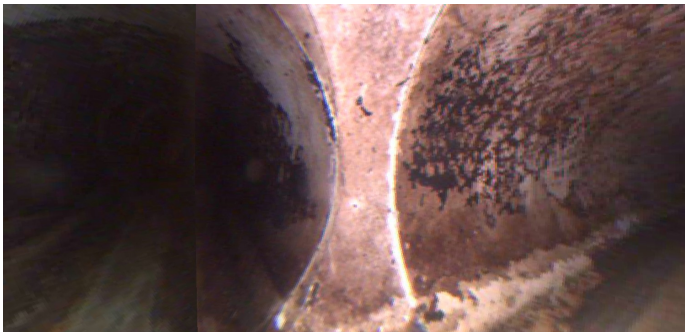
Code:	TF
Description:	Tap Factory

Distance (ft):	25.9
Structural Grade:	0
O&M Grade:	0
Clock Start/From:	9
Clock To:	
1st Value:	4.000
2nd Value:	
Value Percent:	
Continuous Index:	
Within 8" of Joint:	YES
Remarks:

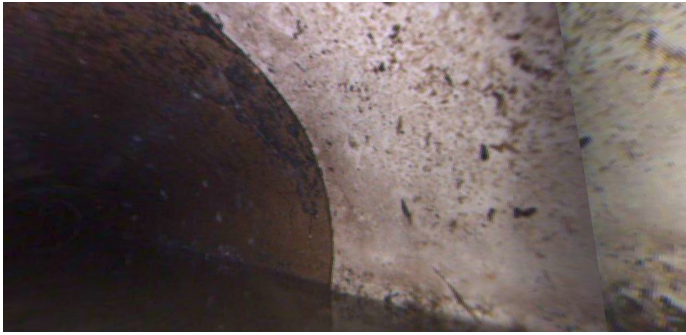
Code: **MMC**
Description: **Material Change**

Distance (ft): **39.7**
Structural Grade: **0**
O&M Grade: **0**
Clock Start/From:
Clock To:
1st Value:
2nd Value:
Value Percent:
Continuous Index:
Within 8" of Joint: **NO**
Remarks: **vcp**

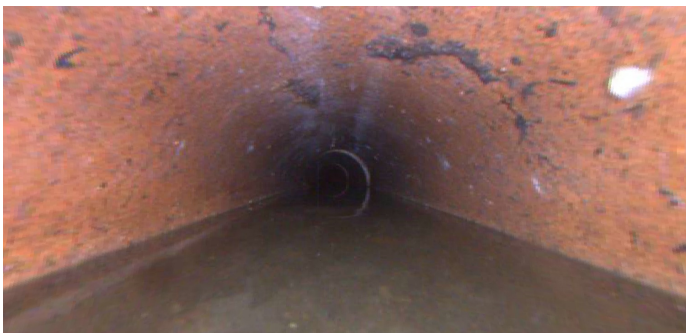
Code: **MWL**
Description: **Water Level**

Distance (ft): **43.0**
Structural Grade: **0**
O&M Grade: **0**
Clock Start/From:
Clock To:
1st Value:
2nd Value:
Value Percent: **20.000**
Continuous Index:
Within 8" of Joint: **NO**
Remarks:

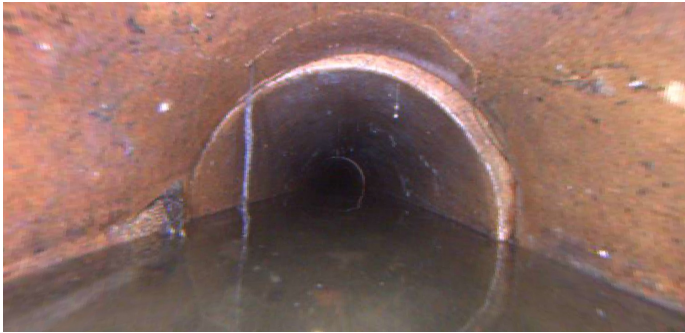
Code: **CM**
Description: **Crack Multiple**

Distance (ft): **45.4**
Structural Grade: **3**
O&M Grade: **0**
Clock Start/From: **9**
Clock To: **1**
1st Value:
2nd Value:
Value Percent:
Continuous Index:
Within 8" of Joint: **YES**
Remarks:

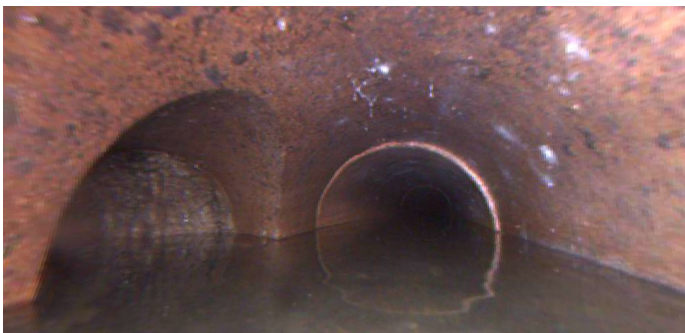
Code: **TFC**
Description: **Tap Factory Capped**

Distance (ft): **47.9**
Structural Grade: **0**
O&M Grade: **0**
Clock Start/From: **9**
Clock To:
1st Value: **4.000**
2nd Value:
Value Percent:
Continuous Index:
Within 8" of Joint: **YES**
Remarks:

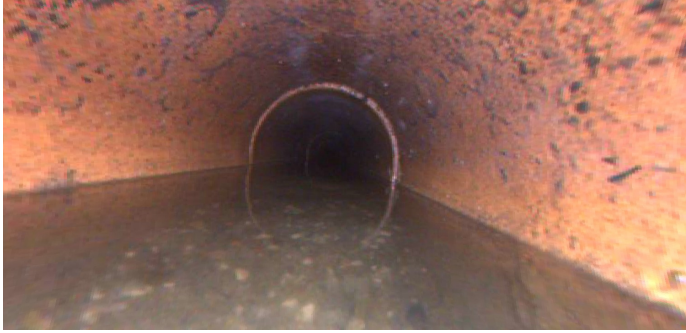
Code:	MSA
Description:	Abandoned Survey
Distance (ft):	50.7
Structural Grade:	0
O&M Grade:	0
Clock Start/From:	
Clock To:	
1st Value:	
2nd Value:	
Value Percent:	
Continuous Index:	
Within 8" of Joint:	NO
Remarks:	no blockage
