## Profile/Photo Observation Report

Street:	<b>FOXCROFT STREET</b>	Flow Control:	<b>Not Controlled</b>
City:	<b>Hobart, IN</b>	Year Renewed:	
Location:	<b>Yard</b>	Tape/Media #:	
Purpose:	<b>Routine Assessment</b>	Dia/Height:	<b>8"</b>
Use:	<b>Sanitary</b>	Material:	<b>PVC</b>
Drain Area:	<b>NA</b>	Lining:	
Category:	<b>NA</b>		
Comment:	<b>P_C at 49 ft debris</b>

Location Details:		Direction of Survey:	<b>Downstream</b>
US MH:	<b>M-405-041</b>	DS MH:	<b>M-405-042</b>
		Total Length Surveyed (ft):	<b>50.7</b>

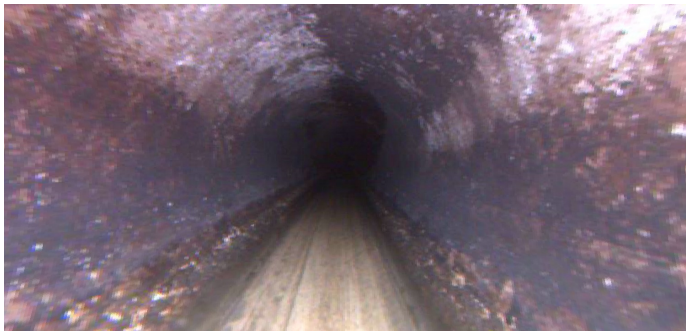
Code: **AMH**  
Description: **Manhole**

Distance (ft): **.0**  
Structural Grade: **0**  
O&M Grade: **0**  
Clock Start/From:  
Clock To:  
1st Value:  
2nd Value:  
Value Percent:  
Continuous Index:  
Within 8" of Joint: **NO**  
Remarks: **M-405-041**

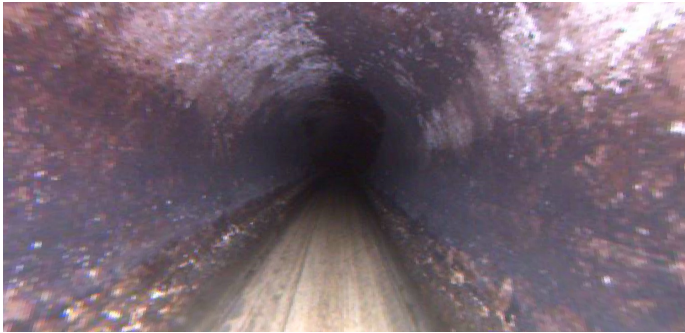
Code:	<b>MWL</b>
Description:	<b>Water Level</b>

Distance (ft):	<b>.0</b>
Structural Grade:	<b>0</b>
O&M Grade:	<b>0</b>
Clock Start/From:	
Clock To:	
1st Value:	
2nd Value:	
Value Percent:	<b>5.000</b>
Continuous Index:	
Within 8" of Joint:	<b>NO</b>
Remarks:

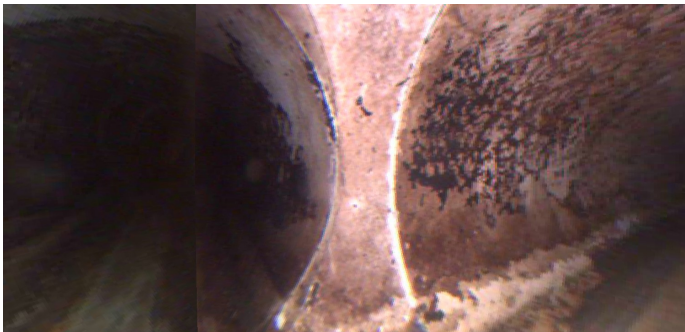
Code:	<b>TF</b>
Description:	<b>Tap Factory</b>

Distance (ft):	<b>25.9</b>
Structural Grade:	<b>0</b>
O&M Grade:	<b>0</b>
Clock Start/From:	<b>9</b>
Clock To:	
1st Value:	<b>4.000</b>
2nd Value:	
Value Percent:	
Continuous Index:	
Within 8" of Joint:	<b>YES</b>
Remarks:

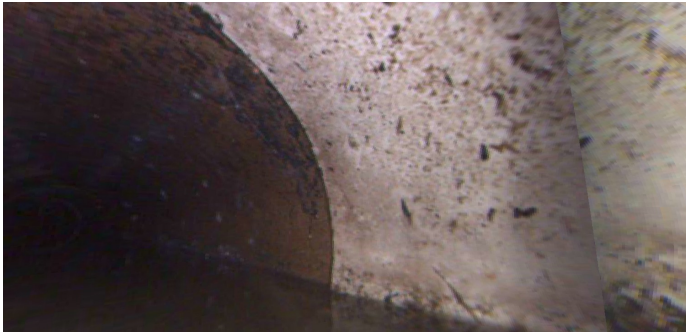
Code: **MMC**  
Description: **Material Change**

Distance (ft): **39.7**  
Structural Grade: **0**  
O&M Grade: **0**  
Clock Start/From:  
Clock To:  
1st Value:  
2nd Value:  
Value Percent:  
Continuous Index:  
Within 8" of Joint: **NO**  
Remarks: **vcp**

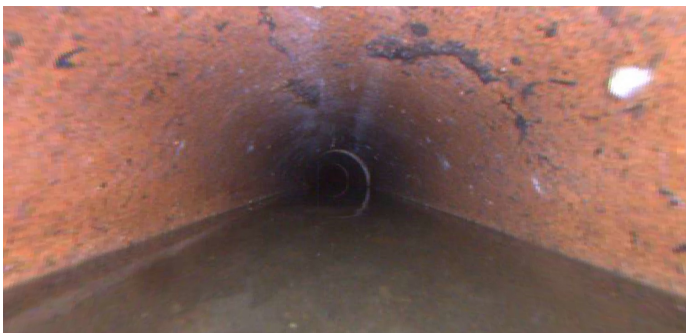
Code: **MWL**  
Description: **Water Level**

Distance (ft): **43.0**  
Structural Grade: **0**  
O&M Grade: **0**  
Clock Start/From:  
Clock To:  
1st Value:  
2nd Value:  
Value Percent: **20.000**  
Continuous Index:  
Within 8" of Joint: **NO**  
Remarks:

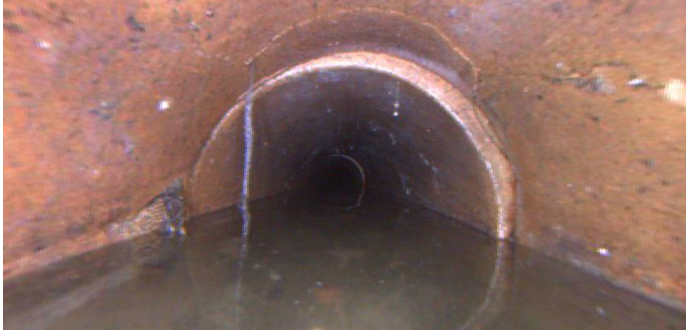
Code: **CM**  
Description: **Crack Multiple**

Distance (ft): **45.4**  
Structural Grade: **3**  
O&M Grade: **0**  
Clock Start/From: **9**  
Clock To: **1**  
1st Value:  
2nd Value:  
Value Percent:  
Continuous Index:  
Within 8" of Joint: **YES**  
Remarks:

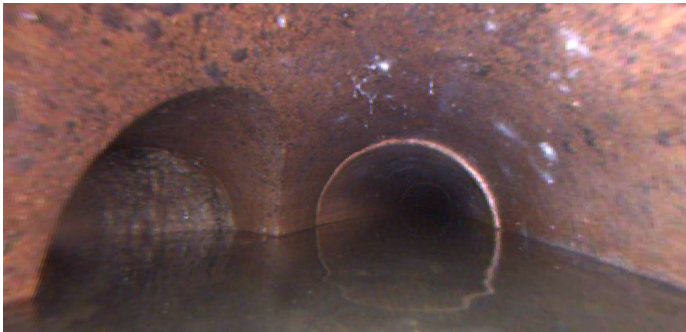
Code: **TFC**  
Description: **Tap Factory Capped**

Distance (ft): **47.9**  
Structural Grade: **0**  
O&M Grade: **0**  
Clock Start/From: **9**  
Clock To:  
1st Value: **4.000**  
2nd Value:  
Value Percent:  
Continuous Index:  
Within 8" of Joint: **YES**  
Remarks:

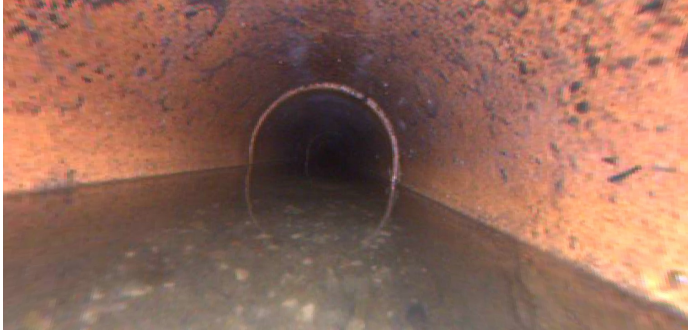
Code:	<b>MSA</b>
Description:	<b>Abandoned Survey</b>
Distance (ft):	<b>50.7</b>
Structural Grade:	<b>0</b>
O&M Grade:	<b>0</b>
Clock Start/From:	
Clock To:	
1st Value:	
2nd Value:	
Value Percent:	
Continuous Index:	
Within 8" of Joint:	<b>NO</b>
Remarks:	<b>no blockage</b>
