# Profile/Photo Observation Report

Date:	<b>03/06/2024</b>	Weather:		Coding:	<b>PACP 7.0</b>
Pipe Length (ft):	<b>338.0</b>	Owner:	<b>City of Hobart</b>	Pre Clean:	<b>Heavy Cleaning</b>
P.O.#:		Surveyor:	<b>S. Bucklin</b>	PSR:	<b>P-405-042-041</b>
Customer:	<b>City of Hobart</b>	Clean Date:	<b>10/21/2023</b>	Shape:	<b>C</b>

Street:	<b>SOFTWOOD DR</b>	Flow Control:	<b>Not Controlled</b>
City:	<b>Hobart, IN</b>	Year Renewed:	
Location:	<b>Easement/Right of Way</b>	Tape/Media #:	
Purpose:	<b>Sewer System Evaluation Survey (SS)</b>	Dia/Height:	<b>8"</b>
Use:	<b>Sanitary Sewage Pipe</b>	Material:	<b>VCP</b>
Drain Area:		Lining:	<b>None</b>
Category:	<b>NA</b>		
Comment:			
Location Details:		Direction of Survey:	<b>Upstream</b>
US MH:	<b>M-405-041</b>	DS MH:	<b>M-405-042</b>
		Total Length Surveyed (ft):	<b>338.4</b>

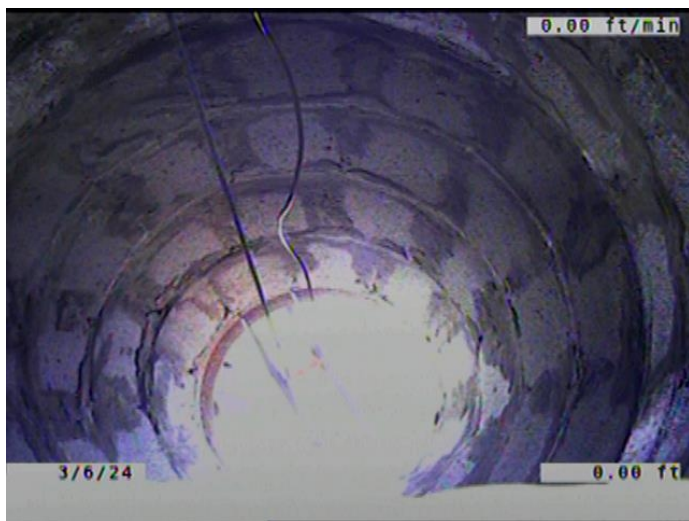
Code: **AMH**  
Description: **Manhole**

Distance (ft): **.0**  
Structural Grade: **0**  
O&M Grade: **0**  
Clock Start/From:  
Clock To:  
1st Value:  
2nd Value:  
Value Percent:  
Continuous Index:  
Within 8" of Joint: **NO**  
Remarks: **M-405-042**

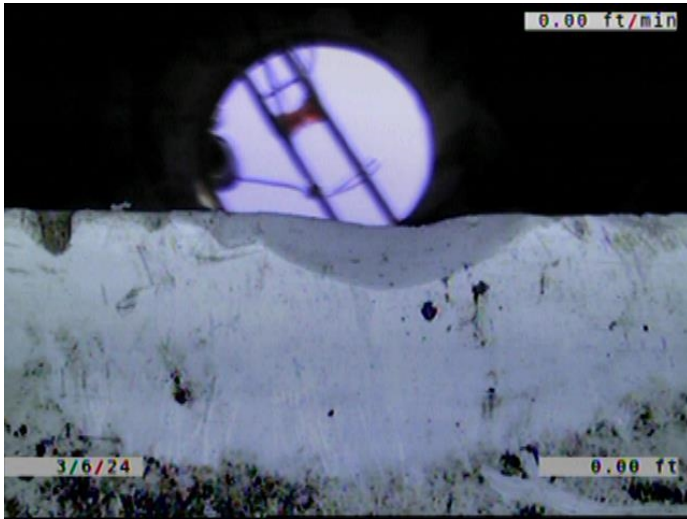
Code: **RPR**  
Description: **Point Repair Replacement**

Distance (ft): **.0**  
Structural Grade: **0**  
O&M Grade: **0**  
Clock Start/From:  
Clock To:  
1st Value:  
2nd Value:  
Value Percent:  
Continuous Index: **S01**  
Within 8" of Joint: **YES**  
Remarks: **REPLACED WITH PVC.**

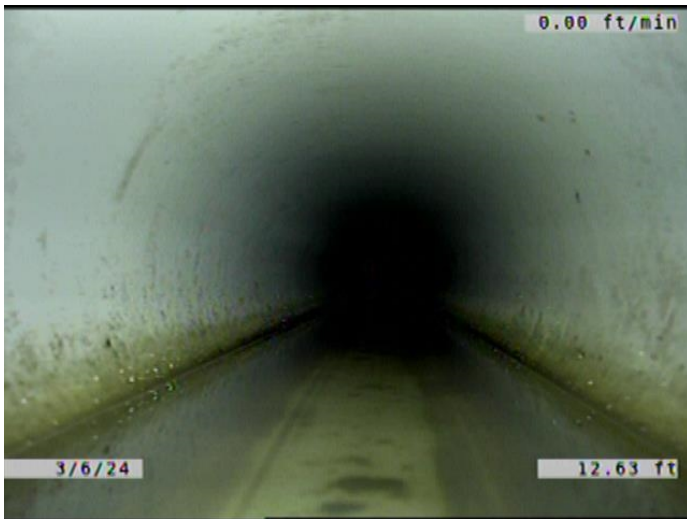
Code: **LR**  
Description: **Line Right**

Distance (ft): **12.6**  
Structural Grade: **0**  
O&M Grade: **1**  
Clock Start/From:  
Clock To:  
1st Value:  
2nd Value:  
Value Percent: **5.000**  
Continuous Index:  
Within 8" of Joint: **NO**  
Remarks:

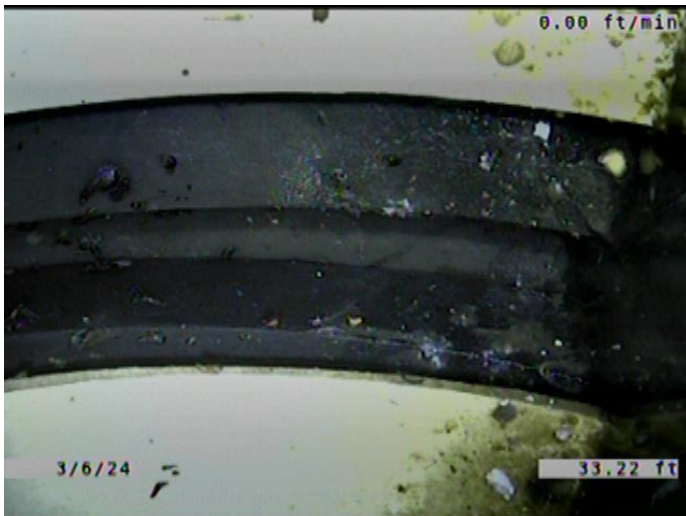
Code: **JOMD**  
Description: **Joint Offset Medium Defective**

Distance (ft): **33.2**  
Structural Grade: **3**  
O&M Grade: **0**  
Clock Start/From:  
Clock To:  
1st Value:  
2nd Value:  
Value Percent:  
Continuous Index:  
Within 8" of Joint: **NO**  
Remarks:

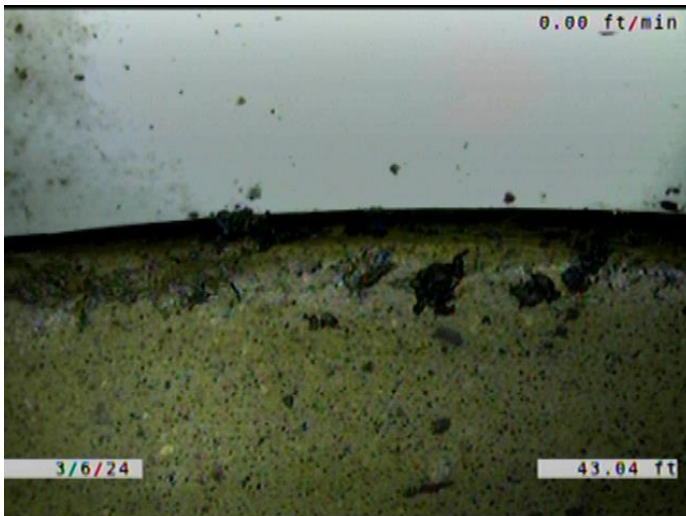
Code: **RPR**  
Description: **Point Repair Replacement**

Distance (ft): **43.0**  
Structural Grade: **0**  
O&M Grade: **0**  
Clock Start/From:  
Clock To:  
1st Value:  
2nd Value:  
Value Percent:  
Continuous Index: **F01**  
Within 8" of Joint: **YES**  
Remarks: **REPLACED WITH PVC.**

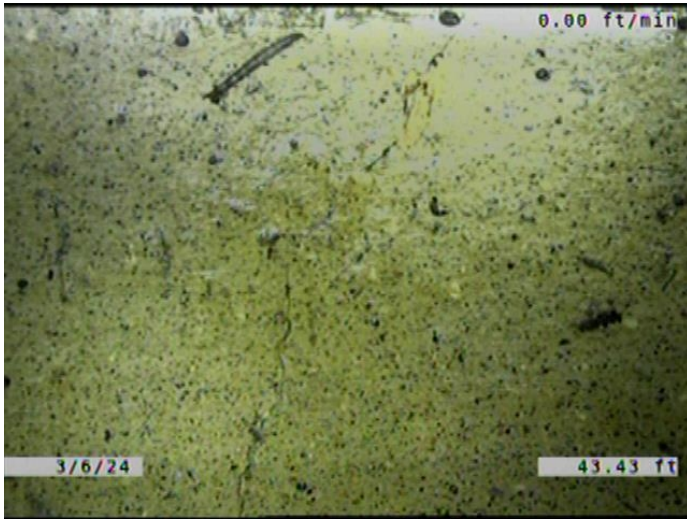
Code: **FM**  
Description: **Fracture Multiple**

Distance (ft): **43.4**  
Structural Grade: **4**  
O&M Grade: **0**  
Clock Start/From: **8**  
Clock To: **4**  
1st Value:  
2nd Value:  
Value Percent:  
Continuous Index: **S03**  
Within 8" of Joint: **YES**  
Remarks:

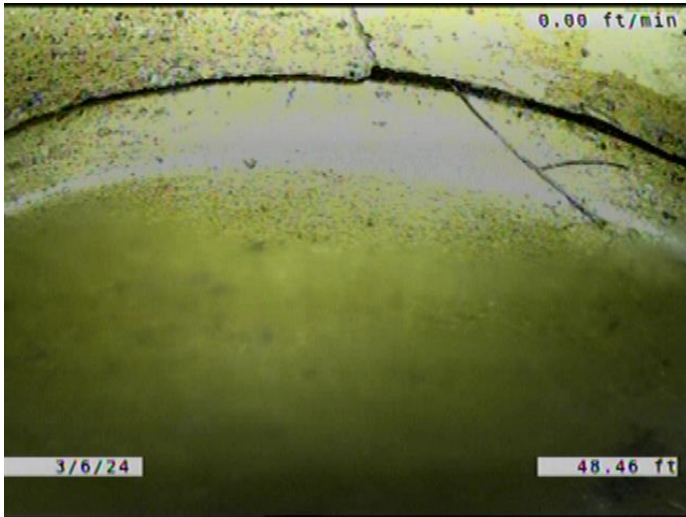
Code: **JOMD**  
Description: **Joint Offset Medium Defective**

Distance (ft): **48.5**  
Structural Grade: **3**  
O&M Grade: **0**  
Clock Start/From:  
Clock To:  
1st Value:  
2nd Value:  
Value Percent:  
Continuous Index:  
Within 8" of Joint: **NO**  
Remarks:

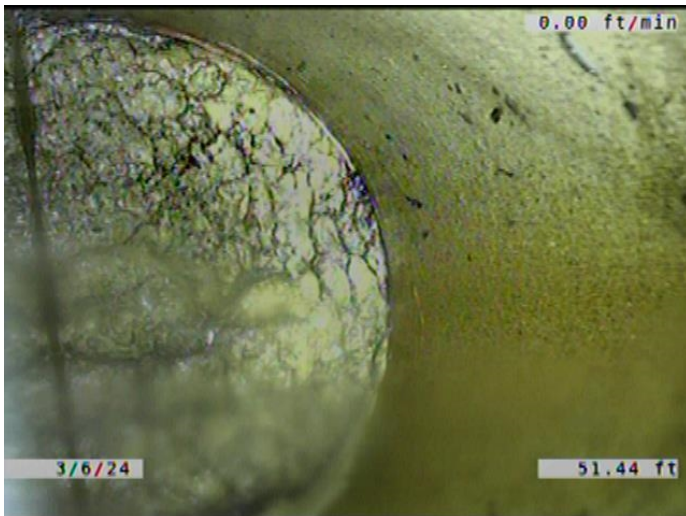
Code: **TFD**  
Description: **Tap Factory Defective**

Distance (ft): **51.4**  
Structural Grade: **0**  
O&M Grade: **3**  
Clock Start/From: **9**  
Clock To:  
1st Value: **6.000**  
2nd Value:  
Value Percent:  
Continuous Index:  
Within 8" of Joint: **YES**  
Remarks: **LOOKS TO BE PLUGGED WITH ENCRUSTATION.**

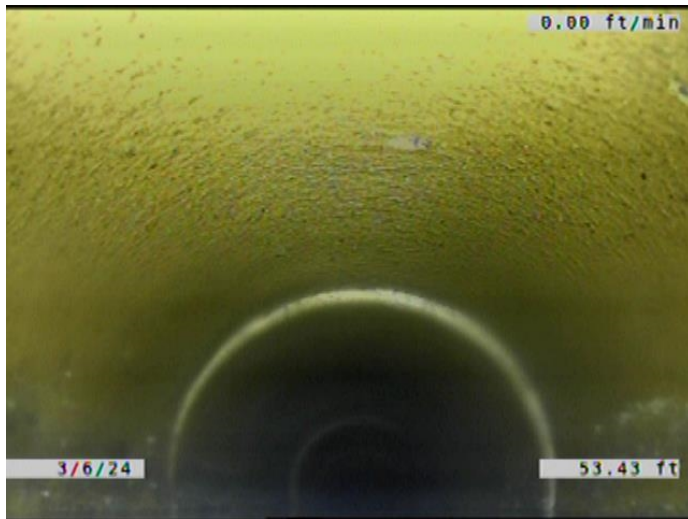
Code: **FM**  
Description: **Fracture Multiple**

Distance (ft): **53.4**  
Structural Grade: **4**  
O&M Grade: **0**  
Clock Start/From: **8**  
Clock To: **4**  
1st Value:  
2nd Value:  
Value Percent:  
Continuous Index: **F03**  
Within 8" of Joint: **YES**  
Remarks:

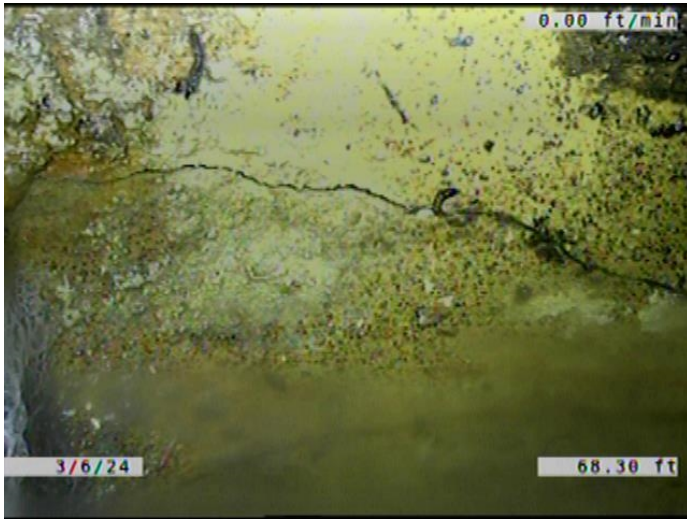
Code: **FC**  
Description: **Fracture Circumferential**

Distance (ft): **68.3**  
Structural Grade: **2**  
O&M Grade: **0**  
Clock Start/From: **8**  
Clock To: **4**  
1st Value:  
2nd Value:  
Value Percent:  
Continuous Index:  
Within 8" of Joint: **NO**  
Remarks:

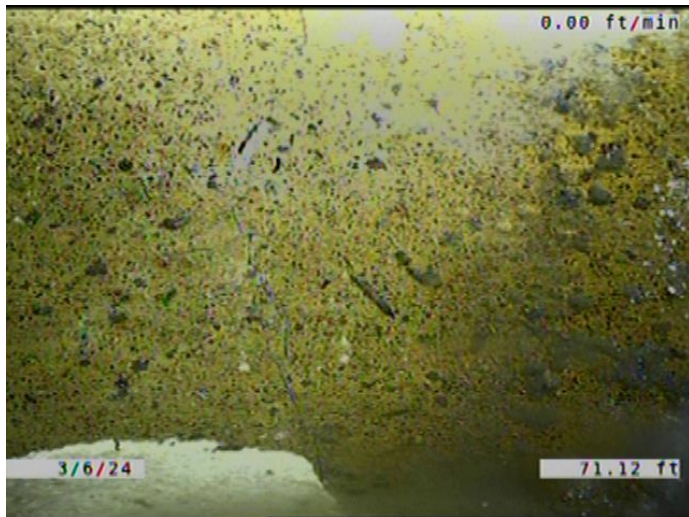
Code: **FM**  
 Description: **Fracture Multiple**

Distance (ft): **71.1**  
 Structural Grade: **4**  
 O&M Grade: **0**  
 Clock Start/From: **10**  
 Clock To: **2**  
 1st Value:  
 2nd Value:  
 Value Percent:  
 Continuous Index:  
 Within 8" of Joint: **YES**  
 Remarks:

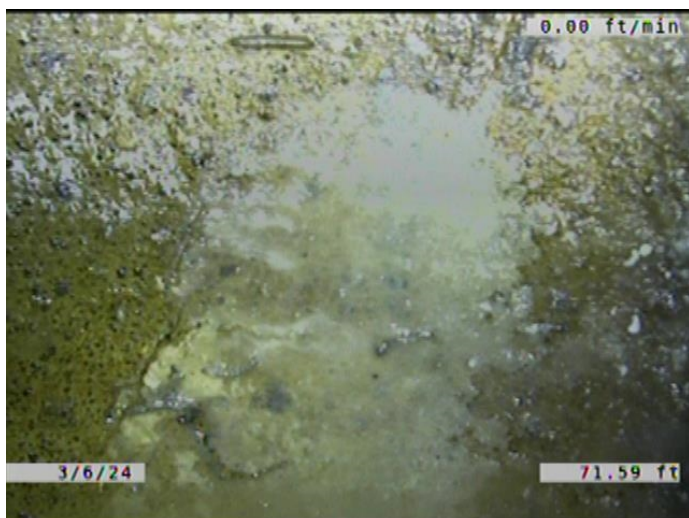
Code: **DAE**  
 Description: **Deposits Attached Encrustation**

Distance (ft): **71.6**  
 Structural Grade: **0**  
 O&M Grade: **2**  
 Clock Start/From: **8**  
 Clock To: **4**  
 1st Value:  
 2nd Value:  
 Value Percent: **5.000**  
 Continuous Index: **S04**  
 Within 8" of Joint: **YES**  
 Remarks:

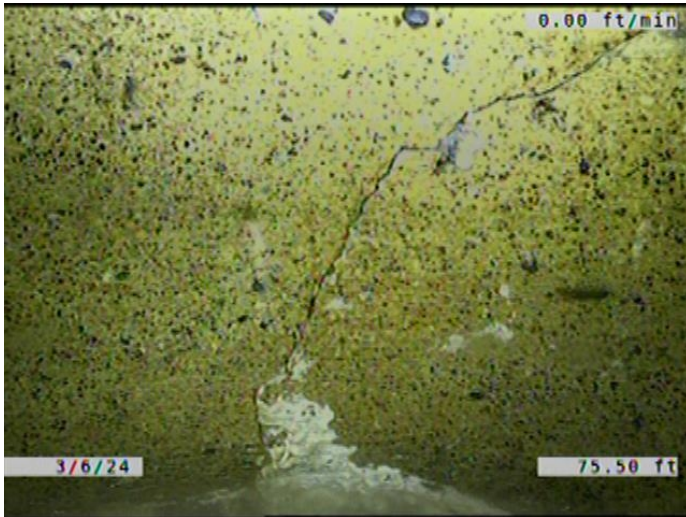
Code: **FM**  
Description: **Fracture Multiple**

Distance (ft): **75.5**  
Structural Grade: **4**  
O&M Grade: **0**  
Clock Start/From: **2**  
Clock To: **4**  
1st Value:  
2nd Value:  
Value Percent:  
Continuous Index:  
Within 8" of Joint: **YES**  
Remarks:

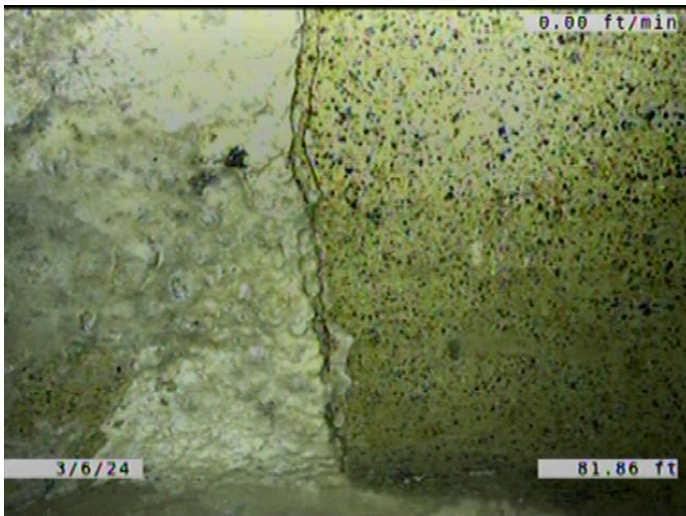
Code: **CL**  
Description: **Crack Longitudinal**

Distance (ft): **81.9**  
Structural Grade: **2**  
O&M Grade: **0**  
Clock Start/From: **11**  
Clock To:  
1st Value:  
2nd Value:  
Value Percent:  
Continuous Index:  
Within 8" of Joint: **YES**  
Remarks:

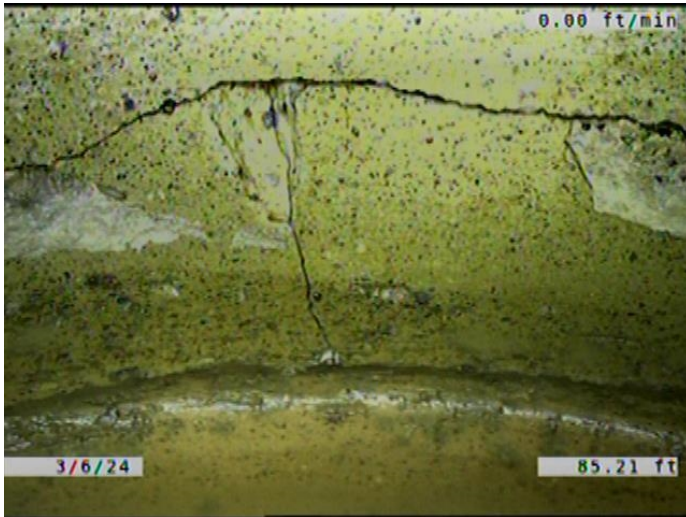
Code: **B**  
 Description: **Broken**

Distance (ft): **85.2**  
 Structural Grade: **4**  
 O&M Grade: **0**  
 Clock Start/From: **7**  
 Clock To: **3**  
 1st Value:  
 2nd Value:  
 Value Percent:  
 Continuous Index:  
 Within 8" of Joint: **YES**  
 Remarks:

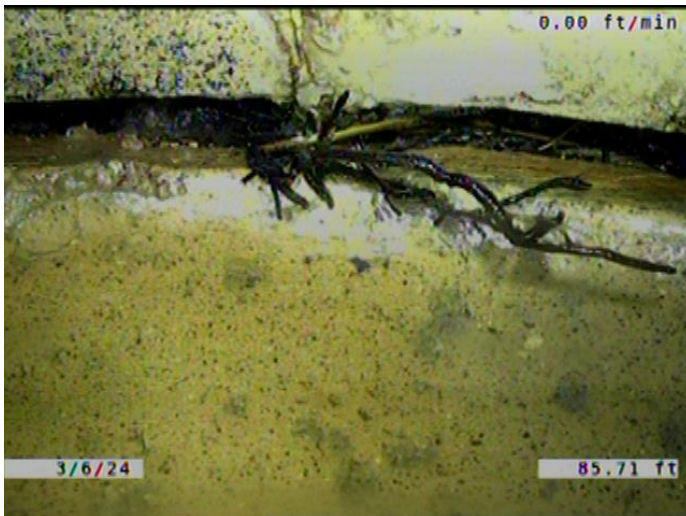
Code: **RFJ**  
 Description: **Roots Fine Joint**

Distance (ft): **85.7**  
 Structural Grade: **0**  
 O&M Grade: **1**  
 Clock Start/From: **1**  
 Clock To: **5**  
 1st Value:  
 2nd Value:  
 Value Percent:  
 Continuous Index:  
 Within 8" of Joint: **YES**  
 Remarks:

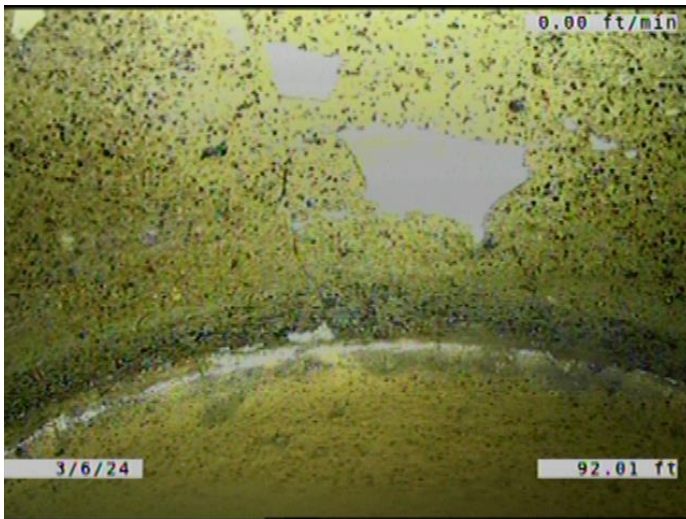
Code: **CM**  
 Description: **Crack Multiple**

Distance (ft): **92.0**  
 Structural Grade: **3**  
 O&M Grade: **0**  
 Clock Start/From: **10**  
 Clock To: **4**  
 1st Value:  
 2nd Value:  
 Value Percent:  
 Continuous Index:  
 Within 8" of Joint: **YES**  
 Remarks:

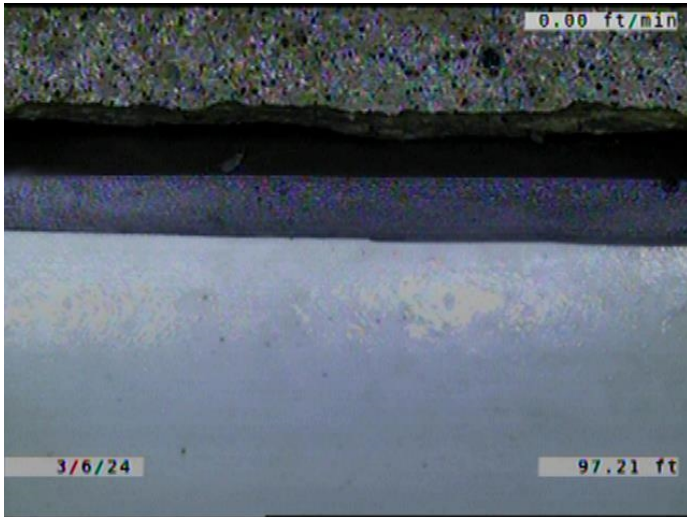
Code: **RPR**  
Description: **Point Repair Replacement**

Distance (ft): **97.2**  
Structural Grade: **0**  
O&M Grade: **0**  
Clock Start/From:  
Clock To:  
1st Value:  
2nd Value:  
Value Percent:  
Continuous Index: **S05**  
Within 8" of Joint: **YES**  
Remarks: **REPLACED WITH PVC.**

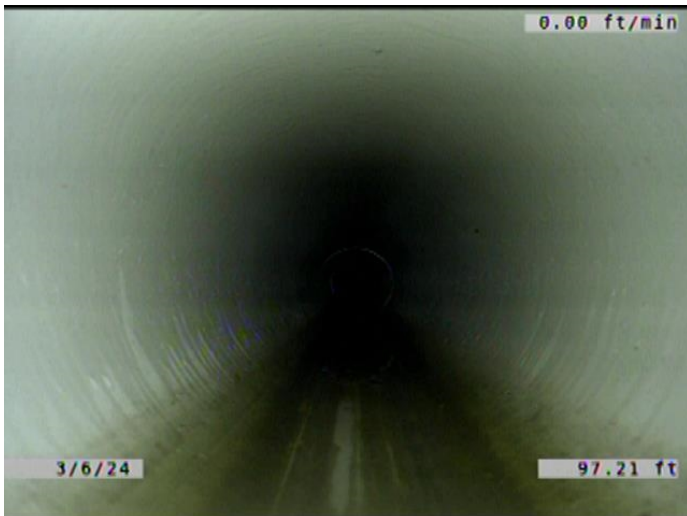
Code: **DAE**  
Description: **Deposits Attached Encrustation**

Distance (ft): **97.2**  
Structural Grade: **0**  
O&M Grade: **2**  
Clock Start/From: **8**  
Clock To: **4**  
1st Value:  
2nd Value:  
Value Percent: **5.000**  
Continuous Index: **F04**  
Within 8" of Joint: **YES**  
Remarks:

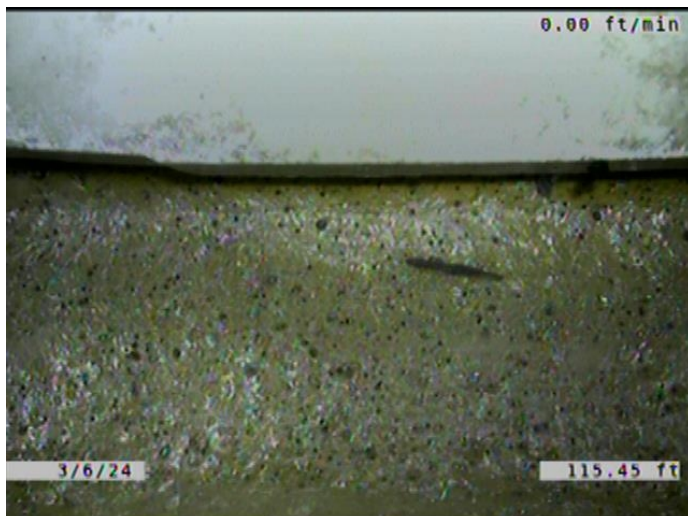
Code: **RPR**  
Description: **Point Repair Replacement**

Distance (ft): **115.4**  
Structural Grade: **0**  
O&M Grade: **0**  
Clock Start/From:  
Clock To:  
1st Value:  
2nd Value:  
Value Percent:  
Continuous Index: **F05**  
Within 8" of Joint: **YES**  
Remarks: **REPLACED WITH PVC.**

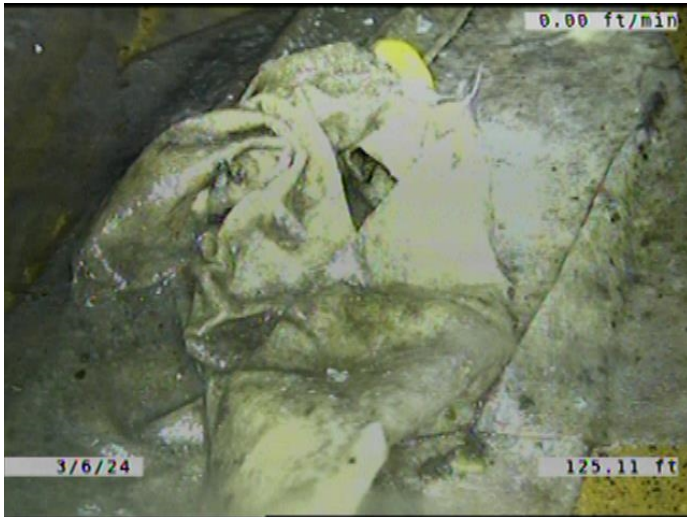
Code: **DAR**  
 Description: **Deposits Attached Ragging**

Distance (ft): **124.9**  
 Structural Grade: **0**  
 O&M Grade: **2**  
 Clock Start/From: **5**  
 Clock To:  
 1st Value:  
 2nd Value:  
 Value Percent: **5.000**  
 Continuous Index:  
 Within 8" of Joint: **YES**  
 Remarks:

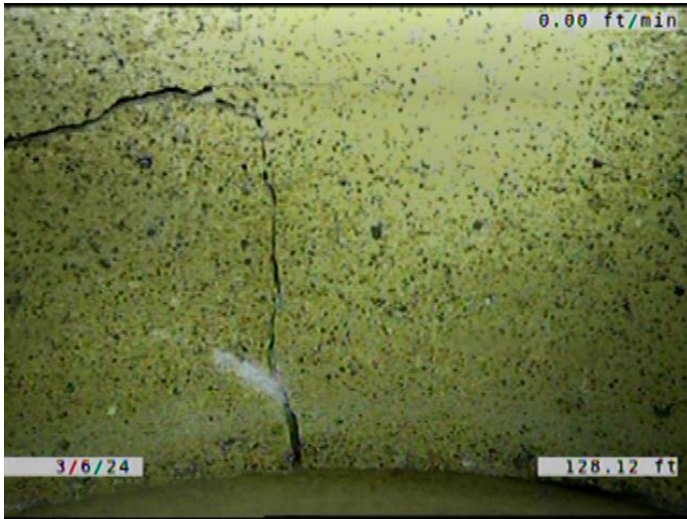
Code: **B**  
Description: **Broken**

Distance (ft): **128.1**  
Structural Grade: **4**  
O&M Grade: **0**  
Clock Start/From: **2**  
Clock To: **10**  
1st Value:  
2nd Value:  
Value Percent:  
Continuous Index:  
Within 8" of Joint: **YES**  
Remarks:

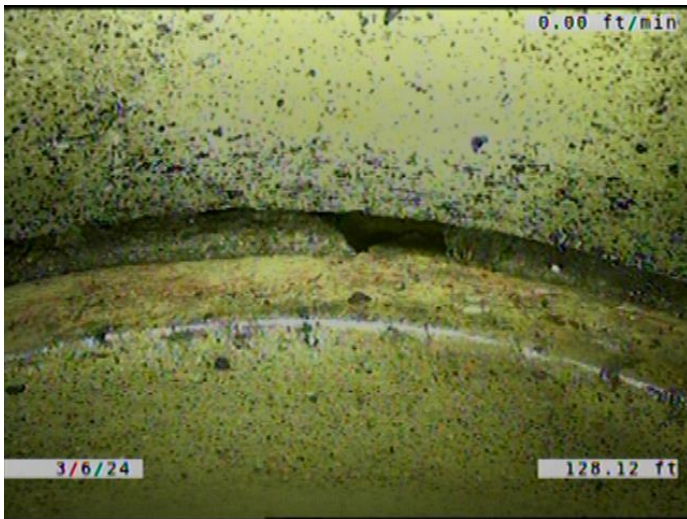
Code: **JOMD**  
Description: **Joint Offset Medium Defective**

Distance (ft): **128.1**  
Structural Grade: **3**  
O&M Grade: **0**  
Clock Start/From:  
Clock To:  
1st Value:  
2nd Value:  
Value Percent:  
Continuous Index:  
Within 8" of Joint: **NO**  
Remarks:

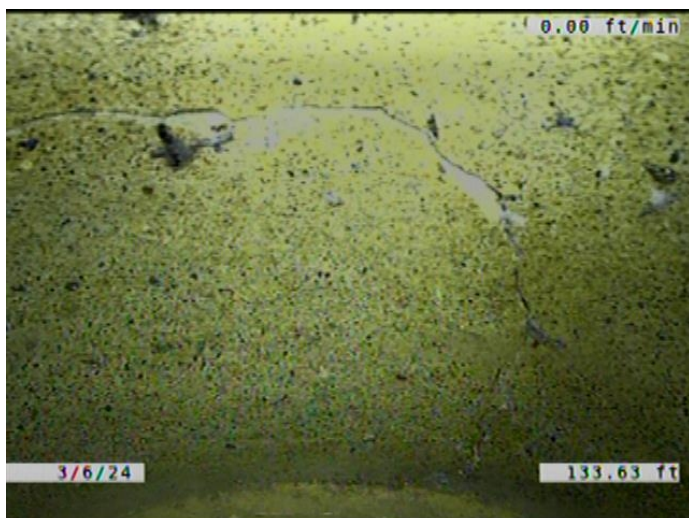
Code: **FM**  
 Description: **Fracture Multiple**

Distance (ft): **133.6**  
 Structural Grade: **4**  
 O&M Grade: **0**  
 Clock Start/From: **8**  
 Clock To: **3**  
 1st Value:  
 2nd Value:  
 Value Percent:  
 Continuous Index:  
 Within 8" of Joint: **YES**  
 Remarks:

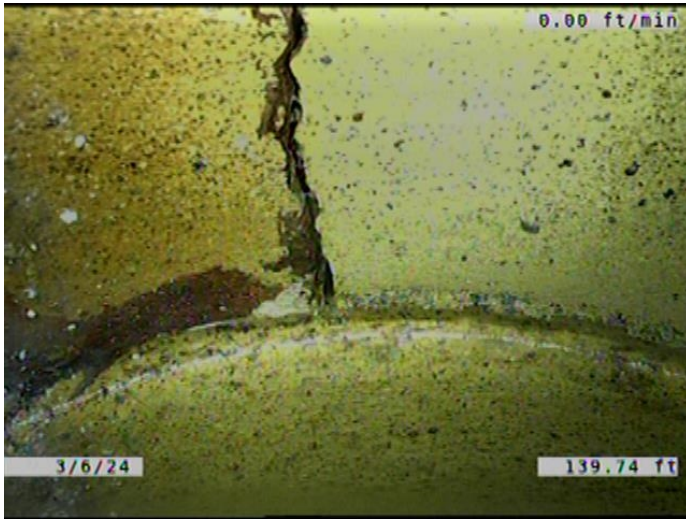
Code: **B**  
Description: **Broken**

Distance (ft): **139.7**  
Structural Grade: **4**  
O&M Grade: **0**  
Clock Start/From: **7**  
Clock To: **9**  
1st Value:  
2nd Value:  
Value Percent:  
Continuous Index:  
Within 8" of Joint: **YES**  
Remarks:

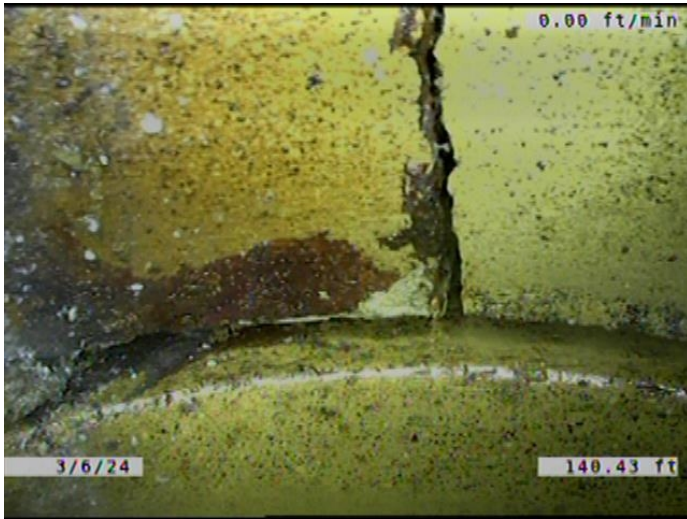
Code: **ISB**  
Description: **Infiltration Stain Barrel**

Distance (ft): **140.4**  
Structural Grade: **0**  
O&M Grade: **1**  
Clock Start/From: **7**  
Clock To: **9**  
1st Value:  
2nd Value:  
Value Percent:  
Continuous Index:  
Within 8" of Joint: **YES**  
Remarks:

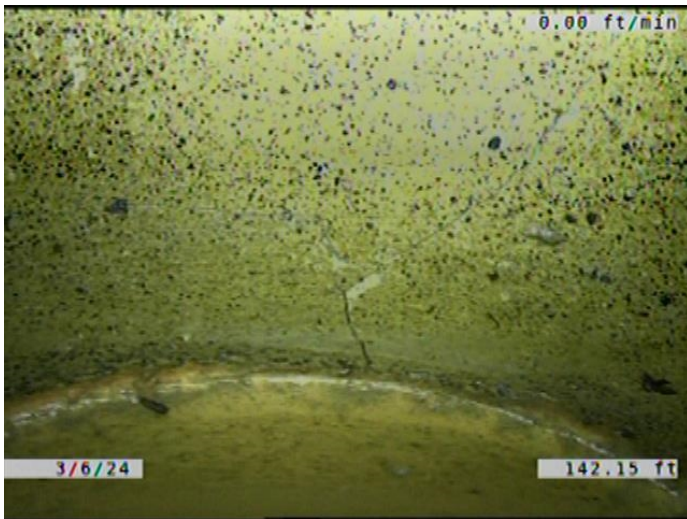
Code: **CM**  
Description: **Crack Multiple**

Distance (ft): **142.1**  
Structural Grade: **3**  
O&M Grade: **0**  
Clock Start/From: **10**  
Clock To: **4**  
1st Value:  
2nd Value:  
Value Percent:  
Continuous Index:  
Within 8" of Joint: **YES**  
Remarks:

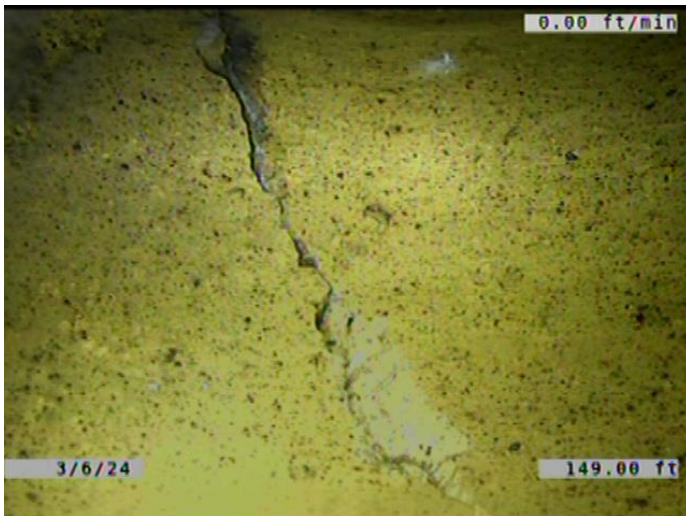
Code: **FM**  
Description: **Fracture Multiple**

Distance (ft): **149.0**  
Structural Grade: **4**  
O&M Grade: **0**  
Clock Start/From: **3**  
Clock To: **5**  
1st Value:  
2nd Value:  
Value Percent:  
Continuous Index:  
Within 8" of Joint: **YES**  
Remarks:

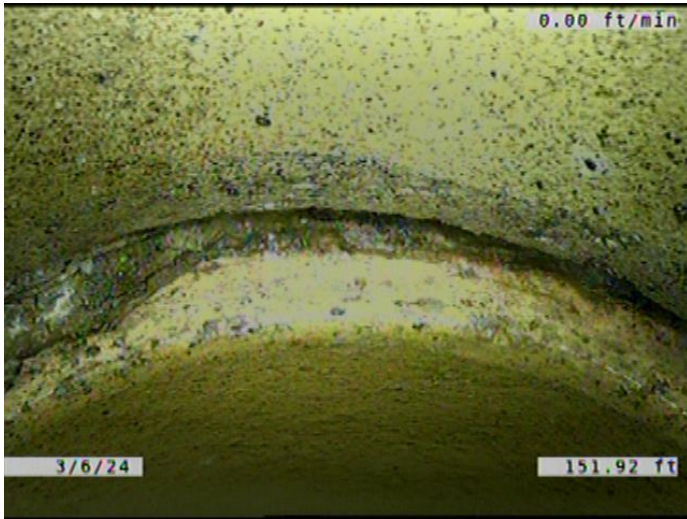
Code: **JOMD**  
Description: **Joint Offset Medium Defective**

Distance (ft): **151.9**  
Structural Grade: **3**  
O&M Grade: **0**  
Clock Start/From:  
Clock To:  
1st Value:  
2nd Value:  
Value Percent:  
Continuous Index:  
Within 8" of Joint: **NO**  
Remarks:

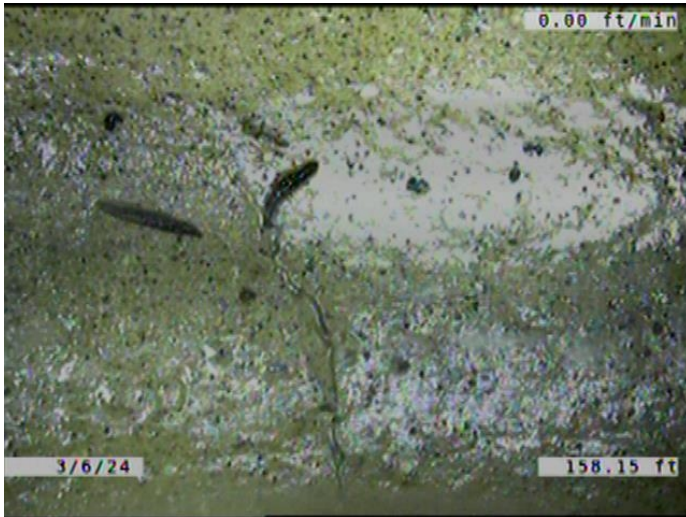
Code: **CM**  
Description: **Crack Multiple**

Distance (ft): **158.1**  
Structural Grade: **3**  
O&M Grade: **0**  
Clock Start/From: **8**  
Clock To: **9**  
1st Value:  
2nd Value:  
Value Percent:  
Continuous Index:  
Within 8" of Joint: **YES**  
Remarks:

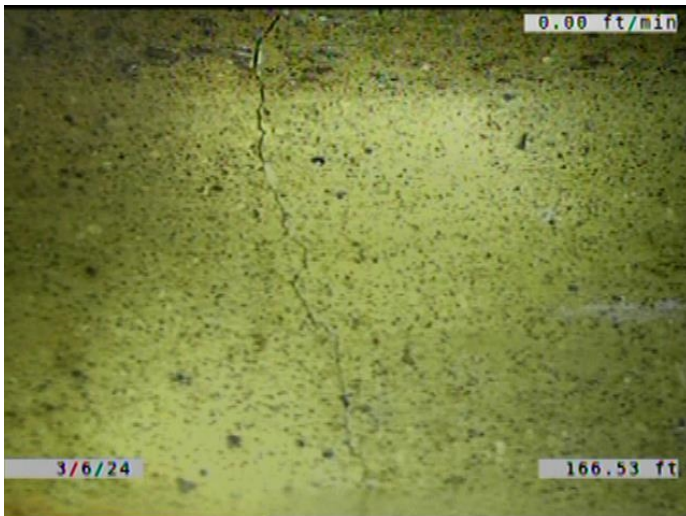
Code: **CS**  
Description: **Crack Spiral**

Distance (ft): **166.5**  
Structural Grade: **2**  
O&M Grade: **0**  
Clock Start/From: **3**  
Clock To: **4**  
1st Value:  
2nd Value:  
Value Percent:  
Continuous Index:  
Within 8" of Joint: **YES**  
Remarks:

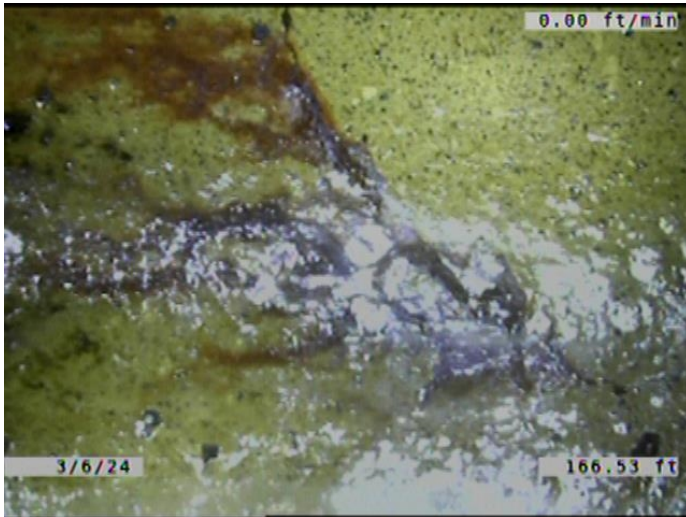
Code: **ISB**  
Description: **Infiltration Stain Barrel**

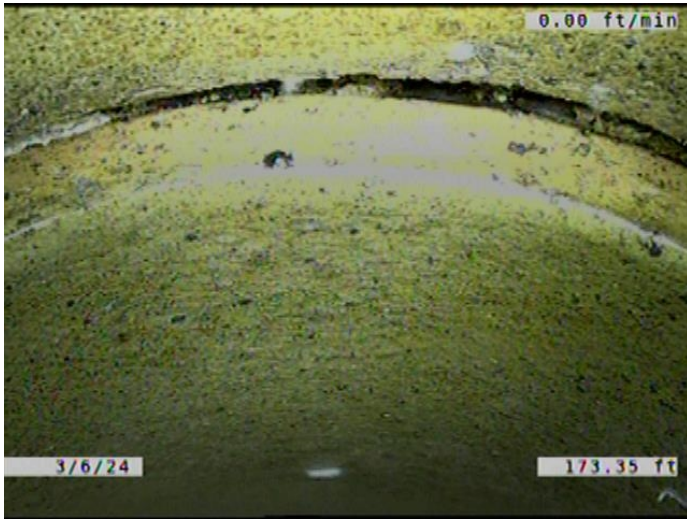
Code: **JOMD**  
 Description: **Joint Offset Medium Defective**

Distance (ft): **173.3**  
 Structural Grade: **3**  
 O&M Grade: **0**  
 Clock Start/From:  
 Clock To:  
 1st Value:  
 2nd Value:  
 Value Percent:  
 Continuous Index:  
 Within 8" of Joint: **NO**  
 Remarks:

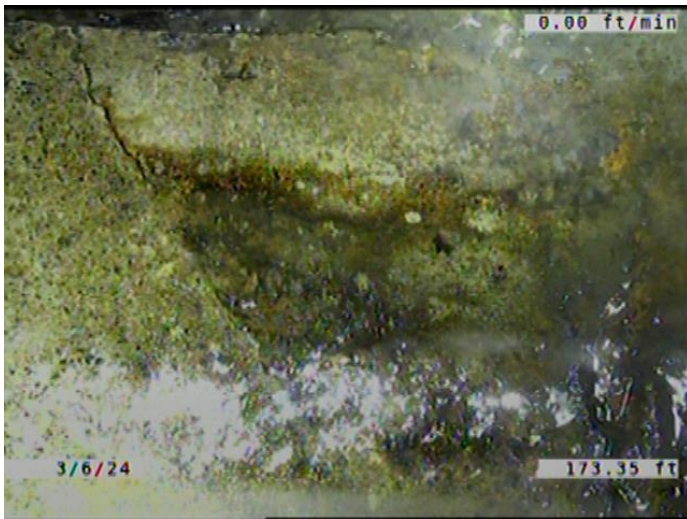
Code: **DAE**  
 Description: **Deposits Attached Encrustation**

Distance (ft): **173.3**  
 Structural Grade: **0**  
 O&M Grade: **2**  
 Clock Start/From: **7**  
 Clock To: **9**  
 1st Value:  
 2nd Value:  
 Value Percent: **5.000**  
 Continuous Index:  
 Within 8" of Joint: **YES**  
 Remarks:

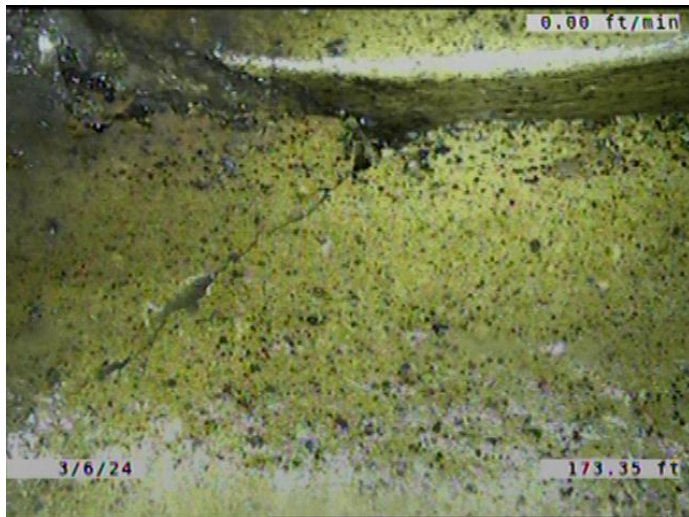
Code: **B**  
 Description: **Broken**

Distance (ft): **173.3**  
 Structural Grade: **4**  
 O&M Grade: **0**  
 Clock Start/From: **4**  
 Clock To: **9**  
 1st Value:  
 2nd Value:  
 Value Percent:  
 Continuous Index:  
 Within 8" of Joint: **YES**  
 Remarks:

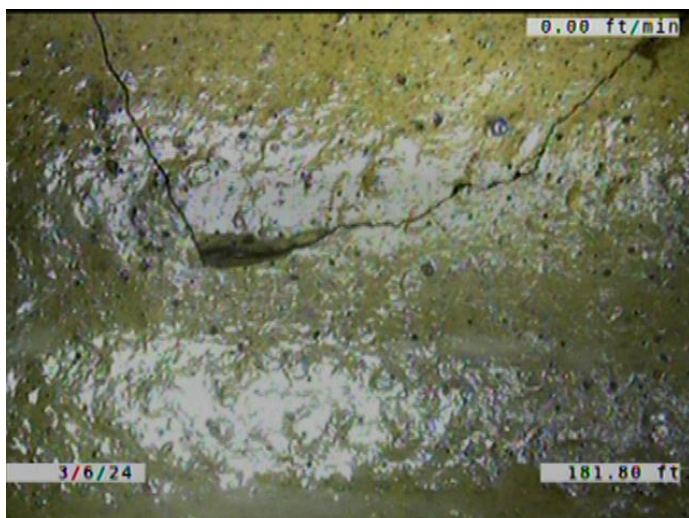
Code: **FM**  
 Description: **Fracture Multiple**

Distance (ft): **181.8**  
 Structural Grade: **4**  
 O&M Grade: **0**  
 Clock Start/From: **7**  
 Clock To: **2**  
 1st Value:  
 2nd Value:  
 Value Percent:  
 Continuous Index:  
 Within 8" of Joint: **YES**  
 Remarks:

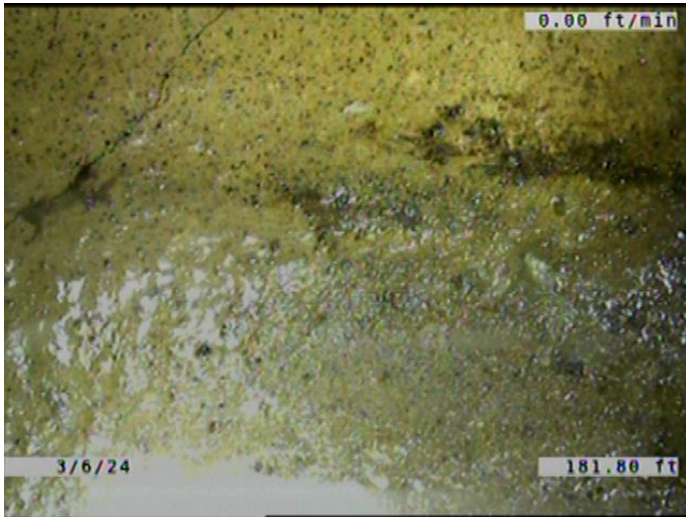
Code: **ISB**  
Description: **Infiltration Stain Barrel**

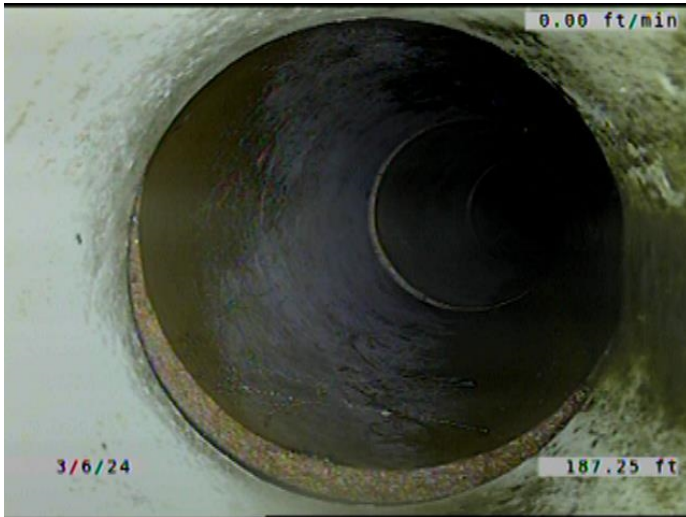
Code: **TF**  
Description: **Tap Factory**

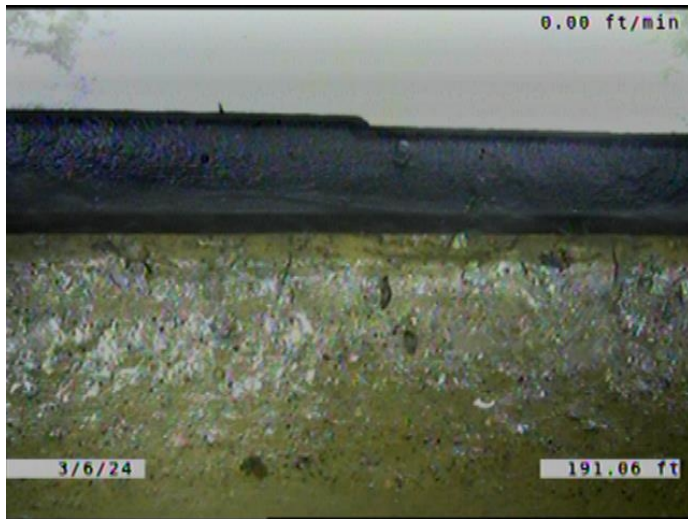
Code: **RPR**  
Description: **Point Repair Replacement**

Distance (ft): **191.1**  
Structural Grade: **0**  
O&M Grade: **0**  
Clock Start/From:  
Clock To:  
1st Value:  
2nd Value:  
Value Percent:  
Continuous Index: **F07**  
Within 8" of Joint: **YES**  
Remarks: **REPLACED WITH PVC.**

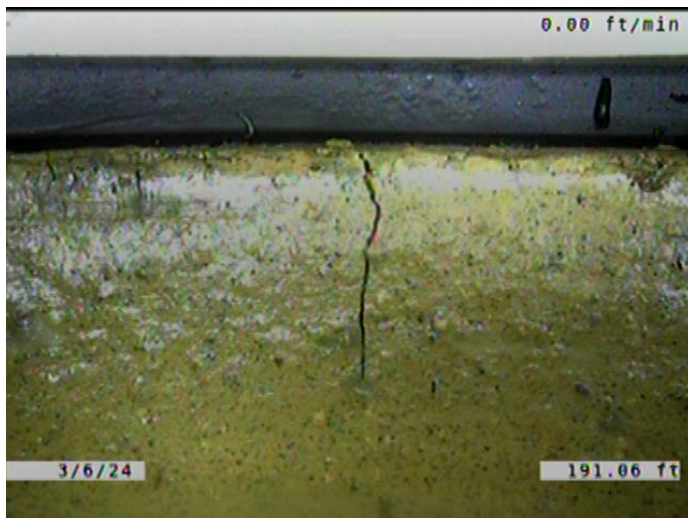
Code: **CL**  
Description: **Crack Longitudinal**

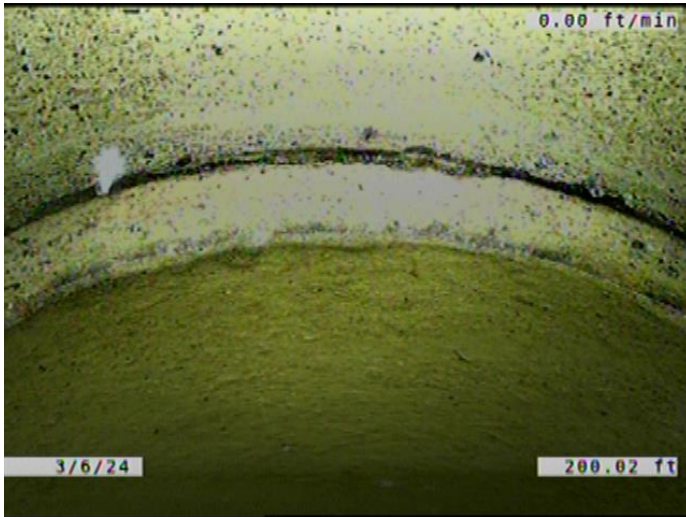
Code: **JOMD**  
Description: **Joint Offset Medium Defective**

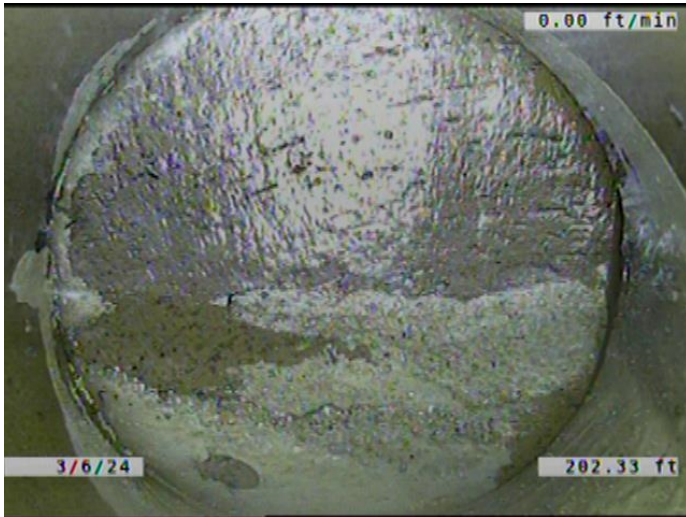
Code: **TFD**  
Description: **Tap Factory Defective**

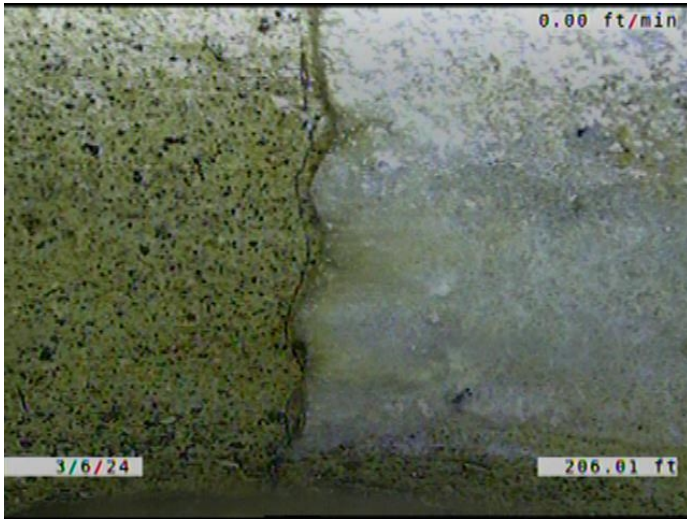
Code: **CL**  
Description: **Crack Longitudinal**

Distance (ft): **206.0**  
Structural Grade: **2**  
O&M Grade: **0**  
Clock Start/From: **1**  
Clock To:  
1st Value:  
2nd Value:  
Value Percent:  
Continuous Index:  
Within 8" of Joint: **YES**  
Remarks:

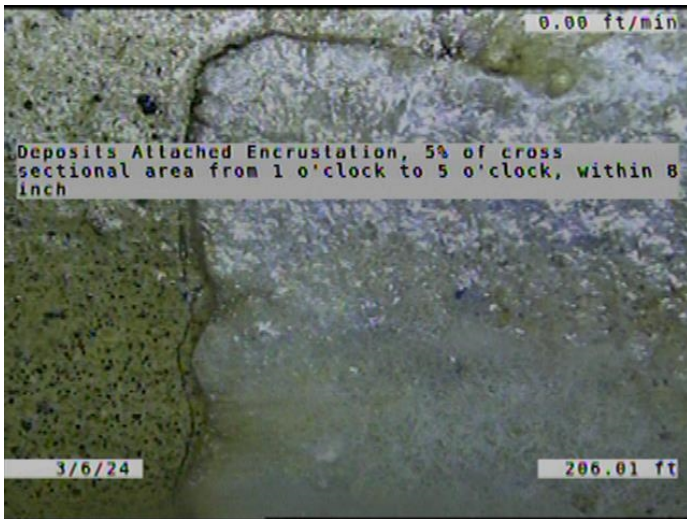
Code: **DAE**  
Description: **Deposits Attached Encrustation**

Distance (ft): **206.0**  
Structural Grade: **0**  
O&M Grade: **2**  
Clock Start/From: **1**  
Clock To: **5**  
1st Value:  
2nd Value:  
Value Percent: **5.000**  
Continuous Index:  
Within 8" of Joint: **YES**  
Remarks:

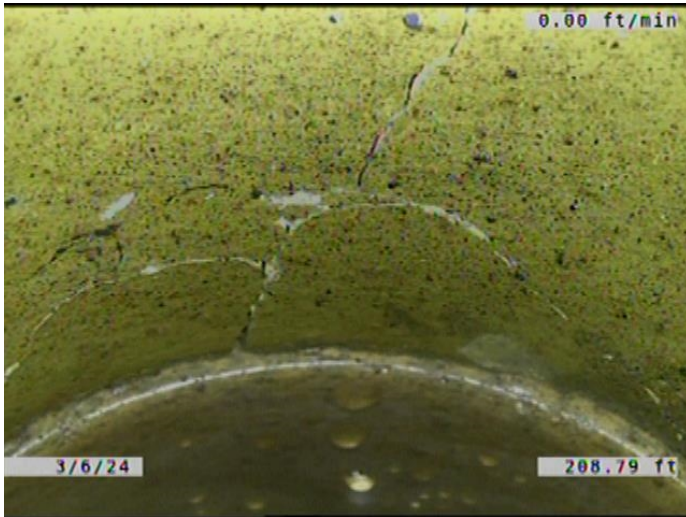
Code: **FM**  
Description: **Fracture Multiple**

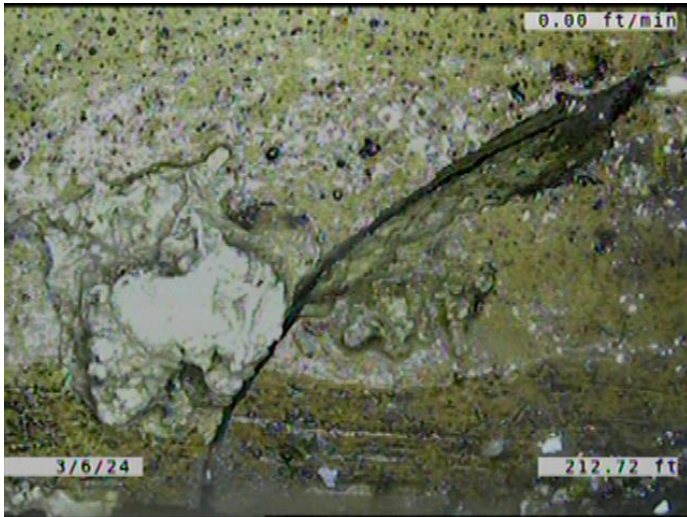
Code: **B**  
Description: **Broken**

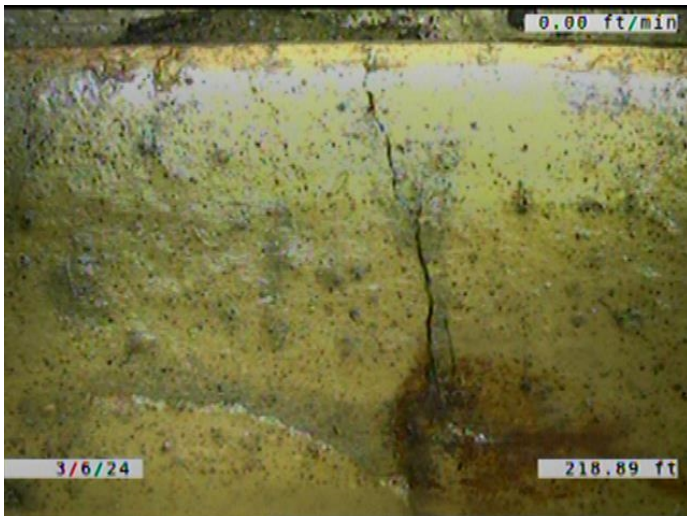
Code: **FM**  
Description: **Fracture Multiple**

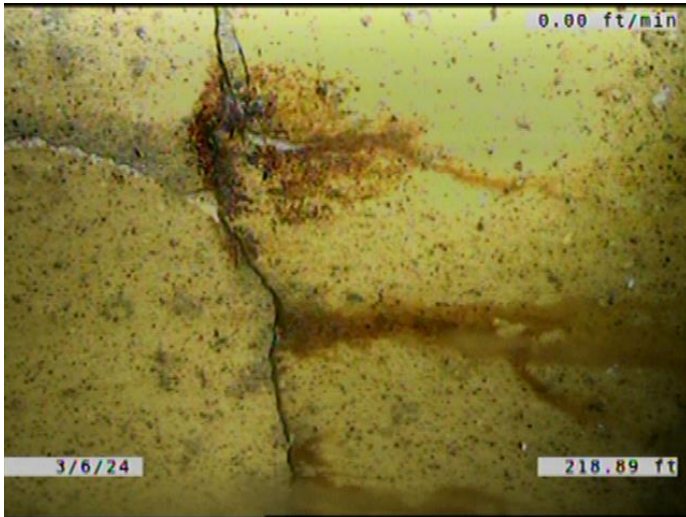
Code: **ISB**  
Description: **Infiltration Stain Barrel**

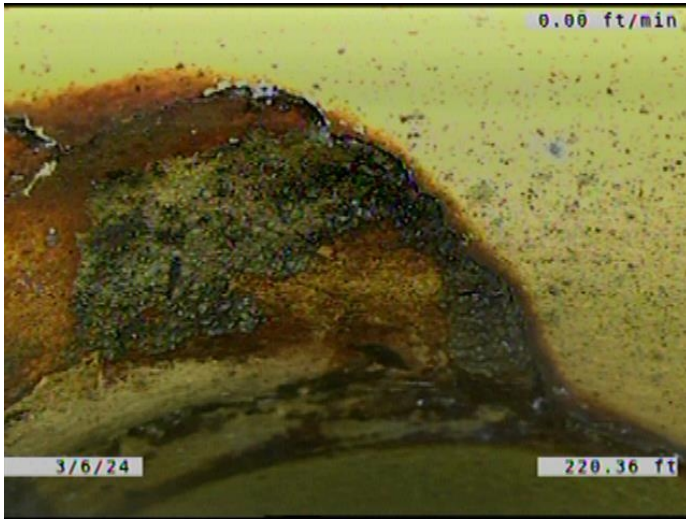
Code: **FM**  
Description: **Fracture Multiple**

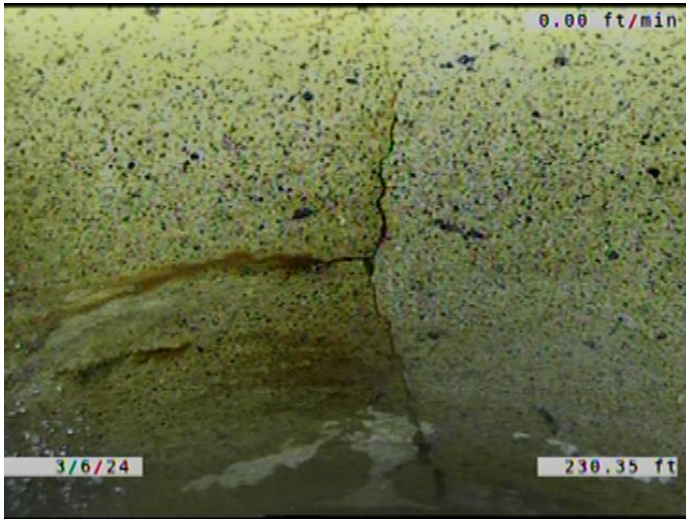
Code: **CM**  
Description: **Crack Multiple**

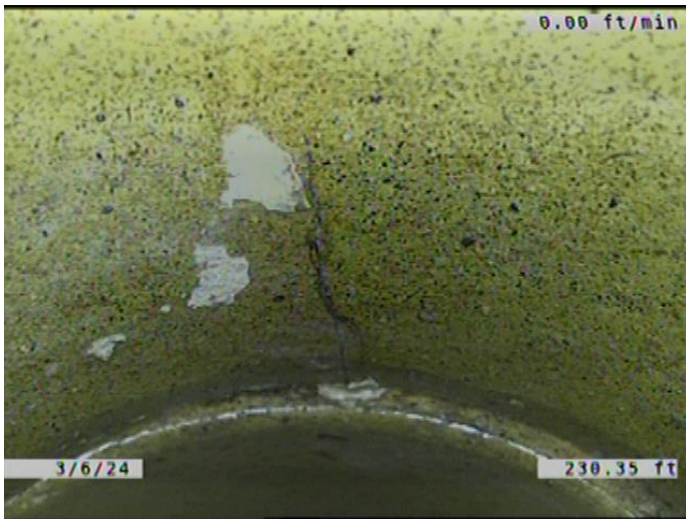
Code: **CL**  
Description: **Crack Longitudinal**

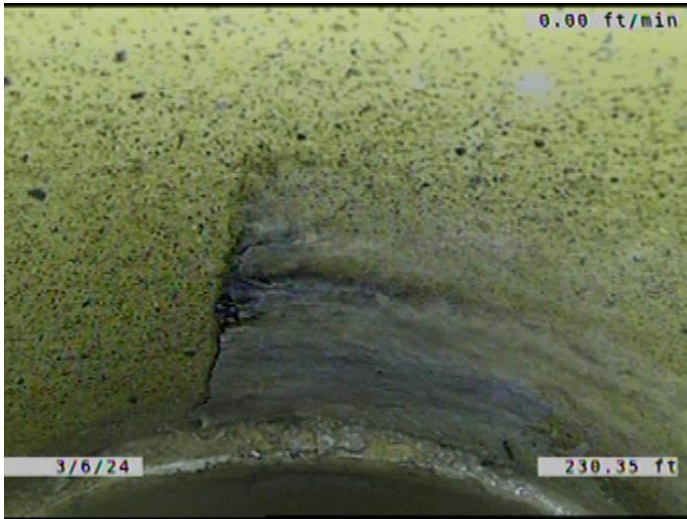
Code: **CS**  
Description: **Crack Spiral**

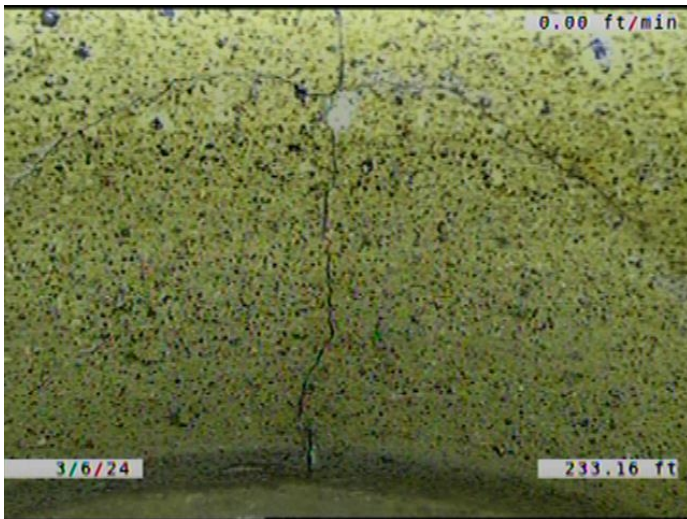
Code: **CM**  
Description: **Crack Multiple**

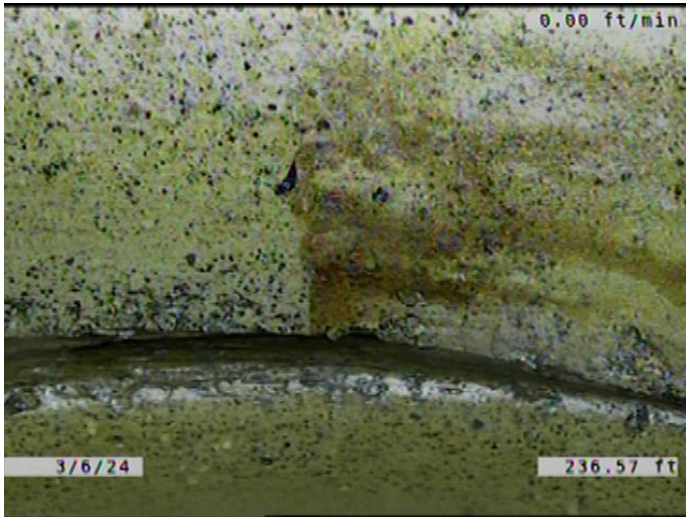
Code: **CL**  
Description: **Crack Longitudinal**

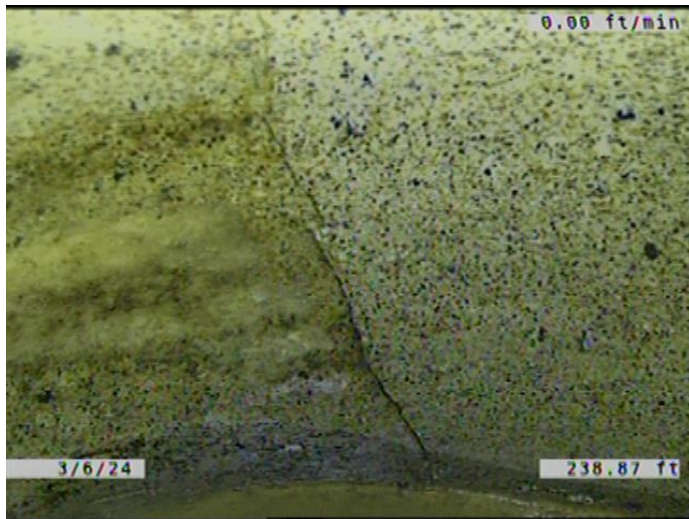
Code: **CS**  
Description: **Crack Spiral**
