# Profile/Photo Observation Report

Date:	<b>03/06/2024</b>	Weather:		Coding:	<b>PACP 7.0</b>
Pipe Length (ft):	<b>338.0</b>	Owner:	<b>City of Hobart</b>	Pre Clean:	<b>Heavy Cleaning</b>
P.O.#:		Surveyor:	<b>S. Bucklin</b>	PSR:	<b>P-405-042-041</b>
Customer:	<b>City of Hobart</b>	Clean Date:	<b>10/21/2023</b>	Shape:	<b>C</b>

Street:	<b>SOFTWOOD DR</b>	Flow Control:	<b>Not Controlled</b>
City:	<b>Hobart, IN</b>	Year Renewed:	
Location:	<b>Easement/Right of Way</b>	Tape/Media #:	
Purpose:	<b>Sewer System Evaluation Survey (SS)</b>	Dia/Height:	<b>8"</b>
Use:	<b>Sanitary Sewage Pipe</b>	Material:	<b>VCP</b>
Drain Area:		Lining:	<b>None</b>
Category:	<b>NA</b>		
Comment:			
Location Details:		Direction of Survey:	<b>Upstream</b>
US MH:	<b>M-405-041</b>	DS MH:	<b>M-405-042</b>
		Total Length Surveyed (ft):	<b>338.4</b>

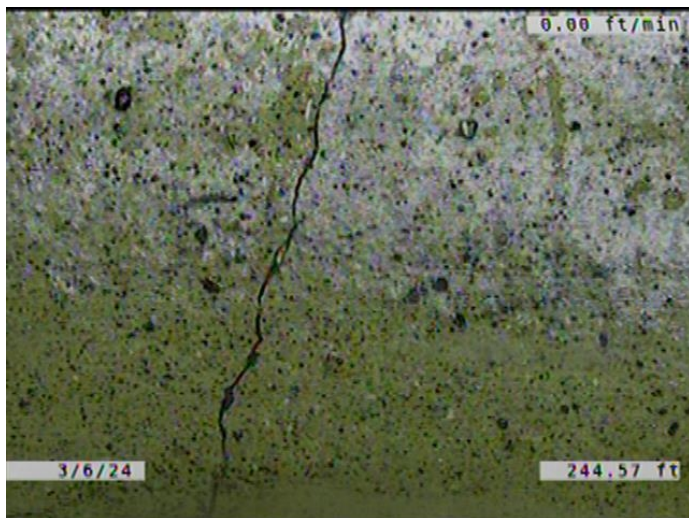
Code: **CS**  
Description: **Crack Spiral**

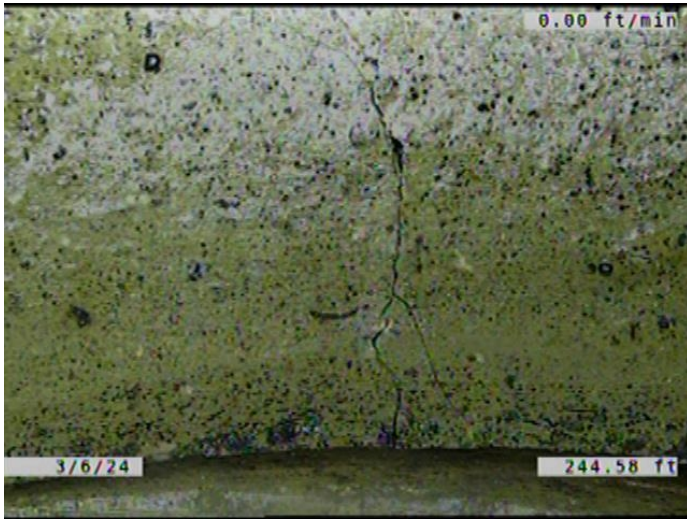
Code: **CM**  
Description: **Crack Multiple**

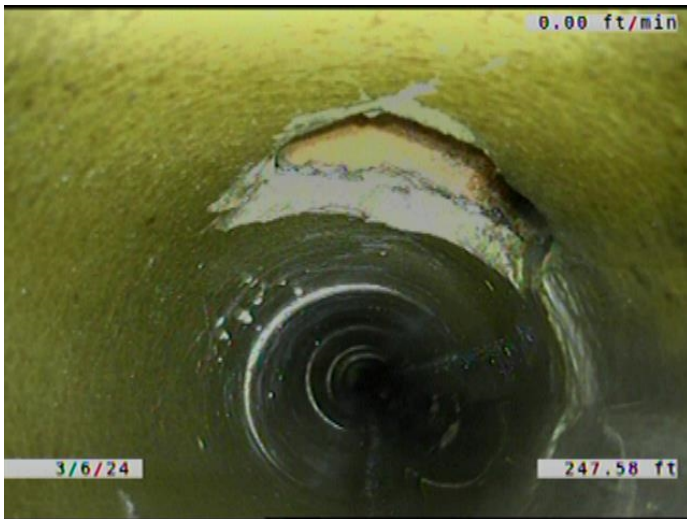
Code: **FM**  
Description: **Fracture Multiple**

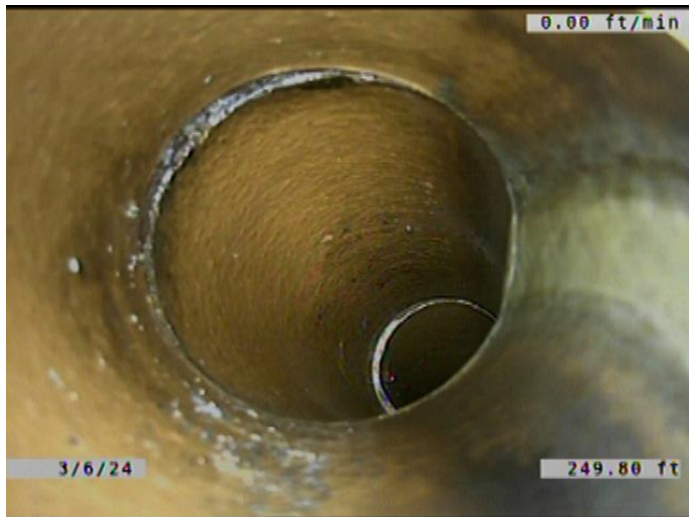
Code: **TBD**  
Description: **Tap Break-in/Hammer Defective**

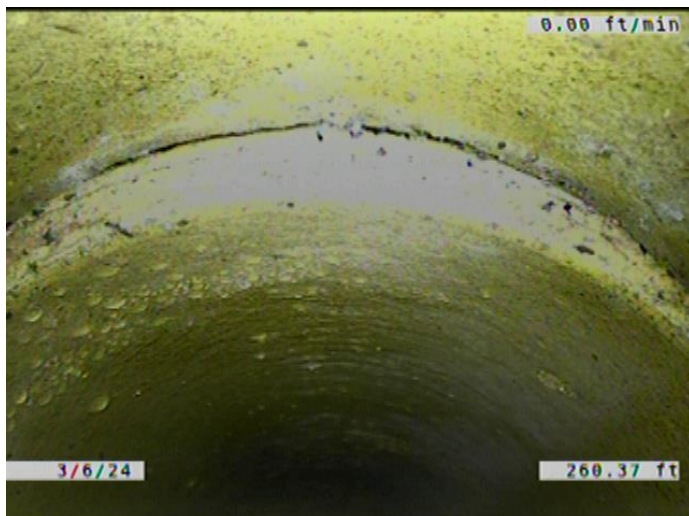
Code: **JOMD**  
Description: **Joint Offset Medium Defective**

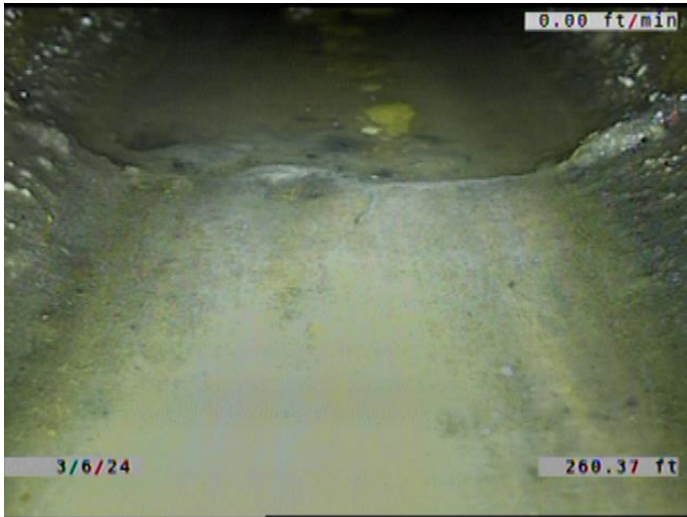
Code: **CL**  
Description: **Crack Longitudinal**

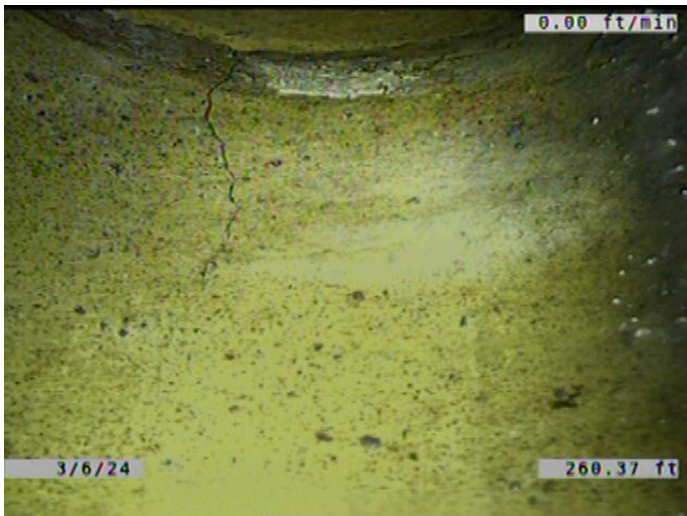
Code: **CM**  
Description: **Crack Multiple**

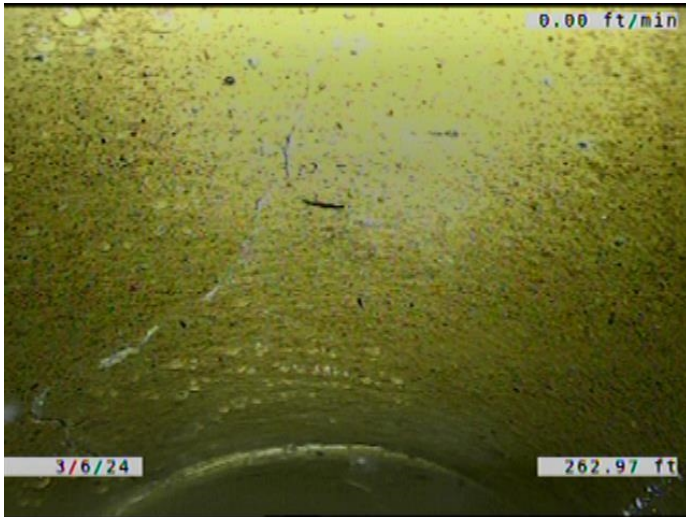
Code: **FM**  
Description: **Fracture Multiple**

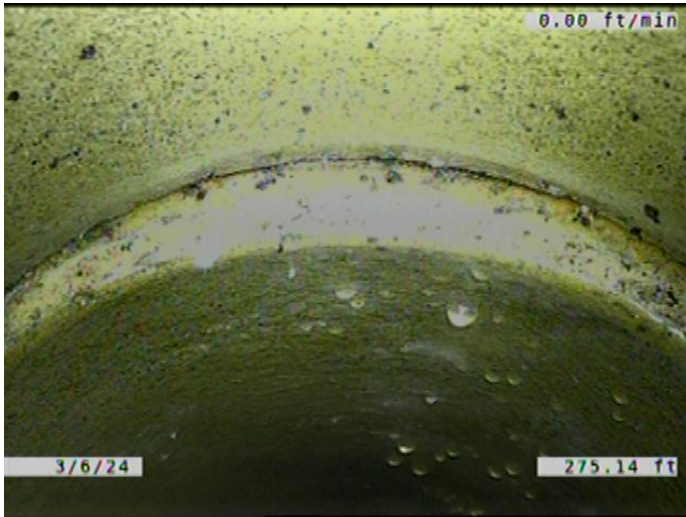
Code: **JOMD**  
 Description: **Joint Offset Medium Defective**

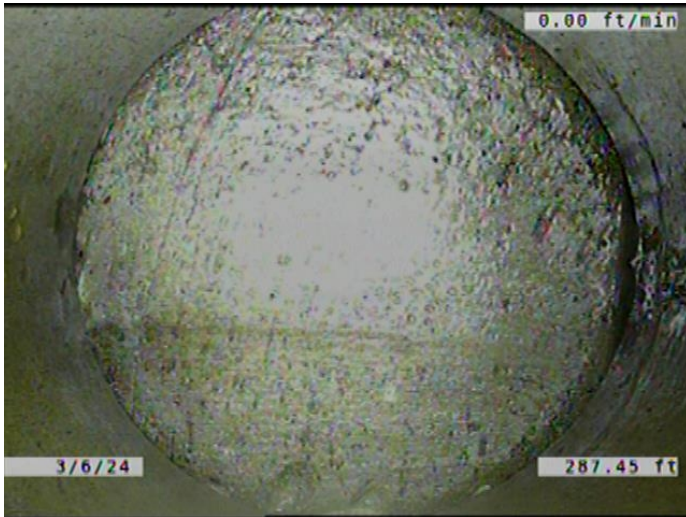
Code: **TFC**  
Description: **Tap Factory Capped**

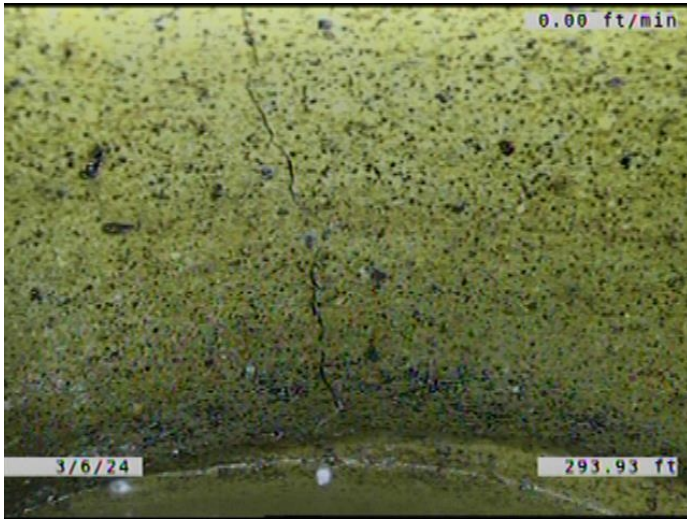
Code: **CS**  
Description: **Crack Spiral**

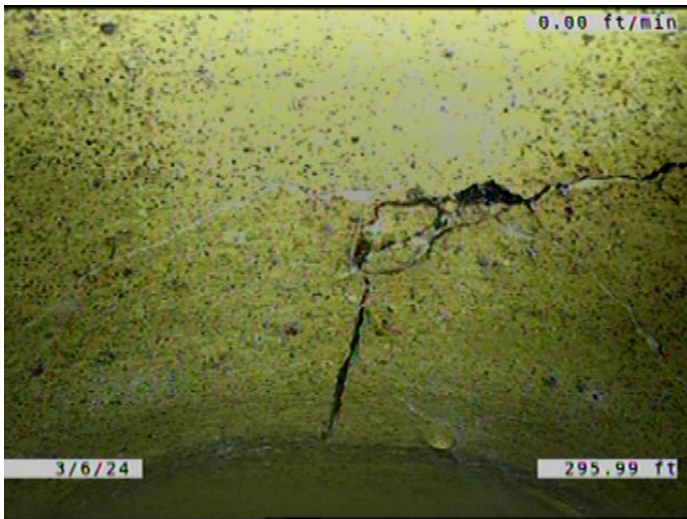
Code: **B**  
Description: **Broken**

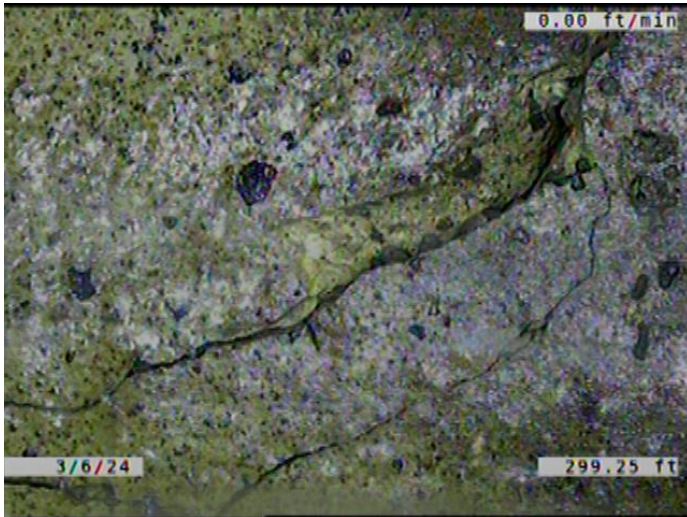
Code: **B**  
Description: **Broken**

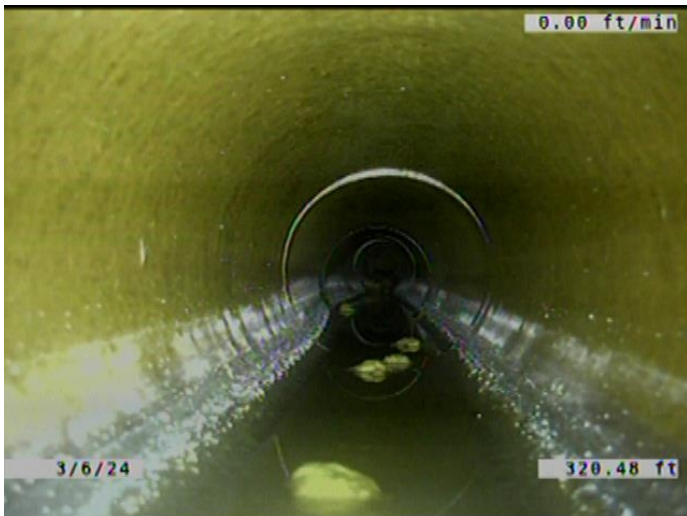
Code: **FM**  
Description: **Fracture Multiple**

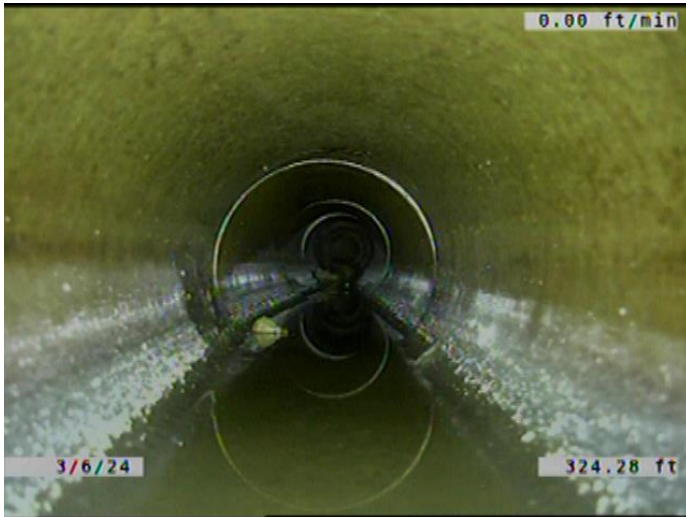
Code: **JOMD**  
Description: **Joint Offset Medium Defective**
