## Profile/Photo Observation Report

Date:	<b>04/25/2018</b>	Weather:		Coding:	<b>PACP 6.0</b>
Pipe Length (ft):		Owner:	<b>City of Hobart</b>	Pre Clean:	<b>No Pre-Cleaning</b>
P.O.#:	<b>79</b>	Surveyor:	<b>M. Pielacha</b>	PSR:	<b>P-405-043-020</b>
Customer:	<b>City of Hobart</b>	Clean Date:		Shape:	<b>C</b>

Street:	<b>3rd Street</b>	Flow Control:	<b>Not Controlled</b>
City:	<b>Hobart, IN</b>	Year Renewed:	
Location:	<b>Light Highway</b>	Tape/Media #:	<b>DEP 79</b>
Purpose:	<b>Routine Assessment</b>	Dia/Height:	<b>15"</b>
Use:	<b>Sanitary</b>	Material:	<b>CP</b>
Drain Area:		Lining:	
Category:	<b>NA</b>		
Comment:	<b>YES501824 Submittal 2</b>		
Location Details:		Direction of Survey:	<b>Downstream</b>
US MH:	<b>M-405-043</b>	DS MH:	<b>M-405-020</b>
		Total Length Surveyed (ft):	<b>135.4</b>

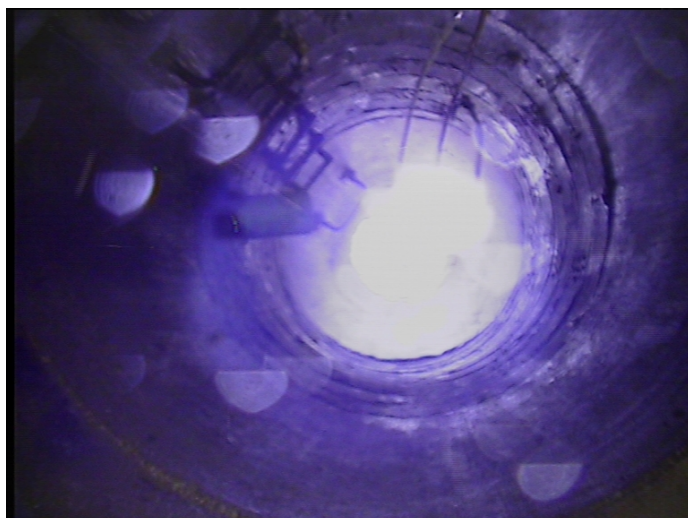
Code: **AMH**  
 Description: **Manhole**

Distance (ft): **.0**  
 Structural Grade: **0**  
 O&M Grade: **0**  
 Clock Start/From:  
 Clock To:  
 1st Value:  
 2nd Value:  
 Value Percent:  
 Continuous Index:  
 Within 8" of Joint: **NO**  
 Remarks: **M-405-043**

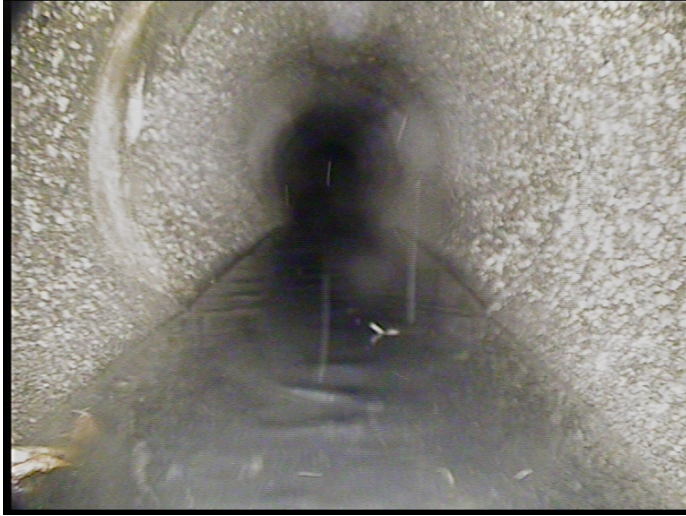
Code: **MWL**  
Description: **Water Level**

Distance (ft): **.0**  
Structural Grade: **0**  
O&M Grade: **0**  
Clock Start/From:  
Clock To:  
1st Value:  
2nd Value:  
Value Percent: **10.000**  
Continuous Index:  
Within 8" of Joint: **NO**  
Remarks:

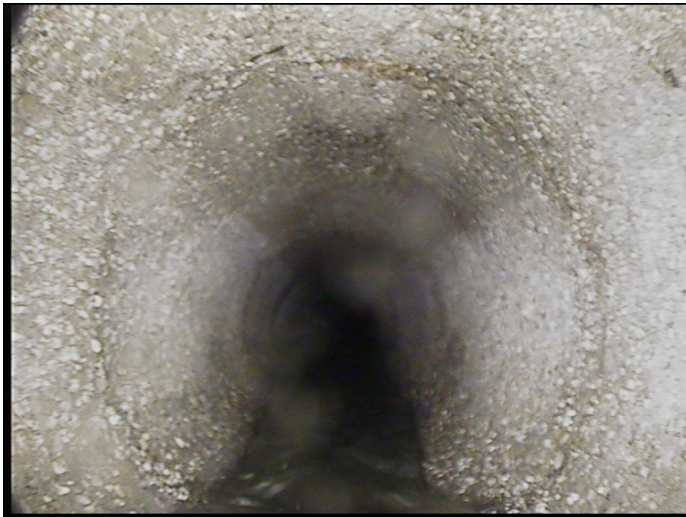
Code: **SAV**  
Description: **Surface Aggregate Visible**

Distance (ft): **.0**  
Structural Grade: **3**  
O&M Grade: **0**  
Clock Start/From: **8**  
Clock To: **4**  
1st Value:  
2nd Value:  
Value Percent:  
Continuous Index: **S01**  
Within 8" of Joint: **YES**  
Remarks:

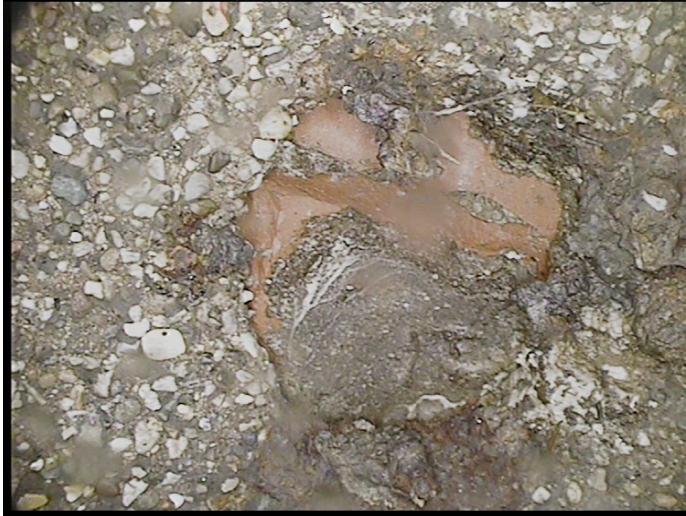
Code:	<b>RPP</b>
Description:	<b>Repair Patch</b>
Distance (ft):	<b>7.6</b>
Structural Grade:	<b>0</b>
O&M Grade:	<b>0</b>
Clock Start/From:	<b>1</b>
Clock To:	
1st Value:	
2nd Value:	
Value Percent:	
Continuous Index:	
Within 8" of Joint:	<b>NO</b>
Remarks:	<b>repair patch</b>

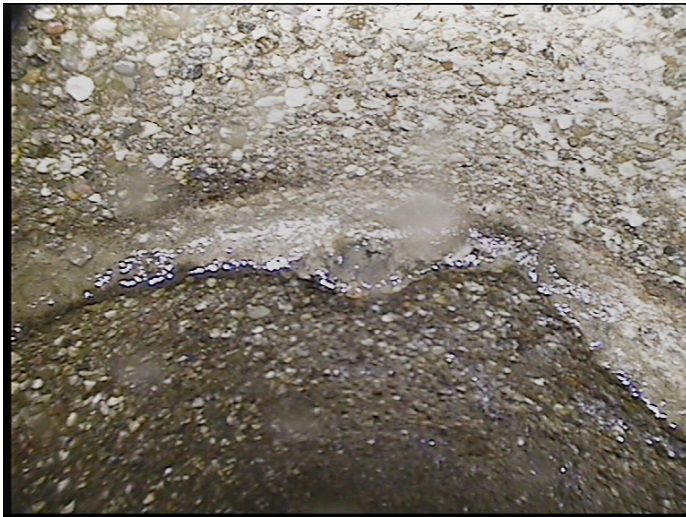
Code:	<b>ID</b>
Description:	<b>Infil Dripper</b>
Distance (ft):	<b>84.7</b>
Structural Grade:	<b>0</b>
O&M Grade:	<b>3</b>
Clock Start/From:	<b>1</b>
Clock To:	
1st Value:	
2nd Value:	
Value Percent:	
Continuous Index:	
Within 8" of Joint:	<b>NO</b>
Remarks:

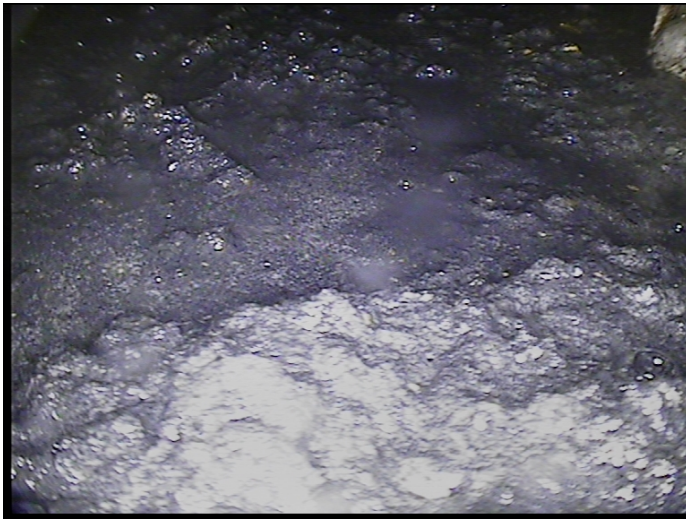
Code: **DSF**  
Description: **Deposits Settled Fine**

Distance (ft): **84.7**  
Structural Grade: **0**  
O&M Grade: **3**  
Clock Start/From: **5**  
Clock To: **7**  
1st Value:  
2nd Value:  
Value Percent: **15.000**  
Continuous Index: **S02**  
Within 8" of Joint: **YES**  
Remarks:

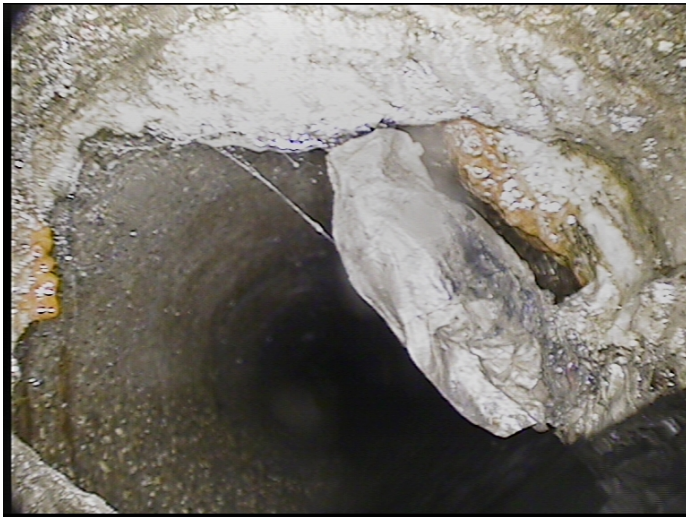
Code: **DAE**  
Description: **Deposits Attached Encrustation**

Distance (ft): **96.3**  
Structural Grade: **0**  
O&M Grade: **3**  
Clock Start/From: **11**  
Clock To: **5**  
1st Value:  
2nd Value:  
Value Percent: **20.000**  
Continuous Index:  
Within 8" of Joint: **YES**  
Remarks:

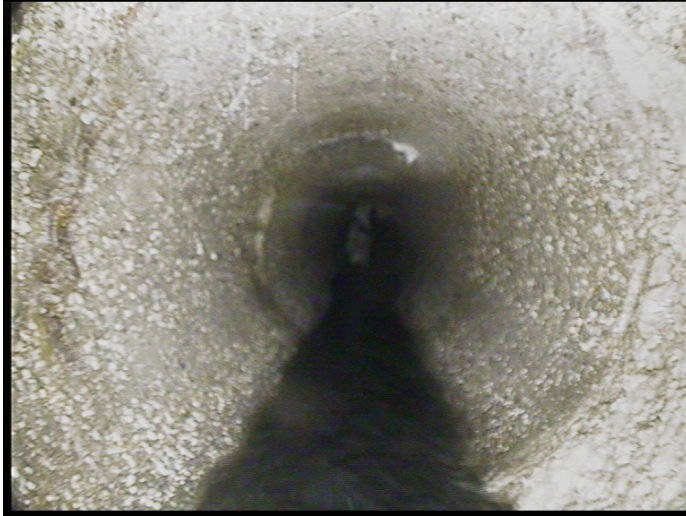
Code: **DSF**  
Description: **Deposits Settled Fine**

Distance (ft): **102.0**  
Structural Grade: **0**  
O&M Grade: **3**  
Clock Start/From: **5**  
Clock To: **7**  
1st Value:  
2nd Value:  
Value Percent: **15.000**  
Continuous Index: **F02**  
Within 8" of Joint: **NO**  
Remarks:

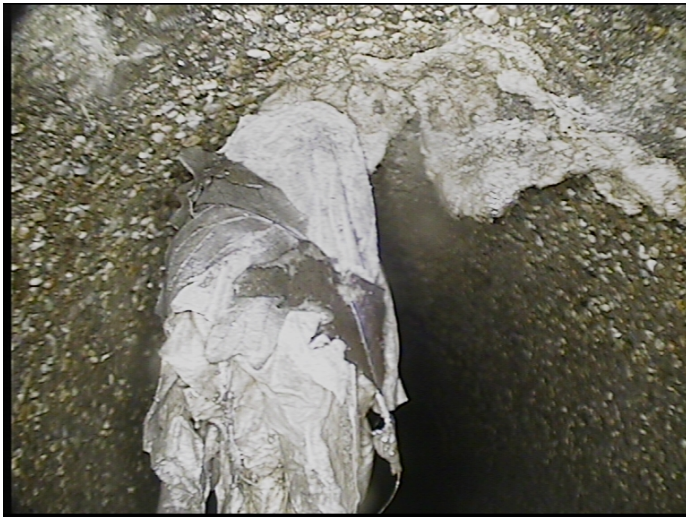
Code: **DAE**  
Description: **Deposits Attached Encrustation**

Distance (ft): **111.3**  
Structural Grade: **0**  
O&M Grade: **3**  
Clock Start/From: **12**  
Clock To:  
1st Value:  
2nd Value:  
Value Percent: **15.000**  
Continuous Index:  
Within 8" of Joint: **NO**  
Remarks:

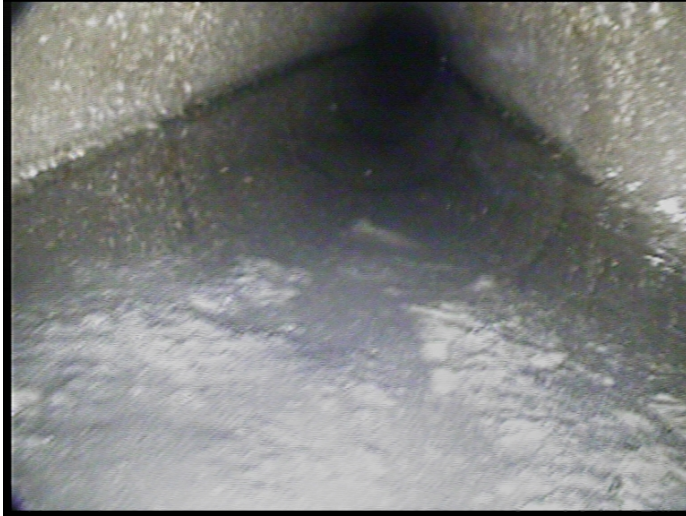
Code: **DSF**  
Description: **Deposits Settled Fine**

Distance (ft): **128.2**  
Structural Grade: **0**  
O&M Grade: **3**  
Clock Start/From: **4**  
Clock To: **8**  
1st Value:  
2nd Value:  
Value Percent: **20.000**  
Continuous Index: **S03**  
Within 8" of Joint: **YES**  
Remarks:

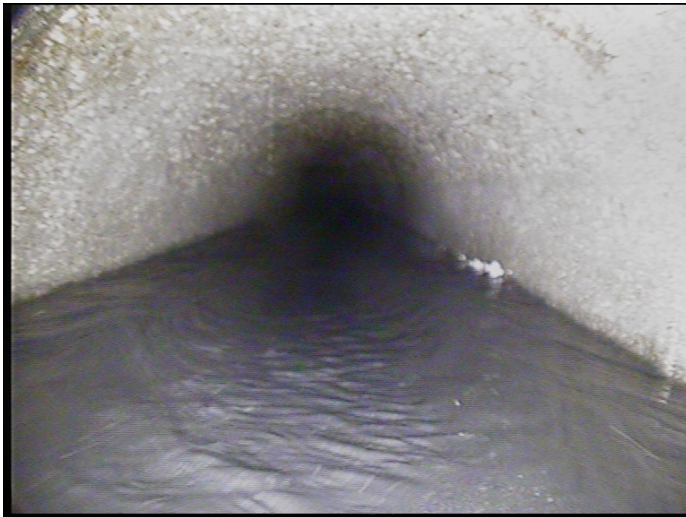
Code: **SAV**  
Description: **Surface Aggregate Visible**

Distance (ft): **135.2**  
Structural Grade: **3**  
O&M Grade: **0**  
Clock Start/From: **8**  
Clock To: **4**  
1st Value:  
2nd Value:  
Value Percent:  
Continuous Index: **F01**  
Within 8" of Joint: **NO**  
Remarks:

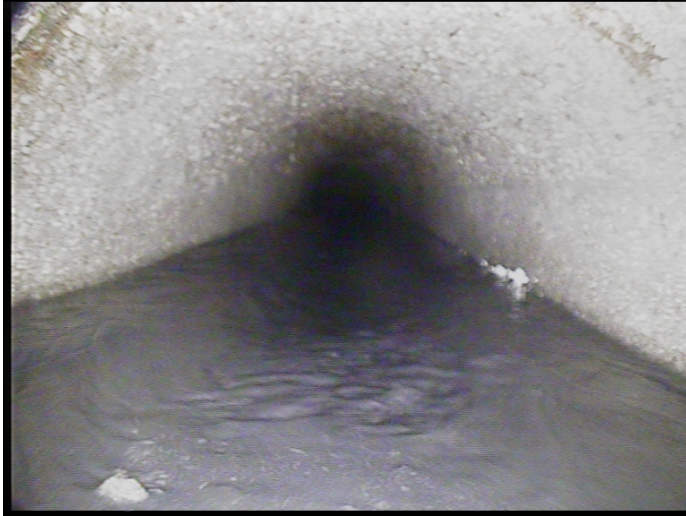
Code: **DSF**  
Description: **Deposits Settled Fine**

Distance (ft): **135.3**  
Structural Grade: **0**  
O&M Grade: **3**  
Clock Start/From: **4**  
Clock To: **8**  
1st Value:  
2nd Value:  
Value Percent: **20.000**  
Continuous Index: **F03**  
Within 8" of Joint: **NO**  
Remarks:

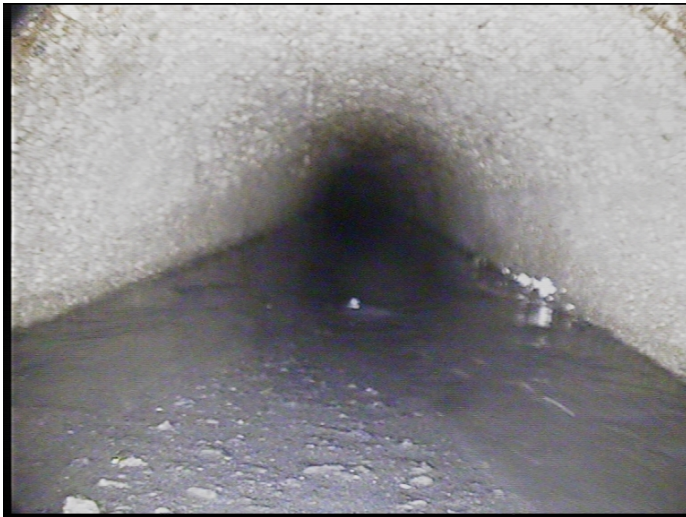
Code: **MSA**  
Description: **Abandoned Survey**

Distance (ft): **135.4**  
Structural Grade: **0**  
O&M Grade: **0**  
Clock Start/From:  
Clock To:  
1st Value:  
2nd Value:  
Value Percent:  
Continuous Index:  
Within 8" of Joint: **NO**  
Remarks: **deep sediment**
