Profile/Photo Observation Report

Date:	04/25/2018	Weather:		Coding:	PACP 6.0
Pipe Length (ft):		Owner:	City of Hobart	Pre Clean:	No Pre-Cleaning
P.O.#:	80	Surveyor:	M. Pielacha	PSR:	P-405-043-020
Customer:	City of Hobart	Clean Date:		Shape:	C

Street:	3rd Street	Flow Control:	Not Controlled
City:	Hobart, IN	Year Renewed:	
Location:	Light Highway	Tape/Media #:	DEP 80
Purpose:	Routine Assessment	Dia/Height:	15"
Use:	Sanitary	Material:	CP
Drain Area:		Lining:	
Category:	NA		
Comment:	YES501824 Submittal 2		
Location Details:		Direction of Survey:	Upstream
US MH:	M-405-043	DS MH:	M-405-020
		Total Length Surveyed (ft):	35.3

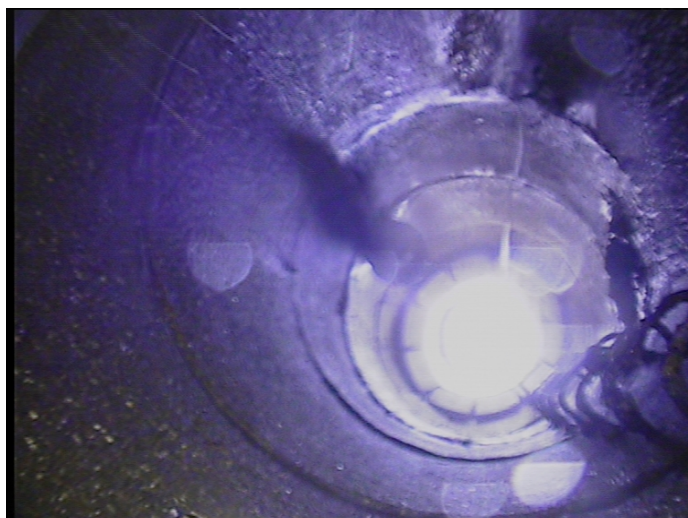
Code: **AMH**
Description: **Manhole**

Distance (ft): **.0**
Structural Grade: **0**
O&M Grade: **0**
Clock Start/From:
Clock To:
1st Value:
2nd Value:
Value Percent:
Continuous Index:
Within 8" of Joint: **NO**
Remarks: **M-405-020**

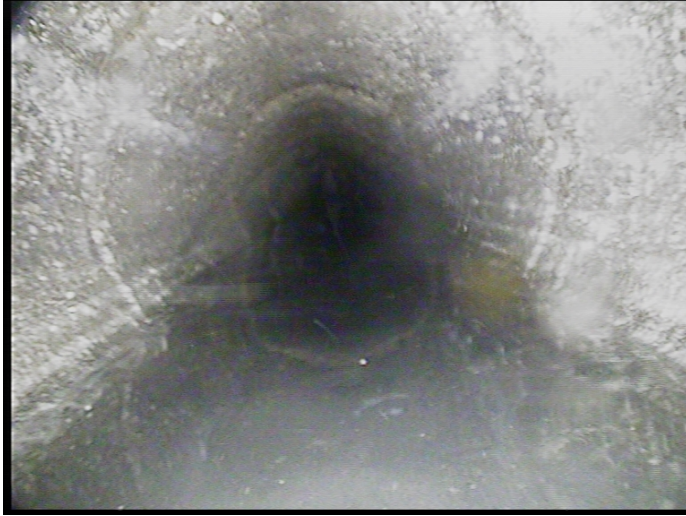
Code: **MWL**
Description: **Water Level**

Distance (ft): **.0**
Structural Grade: **0**
O&M Grade: **0**
Clock Start/From:
Clock To:
1st Value:
2nd Value:
Value Percent: **10.000**
Continuous Index:
Within 8" of Joint: **NO**
Remarks:

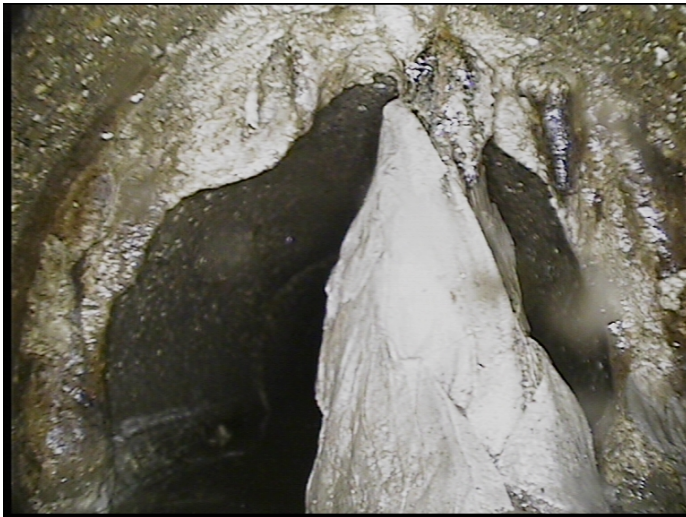
Code: **DAE**
Description: **Deposits Attached Encrustation**

Distance (ft): **18.4**
Structural Grade: **0**
O&M Grade: **3**
Clock Start/From: **8**
Clock To: **4**
1st Value:
2nd Value:
Value Percent: **20.000**
Continuous Index:
Within 8" of Joint: **YES**
Remarks:

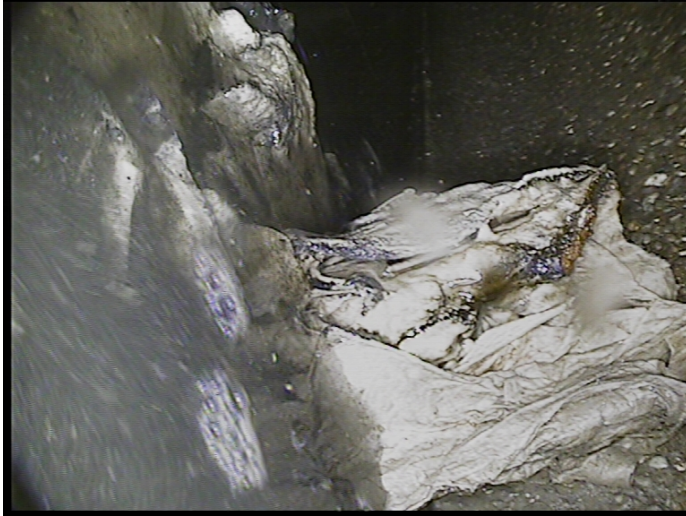
Code: **OBZ**
Description: **Obstacle Other**

Distance (ft): **24.1**
Structural Grade: **0**
O&M Grade: **3**
Clock Start/From: **3**
Clock To: **6**
1st Value:
2nd Value:
Value Percent: **15.000**
Continuous Index:
Within 8" of Joint: **NO**
Remarks: **Debris**

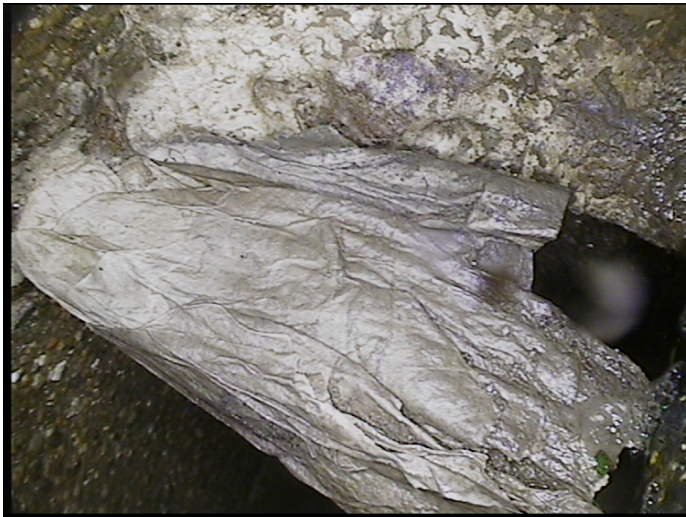
Code: **DAR**
Description: **Deposits Attached Ragging**

Distance (ft): **32.2**
Structural Grade: **0**
O&M Grade: **2**
Clock Start/From: **12**
Clock To:
1st Value:
2nd Value:
Value Percent: **10.000**
Continuous Index:
Within 8" of Joint: **NO**
Remarks:

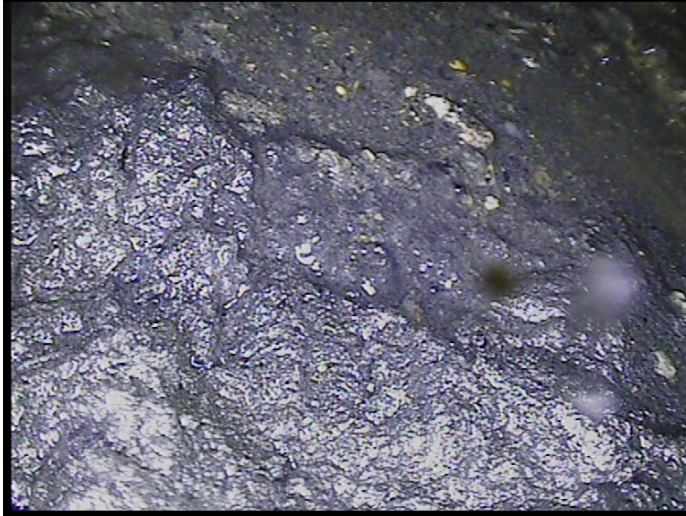
Code: **DSF**
Description: **Deposits Settled Fine**

Distance (ft): **33.8**
Structural Grade: **0**
O&M Grade: **3**
Clock Start/From: **4**
Clock To: **8**
1st Value:
2nd Value:
Value Percent: **20.000**
Continuous Index:
Within 8" of Joint: **YES**
Remarks:

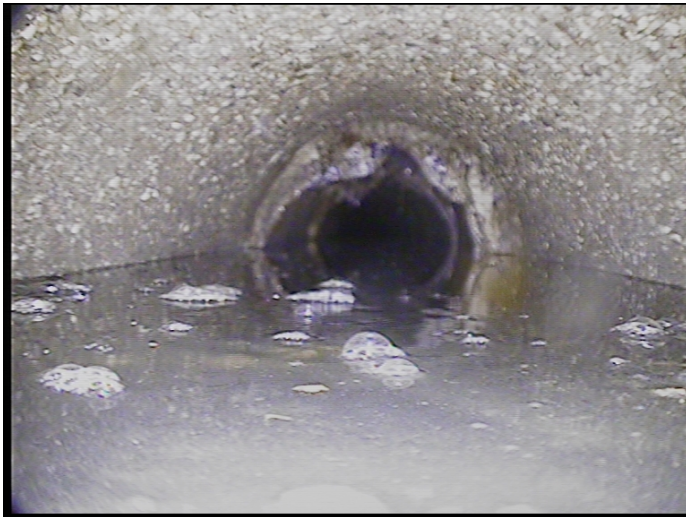
Code: **MSA**
Description: **Abandoned Survey**

Distance (ft): **35.3**
Structural Grade: **0**
O&M Grade: **0**
Clock Start/From:
Clock To:
1st Value:
2nd Value:
Value Percent:
Continuous Index:
Within 8" of Joint: **NO**
Remarks: **sediment**
