Profile/Photo Observation Report

| Profile/Prioto Observation Report | | | | | | | | | |
|---|---|---|---|---|---|---|--|--|--|
| Street: 3rd Street | | | Flow Control: | | Not Controlled | Not Controlled | | | |
| US MH: | M-405-044 | DS MH: | M-405-043 | Tota | Il Length Surveyed (ft): | 61.1 | | | |

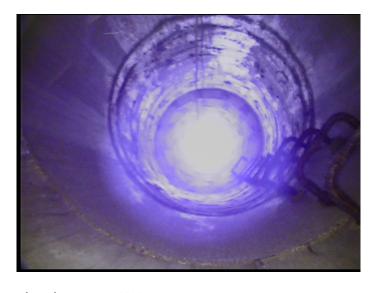
| Description: | Manhole |
| Distance (ft): | .0 |
| Remarks: | M-405-044 |

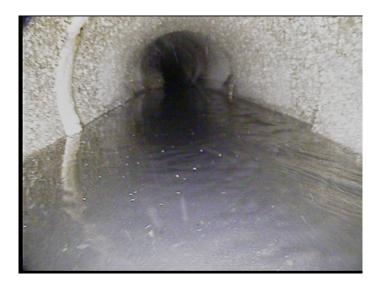
Code: MWL

Description: Water Level

Value Percent: 10.000

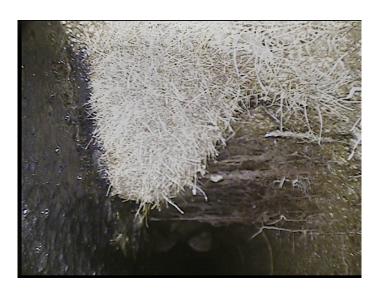
Code: RMJ

Description: Roots Medium Joint

Distance (ft): 7.4
Structural Grade: 0
O&M Grade: 3
Clock Start/From: 7
Clock To: 12
1st Value:

Value Percent: 15.000

Within 8" of Joint: YES

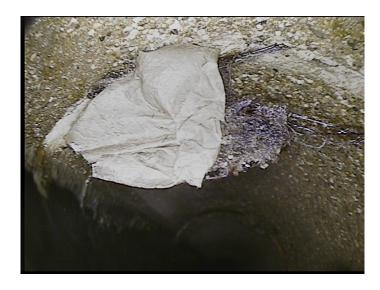
Code: RMJ

Description: **Roots Medium Joint**

Distance (ft): 13.6 Structural Grade: 0 3 O&M Grade: Clock Start/From: 7 Clock To: 11

Value Percent: 10.000

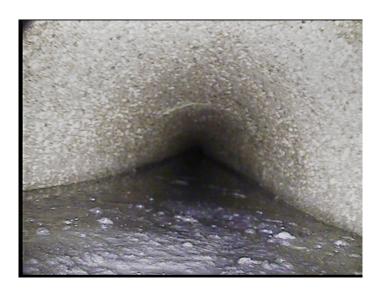
DSF Code:

Description: **Deposits Settled Fine**

Distance (ft): 56.2 Structural Grade: 0 O&M Grade: 3 Clock Start/From: 5 7 Clock To: 1st Value:

Value Percent: 15.000 Continuous Index: **S01** Within 8" of Joint: YES

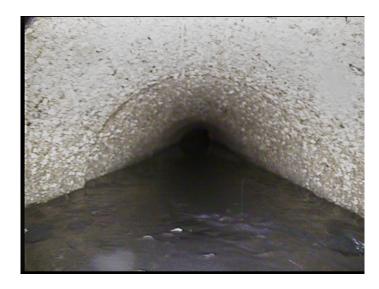
Code: **DSF**

Description: Deposits Settled Fine

Distance (ft): 61.1
Structural Grade: 0
O&M Grade: 4
Clock Start/From: 5
Clock To: 7

Value Percent: 25.000
Continuous Index: F01
Within 8" of Joint: NO

Remarks: deep sediment
