Profile/Photo Observation Report

Date:	04/24/2018	Weather:		Coding:	PACP 6.0
Pipe Length (ft):		Owner:	City of Hobart	Pre Clean:	No Pre-Cleaning
P.O.#:	75	Surveyor:	M. Pielacha	PSR:	P-405-045-044
Customer:	City of Hobart	Clean Date:		Shape:	C

Street:	3rd Street	Flow Control:	Not Controlled
City:	Hobart, IN	Year Renewed:	
Location:	Light Highway	Tape/Media #:	DEP 75
Purpose:	Routine Assessment	Dia/Height:	15"
Use:	Sanitary	Material:	CP
Drain Area:		Lining:	
Category:	NA		
Comment:	YES501824 Submittal 2		
Location Details:		Direction of Survey:	Downstream
US MH:	M-405-045	DS MH:	M-405-044
		Total Length Surveyed (ft):	178.8

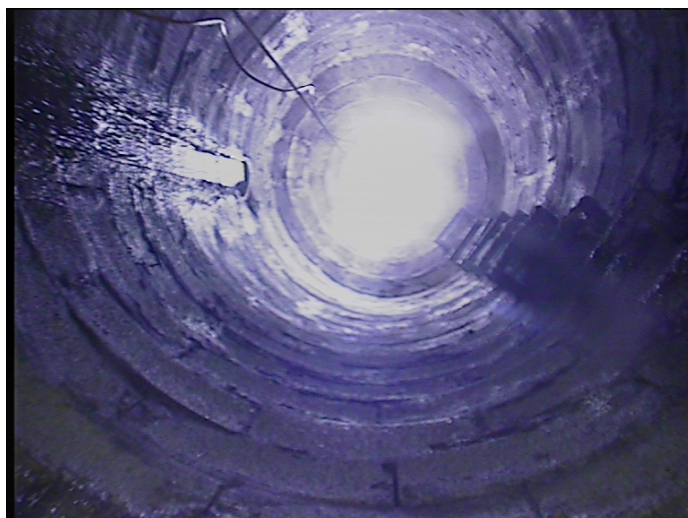
Code: **AMH**
Description: **Manhole**

Distance (ft): **.0**
Structural Grade: **0**
O&M Grade: **0**
Clock Start/From:
Clock To:
1st Value:
2nd Value:
Value Percent:
Continuous Index:
Within 8" of Joint: **NO**
Remarks: **M-405-045**

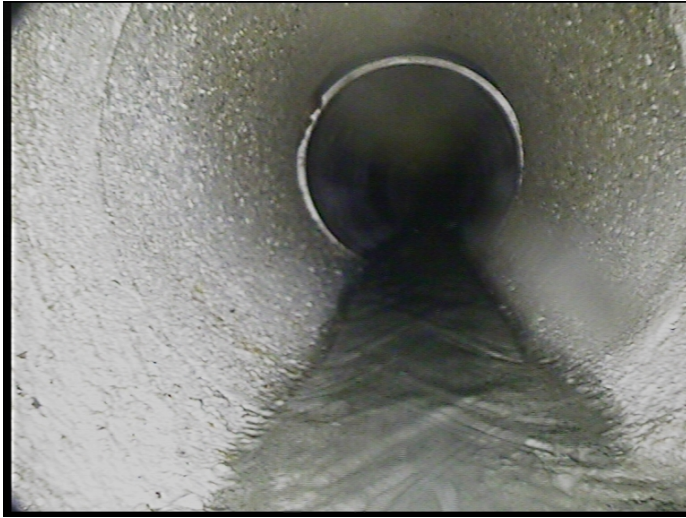
Code: **MWL**
Description: **Water Level**

Distance (ft): **.0**
Structural Grade: **0**
O&M Grade: **0**
Clock Start/From:
Clock To:
1st Value:
2nd Value:
Value Percent: **5.000**
Continuous Index:
Within 8" of Joint: **NO**
Remarks:

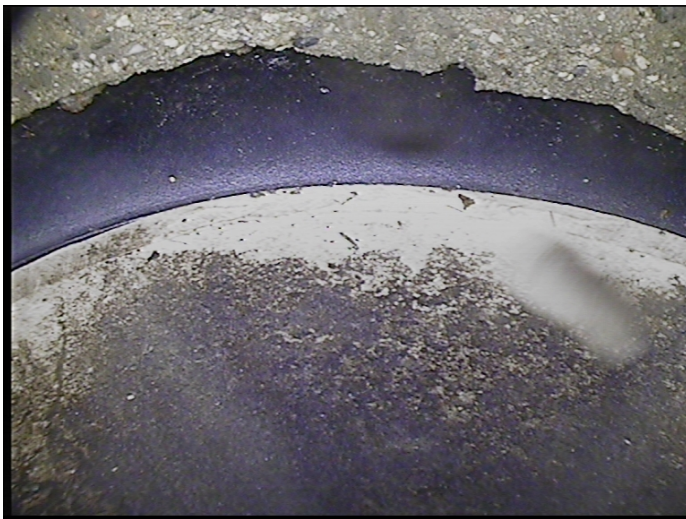
Code: **MMC**
Description: **Material Change**

Distance (ft): **4.0**
Structural Grade: **0**
O&M Grade: **0**
Clock Start/From:
Clock To:
1st Value:
2nd Value:
Value Percent:
Continuous Index:
Within 8" of Joint: **NO**
Remarks: **pvc**

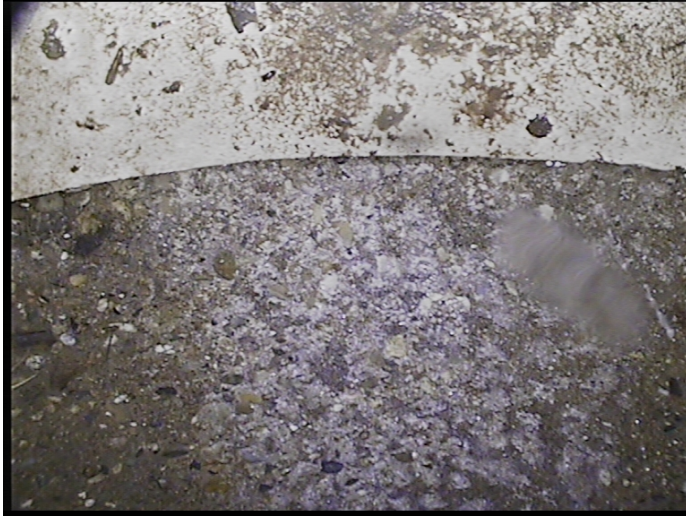
Code: **MMC**
Description: **Material Change**

Distance (ft): **10.0**
Structural Grade: **0**
O&M Grade: **0**
Clock Start/From:
Clock To:
1st Value:
2nd Value:
Value Percent:
Continuous Index:
Within 8" of Joint: **NO**
Remarks: **CP**

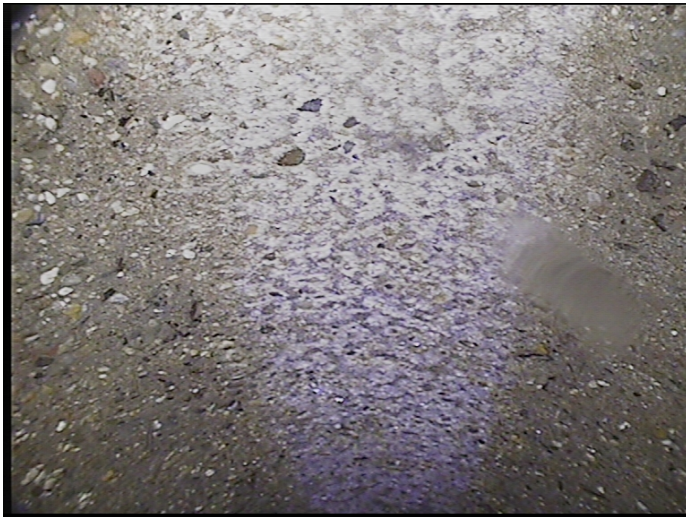
Code: **SAV**
Description: **Surface Aggregate Visible**

Distance (ft): **10.8**
Structural Grade: **3**
O&M Grade: **0**
Clock Start/From: **8**
Clock To: **4**
1st Value:
2nd Value:
Value Percent:
Continuous Index: **S01**
Within 8" of Joint: **YES**
Remarks:

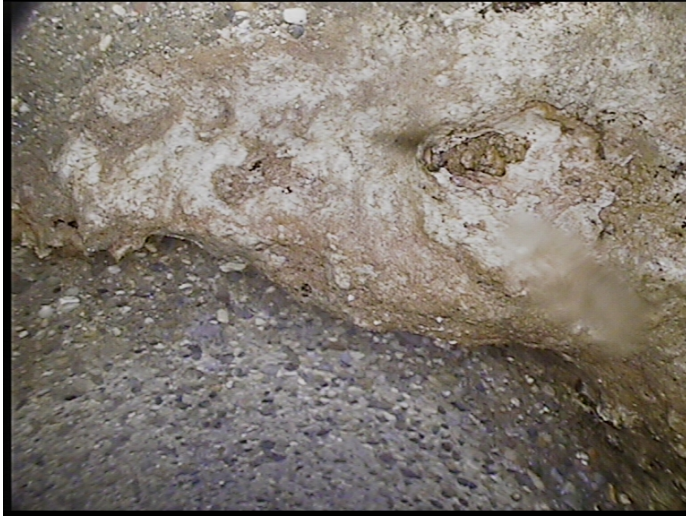
Code:	DAE
Description:	Deposits Attached Encrustation
Distance (ft):	37.0
Structural Grade:	0
O&M Grade:	3
Clock Start/From:	1
Clock To:	5
1st Value:	
2nd Value:	
Value Percent:	15.000
Continuous Index:	
Within 8" of Joint:	YES
Remarks:

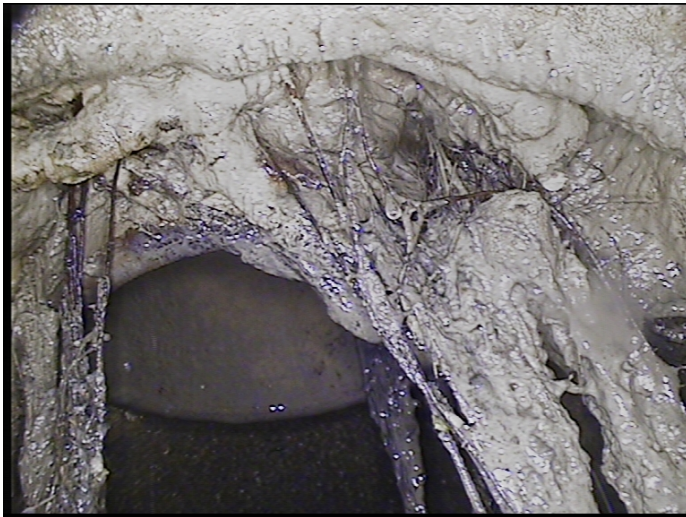
Code:	TBD
Description:	Tap Break-in Defective
Distance (ft):	109.4
Structural Grade:	0
O&M Grade:	3
Clock Start/From:	12
Clock To:	
1st Value:	6.000
2nd Value:	
Value Percent:	
Continuous Index:	
Within 8" of Joint:	NO
Remarks:	Defective

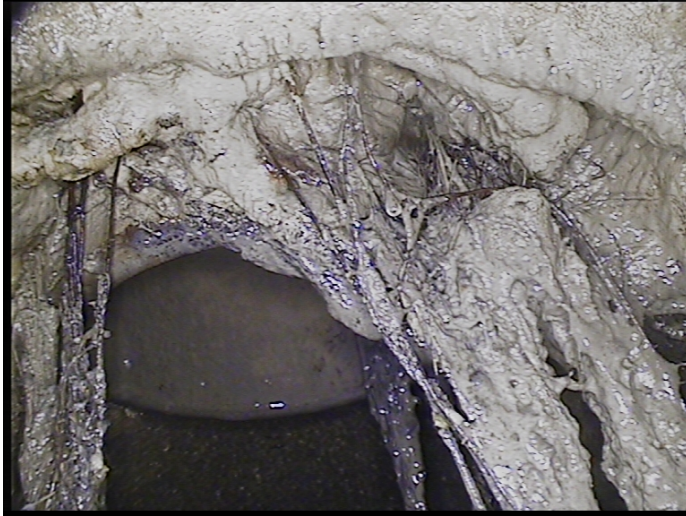
Code: **RML**
Description: **Roots Medium Lateral**

Distance (ft): **109.4**
Structural Grade: **0**
O&M Grade: **3**
Clock Start/From: **12**
Clock To:
1st Value:
2nd Value:
Value Percent: **10.000**
Continuous Index:
Within 8" of Joint: **NO**
Remarks:

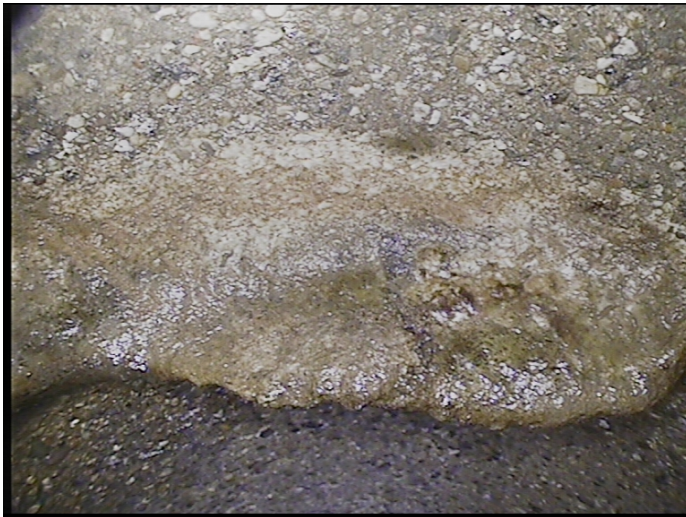
Code: **DAE**
Description: **Deposits Attached Encrustation**

Distance (ft): **139.4**
Structural Grade: **0**
O&M Grade: **2**
Clock Start/From: **9**
Clock To: **11**
1st Value:
2nd Value:
Value Percent: **5.000**
Continuous Index:
Within 8" of Joint: **YES**
Remarks:

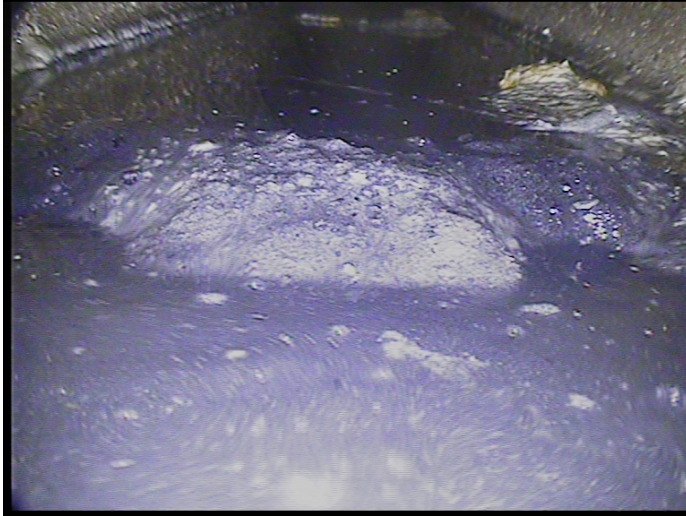
Code: **DSF**
Description: **Deposits Settled Fine**

Distance (ft): **163.0**
Structural Grade: **0**
O&M Grade: **3**
Clock Start/From: **5**
Clock To: **7**
1st Value:
2nd Value:
Value Percent: **15.000**
Continuous Index: **S02**
Within 8" of Joint: **YES**
Remarks:

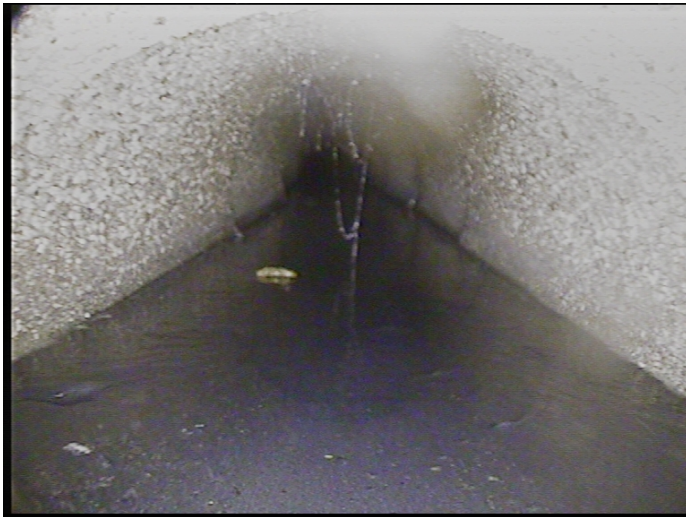
Code: **DSF**
Description: **Deposits Settled Fine**

Distance (ft): **178.6**
Structural Grade: **0**
O&M Grade: **3**
Clock Start/From: **5**
Clock To: **7**
1st Value:
2nd Value:
Value Percent: **15.000**
Continuous Index: **F02**
Within 8" of Joint: **NO**
Remarks:

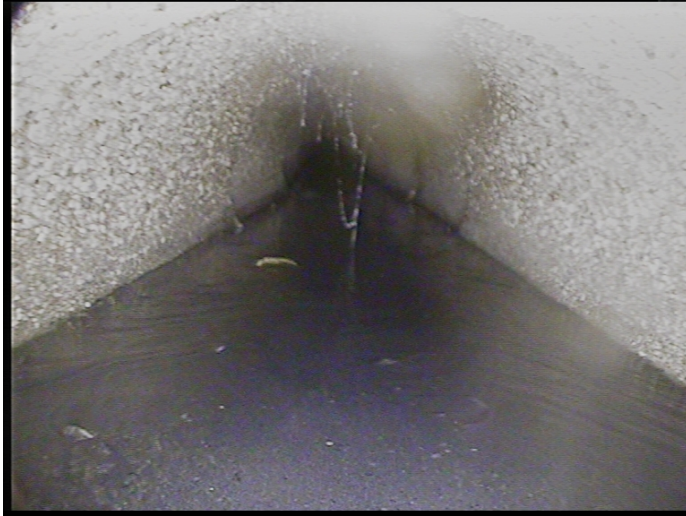
Code: **SAV**
Description: **Surface Aggregate Visible**

Distance (ft): **178.7**
Structural Grade: **3**
O&M Grade: **0**
Clock Start/From: **8**
Clock To: **4**
1st Value:
2nd Value:
Value Percent:
Continuous Index: **F01**
Within 8" of Joint: **NO**
Remarks:

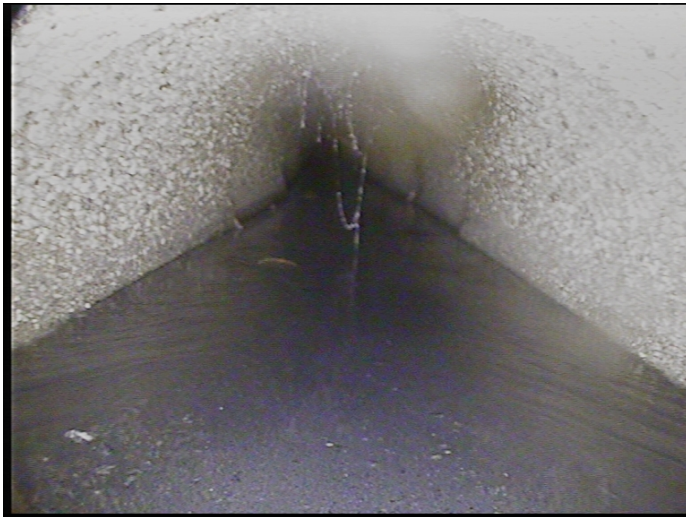
Code: **MSA**
Description: **Abandoned Survey**

Distance (ft): **178.7**
Structural Grade: **0**
O&M Grade: **0**
Clock Start/From:
Clock To:
1st Value:
2nd Value:
Value Percent:
Continuous Index:
Within 8" of Joint: **NO**
Remarks: **sediment**
