Profile/Photo Observation Report

Date:	09/15/2022	Weather:		Coding:	PACP 7.0
Pipe Length (ft):	297.0	Owner:	City of Hobart	Pre Clean:	Heavy Cleaning
P.O.#:	YES502259	Surveyor:	S. Bucklin	PSR:	P-405-045-044
Customer:	City of Hobart	Clean Date:	08/15/2022	Shape:	C

Street:	West 3rd Street	Flow Control:	Not Controlled
City:	Hobart, IN	Year Renewed:	
Location:	Local rural streets with light traffic, t	Tape/Media #:	
Purpose:	Routine Assessment	Dia/Height:	15"
Use:	Sanitary Sewage Pipe	Material:	RCP
Drain Area:		Lining:	None
Category:	NA		
Comment:

Location Details:		Direction of Survey:	Downstream
US MH:	M-405-045	DS MH:	M-405-044
		Total Length Surveyed (ft):	289.7

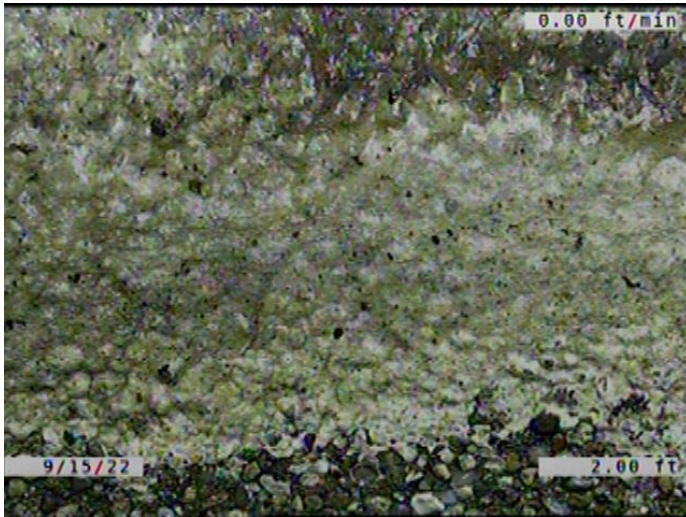
Code: **DAE**
Description: **Deposits Attached Encrustation**

Distance (ft): **2.0**
Structural Grade: **0**
O&M Grade: **2**
Clock Start/From: **7**
Clock To: **5**
1st Value:
2nd Value:
Value Percent: **5.000**
Continuous Index: **S01**
Within 8" of Joint: **YES**
Remarks:

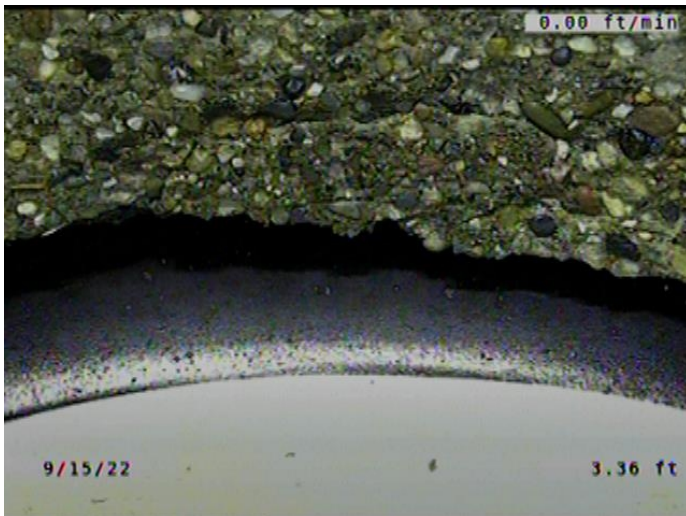
Code: **JOM**
Description: **Joint Offset Medium**

Distance (ft): **3.3**
Structural Grade: **3**
O&M Grade: **0**
Clock Start/From:
Clock To:
1st Value:
2nd Value:
Value Percent:
Continuous Index:
Within 8" of Joint: **NO**
Remarks:

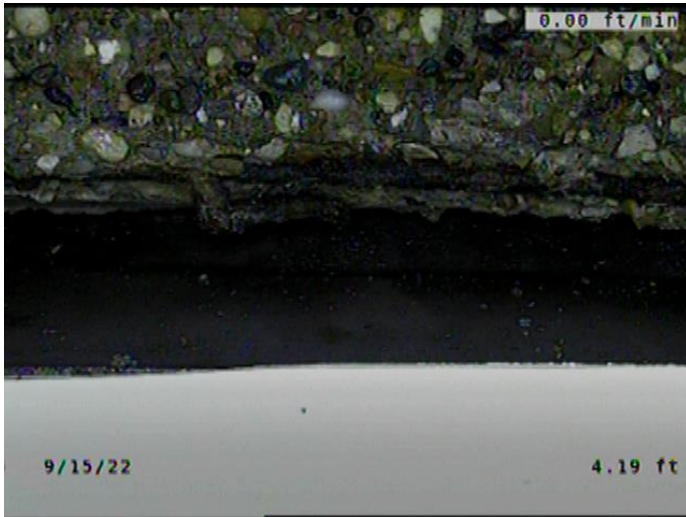
Code: **SRP**
Description: **Surface Damage Reinforcement Projecting**

Distance (ft): **4.2**
Structural Grade: **5**
O&M Grade: **0**
Clock Start/From: **8**
Clock To: **4**
1st Value:
2nd Value:
Value Percent:
Continuous Index:
Within 8" of Joint: **YES**
Remarks:

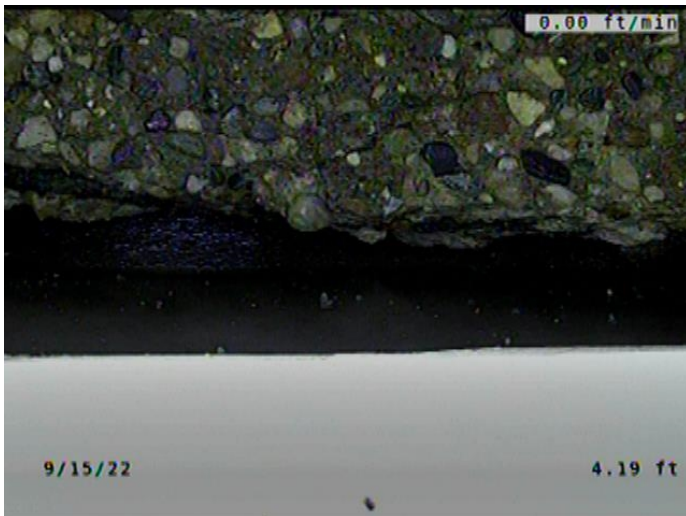
Code: **RPR**
Description: **Point Repair Replacement**

Distance (ft): **4.2**
Structural Grade: **0**
O&M Grade: **0**
Clock Start/From:
Clock To:
1st Value:
2nd Value:
Value Percent:
Continuous Index: **S02**
Within 8" of Joint: **YES**
Remarks: **RCP TO PVC**

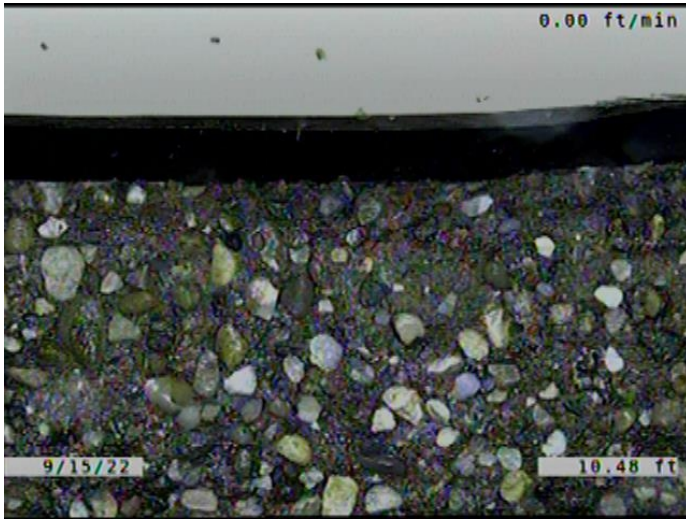
Code: **RPR**
Description: **Point Repair Replacement**

Distance (ft): **10.5**
Structural Grade: **0**
O&M Grade: **0**
Clock Start/From:
Clock To:
1st Value:
2nd Value:
Value Percent:
Continuous Index: **F02**
Within 8" of Joint: **YES**
Remarks: **RCP TO PVC**

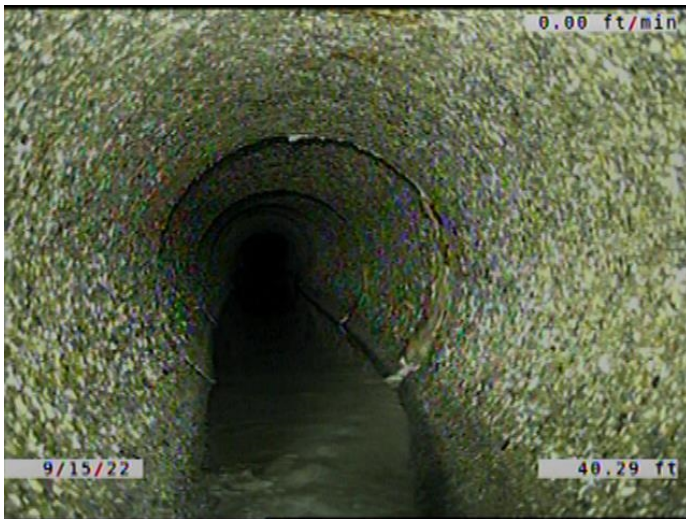
Code: **LL**
Description: **Line Left**

Distance (ft): **40.3**
Structural Grade: **0**
O&M Grade: **1**
Clock Start/From:
Clock To:
1st Value:
2nd Value:
Value Percent: **10.000**
Continuous Index:
Within 8" of Joint: **NO**
Remarks:

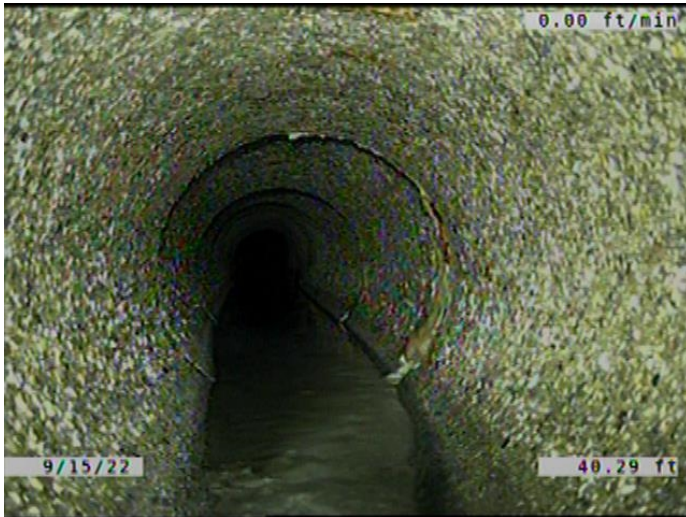
Code: **MWLS**
 Description: **Miscellaneous Water Level Sag**

Distance (ft): **40.3**
 Structural Grade: **2**
 O&M Grade: **0**
 Clock Start/From:
 Clock To:
 1st Value:
 2nd Value:
 Value Percent: **15.000**
 Continuous Index: **S03**
 Within 8" of Joint: **NO**
 Remarks:

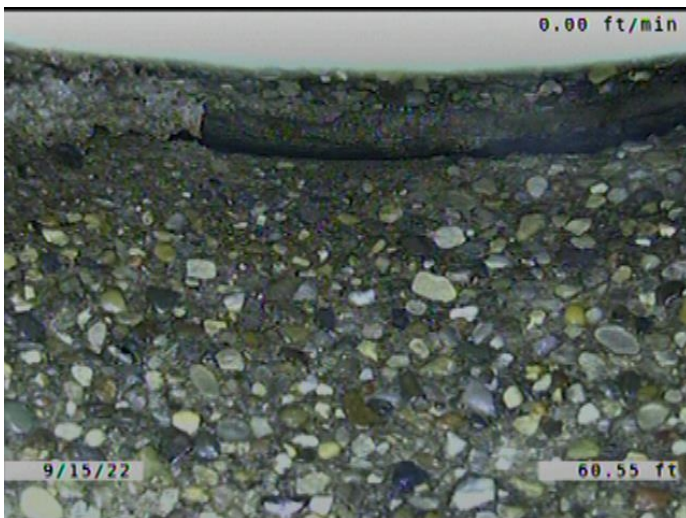
Code: **JOM**
 Description: **Joint Offset Medium**

Distance (ft): **60.5**
 Structural Grade: **3**
 O&M Grade: **0**
 Clock Start/From:
 Clock To:
 1st Value:
 2nd Value:
 Value Percent:
 Continuous Index:
 Within 8" of Joint: **NO**
 Remarks:

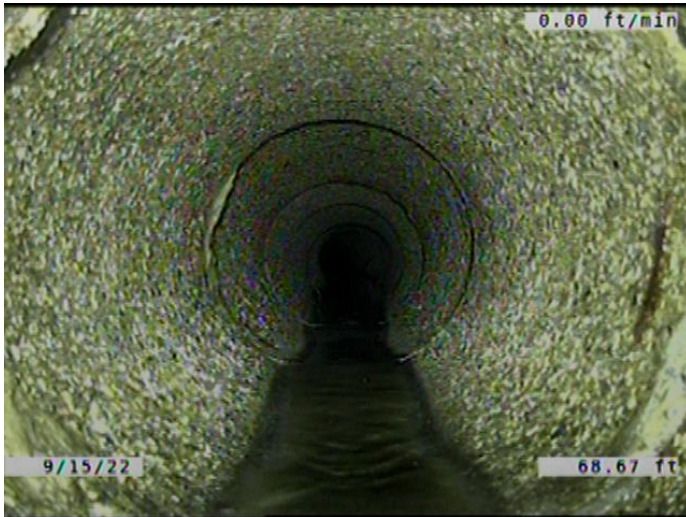
Code: **MWLS**
Description: **Miscellaneous Water Level Sag**

Distance (ft): **68.7**
Structural Grade: **2**
O&M Grade: **0**
Clock Start/From:
Clock To:
1st Value:
2nd Value:
Value Percent: **15.000**
Continuous Index: **F03**
Within 8" of Joint: **NO**
Remarks:

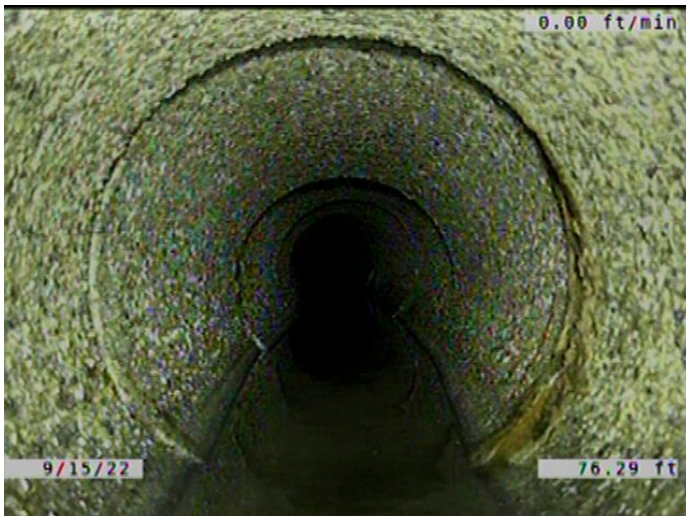
Code: **MWLS**
Description: **Miscellaneous Water Level Sag**

Distance (ft): **76.3**
Structural Grade: **2**
O&M Grade: **0**
Clock Start/From:
Clock To:
1st Value:
2nd Value:
Value Percent: **15.000**
Continuous Index: **S04**
Within 8" of Joint: **NO**
Remarks:

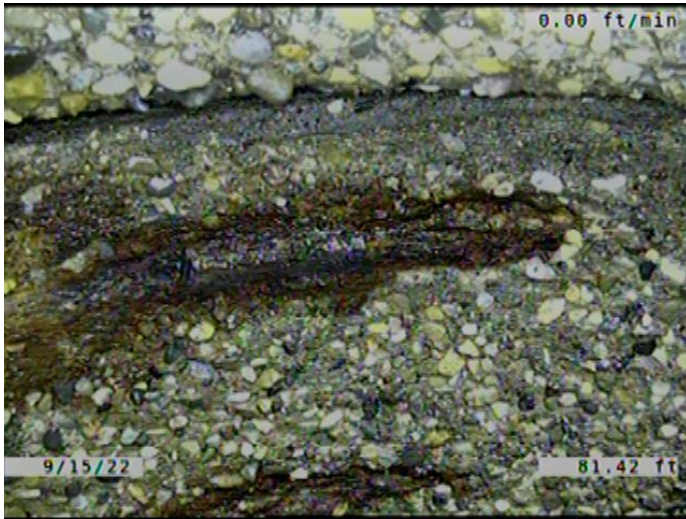
Code: **SRP**
 Description: **Surface Damage Reinforcement Projecting**

Distance (ft): **81.4**
 Structural Grade: **5**
 O&M Grade: **0**
 Clock Start/From: **9**
 Clock To: **11**
 1st Value:
 2nd Value:
 Value Percent:
 Continuous Index:
 Within 8" of Joint: **YES**
 Remarks:

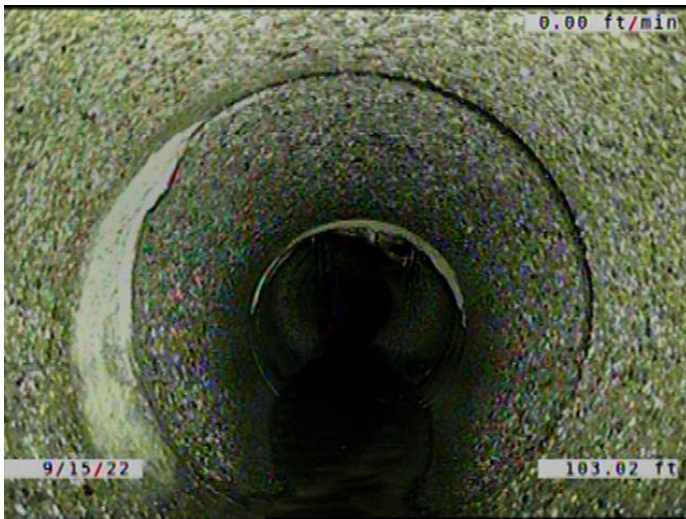
Code: **MWLS**
 Description: **Miscellaneous Water Level Sag**

Distance (ft): **103.0**
 Structural Grade: **2**
 O&M Grade: **0**
 Clock Start/From:
 Clock To:
 1st Value:
 2nd Value:
 Value Percent: **15.000**
 Continuous Index: **F04**
 Within 8" of Joint: **NO**
 Remarks:

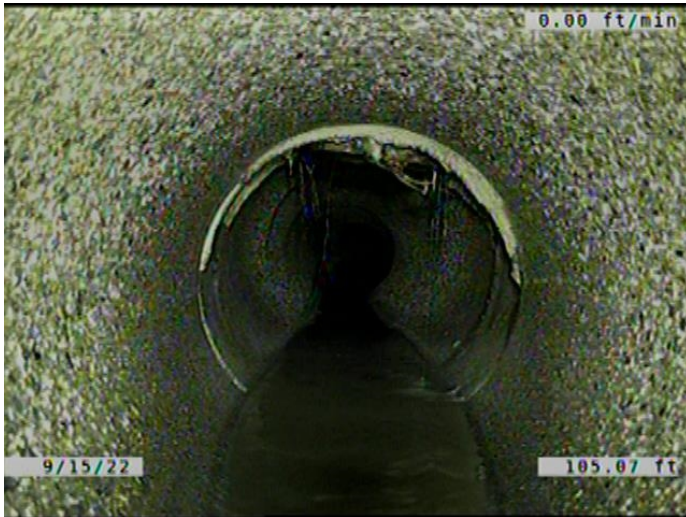
Code: **MWLS**
 Description: **Miscellaneous Water Level Sag**

Distance (ft): **105.1**
 Structural Grade: **2**
 O&M Grade: **0**
 Clock Start/From:
 Clock To:
 1st Value:
 2nd Value:
 Value Percent: **10.000**
 Continuous Index: **S05**
 Within 8" of Joint: **NO**
 Remarks:

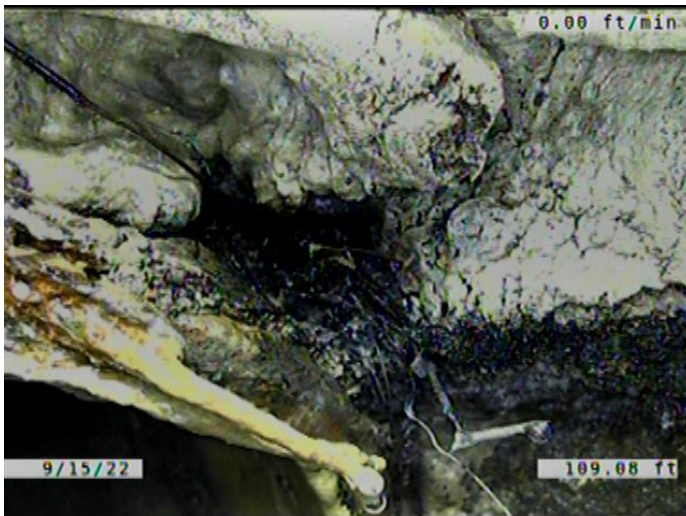
Code: **B**
 Description: **Broken**

Distance (ft): **109.1**
 Structural Grade: **4**
 O&M Grade: **0**
 Clock Start/From: **11**
 Clock To: **5**
 1st Value:
 2nd Value:
 Value Percent:
 Continuous Index:
 Within 8" of Joint: **YES**
 Remarks:

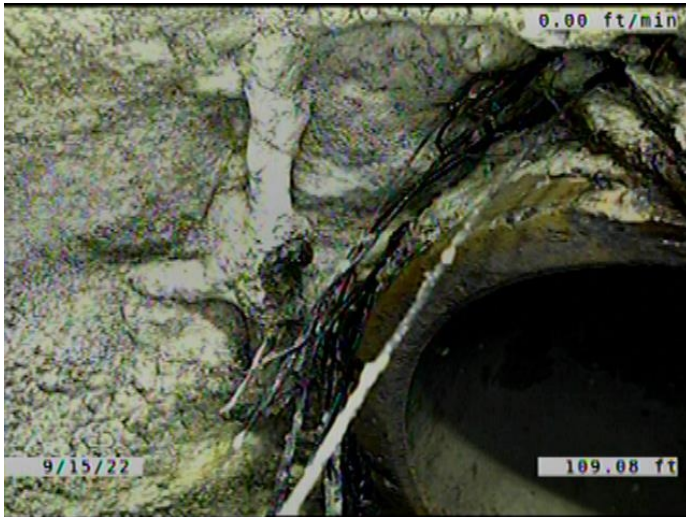
Code: **RFC**
 Description: **Roots Fine Connection**

Distance (ft): **109.1**
 Structural Grade: **0**
 O&M Grade: **1**
 Clock Start/From: **11**
 Clock To: **1**
 1st Value:
 2nd Value:
 Value Percent:
 Continuous Index:
 Within 8" of Joint: **NO**
 Remarks:

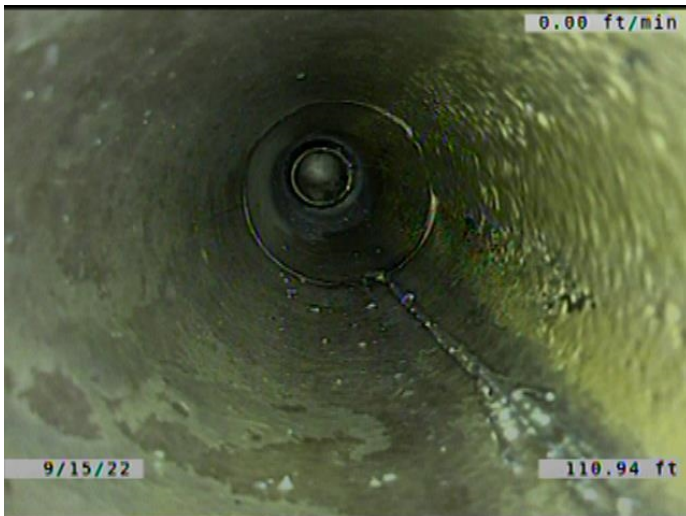
Code: **TBI**
 Description: **Tap Break-in Intruding**

Distance (ft): **110.9**
 Structural Grade: **0**
 O&M Grade: **2**
 Clock Start/From: **12**
 Clock To:
 1st Value: **6.000**
 2nd Value: **1.000**
 Value Percent:
 Continuous Index:
 Within 8" of Joint: **YES**
 Remarks: **CONSTANTLY RUNNING WATER.**

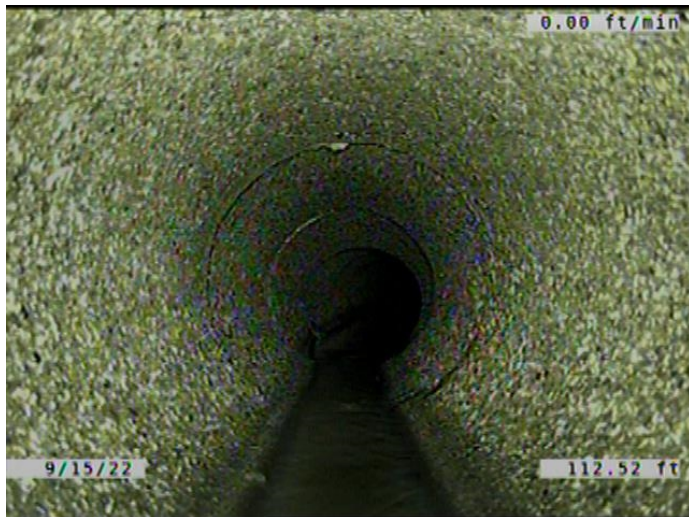
Code: **MWLS**
Description: **Miscellaneous Water Level Sag**

Distance (ft): **112.5**
Structural Grade: **2**
O&M Grade: **0**
Clock Start/From:
Clock To:
1st Value:
2nd Value:
Value Percent: **10.000**
Continuous Index: **F05**
Within 8" of Joint: **NO**
Remarks:

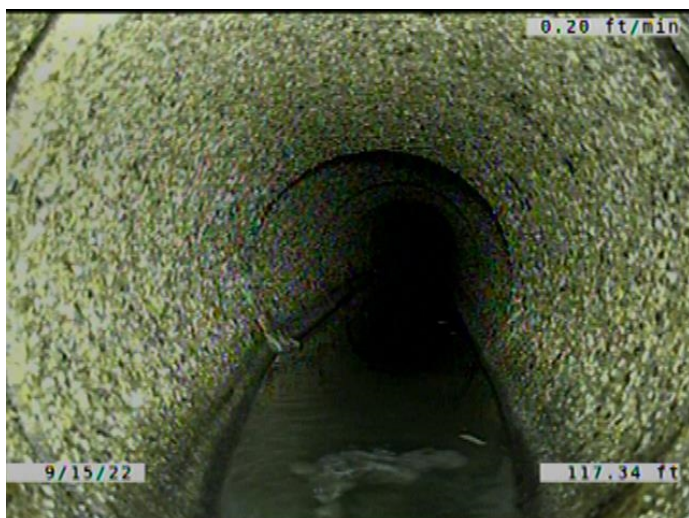
Code: **LR**
Description: **Line Right**

Distance (ft): **117.3**
Structural Grade: **0**
O&M Grade: **1**
Clock Start/From:
Clock To:
1st Value:
2nd Value:
Value Percent: **5.000**
Continuous Index:
Within 8" of Joint: **NO**
Remarks:

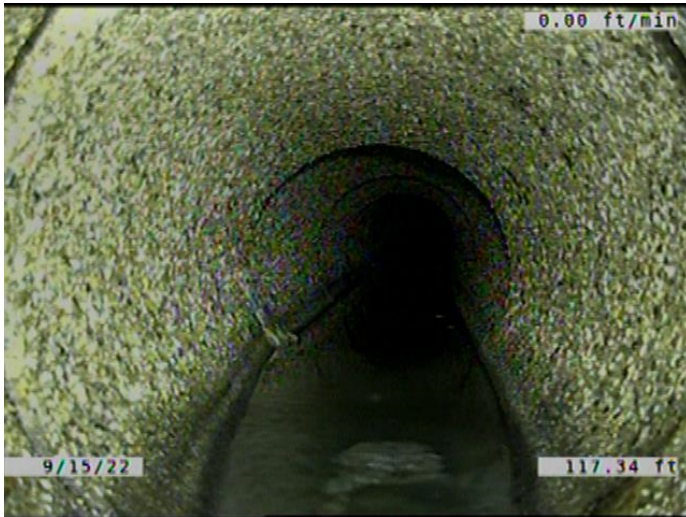
Code: **MWLS**
Description: **Miscellaneous Water Level Sag**

Distance (ft): **117.3**
Structural Grade: **2**
O&M Grade: **0**
Clock Start/From:
Clock To:
1st Value:
2nd Value:
Value Percent: **15.000**
Continuous Index: **S06**
Within 8" of Joint: **NO**
Remarks:

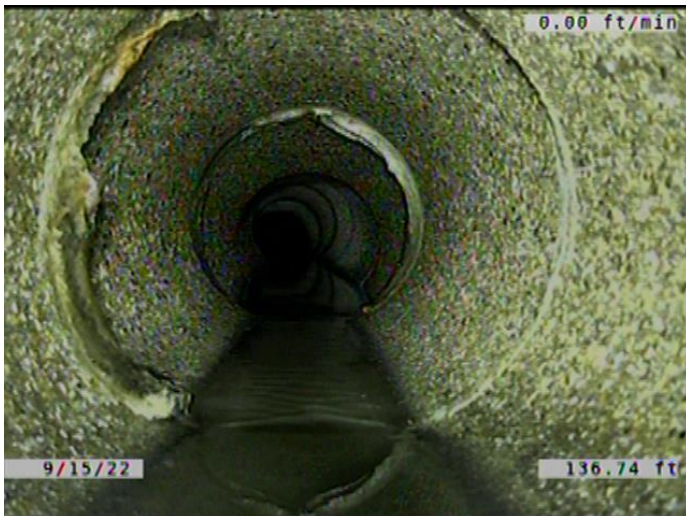
Code: **MWLS**
Description: **Miscellaneous Water Level Sag**

Distance (ft): **136.7**
Structural Grade: **2**
O&M Grade: **0**
Clock Start/From:
Clock To:
1st Value:
2nd Value:
Value Percent: **15.000**
Continuous Index: **F06**
Within 8" of Joint: **NO**
Remarks:

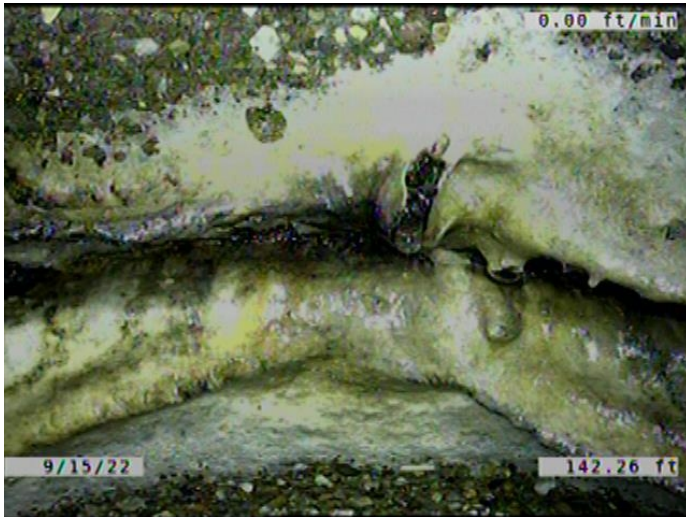
Code: **IDJ**
 Description: **Infiltration Dripper Joint**

Distance (ft): **142.3**
 Structural Grade: **0**
 O&M Grade: **3**
 Clock Start/From: **12**
 Clock To:
 1st Value:
 2nd Value:
 Value Percent:
 Continuous Index:
 Within 8" of Joint: **YES**
 Remarks:

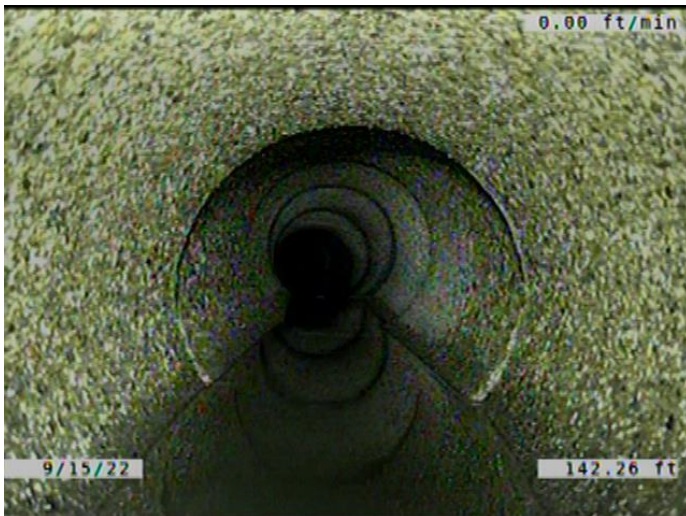
Code: **MWLS**
 Description: **Miscellaneous Water Level Sag**

Distance (ft): **142.3**
 Structural Grade: **2**
 O&M Grade: **0**
 Clock Start/From:
 Clock To:
 1st Value:
 2nd Value:
 Value Percent: **15.000**
 Continuous Index: **S07**
 Within 8" of Joint: **NO**
 Remarks:

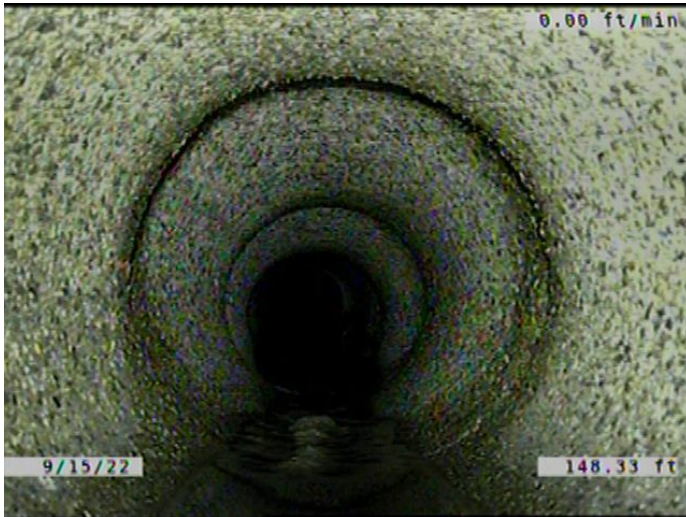
Code: **MWLS**
Description: **Miscellaneous Water Level Sag**

Distance (ft): **148.3**
Structural Grade: **2**
O&M Grade: **0**
Clock Start/From:
Clock To:
1st Value:
2nd Value:
Value Percent: **15.000**
Continuous Index: **F07**
Within 8" of Joint: **NO**
Remarks:

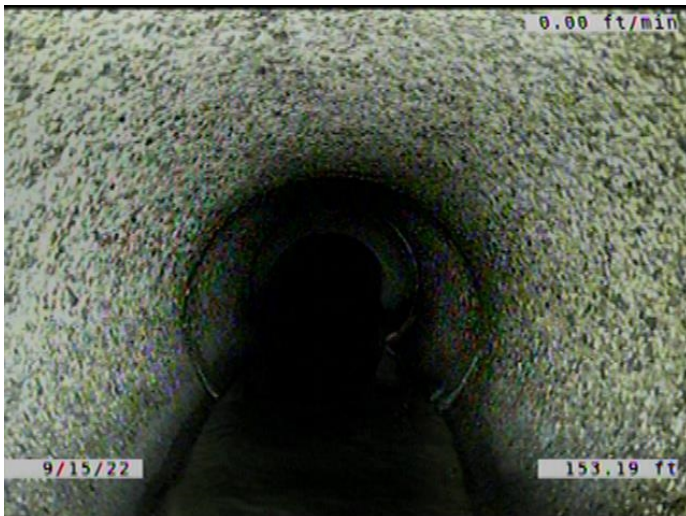
Code: **MWLS**
Description: **Miscellaneous Water Level Sag**

Distance (ft): **153.2**
Structural Grade: **2**
O&M Grade: **0**
Clock Start/From:
Clock To:
1st Value:
2nd Value:
Value Percent: **25.000**
Continuous Index: **S08**
Within 8" of Joint: **NO**
Remarks:

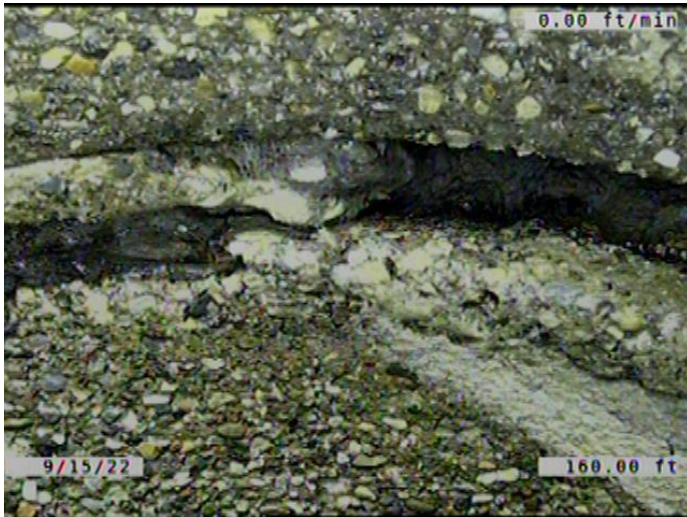
Code: **IDJ**
 Description: **Infiltration Dripper Joint**

Distance (ft): **160.0**
 Structural Grade: **0**
 O&M Grade: **3**
 Clock Start/From: **1**
 Clock To:
 1st Value:
 2nd Value:
 Value Percent:
 Continuous Index:
 Within 8" of Joint: **YES**
 Remarks:

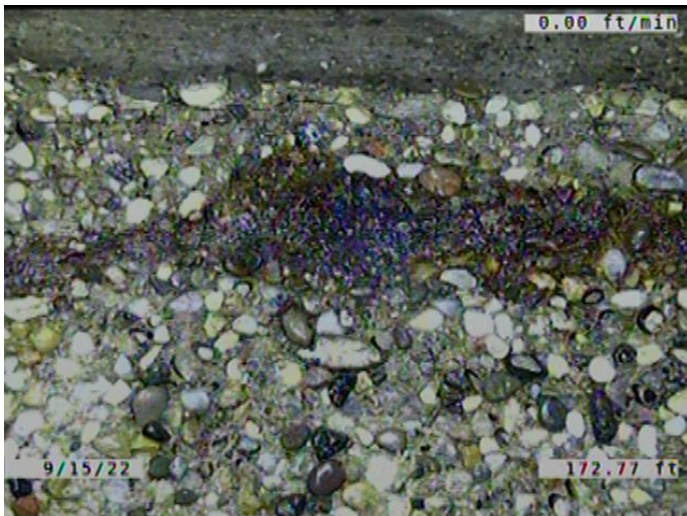
Code: **SRV**
 Description: **Surface Damage Reinforcement Visible**

Distance (ft): **172.8**
 Structural Grade: **4**
 O&M Grade: **0**
 Clock Start/From: **11**
 Clock To: **2**
 1st Value:
 2nd Value:
 Value Percent:
 Continuous Index:
 Within 8" of Joint: **YES**
 Remarks:

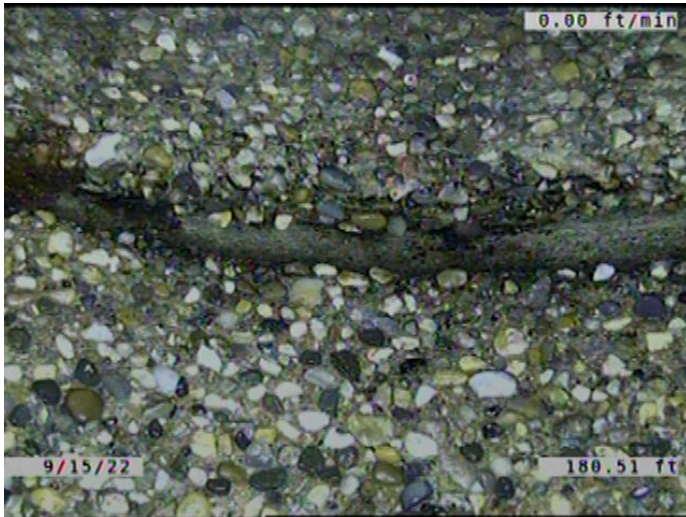
Code: **JOMD**
 Description: **Joint Offset Medium Defective**

Distance (ft): **180.5**
 Structural Grade: **3**
 O&M Grade: **0**
 Clock Start/From:
 Clock To:
 1st Value:
 2nd Value:
 Value Percent:
 Continuous Index:
 Within 8" of Joint: **NO**
 Remarks:

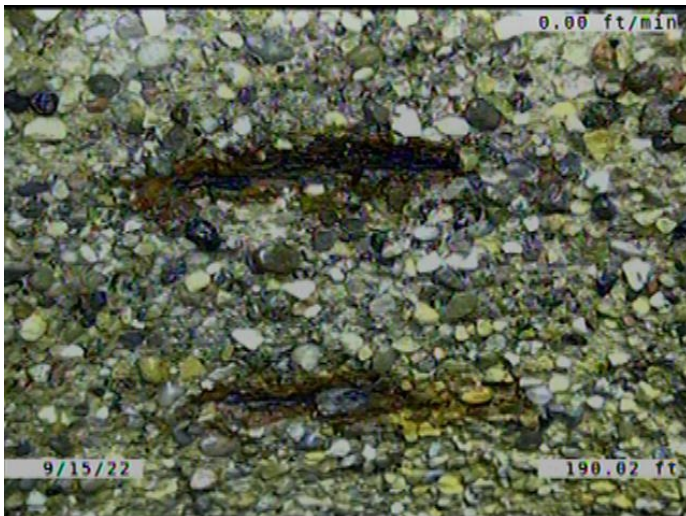
Code: **SRV**
 Description: **Surface Damage Reinforcement Visible**

Distance (ft): **190.0**
 Structural Grade: **4**
 O&M Grade: **0**
 Clock Start/From: **10**
 Clock To: **11**
 1st Value:
 2nd Value:
 Value Percent:
 Continuous Index:
 Within 8" of Joint: **YES**
 Remarks:

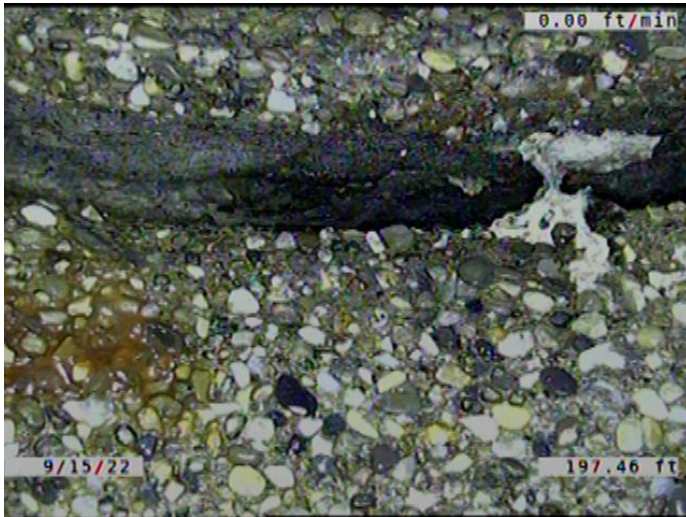
Code: **JOMD**
 Description: **Joint Offset Medium Defective**

Distance (ft): **197.5**
 Structural Grade: **3**
 O&M Grade: **0**
 Clock Start/From:
 Clock To:
 1st Value:
 2nd Value:
 Value Percent:
 Continuous Index:
 Within 8" of Joint: **NO**
 Remarks:

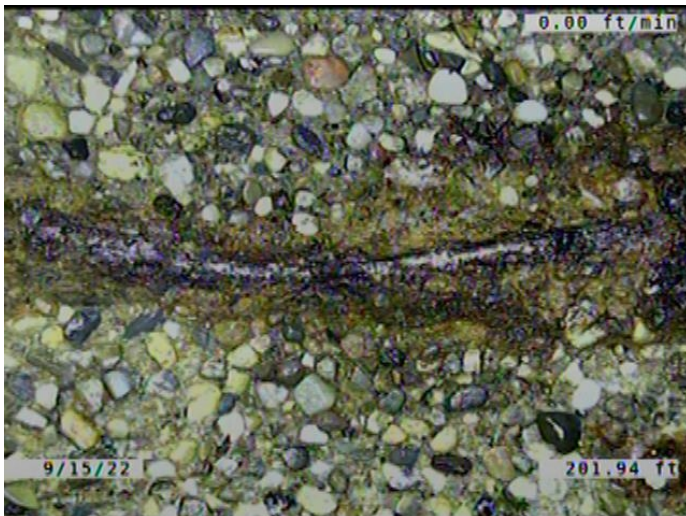
Code: **SRV**
 Description: **Surface Damage Reinforcement Visible**

Distance (ft): **201.9**
 Structural Grade: **4**
 O&M Grade: **0**
 Clock Start/From: **11**
 Clock To: **3**
 1st Value:
 2nd Value:
 Value Percent:
 Continuous Index:
 Within 8" of Joint: **YES**
 Remarks:

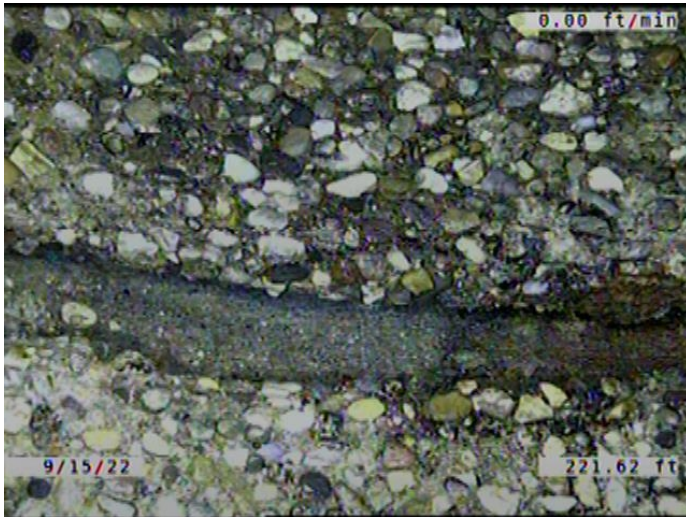
Code: **JOMD**
Description: **Joint Offset Medium Defective**

Distance (ft): **221.6**
Structural Grade: **3**
O&M Grade: **0**
Clock Start/From:
Clock To:
1st Value:
2nd Value:
Value Percent:
Continuous Index:
Within 8" of Joint: **NO**
Remarks:

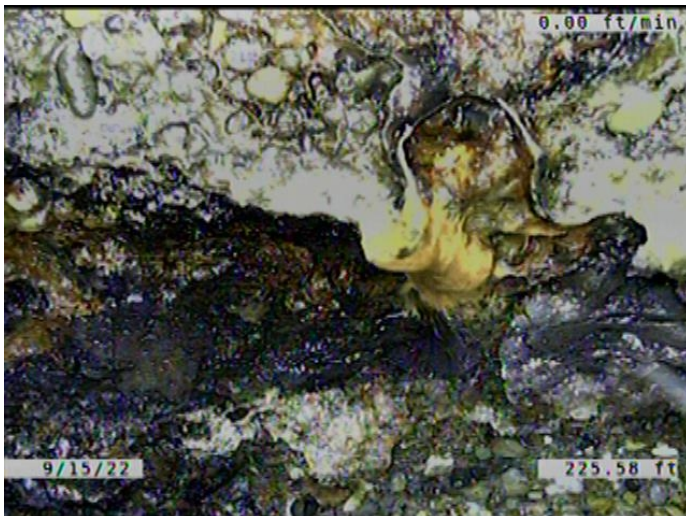
Code: **IWJ**
Description: **Infiltration Weeper Joint**

Distance (ft): **225.6**
Structural Grade: **0**
O&M Grade: **2**
Clock Start/From: **12**
Clock To: **1**
1st Value:
2nd Value:
Value Percent:
Continuous Index:
Within 8" of Joint: **YES**
Remarks:

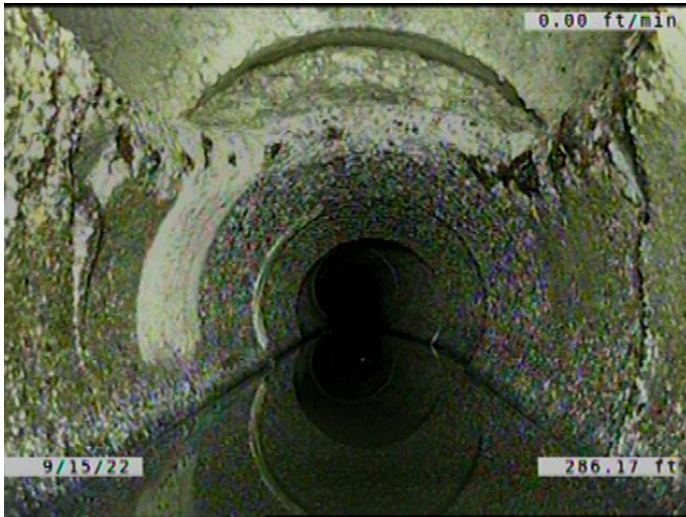
Code: **MWLS**
Description: **Miscellaneous Water Level Sag**

Distance (ft): **286.2**
Structural Grade: **2**
O&M Grade: **0**
Clock Start/From:
Clock To:
1st Value:
2nd Value:
Value Percent: **25.000**
Continuous Index: **F08**
Within 8" of Joint: **NO**
Remarks:

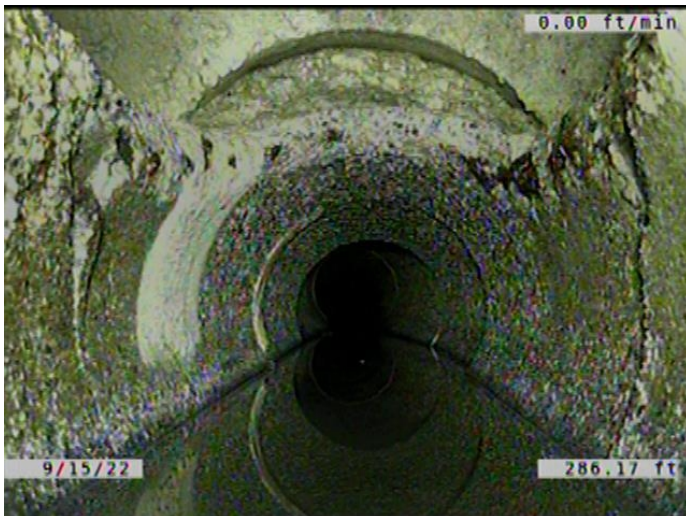
Code: **DAE**
Description: **Deposits Attached Encrustation**

Distance (ft): **286.2**
Structural Grade: **0**
O&M Grade: **2**
Clock Start/From: **7**
Clock To: **5**
1st Value:
2nd Value:
Value Percent: **5.000**
Continuous Index: **F01**
Within 8" of Joint: **YES**
Remarks:
