## Profile/Photo Observation Report

Date:	<b>04/23/2018</b>	Weather:		Coding:	<b>PACP 6.0</b>
Pipe Length (ft):	<b>333.1</b>	Owner:	<b>NA</b>	Pre Clean:	<b>No Pre-Cleaning</b>
P.O.#:		Surveyor:	<b>Jen Costello</b>	PSR:	<b>P-405-051-050</b>
Customer:		Clean Date:	<b>01/01/1900</b>	Shape:	<b>C</b>

Street:	<b>OAKWOOD DR</b>	Flow Control:	<b>Not Controlled</b>
City:	<b>Hobart, IN</b>	Year Renewed:	
Location:	<b>Yard</b>	Tape/Media #:	
Purpose:	<b>Routine Assessment</b>	Dia/Height:	<b>10"</b>
Use:	<b>Sanitary</b>	Material:	<b>VCP</b>
Drain Area:	<b>NA</b>	Lining:	
Category:	<b>NA</b>		
Comment:	<b>P_C at 110 ft root Flow direction wrong</b>		
Location Details:		Direction of Survey:	<b>Downstream</b>
US MH:	<b>M-405-050</b>	DS MH:	<b>M-405-051</b>
		Total Length Surveyed (ft):	<b>111.6</b>

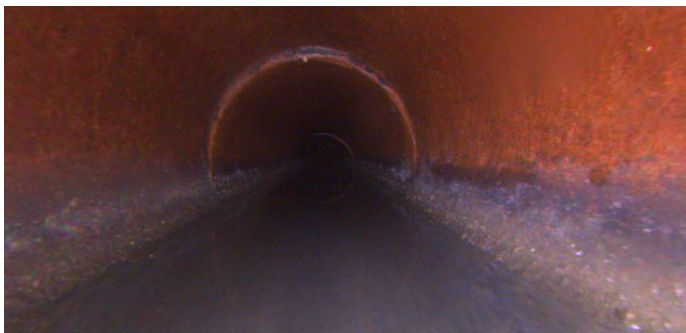
Code: **AMH**  
Description: **Manhole**

Distance (ft): **.0**  
Structural Grade: **0**  
O&M Grade: **0**  
Clock Start/From:  
Clock To:  
1st Value:  
2nd Value:  
Value Percent:  
Continuous Index:  
Within 8" of Joint: **NO**  
Remarks: **M-405-050**

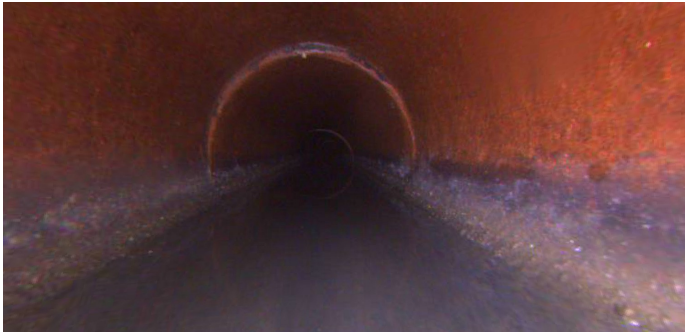
Code:	<b>MWL</b>
Description:	<b>Water Level</b>

Distance (ft):	<b>.0</b>
Structural Grade:	<b>0</b>
O&M Grade:	<b>0</b>
Clock Start/From:	
Clock To:	
1st Value:	
2nd Value:	
Value Percent:	<b>20.000</b>
Continuous Index:	
Within 8" of Joint:	<b>NO</b>
Remarks:

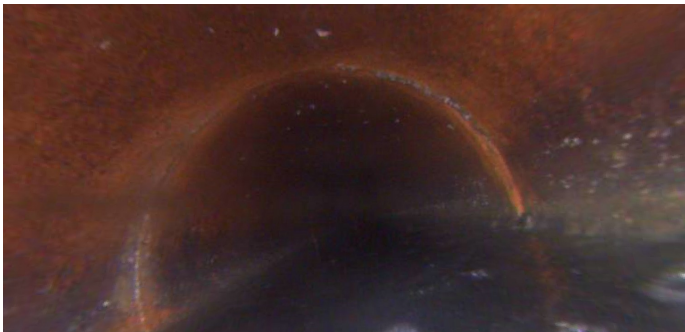
Code:	<b>MGO</b>
Description:	<b>General Observation</b>

Distance (ft):	<b>18.3</b>
Structural Grade:	<b>0</b>
O&M Grade:	<b>0</b>
Clock Start/From:	
Clock To:	
1st Value:	
2nd Value:	
Value Percent:	
Continuous Index:	
Within 8" of Joint:	<b>NO</b>
Remarks:	<b>REAR CAMERA</b>

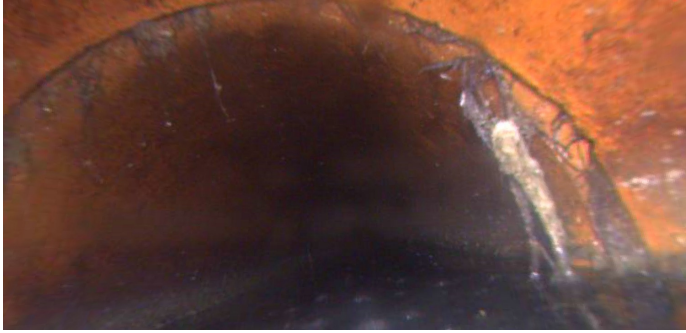
Code: **RFJ**  
Description: **Roots Fine Joint**

Distance (ft): **20.9**  
Structural Grade: **0**  
O&M Grade: **1**  
Clock Start/From: **8**  
Clock To: **4**  
1st Value:  
2nd Value:  
Value Percent:  
Continuous Index: **S01**  
Within 8" of Joint: **YES**  
Remarks:

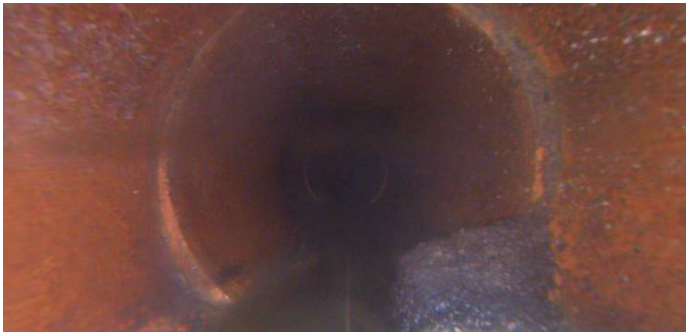
Code: **DAZ**  
Description: **Deposits Attached Other**

Distance (ft): **87.3**  
Structural Grade: **0**  
O&M Grade: **2**  
Clock Start/From: **7**  
Clock To: **9**  
1st Value:  
2nd Value:  
Value Percent: **10.000**  
Continuous Index:  
Within 8" of Joint: **YES**  
Remarks:

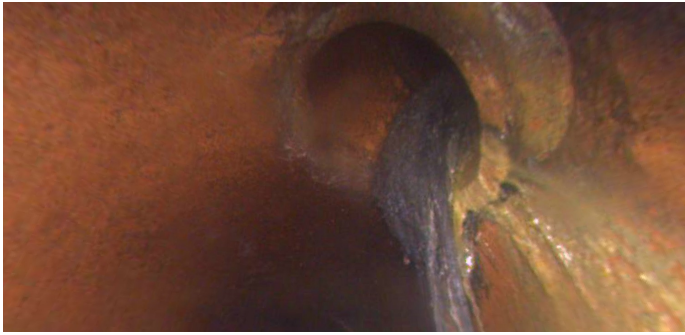
Code: **TBI**  
Description: **Tap Break-in Intruding**

Distance (ft): **89.4**  
Structural Grade: **0**  
O&M Grade: **2**  
Clock Start/From: **11**  
Clock To:  
1st Value: **4.000**  
2nd Value: **1.000**  
Value Percent:  
Continuous Index:  
Within 8" of Joint:  
Remarks: **ROOTS**

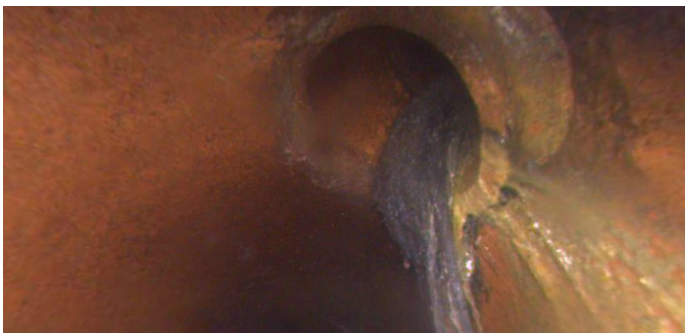
Code: **RML**  
Description: **Roots Medium Lateral**

Distance (ft): **89.4**  
Structural Grade: **0**  
O&M Grade: **3**  
Clock Start/From: **11**  
Clock To:  
1st Value:  
2nd Value:  
Value Percent: **10.000**  
Continuous Index:  
Within 8" of Joint: **NO**  
Remarks:

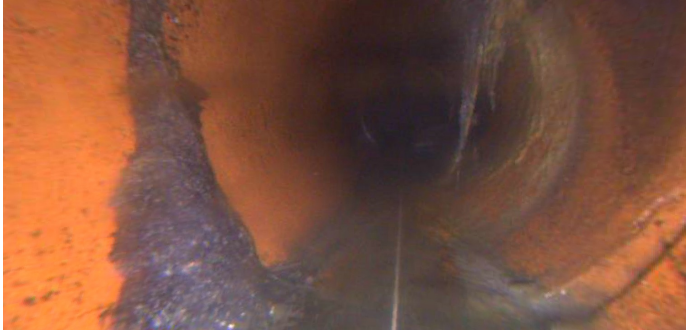
Code: **RMJ**  
Description: **Roots Medium Joint**

Distance (ft): **90.1**  
Structural Grade: **0**  
O&M Grade: **3**  
Clock Start/From: **3**  
Clock To: **5**  
1st Value:  
2nd Value:  
Value Percent: **10.000**  
Continuous Index:  
Within 8" of Joint: **YES**  
Remarks:

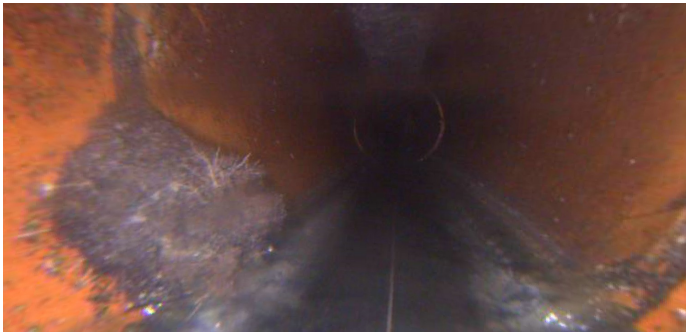
Code: **RMJ**  
Description: **Roots Medium Joint**

Distance (ft): **96.1**  
Structural Grade: **0**  
O&M Grade: **3**  
Clock Start/From: **8**  
Clock To: **4**  
1st Value:  
2nd Value:  
Value Percent: **10.000**  
Continuous Index:  
Within 8" of Joint: **YES**  
Remarks:

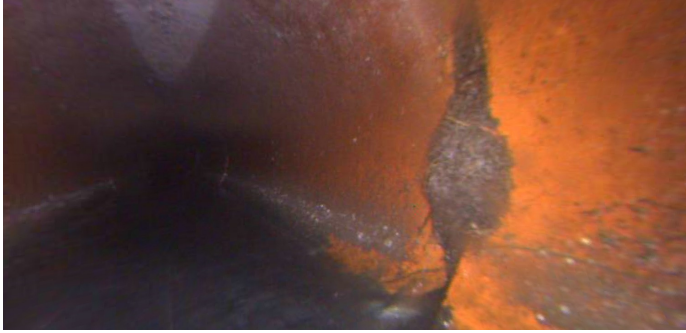
Code: **RMJ**  
Description: **Roots Medium Joint**

Distance (ft): **102.1**  
Structural Grade: **0**  
O&M Grade: **3**  
Clock Start/From: **9**  
Clock To:  
1st Value:  
2nd Value:  
Value Percent: **5.000**  
Continuous Index:  
Within 8" of Joint: **YES**  
Remarks:

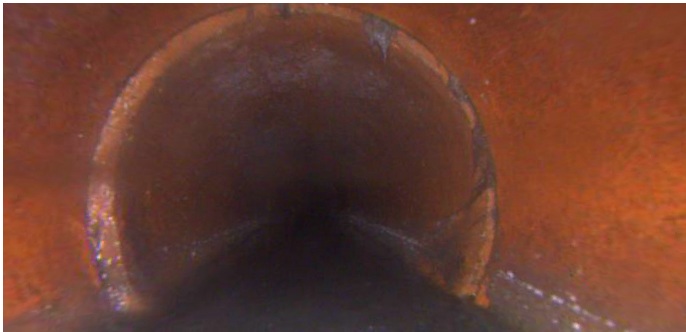
Code: **RFJ**  
Description: **Roots Fine Joint**

Distance (ft): **108.7**  
Structural Grade: **0**  
O&M Grade: **1**  
Clock Start/From: **8**  
Clock To: **4**  
1st Value:  
2nd Value:  
Value Percent:  
Continuous Index:  
Within 8" of Joint: **YES**  
Remarks:

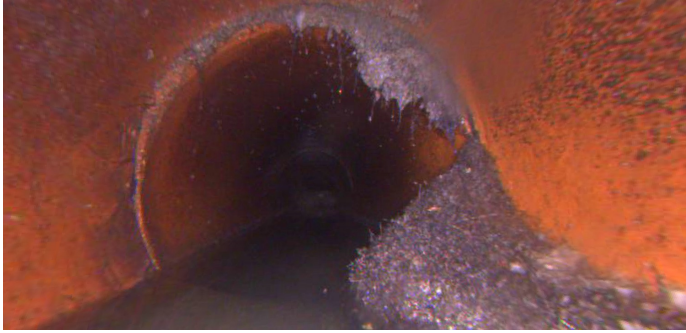
Code: **RMJ**  
Description: **Roots Medium Joint**

Distance (ft): **110.0**  
Structural Grade: **0**  
O&M Grade: **3**  
Clock Start/From: **8**  
Clock To: **4**  
1st Value:  
2nd Value:  
Value Percent: **30.000**  
Continuous Index:  
Within 8" of Joint: **YES**  
Remarks:

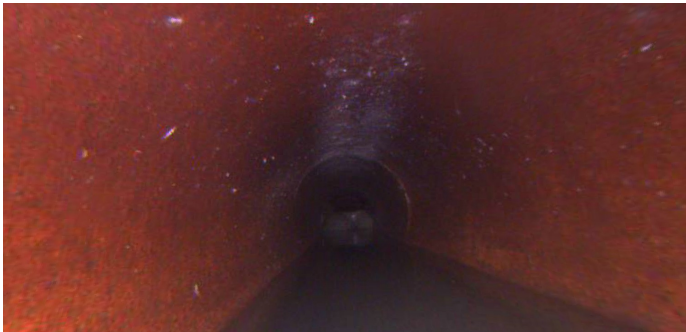
Code: **MSA**  
Description: **Abandoned Survey**

Distance (ft): **111.6**  
Structural Grade: **0**  
O&M Grade: **0**  
Clock Start/From:  
Clock To:  
1st Value:  
2nd Value:  
Value Percent:  
Continuous Index:  
Within 8" of Joint: **NO**  
Remarks: **ROOTS**

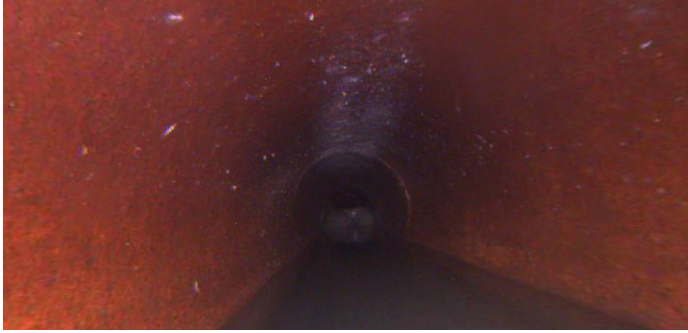
Code:	<b>RFJ</b>
Description:	<b>Roots Fine Joint</b>
Distance (ft):	<b>111.6</b>
Structural Grade:	<b>0</b>
O&M Grade:	<b>1</b>
Clock Start/From:	<b>8</b>
Clock To:	<b>4</b>
1st Value:	
2nd Value:	
Value Percent:	
Continuous Index:	<b>F01</b>
Within 8" of Joint:	<b>YES</b>
Remarks:
