## Profile/Photo Observation Report

Street:	<b>FOXCROFT STREET</b>	Flow Control:	<b>Not Controlled</b>
City:	<b>Hobart, IN</b>	Year Renewed:	
Location:	<b>Yard</b>	Tape/Media #:	
Purpose:	<b>Routine Assessment</b>	Dia/Height:	<b>10"</b>
Use:	<b>Sanitary</b>	Material:	<b>VCP</b>
Drain Area:	<b>NA</b>	Lining:	
Category:	<b>NA</b>		
Comment:	<b>P_C at 110 ft root Flow direction wrong</b>		
Location Details:		Direction of Survey:	<b>Downstream</b>
US MH:	<b>M-405-050</b>	DS MH:	<b>M-405-051</b>
		Total Length Surveyed (ft):	<b>111.6</b>

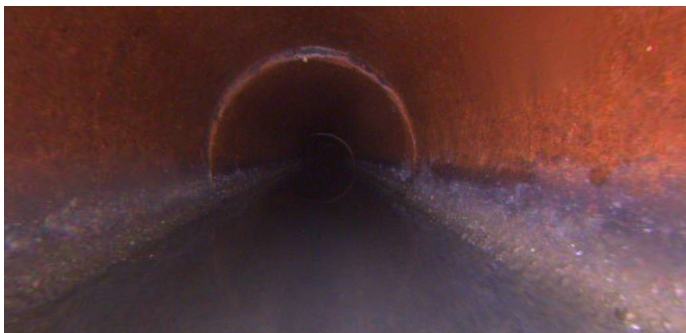
Code: **AMH**  
Description: **Manhole**

Distance (ft): **.0**  
Structural Grade: **0**  
O&M Grade: **0**  
Clock Start/From:  
Clock To:  
1st Value:  
2nd Value:  
Value Percent:  
Continuous Index:  
Within 8" of Joint: **NO**  
Remarks: **M-405-050**

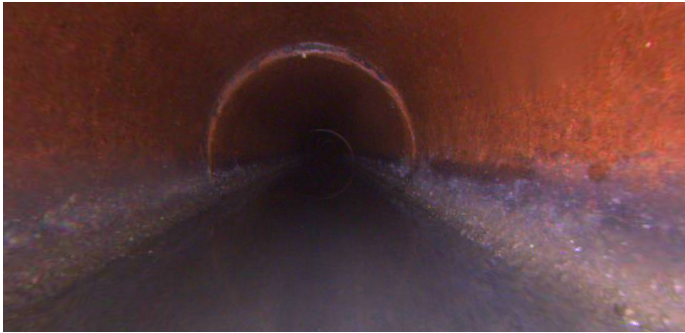
Code:	<b>MWL</b>
Description:	<b>Water Level</b>

Distance (ft):	<b>.0</b>
Structural Grade:	<b>0</b>
O&M Grade:	<b>0</b>
Clock Start/From:	
Clock To:	
1st Value:	
2nd Value:	
Value Percent:	<b>20.000</b>
Continuous Index:	
Within 8" of Joint:	<b>NO</b>
Remarks:

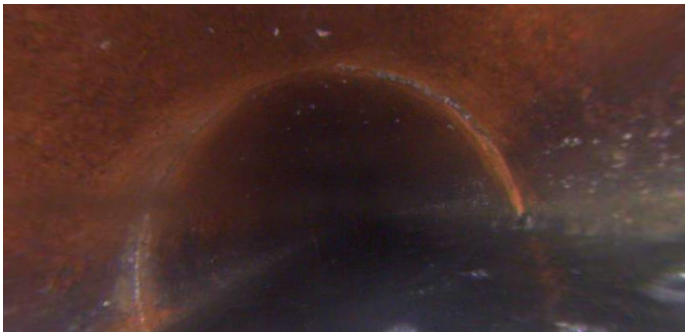
Code:	<b>MGO</b>
Description:	<b>General Observation</b>

Distance (ft):	<b>18.3</b>
Structural Grade:	<b>0</b>
O&M Grade:	<b>0</b>
Clock Start/From:	
Clock To:	
1st Value:	
2nd Value:	
Value Percent:	
Continuous Index:	
Within 8" of Joint:	<b>NO</b>
Remarks:	<b>REAR CAMERA</b>

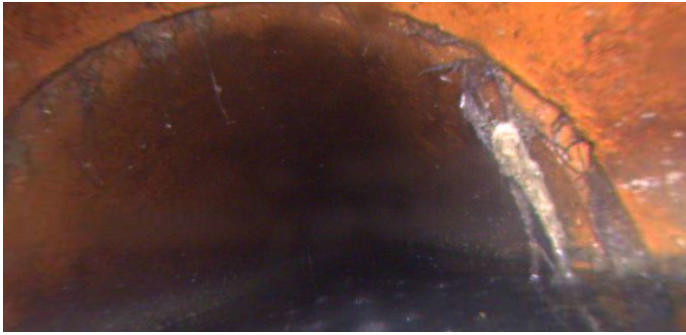
Code: **RFJ**  
Description: **Roots Fine Joint**

Distance (ft): **20.9**  
Structural Grade: **0**  
O&M Grade: **1**  
Clock Start/From: **8**  
Clock To: **4**  
1st Value:  
2nd Value:  
Value Percent:  
Continuous Index: **S01**  
Within 8" of Joint: **YES**  
Remarks:

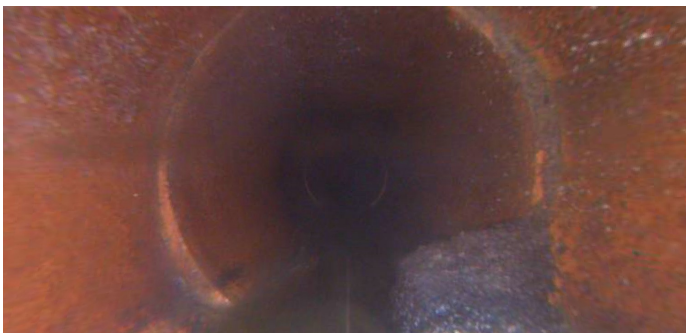
Code: **DAZ**  
Description: **Deposits Attached Other**

Distance (ft): **87.3**  
Structural Grade: **0**  
O&M Grade: **2**  
Clock Start/From: **7**  
Clock To: **9**  
1st Value:  
2nd Value:  
Value Percent: **10.000**  
Continuous Index:  
Within 8" of Joint: **YES**  
Remarks:

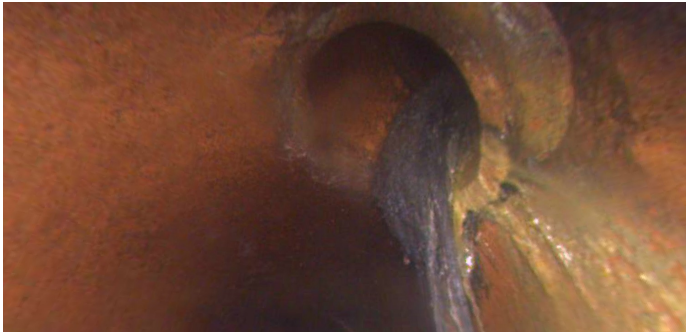
Code: **TBI**  
Description: **Tap Break-in Intruding**

Distance (ft): **89.4**  
Structural Grade: **0**  
O&M Grade: **2**  
Clock Start/From: **11**  
Clock To:  
1st Value: **4.000**  
2nd Value: **1.000**  
Value Percent:  
Continuous Index:  
Within 8" of Joint:  
Remarks: **ROOTS**

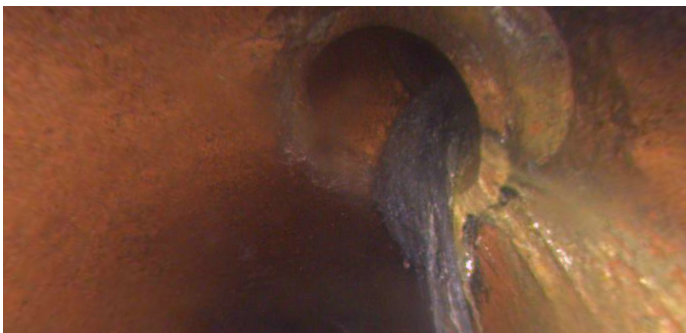
Code: **RML**  
Description: **Roots Medium Lateral**

Distance (ft): **89.4**  
Structural Grade: **0**  
O&M Grade: **3**  
Clock Start/From: **11**  
Clock To:  
1st Value:  
2nd Value:  
Value Percent: **10.000**  
Continuous Index:  
Within 8" of Joint: **NO**  
Remarks:

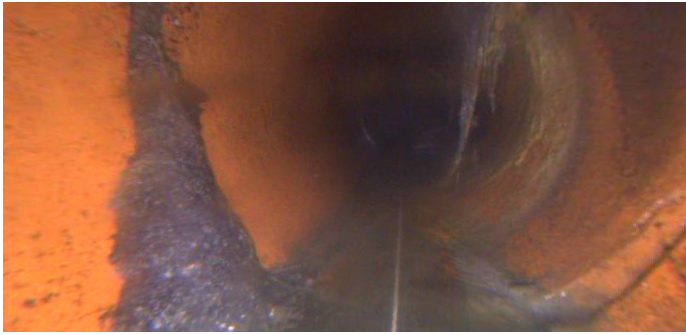
Code: **RMJ**  
Description: **Roots Medium Joint**

Distance (ft): **90.1**  
Structural Grade: **0**  
O&M Grade: **3**  
Clock Start/From: **3**  
Clock To: **5**  
1st Value:  
2nd Value:  
Value Percent: **10.000**  
Continuous Index:  
Within 8" of Joint: **YES**  
Remarks:

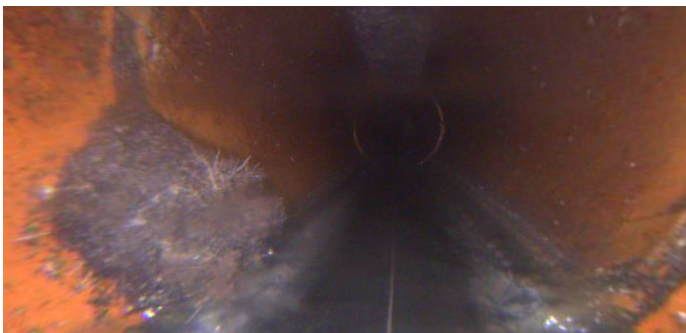
Code: **RMJ**  
Description: **Roots Medium Joint**

Distance (ft): **96.1**  
Structural Grade: **0**  
O&M Grade: **3**  
Clock Start/From: **8**  
Clock To: **4**  
1st Value:  
2nd Value:  
Value Percent: **10.000**  
Continuous Index:  
Within 8" of Joint: **YES**  
Remarks:

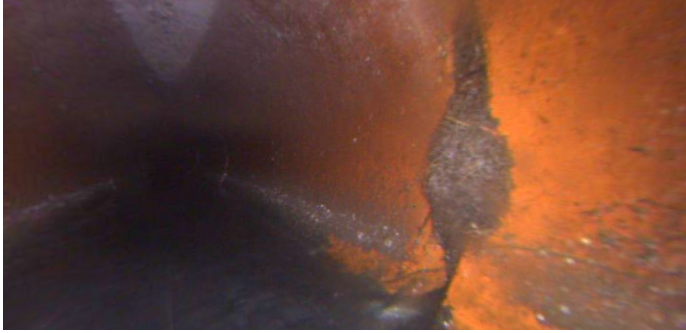
Code: **RMJ**  
Description: **Roots Medium Joint**

Distance (ft): **102.1**  
Structural Grade: **0**  
O&M Grade: **3**  
Clock Start/From: **9**  
Clock To:  
1st Value:  
2nd Value:  
Value Percent: **5.000**  
Continuous Index:  
Within 8" of Joint: **YES**  
Remarks:

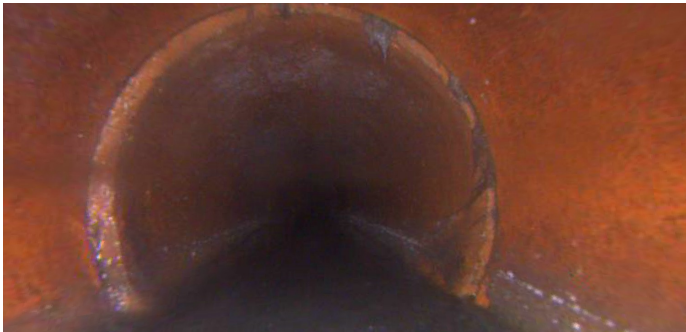
Code: **RFJ**  
Description: **Roots Fine Joint**

Distance (ft): **108.7**  
Structural Grade: **0**  
O&M Grade: **1**  
Clock Start/From: **8**  
Clock To: **4**  
1st Value:  
2nd Value:  
Value Percent:  
Continuous Index:  
Within 8" of Joint: **YES**  
Remarks:

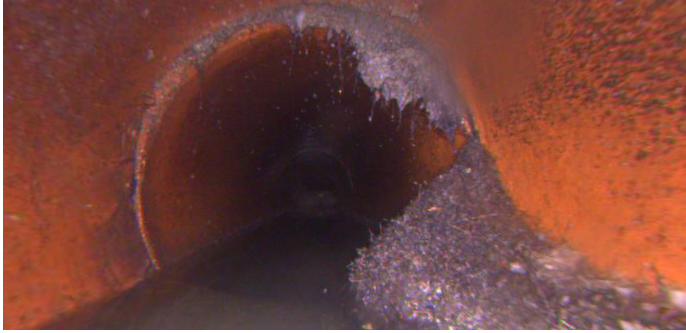
Code: **RMJ**  
Description: **Roots Medium Joint**

Distance (ft): **110.0**  
Structural Grade: **0**  
O&M Grade: **3**  
Clock Start/From: **8**  
Clock To: **4**  
1st Value:  
2nd Value:  
Value Percent: **30.000**  
Continuous Index:  
Within 8" of Joint: **YES**  
Remarks:

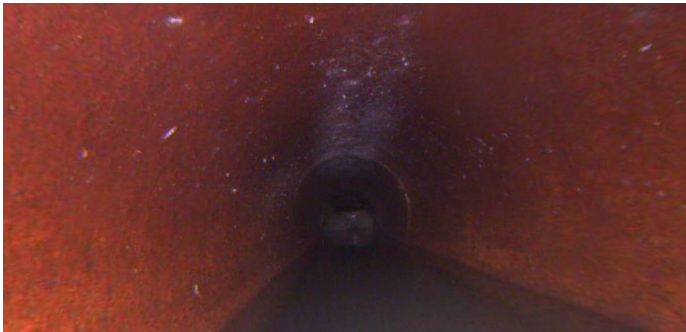
Code: **MSA**  
Description: **Abandoned Survey**

Distance (ft): **111.6**  
Structural Grade: **0**  
O&M Grade: **0**  
Clock Start/From:  
Clock To:  
1st Value:  
2nd Value:  
Value Percent:  
Continuous Index:  
Within 8" of Joint: **NO**  
Remarks: **ROOTS**

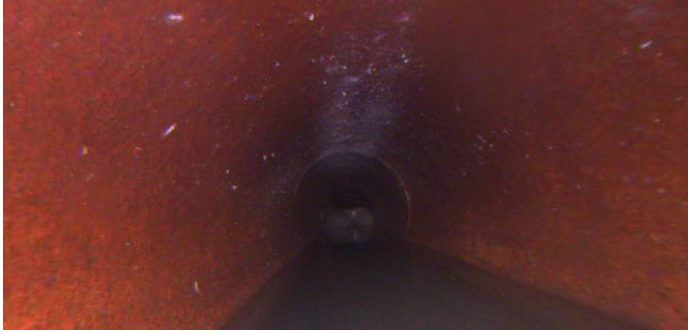
Code:	RFJ
Description:	Roots Fine Joint
Distance (ft):	111.6
Structural Grade:	0
O&M Grade:	1
Clock Start/From:	8
Clock To:	4
1st Value:	
2nd Value:	
Value Percent:	
Continuous Index:	F01
Within 8" of Joint:	YES
Remarks:
