Profile/Photo Observation Report

Date:	03/13/2024	Weather:		Coding:	PACP 7.0
Pipe Length (ft):	329.0	Owner:	City of Hobart	Pre Clean:	Heavy Cleaning
P.O.#:		Surveyor:	S. Bucklin	PSR:	P-405-056-051
Customer:	City of Hobart	Clean Date:	09/25/2023	Shape:	C

Street:	W 3RD ST	Flow Control:	Not Controlled
City:	Hobart, IN	Year Renewed:	
Location:	Easement/Right of Way	Tape/Media #:	
Purpose:	Sewer System Evaluation Survey (SS)	Dia/Height:	12"
Use:	Sanitary Sewage Pipe	Material:	VCP
Drain Area:		Lining:	None
Category:	NA		
Comment:			
Location Details:		Direction of Survey:	Upstream
US MH:	M-405-051	DS MH:	M-405-056
		Total Length Surveyed (ft):	328.3

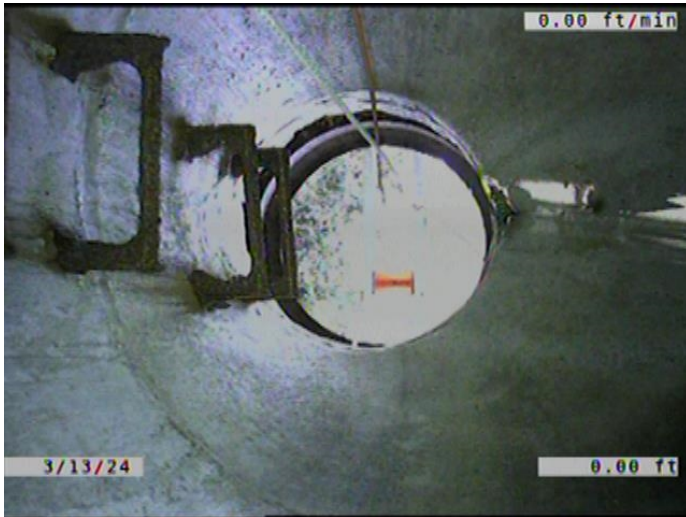
Code: **AMH**
 Description: **Manhole**

Distance (ft): **.0**
 Structural Grade: **0**
 O&M Grade: **0**
 Clock Start/From:
 Clock To:
 1st Value:
 2nd Value:
 Value Percent:
 Continuous Index:
 Within 8" of Joint: **NO**
 Remarks: **M-405-056**

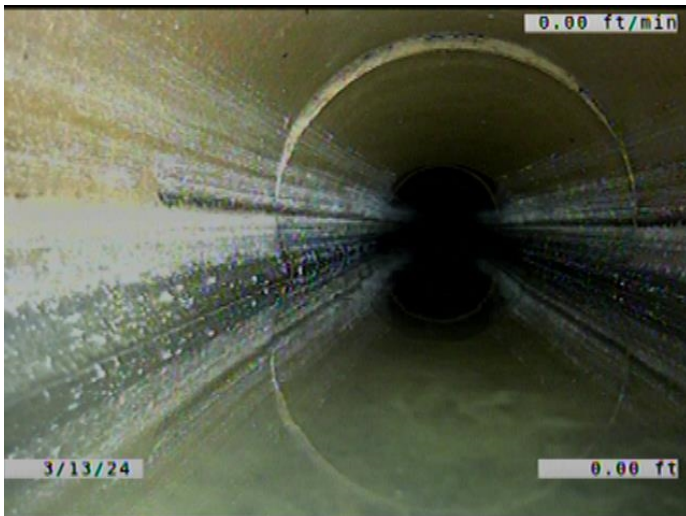
Code: **MWL**
 Description: **Miscellaneous Water Level**

Distance (ft): **.0**
 Structural Grade: **0**
 O&M Grade: **0**
 Clock Start/From:
 Clock To:
 1st Value:
 2nd Value:
 Value Percent: **25.000**
 Continuous Index:
 Within 8" of Joint: **NO**
 Remarks:

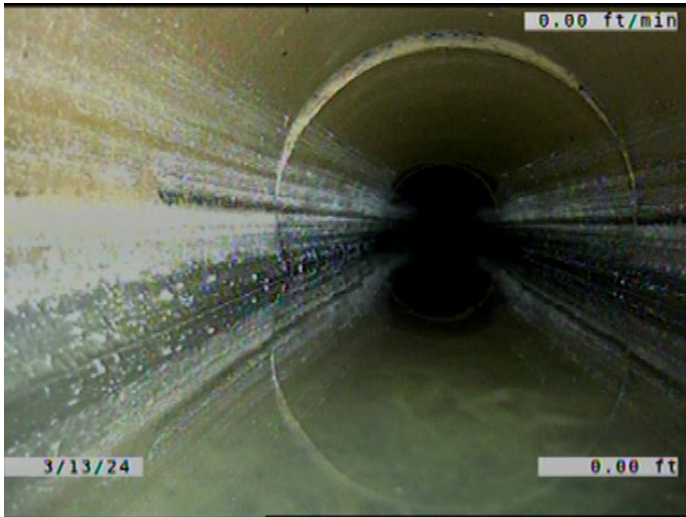
Code: **DSF**
 Description: **Deposits Settled Fine**

Distance (ft): **.0**
 Structural Grade: **0**
 O&M Grade: **2**
 Clock Start/From: **5**
 Clock To: **7**
 1st Value:
 2nd Value:
 Value Percent: **5.000**
 Continuous Index: **S01**
 Within 8" of Joint: **YES**
 Remarks:

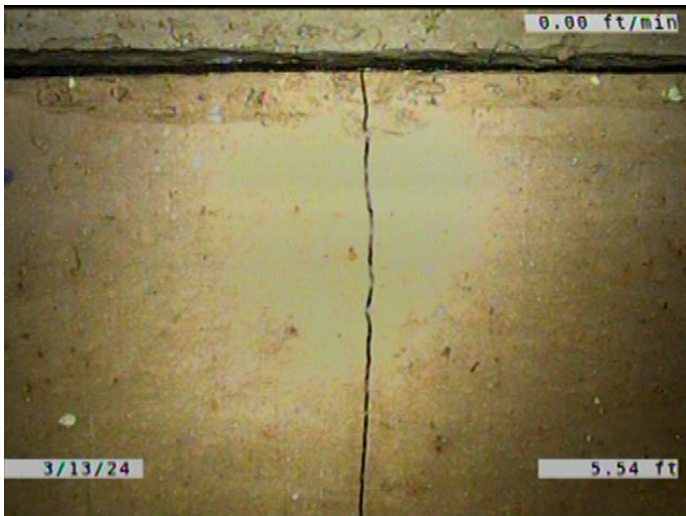
Code: **FM**
 Description: **Fracture Multiple**

Distance (ft): **5.5**
 Structural Grade: **4**
 O&M Grade: **0**
 Clock Start/From: **8**
 Clock To: **4**
 1st Value:
 2nd Value:
 Value Percent:
 Continuous Index: **S02**
 Within 8" of Joint: **YES**
 Remarks:

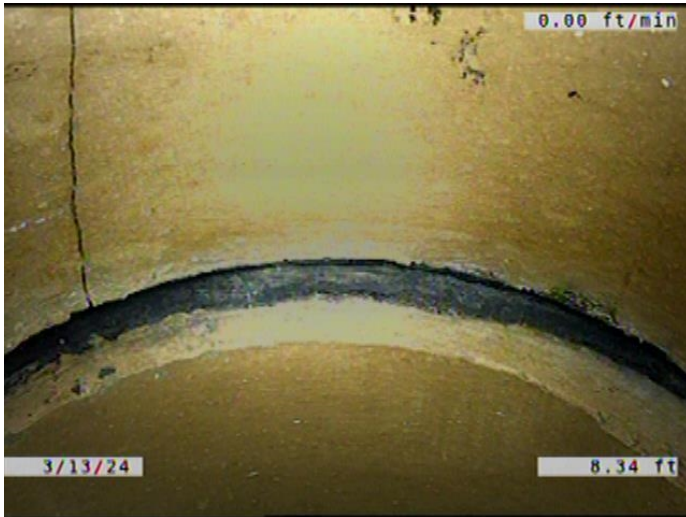
Code: **JOMD**
Description: **Joint Offset Medium Defective**

Distance (ft): **8.3**
Structural Grade: **3**
O&M Grade: **0**
Clock Start/From:
Clock To:
1st Value:
2nd Value:
Value Percent:
Continuous Index:
Within 8" of Joint: **NO**
Remarks:

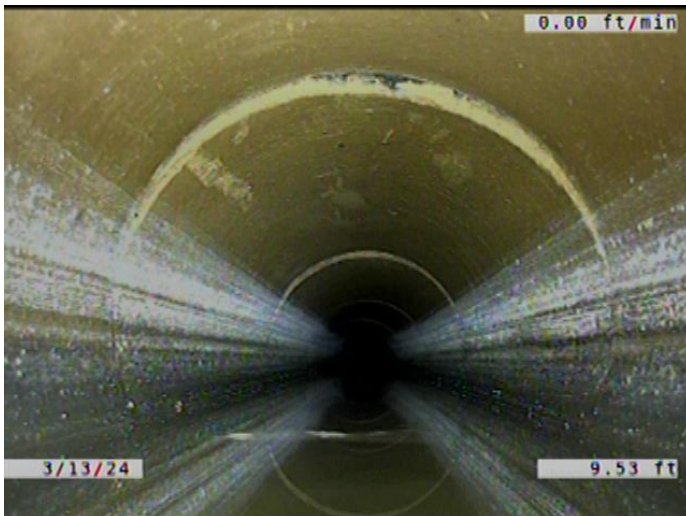
Code: **FM**
Description: **Fracture Multiple**

Distance (ft): **9.5**
Structural Grade: **4**
O&M Grade: **0**
Clock Start/From: **8**
Clock To: **4**
1st Value:
2nd Value:
Value Percent:
Continuous Index: **F02**
Within 8" of Joint: **YES**
Remarks:

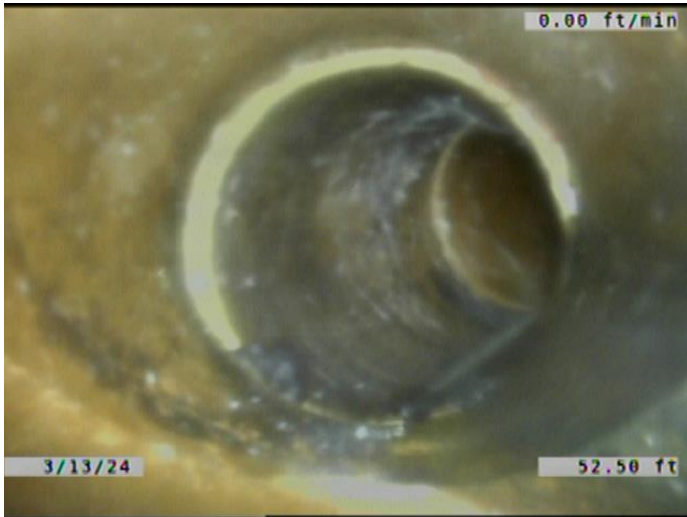
Code: **TFA**
 Description: **Tap Factory Activity**

Distance (ft): **52.5**
 Structural Grade: **0**
 O&M Grade: **0**
 Clock Start/From: **2**
 Clock To:
 1st Value: **6.000**
 2nd Value:
 Value Percent:
 Continuous Index:
 Within 8" of Joint: **YES**
 Remarks:

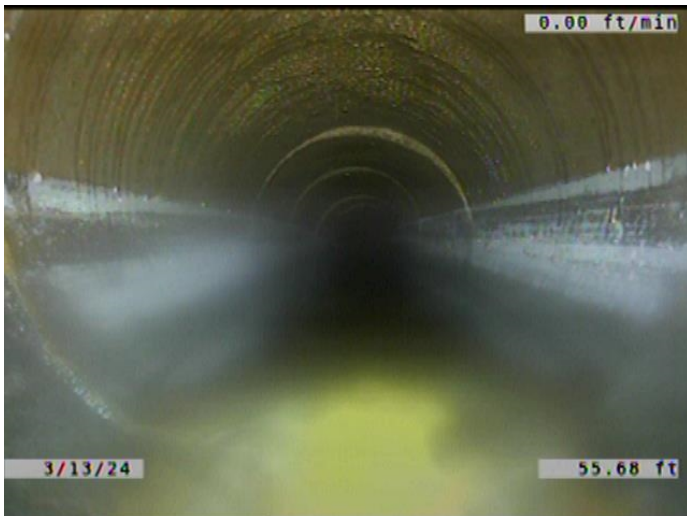
Code: **MWL**
 Description: **Miscellaneous Water Level**

Distance (ft): **55.7**
 Structural Grade: **0**
 O&M Grade: **0**
 Clock Start/From:
 Clock To:
 1st Value:
 2nd Value:
 Value Percent: **10.000**
 Continuous Index:
 Within 8" of Joint: **NO**
 Remarks:

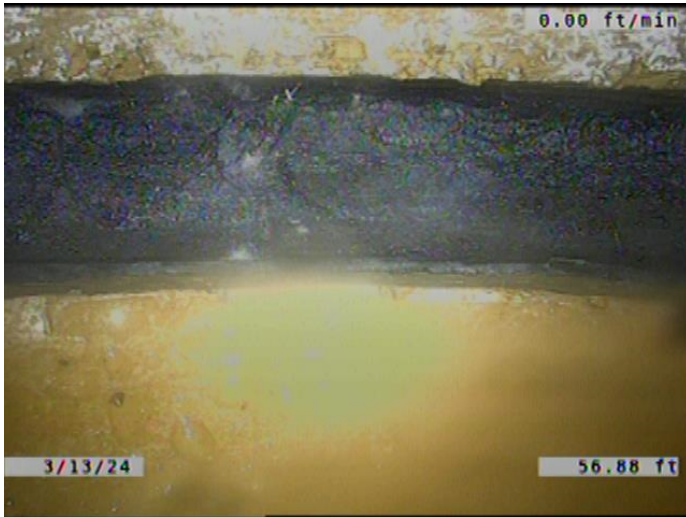
Code: **JAM**
Description: **Joint Angular Medium**

Distance (ft): **56.9**
Structural Grade: **3**
O&M Grade: **0**
Clock Start/From:
Clock To:
1st Value:
2nd Value:
Value Percent:
Continuous Index:
Within 8" of Joint: **NO**
Remarks:

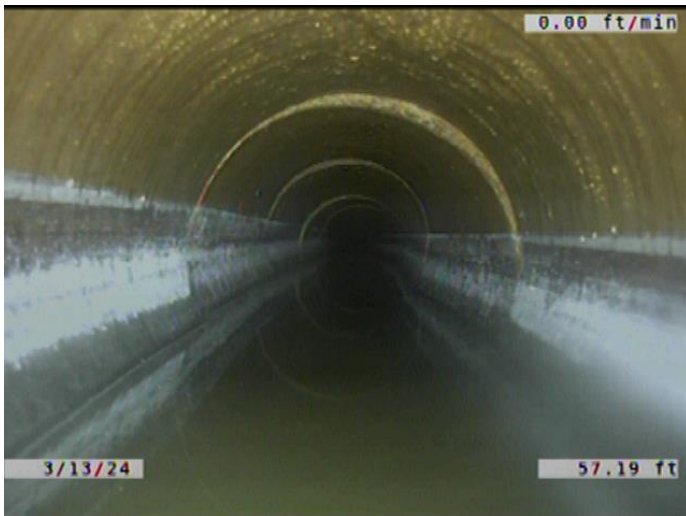
Code: **MWLS**
Description: **Miscellaneous Water Level Sag**

Distance (ft): **57.2**
Structural Grade: **2**
O&M Grade: **0**
Clock Start/From:
Clock To:
1st Value:
2nd Value:
Value Percent: **15.000**
Continuous Index: **S03**
Within 8" of Joint: **NO**
Remarks:

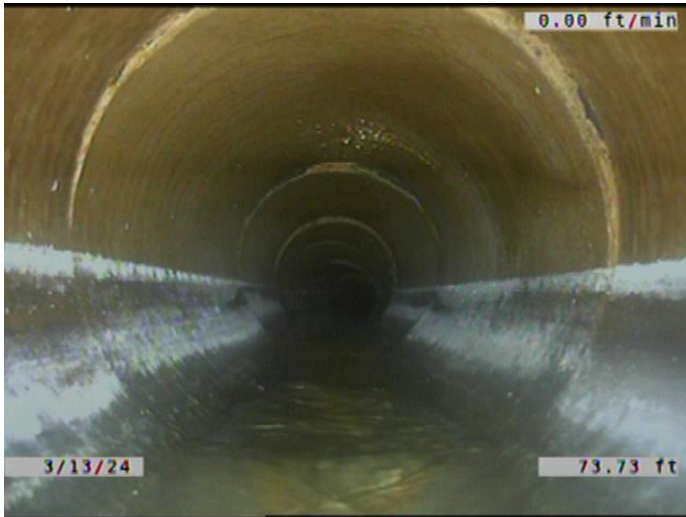
Code: **MWLS**
Description: **Miscellaneous Water Level Sag**

Distance (ft): **73.7**
Structural Grade: **2**
O&M Grade: **0**
Clock Start/From:
Clock To:
1st Value:
2nd Value:
Value Percent: **15.000**
Continuous Index: **F03**
Within 8" of Joint: **NO**
Remarks:

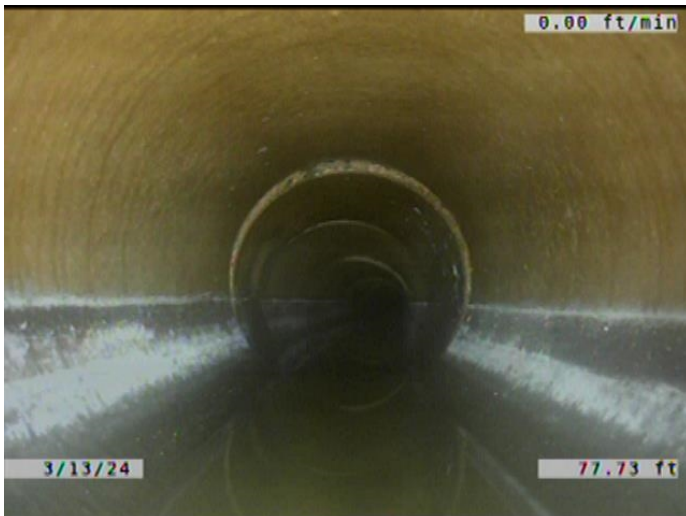
Code: **MWLS**
Description: **Miscellaneous Water Level Sag**

Distance (ft): **77.7**
Structural Grade: **2**
O&M Grade: **0**
Clock Start/From:
Clock To:
1st Value:
2nd Value:
Value Percent: **15.000**
Continuous Index: **S04**
Within 8" of Joint: **NO**
Remarks:

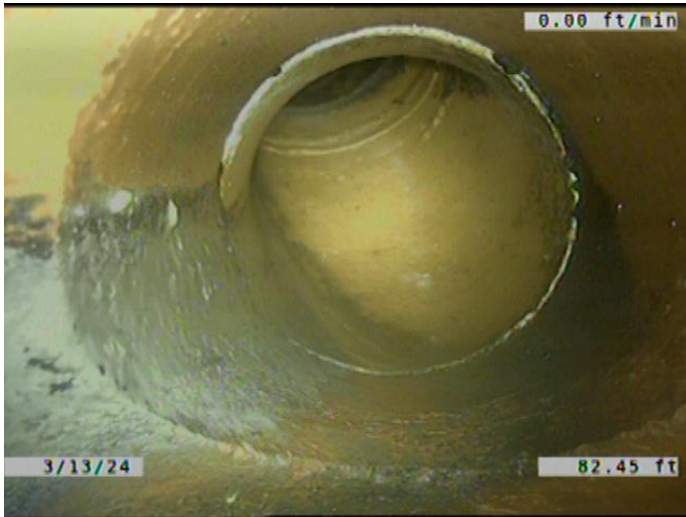
Code: **TF**
Description: **Tap Factory**

Distance (ft): **82.5**
Structural Grade: **0**
O&M Grade: **0**
Clock Start/From: **10**
Clock To:
1st Value: **6.000**
2nd Value:
Value Percent:
Continuous Index:
Within 8" of Joint: **YES**
Remarks: **CONSTANTLY RUNNING WATER.**

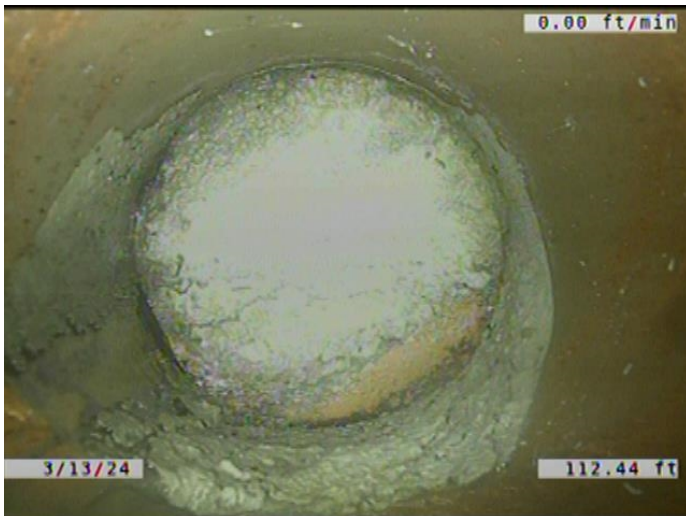
Code: **TFD**
Description: **Tap Factory Defective**

Distance (ft): **112.4**
Structural Grade: **0**
O&M Grade: **3**
Clock Start/From: **10**
Clock To:
1st Value: **6.000**
2nd Value:
Value Percent:
Continuous Index:
Within 8" of Joint: **YES**
Remarks: **CAPPED. WATER CONSTANTLY
RUNNING AROUND THE CAP. ENCUS**

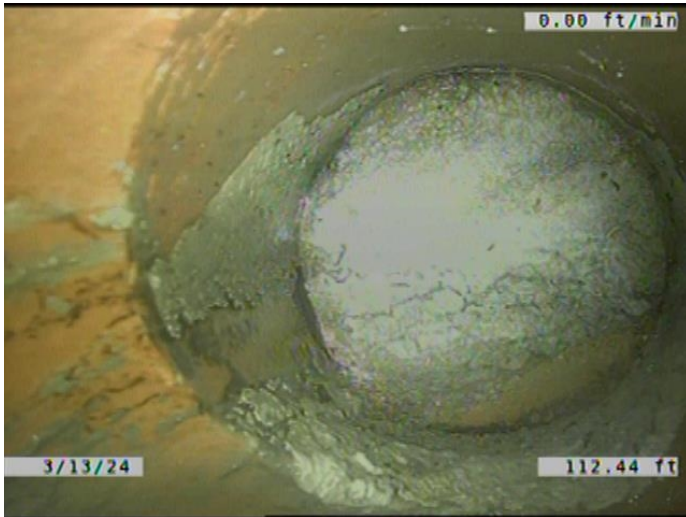
Code: **IRL**
Description: **Infiltration Runner Lateral**

Distance (ft): **112.4**
Structural Grade: **0**
O&M Grade: **4**
Clock Start/From: **10**
Clock To:
1st Value:
2nd Value:
Value Percent:
Continuous Index:
Within 8" of Joint: **YES**
Remarks:

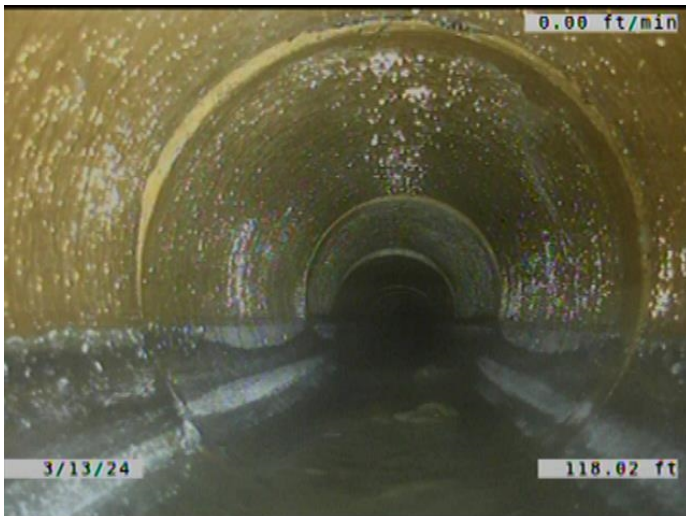
Code: **MWLS**
Description: **Miscellaneous Water Level Sag**

Distance (ft): **118.0**
Structural Grade: **2**
O&M Grade: **0**
Clock Start/From:
Clock To:
1st Value:
2nd Value:
Value Percent: **15.000**
Continuous Index: **F04**
Within 8" of Joint: **NO**
Remarks:

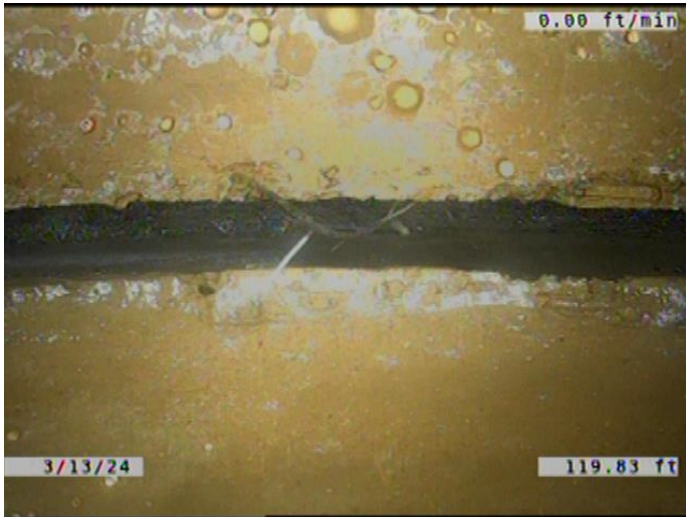
Code: **RFJ**
Description: **Roots Fine Joint**

Distance (ft): **119.8**
Structural Grade: **0**
O&M Grade: **1**
Clock Start/From: **12**
Clock To:
1st Value:
2nd Value:
Value Percent:
Continuous Index:
Within 8" of Joint: **YES**
Remarks:

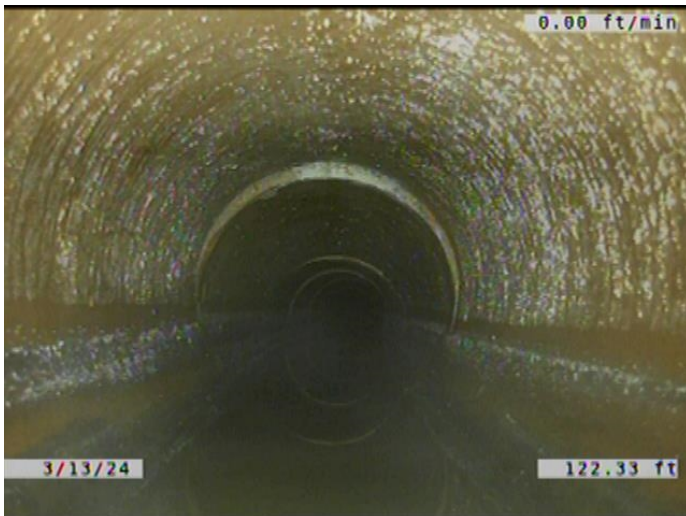
Code: **MWLS**
Description: **Miscellaneous Water Level Sag**

Distance (ft): **122.3**
Structural Grade: **2**
O&M Grade: **0**
Clock Start/From:
Clock To:
1st Value:
2nd Value:
Value Percent: **20.000**
Continuous Index: **S05**
Within 8" of Joint: **NO**
Remarks:

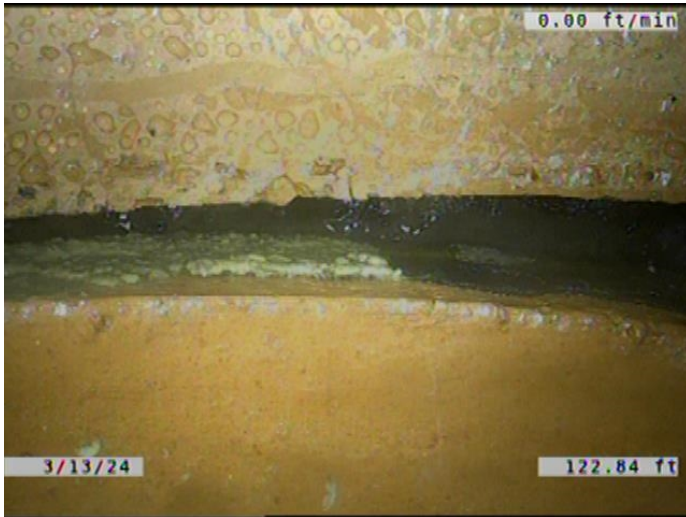
Code: **IRJ**
Description: **Infiltration Runner Joint**

Distance (ft): **122.8**
Structural Grade: **0**
O&M Grade: **4**
Clock Start/From: **10**
Clock To:
1st Value:
2nd Value:
Value Percent:
Continuous Index:
Within 8" of Joint: **YES**
Remarks:

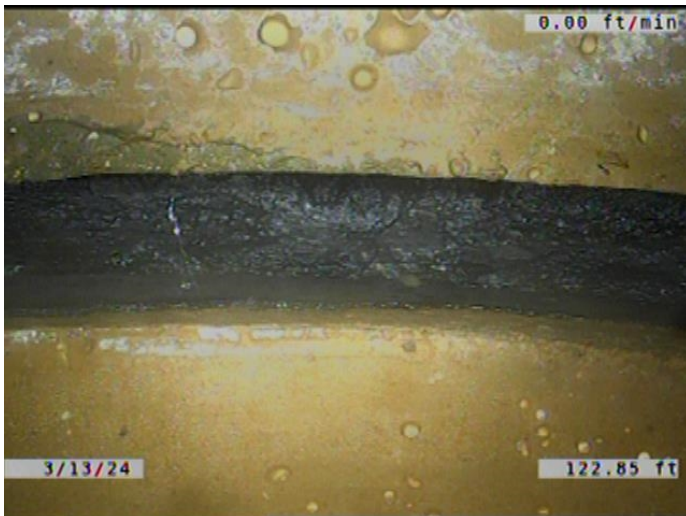
Code: **JAM**
Description: **Joint Angular Medium**

Distance (ft): **122.9**
Structural Grade: **3**
O&M Grade: **0**
Clock Start/From:
Clock To:
1st Value:
2nd Value:
Value Percent:
Continuous Index:
Within 8" of Joint: **NO**
Remarks:

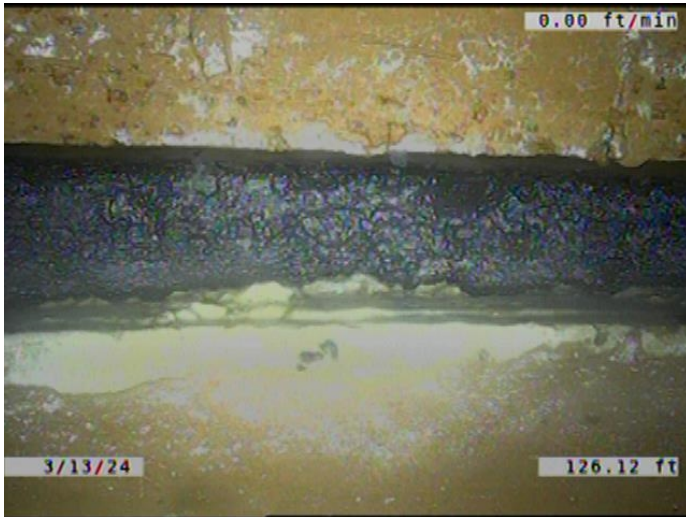
Code: **DAE**
Description: **Deposits Attached Encrustation**

Distance (ft): **126.1**
Structural Grade: **0**
O&M Grade: **2**
Clock Start/From: **8**
Clock To: **2**
1st Value:
2nd Value:
Value Percent: **5.000**
Continuous Index:
Within 8" of Joint: **YES**
Remarks:

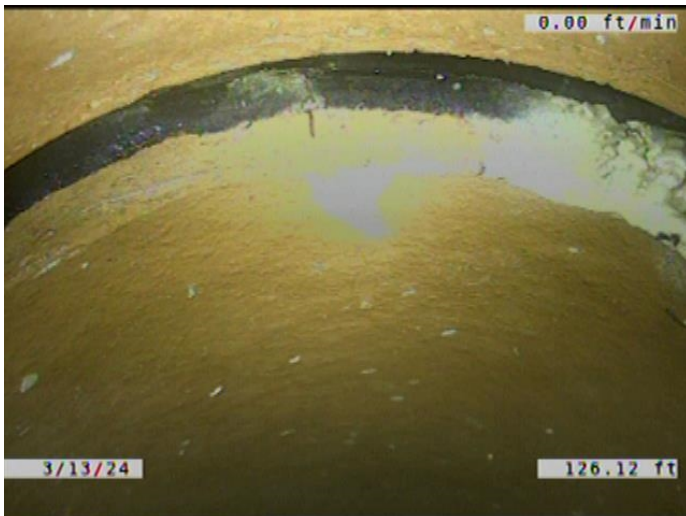
Code: **JOMD**
Description: **Joint Offset Medium Defective**

Distance (ft): **126.1**
Structural Grade: **3**
O&M Grade: **0**
Clock Start/From:
Clock To:
1st Value:
2nd Value:
Value Percent:
Continuous Index:
Within 8" of Joint: **NO**
Remarks:

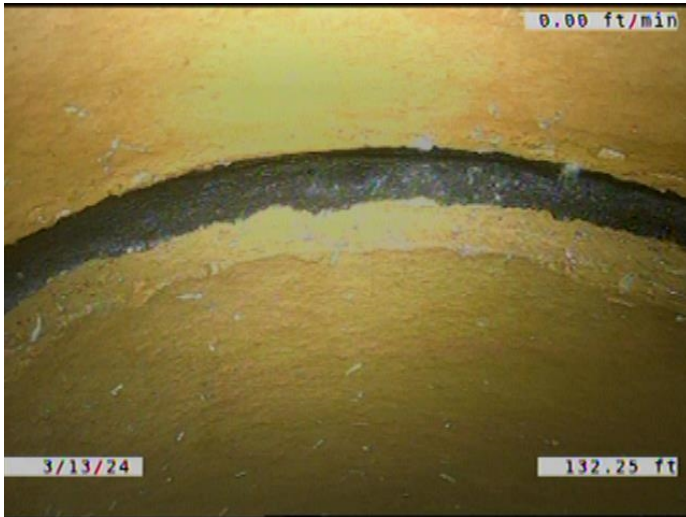
Code: **JOMD**
Description: **Joint Offset Medium Defective**

Distance (ft): **132.2**
Structural Grade: **3**
O&M Grade: **0**
Clock Start/From:
Clock To:
1st Value:
2nd Value:
Value Percent:
Continuous Index:
Within 8" of Joint: **NO**
Remarks:

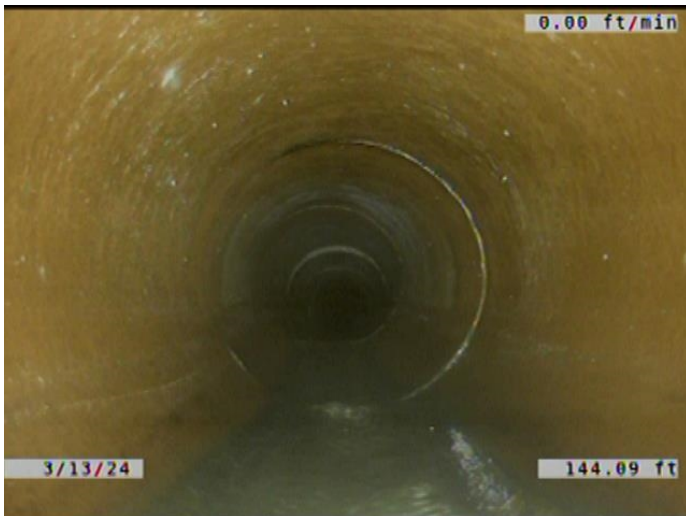
Code: **MWLS**
Description: **Miscellaneous Water Level Sag**

Distance (ft): **144.1**
Structural Grade: **2**
O&M Grade: **0**
Clock Start/From:
Clock To:
1st Value:
2nd Value:
Value Percent: **20.000**
Continuous Index: **F05**
Within 8" of Joint: **NO**
Remarks:

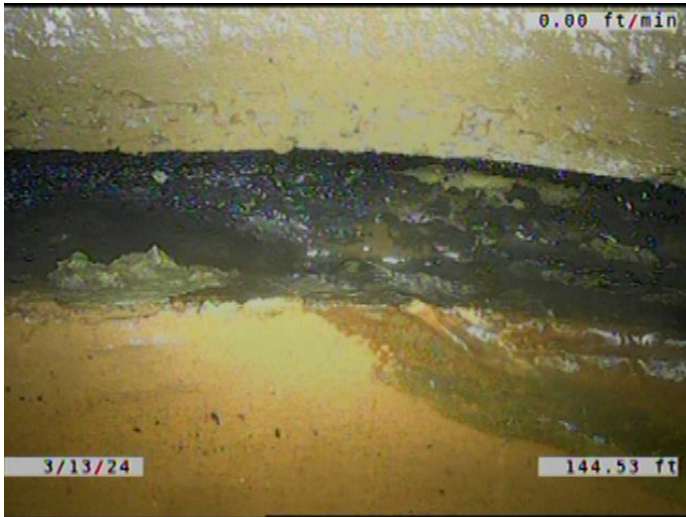
Code: **IRJ**
Description: **Infiltration Runner Joint**

Distance (ft): **144.5**
Structural Grade: **0**
O&M Grade: **4**
Clock Start/From: **1**
Clock To:
1st Value:
2nd Value:
Value Percent:
Continuous Index:
Within 8" of Joint: **YES**
Remarks:

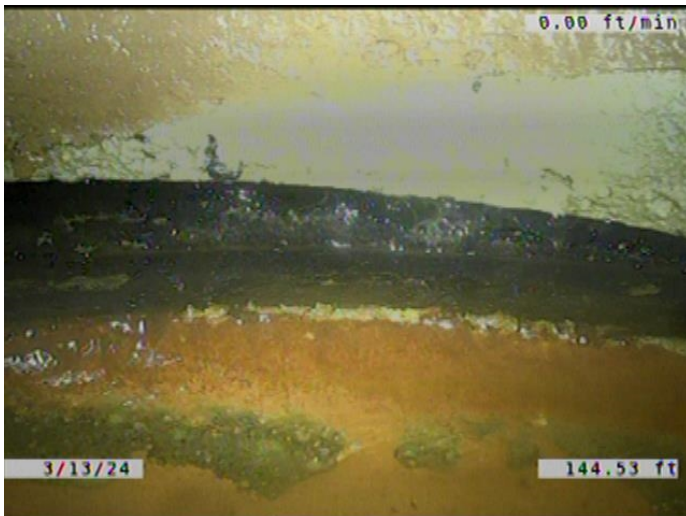
Code: **DAE**
Description: **Deposits Attached Encrustation**

Distance (ft): **144.5**
Structural Grade: **0**
O&M Grade: **2**
Clock Start/From: **10**
Clock To: **5**
1st Value:
2nd Value:
Value Percent: **5.000**
Continuous Index:
Within 8" of Joint: **YES**
Remarks:

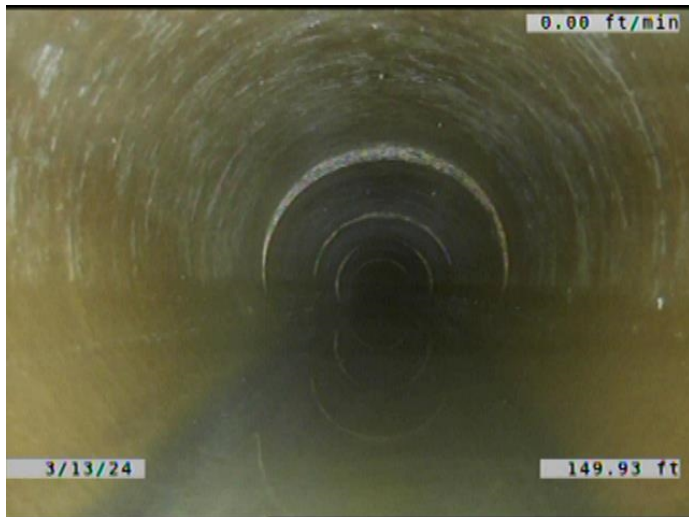
Code: **MWLS**
Description: **Miscellaneous Water Level Sag**

Distance (ft): **149.9**
Structural Grade: **2**
O&M Grade: **0**
Clock Start/From:
Clock To:
1st Value:
2nd Value:
Value Percent: **20.000**
Continuous Index: **S06**
Within 8" of Joint: **NO**
Remarks:

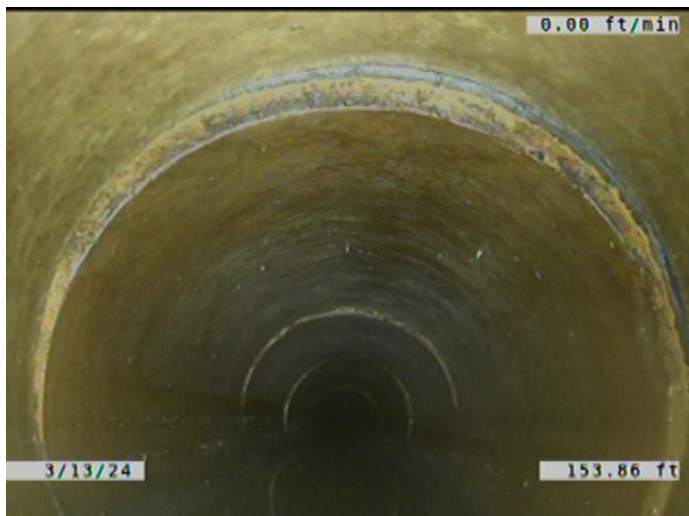
Code: **JOMD**
Description: **Joint Offset Medium Defective**

Distance (ft): **153.9**
Structural Grade: **3**
O&M Grade: **0**
Clock Start/From:
Clock To:
1st Value:
2nd Value:
Value Percent:
Continuous Index:
Within 8" of Joint: **NO**
Remarks:

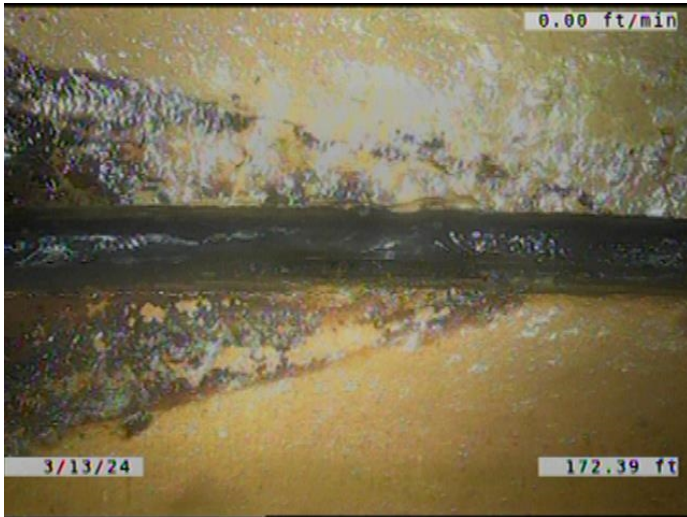
Code: **IRJ**
 Description: **Infiltration Runner Joint**

Distance (ft): **172.4**
 Structural Grade: **0**
 O&M Grade: **4**
 Clock Start/From: **10**
 Clock To: **11**
 1st Value:
 2nd Value:
 Value Percent:
 Continuous Index:
 Within 8" of Joint: **YES**
 Remarks:

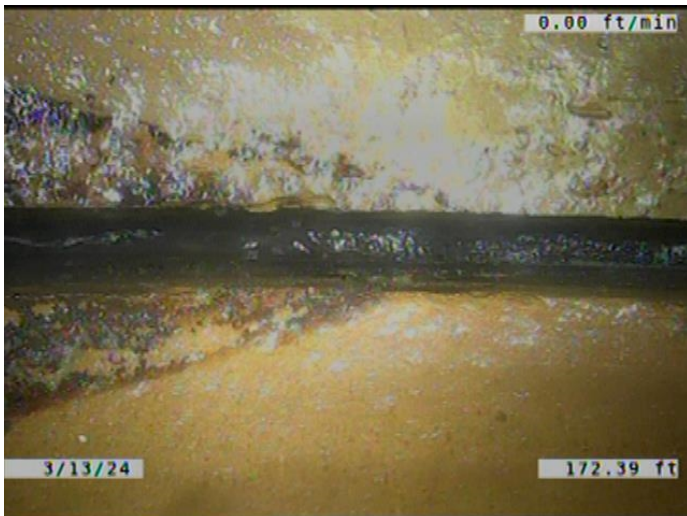
Code: **DAE**
 Description: **Deposits Attached Encrustation**

Distance (ft): **172.4**
 Structural Grade: **0**
 O&M Grade: **2**
 Clock Start/From: **7**
 Clock To: **11**
 1st Value:
 2nd Value:
 Value Percent: **5.000**
 Continuous Index:
 Within 8" of Joint: **YES**
 Remarks:

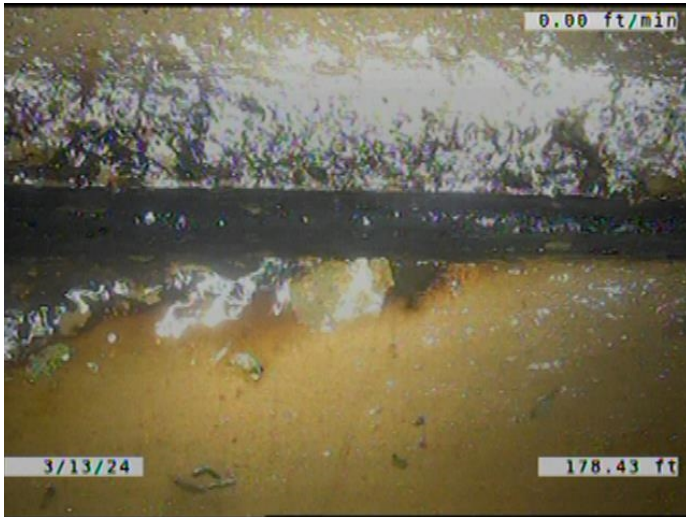
Code: **IRJ**
Description: **Infiltration Runner Joint**

Distance (ft): **178.4**
Structural Grade: **0**
O&M Grade: **4**
Clock Start/From: **11**
Clock To: **12**
1st Value:
2nd Value:
Value Percent:
Continuous Index:
Within 8" of Joint: **YES**
Remarks:

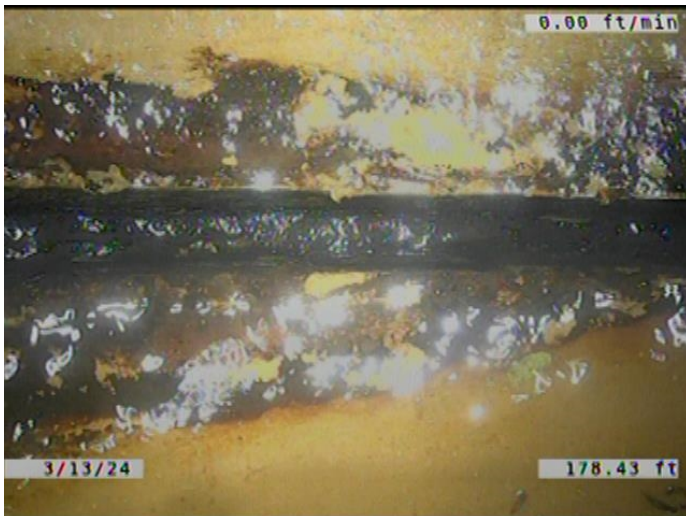
Code: **DAE**
Description: **Deposits Attached Encrustation**

Distance (ft): **178.4**
Structural Grade: **0**
O&M Grade: **2**
Clock Start/From: **7**
Clock To: **12**
1st Value:
2nd Value:
Value Percent: **5.000**
Continuous Index:
Within 8" of Joint: **YES**
Remarks:

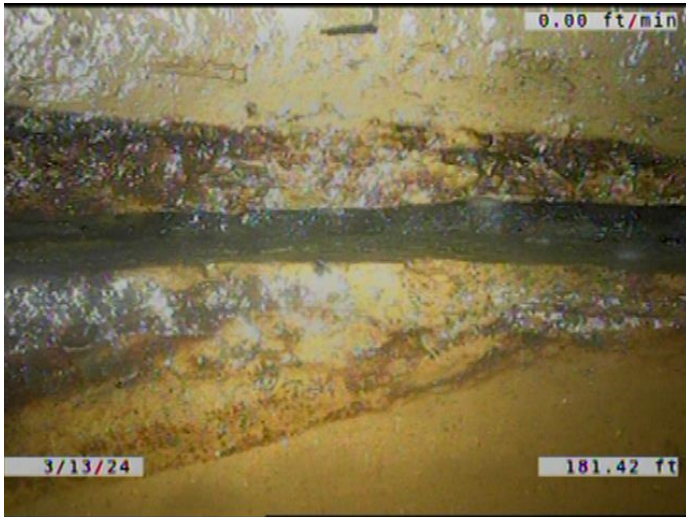
Code: **DAE**
Description: **Deposits Attached Encrustation**

Distance (ft): **181.4**
Structural Grade: **0**
O&M Grade: **2**
Clock Start/From: **8**
Clock To: **12**
1st Value:
2nd Value:
Value Percent: **5.000**
Continuous Index:
Within 8" of Joint: **YES**
Remarks:

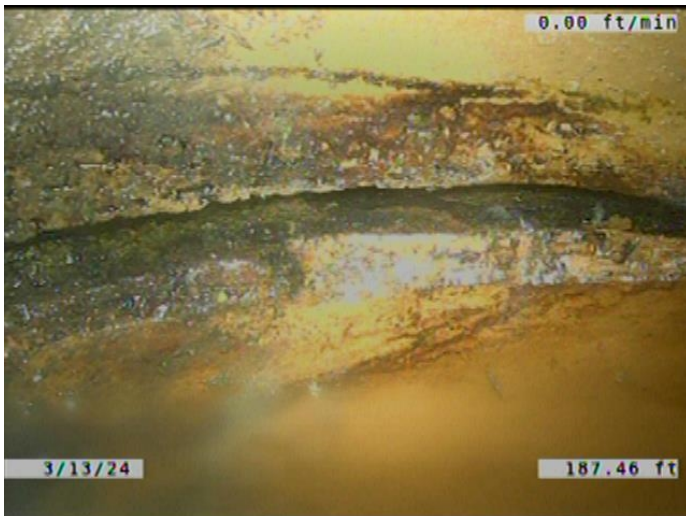
Code: **DAE**
Description: **Deposits Attached Encrustation**

Distance (ft): **187.5**
Structural Grade: **0**
O&M Grade: **2**
Clock Start/From: **8**
Clock To: **4**
1st Value:
2nd Value:
Value Percent: **5.000**
Continuous Index:
Within 8" of Joint: **YES**
Remarks:

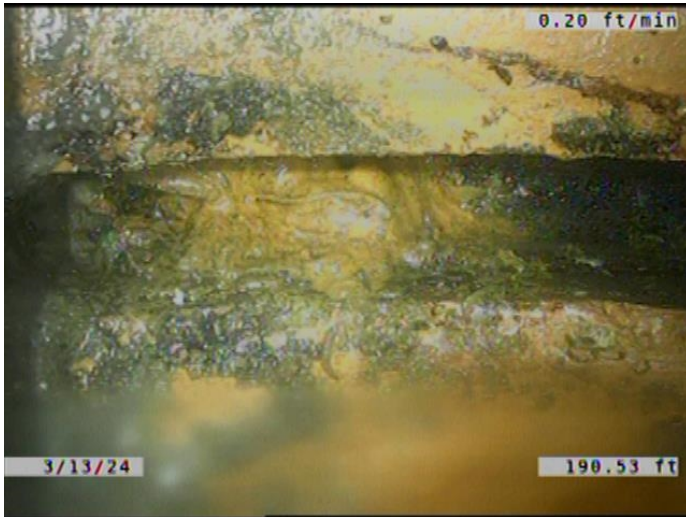
Code: **DAE**
Description: **Deposits Attached Encrustation**

Distance (ft): **190.5**
Structural Grade: **0**
O&M Grade: **2**
Clock Start/From: **8**
Clock To: **11**
1st Value:
2nd Value:
Value Percent: **5.000**
Continuous Index:
Within 8" of Joint: **YES**
Remarks:

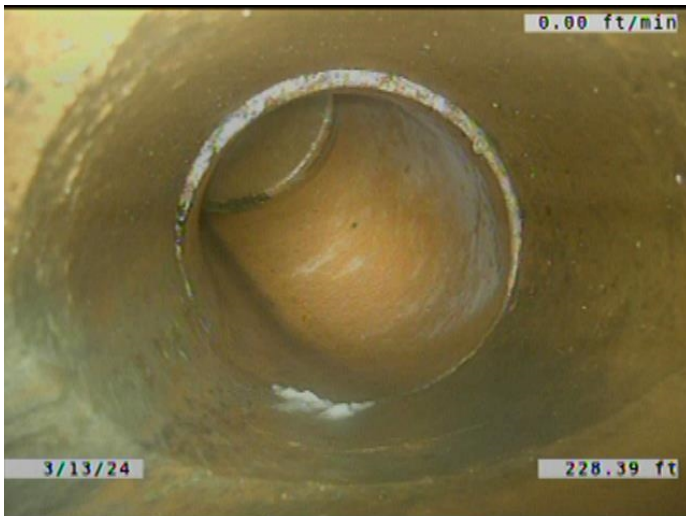
Code: **TF**
Description: **Tap Factory**

Distance (ft): **228.4**
Structural Grade: **0**
O&M Grade: **0**
Clock Start/From: **10**
Clock To:
1st Value: **6.000**
2nd Value:
Value Percent:
Continuous Index:
Within 8" of Joint: **YES**
Remarks:

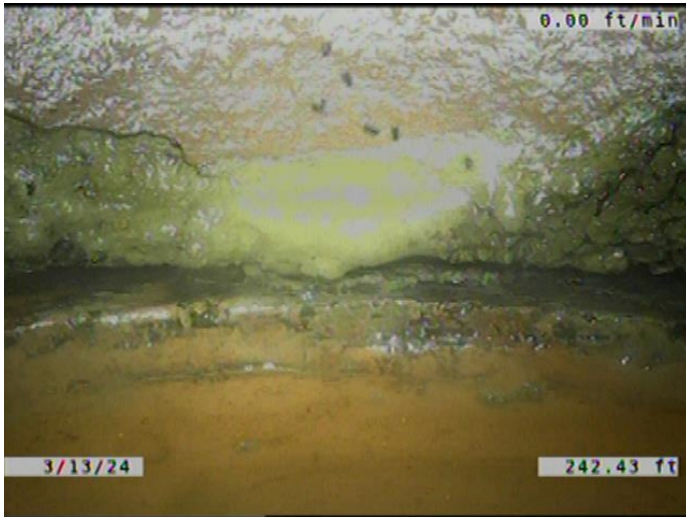
Code: **DAE**
Description: **Deposits Attached Encrustation**

Distance (ft): **242.4**
Structural Grade: **0**
O&M Grade: **2**
Clock Start/From: **7**
Clock To: **5**
1st Value:
2nd Value:
Value Percent: **5.000**
Continuous Index:
Within 8" of Joint: **YES**
Remarks:

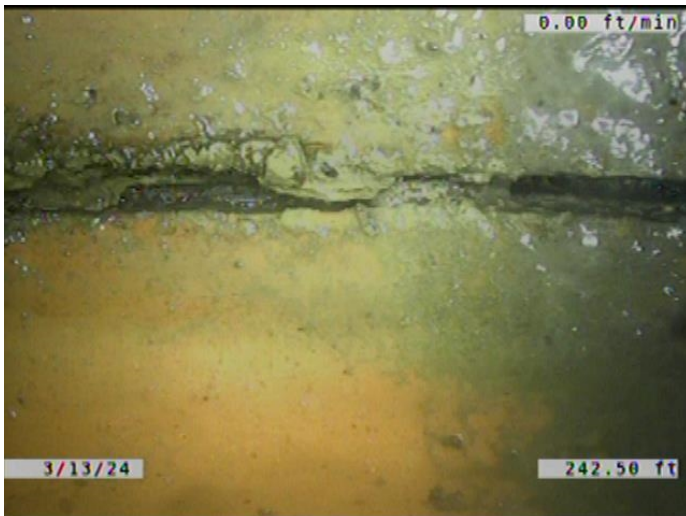
Code: **IDJ**
Description: **Infiltration Dripper Joint**

Distance (ft): **242.5**
Structural Grade: **0**
O&M Grade: **3**
Clock Start/From: **3**
Clock To:
1st Value:
2nd Value:
Value Percent:
Continuous Index:
Within 8" of Joint: **YES**
Remarks:

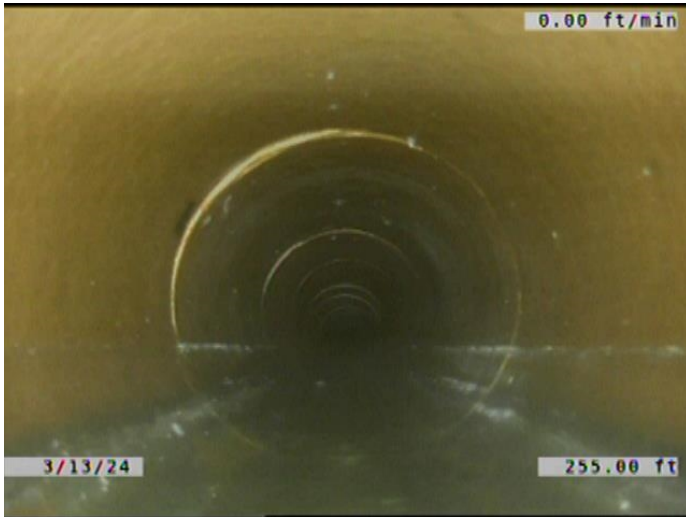
Code: **MWLS**
Description: **Miscellaneous Water Level Sag**

Distance (ft): **255.0**
Structural Grade: **2**
O&M Grade: **0**
Clock Start/From:
Clock To:
1st Value:
2nd Value:
Value Percent: **20.000**
Continuous Index: **F06**
Within 8" of Joint: **NO**
Remarks:

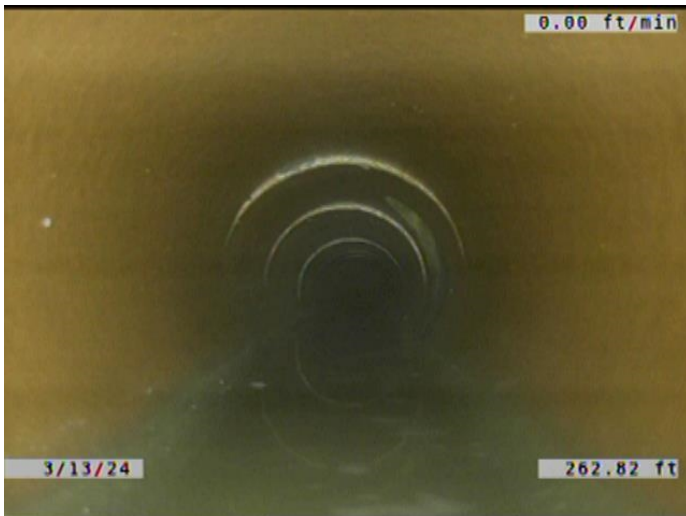
Code: **MWLS**
Description: **Miscellaneous Water Level Sag**

Distance (ft): **262.8**
Structural Grade: **2**
O&M Grade: **0**
Clock Start/From:
Clock To:
1st Value:
2nd Value:
Value Percent: **10.000**
Continuous Index: **S07**
Within 8" of Joint: **NO**
Remarks:

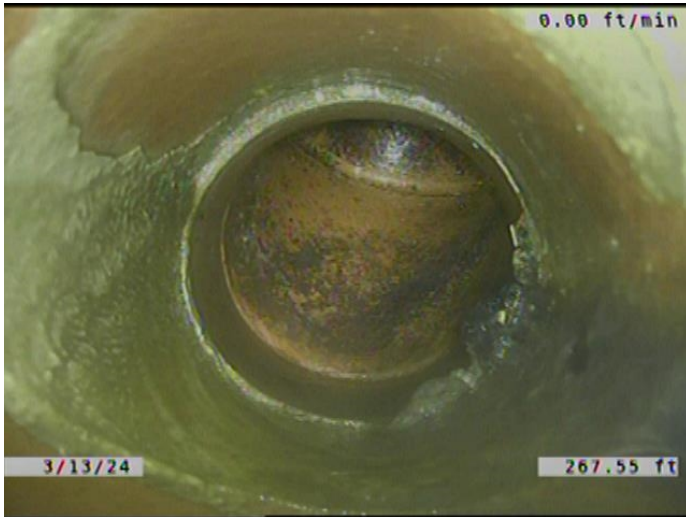
Code: **TFA**
Description: **Tap Factory Activity**

Distance (ft): **267.5**
Structural Grade: **0**
O&M Grade: **0**
Clock Start/From: **2**
Clock To:
1st Value: **6.000**
2nd Value:
Value Percent:
Continuous Index:
Within 8" of Joint: **YES**
Remarks: **CONSTANTLY RUNNING WATER.
ENCrustATION COMING FROM THE**

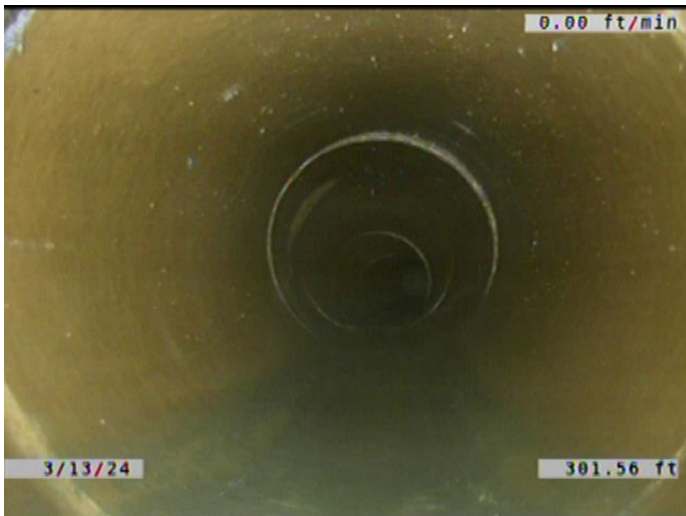
Code: **MWLS**
Description: **Miscellaneous Water Level Sag**

Distance (ft): **301.6**
Structural Grade: **2**
O&M Grade: **0**
Clock Start/From:
Clock To:
1st Value:
2nd Value:
Value Percent: **10.000**
Continuous Index: **F07**
Within 8" of Joint: **NO**
Remarks:

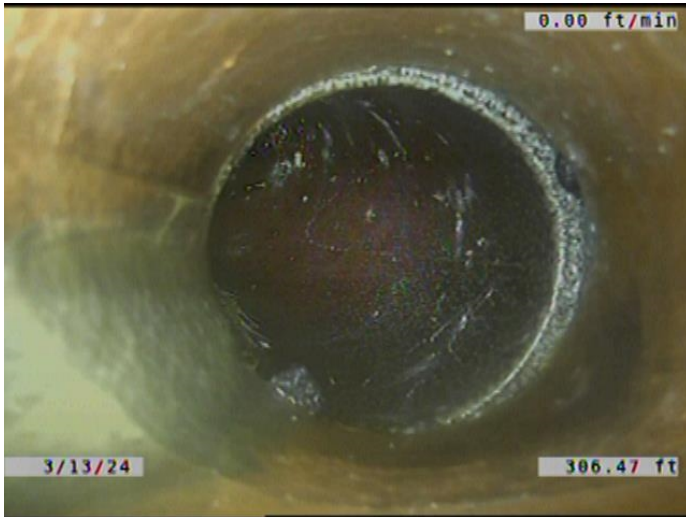
Code: **TF**
 Description: **Tap Factory**

Distance (ft): **306.5**
 Structural Grade: **0**
 O&M Grade: **0**
 Clock Start/From: **10**
 Clock To:
 1st Value: **6.000**
 2nd Value:
 Value Percent:
 Continuous Index:
 Within 8" of Joint: **YES**
 Remarks: **CONSTANTLY RUNNING WATER. ROOTS GROWING IN THE JOINTS.**

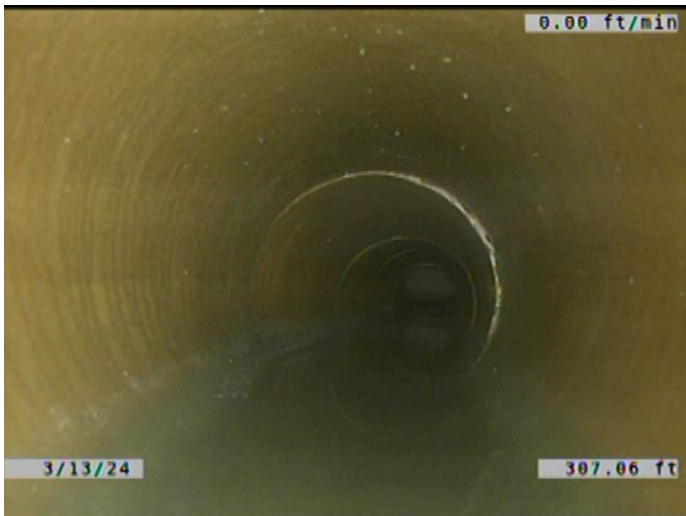
Code: **MWLS**
 Description: **Miscellaneous Water Level Sag**

Distance (ft): **307.1**
 Structural Grade: **2**
 O&M Grade: **0**
 Clock Start/From:
 Clock To:
 1st Value:
 2nd Value:
 Value Percent: **10.000**
 Continuous Index: **S08**
 Within 8" of Joint: **NO**
 Remarks:

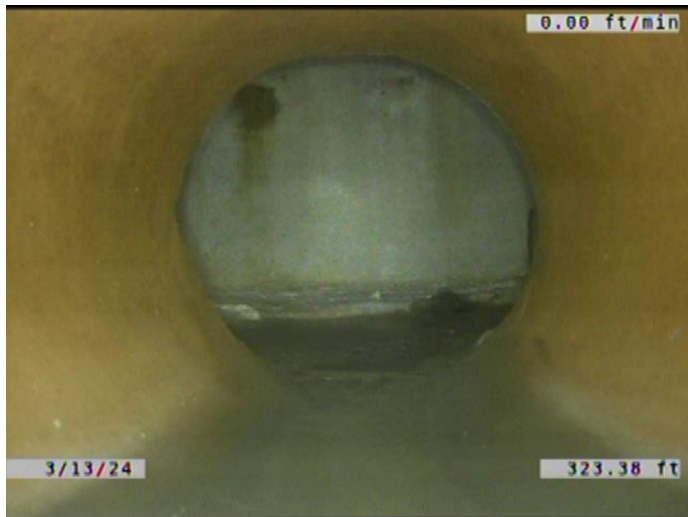
Code: **MWLS**
Description: **Miscellaneous Water Level Sag**

Distance (ft): **323.4**
Structural Grade: **2**
O&M Grade: **0**
Clock Start/From:
Clock To:
1st Value:
2nd Value:
Value Percent: **10.000**
Continuous Index: **F08**
Within 8" of Joint: **NO**
Remarks:

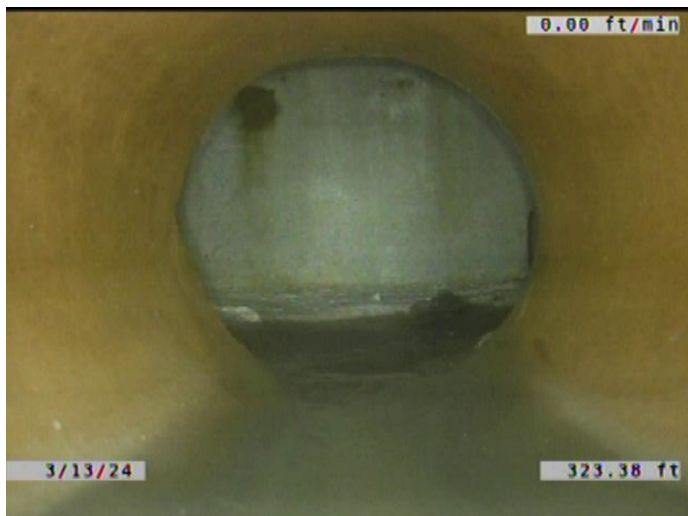
Code: **DSF**
Description: **Deposits Settled Fine**

Distance (ft): **323.4**
Structural Grade: **0**
O&M Grade: **2**
Clock Start/From: **5**
Clock To: **7**
1st Value:
2nd Value:
Value Percent: **5.000**
Continuous Index: **F01**
Within 8" of Joint: **YES**
Remarks:

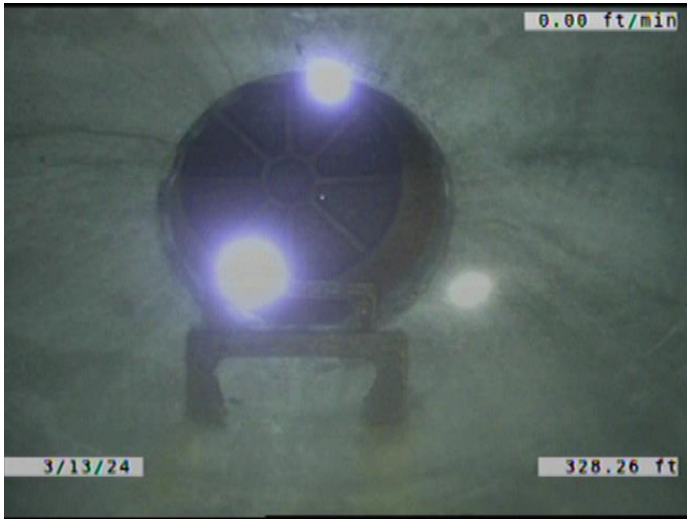
Code:	AMH
Description:	Manhole
Distance (ft):	328.3
Structural Grade:	0
O&M Grade:	0
Clock Start/From:	
Clock To:	
1st Value:	
2nd Value:	
Value Percent:	
Continuous Index:	
Within 8" of Joint:	NO
Remarks:	M-405-051
