Profile/Photo Observation Report

Street:	FOXCROFT STREET	Flow Control:	Not Controlled
City:	Hobart, IN	Year Renewed:	
Location:	Yard	Tape/Media #:	
Purpose:	Routine Assessment	Dia/Height:	10"
Use:	Sanitary	Material:	VCP
Drain Area:	NA	Lining:	
Category:	NA		
Comment:	R_M at 7 ft debris .Flow direction wrong		
Location Details:		Direction of Survey:	Upstream
US MH:	M-405-052	DS MH:	M-405-054
		Total Length Surveyed (ft):	7.5

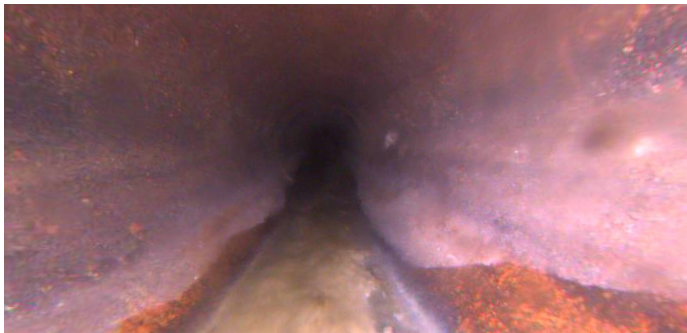
Code: **AMH**
 Description: **Manhole**

Distance (ft): **.0**
 Structural Grade: **0**
 O&M Grade: **0**
 Clock Start/From:
 Clock To:
 1st Value:
 2nd Value:
 Value Percent:
 Continuous Index:
 Within 8" of Joint: **NO**
 Remarks: **M-405-054**

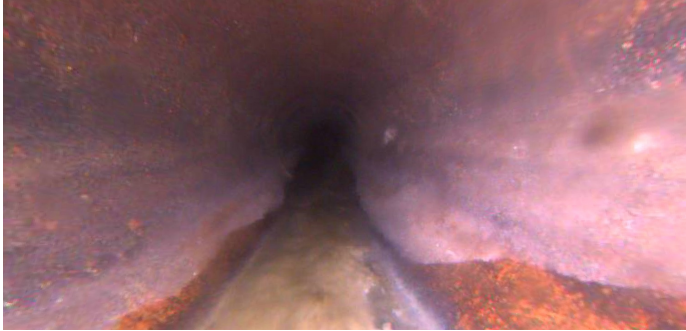
Code: **MWL**
Description: **Water Level**

Distance (ft): **.0**
Structural Grade: **0**
O&M Grade: **0**
Clock Start/From:
Clock To:
1st Value:
2nd Value:
Value Percent: **5.000**
Continuous Index:
Within 8" of Joint: **NO**
Remarks:

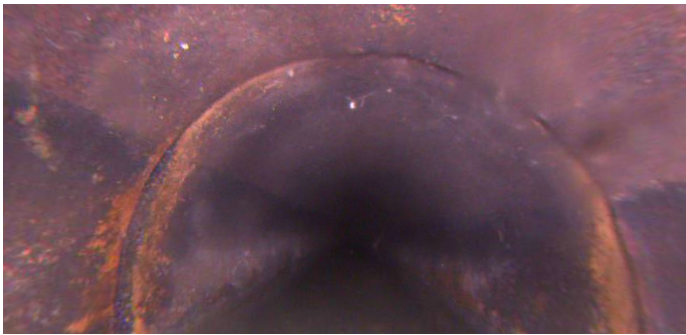
Code: **MSA**
Description: **Abandoned Survey**

Distance (ft): **7.5**
Structural Grade: **0**
O&M Grade: **0**
Clock Start/From:
Clock To:
1st Value:
2nd Value:
Value Percent:
Continuous Index:
Within 8" of Joint: **NO**
Remarks: **UNKNOWN**
