Profile/Photo Observation Report

Date:	04/23/2018	Weather:		Coding:	PACP 6.0
Pipe Length (ft):	191.7	Owner:	NA	Pre Clean:	No Pre-Cleaning
P.O.#:		Surveyor:	Jen Costello	PSR:	P-405-054-052
Customer:		Clean Date:	01/01/1900	Shape:	C

Street:	ALLEY BETWEEN OAKWOOD DR & S	Flow Control:	Not Controlled
City:	Hobart, IN	Year Renewed:	
Location:	Yard	Tape/Media #:	
Purpose:	Routine Assessment	Dia/Height:	10"
Use:	Sanitary	Material:	VCP
Drain Area:	NA	Lining:	
Category:	NA		
Comment:	P_C at 6 ft roots. Flow direction wrong		
Location Details:		Direction of Survey:	Downstream
US MH:	M-405-052	DS MH:	M-405-054
		Total Length Surveyed (ft):	8.0

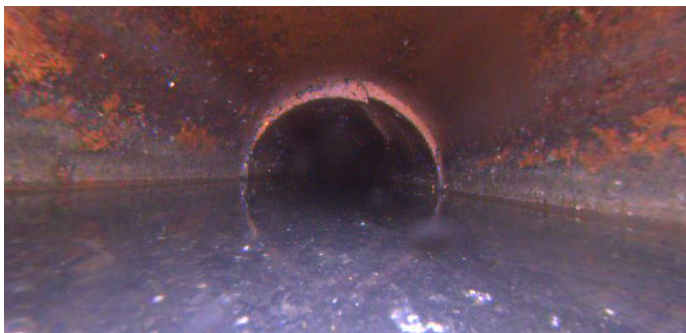
Code: **AMH**
Description: **Manhole**

Distance (ft): **.0**
Structural Grade: **0**
O&M Grade: **0**
Clock Start/From:
Clock To:
1st Value:
2nd Value:
Value Percent:
Continuous Index:
Within 8" of Joint: **NO**
Remarks: **M-405-052**

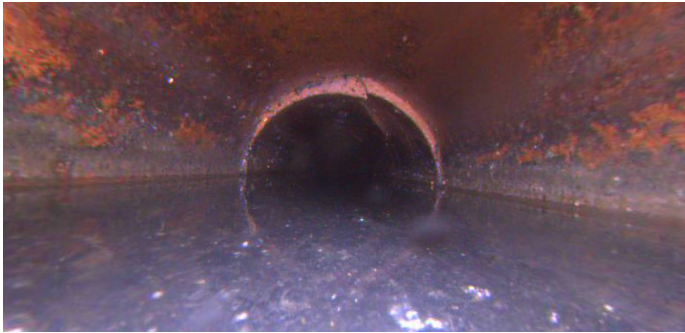
Code:	MWL
Description:	Water Level

Distance (ft):	.0
Structural Grade:	0
O&M Grade:	0
Clock Start/From:	
Clock To:	
1st Value:	
2nd Value:	
Value Percent:	40.000
Continuous Index:	
Within 8" of Joint:	NO
Remarks:

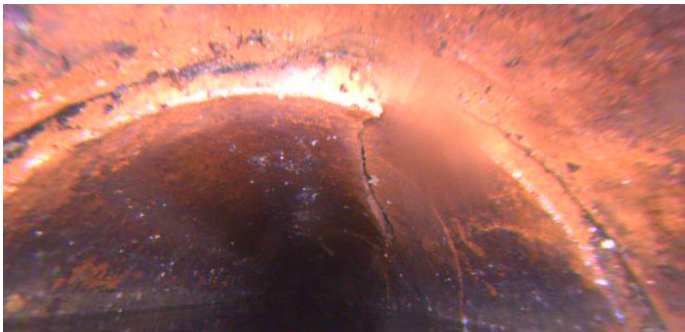
Code:	FM
Description:	Fracture Multiple

Distance (ft):	2.0
Structural Grade:	4
O&M Grade:	0
Clock Start/From:	12
Clock To:	3
1st Value:	
2nd Value:	
Value Percent:	
Continuous Index:	
Within 8" of Joint:	YES
Remarks:

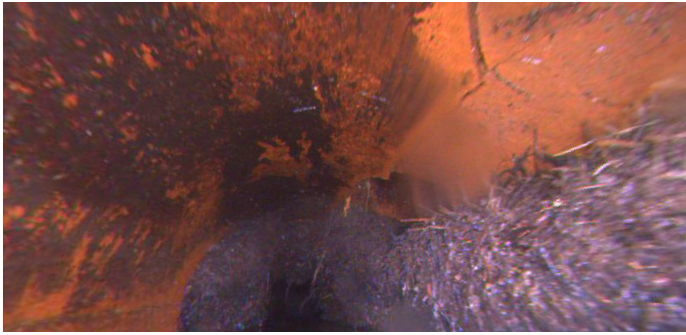
Code: **RMB**
Description: **Roots Medium Barrel**

Distance (ft): **6.2**
Structural Grade: **0**
O&M Grade: **4**
Clock Start/From: **1**
Clock To: **4**
1st Value:
2nd Value:
Value Percent: **10.000**
Continuous Index:
Within 8" of Joint: **NO**
Remarks:

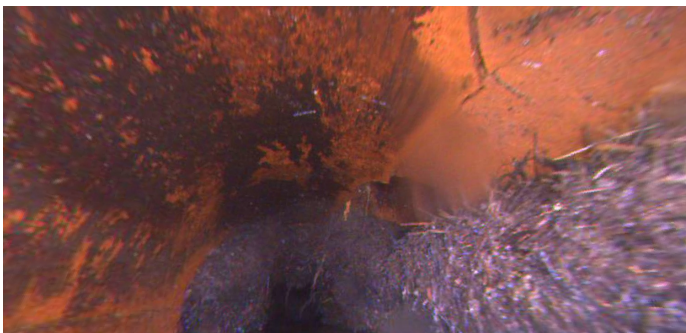
Code: **FM**
Description: **Fracture Multiple**

Distance (ft): **6.2**
Structural Grade: **4**
O&M Grade: **0**
Clock Start/From: **8**
Clock To: **4**
1st Value:
2nd Value:
Value Percent:
Continuous Index:
Within 8" of Joint:
Remarks:

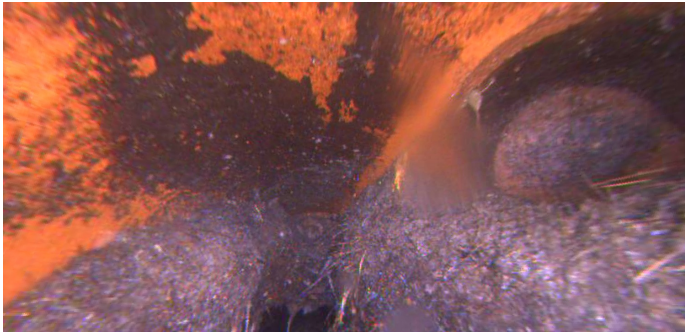
Code: **TFC**
Description: **Tap Factory Capped**

Distance (ft): **6.9**
Structural Grade: **0**
O&M Grade: **0**
Clock Start/From: **2**
Clock To:
1st Value: **4.000**
2nd Value:
Value Percent:
Continuous Index:
Within 8" of Joint:
Remarks:

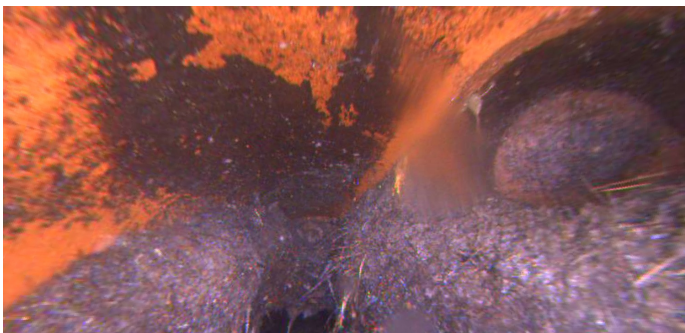
Code: **RBJ**
Description: **Roots Ball Joint**

Distance (ft): **6.9**
Structural Grade: **0**
O&M Grade: **4**
Clock Start/From: **7**
Clock To: **5**
1st Value:
2nd Value:
Value Percent: **80.000**
Continuous Index:
Within 8" of Joint: **YES**
Remarks:

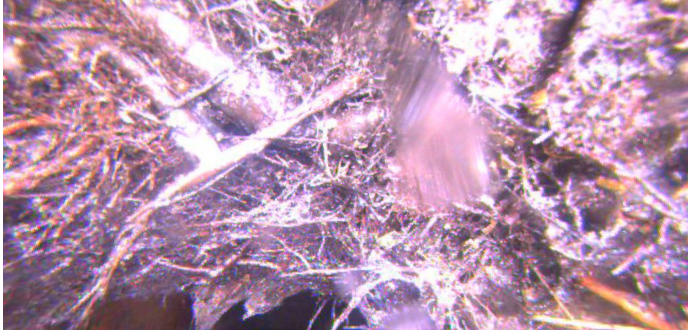
Code:	MSA
Description:	Abandoned Survey
Distance (ft):	8.0
Structural Grade:	0
O&M Grade:	0
Clock Start/From:	
Clock To:	
1st Value:	
2nd Value:	
Value Percent:	
Continuous Index:	
Within 8" of Joint:	NO
Remarks:	roots
