Profile/Photo Observation Report

Street:	FOXCROFT STREET	Flow Control:	Not Controlled
City:	Hobart, IN	Year Renewed:	
Location:	Yard	Tape/Media #:	
Purpose:	Routine Assessment	Dia/Height:	10"
Use:	Sanitary	Material:	VCP
Drain Area:	NA	Lining:	
Category:	NA		
Comment:	P_C at 6 ft roots. Flow direction wrong		
Location Details:		Direction of Survey:	Downstream
US MH:	M-405-052	DS MH:	M-405-054
		Total Length Surveyed (ft):	8.0

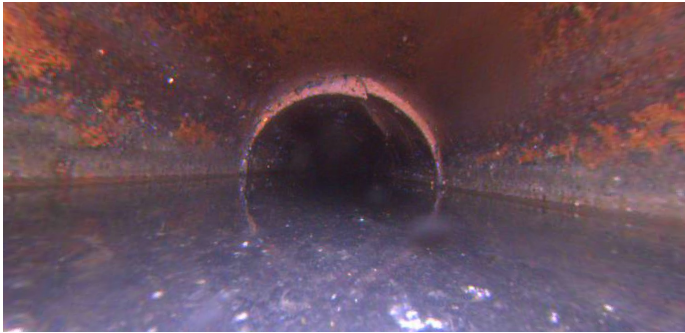
Code:	MWL
Description:	Water Level

Distance (ft):	.0
Structural Grade:	0
O&M Grade:	0
Clock Start/From:	
Clock To:	
1st Value:	
2nd Value:	
Value Percent:	40.000
Continuous Index:	
Within 8" of Joint:	NO
Remarks:

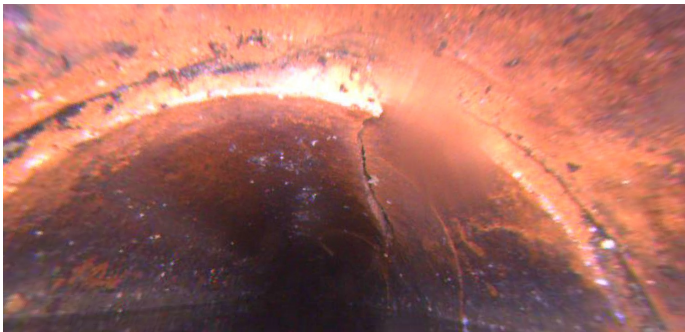
Code:	FM
Description:	Fracture Multiple

Distance (ft):	2.0
Structural Grade:	4
O&M Grade:	0
Clock Start/From:	12
Clock To:	3
1st Value:	
2nd Value:	
Value Percent:	
Continuous Index:	
Within 8" of Joint:	YES
Remarks:

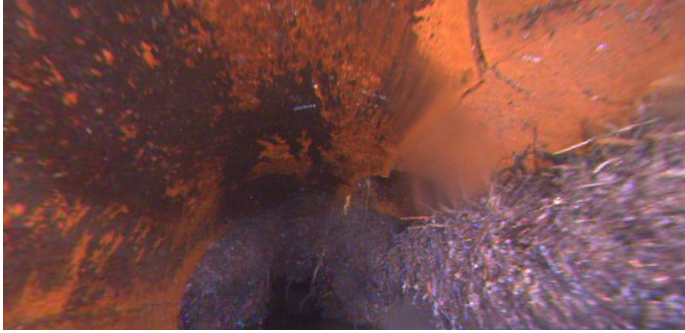
Code: **RMB**
Description: **Roots Medium Barrel**

Distance (ft): **6.2**
Structural Grade: **0**
O&M Grade: **4**
Clock Start/From: **1**
Clock To: **4**
1st Value:
2nd Value:
Value Percent: **10.000**
Continuous Index:
Within 8" of Joint: **NO**
Remarks:

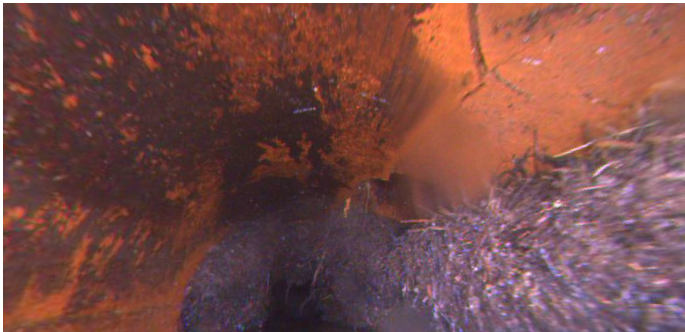
Code: **FM**
Description: **Fracture Multiple**

Distance (ft): **6.2**
Structural Grade: **4**
O&M Grade: **0**
Clock Start/From: **8**
Clock To: **4**
1st Value:
2nd Value:
Value Percent:
Continuous Index:
Within 8" of Joint:
Remarks:

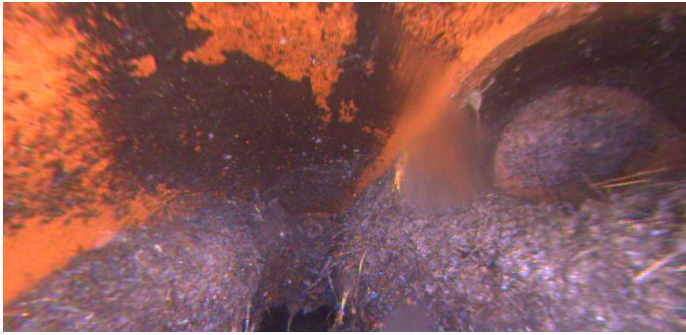
Code: **TFC**
Description: **Tap Factory Capped**

Distance (ft): **6.9**
Structural Grade: **0**
O&M Grade: **0**
Clock Start/From: **2**
Clock To:
1st Value: **4.000**
2nd Value:
Value Percent:
Continuous Index:
Within 8" of Joint:
Remarks:

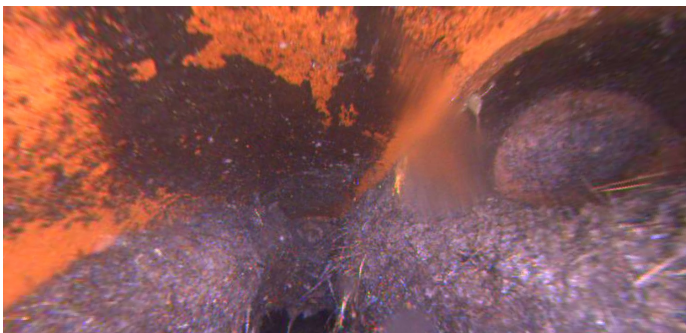
Code: **RBJ**
Description: **Roots Ball Joint**

Distance (ft): **6.9**
Structural Grade: **0**
O&M Grade: **4**
Clock Start/From: **7**
Clock To: **5**
1st Value:
2nd Value:
Value Percent: **80.000**
Continuous Index:
Within 8" of Joint: **YES**
Remarks:

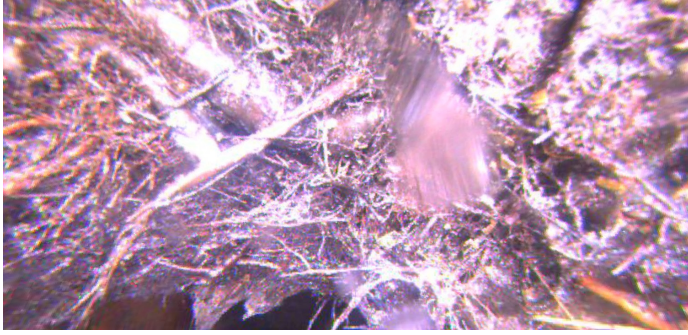
Code:	MSA
Description:	Abandoned Survey
Distance (ft):	8.0
Structural Grade:	0
O&M Grade:	0
Clock Start/From:	
Clock To:	
1st Value:	
2nd Value:	
Value Percent:	
Continuous Index:	
Within 8" of Joint:	NO
Remarks:	roots
