## Profile/Photo Observation Report

Date:	<b>04/23/2018</b>	Weather:		Coding:	<b>PACP 6.0</b>
Pipe Length (ft):	<b>115.4</b>	Owner:	<b>NA</b>	Pre Clean:	<b>No Pre-Cleaning</b>
P.O.#:		Surveyor:	<b>Jen Costello</b>	PSR:	<b>P-405-055-054</b>
Customer:		Clean Date:	<b>01/01/1900</b>	Shape:	<b>C</b>

Street:	<b>ALLEY BETWEEN OAKWOOD DR &amp; S</b>	Flow Control:	<b>Not Controlled</b>
City:	<b>Hobart, IN</b>	Year Renewed:	
Location:	<b>Yard</b>	Tape/Media #:	
Purpose:	<b>Routine Assessment</b>	Dia/Height:	<b>8"</b>
Use:	<b>Sanitary</b>	Material:	<b>VCP</b>
Drain Area:	<b>NA</b>	Lining:	
Category:	<b>NA</b>		
Comment:	<b>False O_C at 1 ft .Flow direction wrong</b>		
Location Details:		Direction of Survey:	<b>Downstream</b>
US MH:	<b>M-405-054</b>	DS MH:	<b>M-405-055</b>
		Total Length Surveyed (ft):	<b>2.4</b>

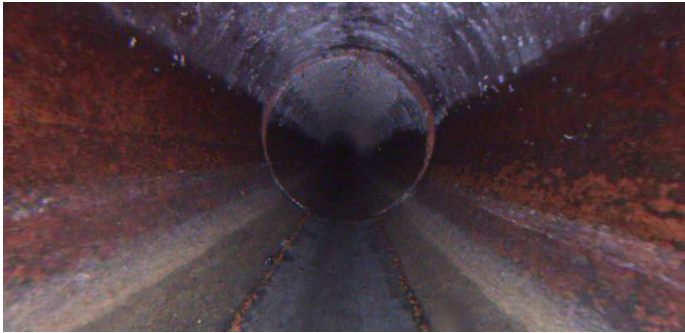
Code:	<b>MWL</b>
Description:	<b>Water Level</b>

Distance (ft):	<b>.0</b>
Structural Grade:	<b>0</b>
O&M Grade:	<b>0</b>
Clock Start/From:	
Clock To:	
1st Value:	
2nd Value:	
Value Percent:	<b>5.000</b>
Continuous Index:	
Within 8" of Joint:	<b>NO</b>
Remarks:

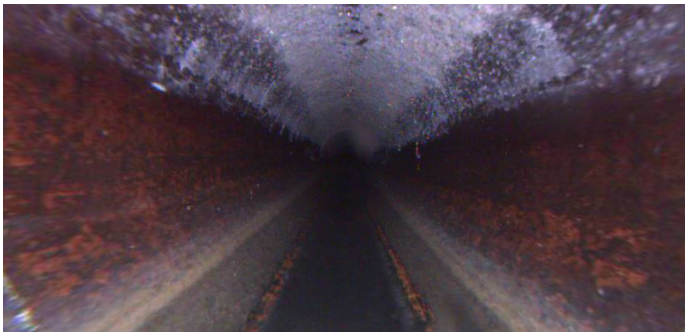
Code:	<b>MSA</b>
Description:	<b>Abandoned Survey</b>

Distance (ft):	<b>2.4</b>
Structural Grade:	<b>0</b>
O&M Grade:	<b>0</b>
Clock Start/From:	
Clock To:	
1st Value:	
2nd Value:	
Value Percent:	
Continuous Index:	
Within 8" of Joint:	<b>NO</b>
Remarks:	<b>UNKNOWN</b>
