## Profile/Photo Observation Report

Street:	<b>FOXCROFT STREET</b>	Flow Control:	<b>Not Controlled</b>
City:	<b>Hobart, IN</b>	Year Renewed:	
Location:	<b>Yard</b>	Tape/Media #:	
Purpose:	<b>Routine Assessment</b>	Dia/Height:	<b>8"</b>
Use:	<b>Sanitary</b>	Material:	<b>VCP</b>
Drain Area:	<b>NA</b>	Lining:	
Category:	<b>NA</b>		
Comment:	<b>False O_C at 1 ft .Flow direction wrong</b>		
Location Details:		Direction of Survey:	<b>Downstream</b>
US MH:	<b>M-405-054</b>	DS MH:	<b>M-405-055</b>
		Total Length Surveyed (ft):	<b>2.4</b>

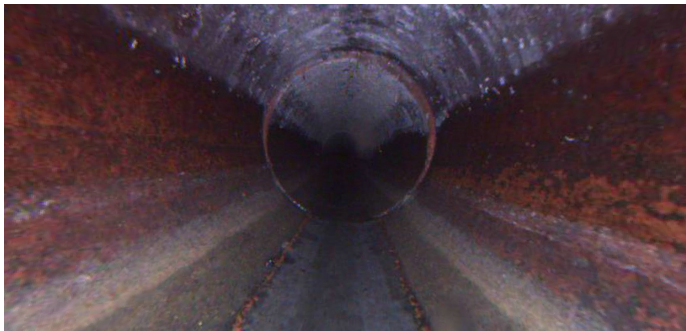
Code: **AMH**  
Description: **Manhole**

Distance (ft): **.0**  
Structural Grade: **0**  
O&M Grade: **0**  
Clock Start/From:  
Clock To:  
1st Value:  
2nd Value:  
Value Percent:  
Continuous Index:  
Within 8" of Joint: **NO**  
Remarks: **M-405-054**

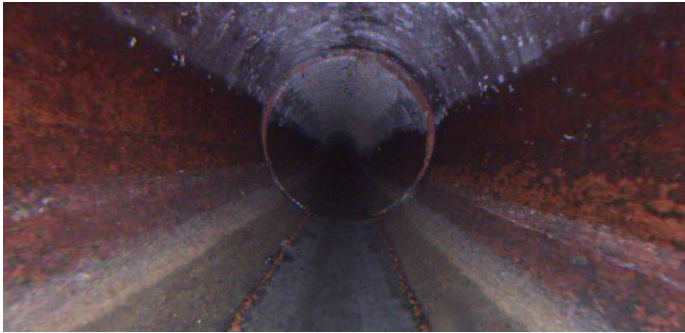
Code:	<b>MWL</b>
Description:	<b>Water Level</b>

Distance (ft):	<b>.0</b>
Structural Grade:	<b>0</b>
O&M Grade:	<b>0</b>
Clock Start/From:	
Clock To:	
1st Value:	
2nd Value:	
Value Percent:	<b>5.000</b>
Continuous Index:	
Within 8" of Joint:	<b>NO</b>
Remarks:

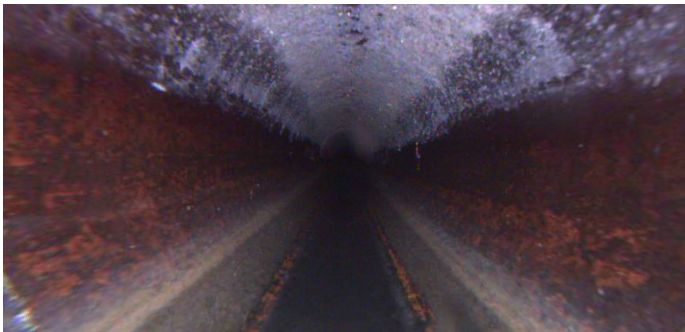
Code:	<b>MSA</b>
Description:	<b>Abandoned Survey</b>

Distance (ft):	<b>2.4</b>
Structural Grade:	<b>0</b>
O&M Grade:	<b>0</b>
Clock Start/From:	
Clock To:	
1st Value:	
2nd Value:	
Value Percent:	
Continuous Index:	
Within 8" of Joint:	<b>NO</b>
Remarks:	<b>UNKNOWN</b>
