## Profile/Photo Observation Report

Date:	<b>03/02/2024</b>	Weather:		Coding:	<b>PACP 7.0</b>
Pipe Length (ft):	<b>115.0</b>	Owner:	<b>City of Hobart</b>	Pre Clean:	<b>Heavy Cleaning</b>
P.O.#:		Surveyor:	<b>S. Bucklin</b>	PSR:	<b>P-405-055-054</b>
Customer:	<b>City of Hobart</b>	Clean Date:	<b>09/22/2023</b>	Shape:	<b>C</b>

Street:	<b>SOFTWOOD DR</b>	Flow Control:	<b>Not Controlled</b>
City:	<b>Hobart, IN</b>	Year Renewed:	
Location:	<b>Easement/Right of Way</b>	Tape/Media #:	
Purpose:	<b>Sewer System Evaluation Survey (SS</b>	Dia/Height:	<b>10"</b>
Use:	<b>Sanitary Sewage Pipe</b>	Material:	<b>VCP</b>
Drain Area:		Lining:	<b>None</b>
Category:	<b>NA</b>		
Comment:			
Location Details:		Direction of Survey:	<b>Downstream</b>
US MH:	<b>M-405-054</b>	DS MH:	<b>M-405-055</b>
		Total Length Surveyed (ft):	<b>85.6</b>

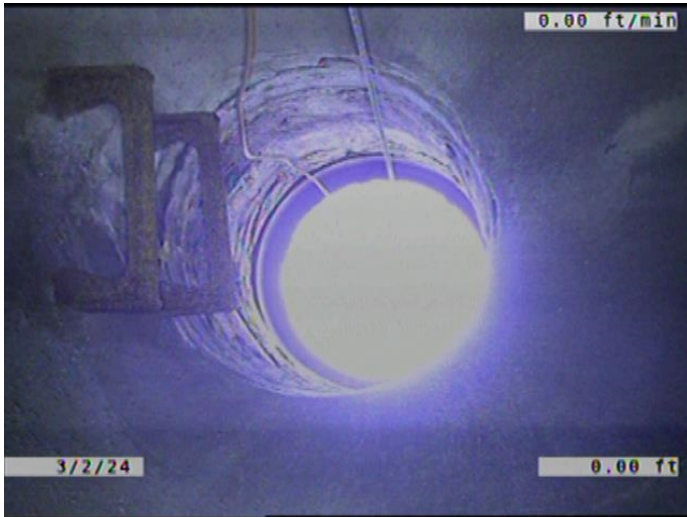
Code: **AMH**  
Description: **Manhole**

Distance (ft): **.0**  
Structural Grade: **0**  
O&M Grade: **0**  
Clock Start/From:  
Clock To:  
1st Value:  
2nd Value:  
Value Percent:  
Continuous Index:  
Within 8" of Joint: **NO**  
Remarks: **M-405-054**

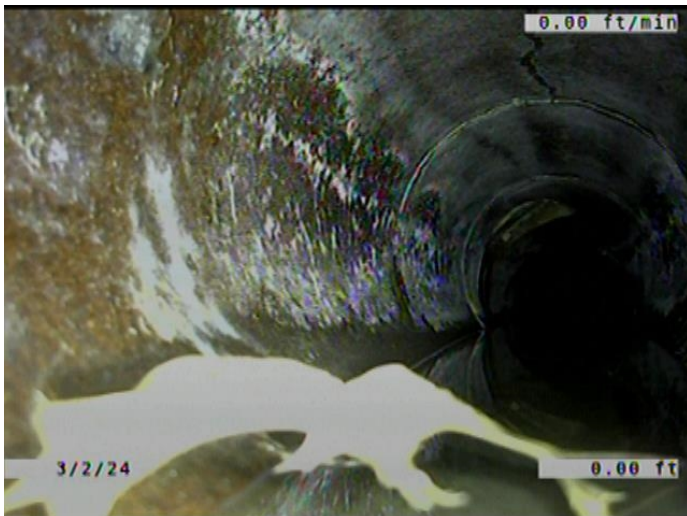
Code: **MWL**  
Description: **Miscellaneous Water Level**

Distance (ft): **.0**  
Structural Grade: **0**  
O&M Grade: **0**  
Clock Start/From:  
Clock To:  
1st Value:  
2nd Value:  
Value Percent: **10.000**  
Continuous Index:  
Within 8" of Joint: **NO**  
Remarks:

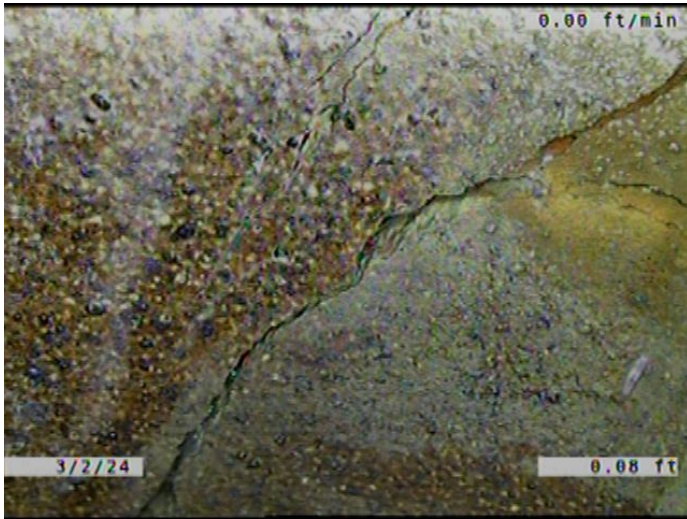
Code: **DSF**  
Description: **Deposits Settled Fine**

Distance (ft): **.0**  
Structural Grade: **0**  
O&M Grade: **2**  
Clock Start/From: **5**  
Clock To: **7**  
1st Value:  
2nd Value:  
Value Percent: **5.000**  
Continuous Index: **S01**  
Within 8" of Joint: **YES**  
Remarks:

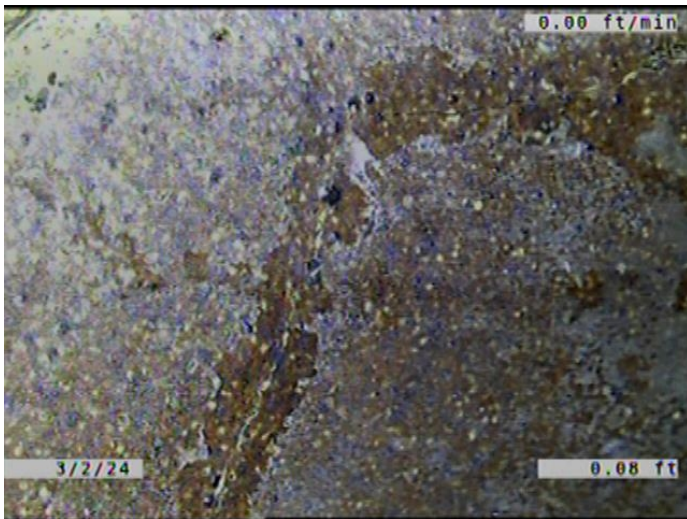
Code: **BSV**  
Description: **Broken Soil Visible**

Distance (ft): **.1**  
Structural Grade: **5**  
O&M Grade: **0**  
Clock Start/From: **12**  
Clock To: **12**  
1st Value:  
2nd Value:  
Value Percent:  
Continuous Index:  
Within 8" of Joint: **YES**  
Remarks:

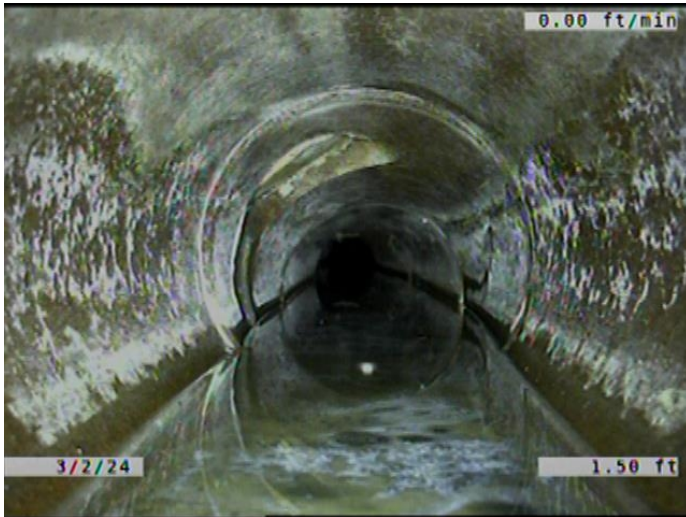
Code: **MWLS**  
Description: **Miscellaneous Water Level Sag**

Distance (ft): **1.5**  
Structural Grade: **3**  
O&M Grade: **0**  
Clock Start/From:  
Clock To:  
1st Value:  
2nd Value:  
Value Percent: **50.000**  
Continuous Index: **S02**  
Within 8" of Joint: **NO**  
Remarks:

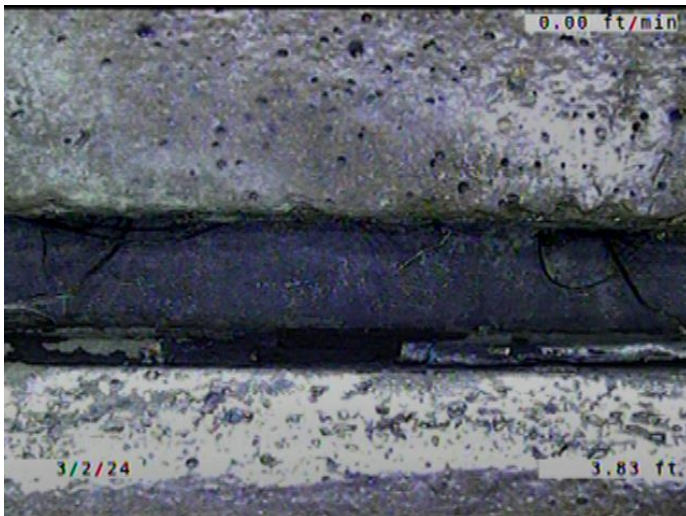
Code: **JAM**  
Description: **Joint Angular Medium**

Distance (ft): **3.8**  
Structural Grade: **3**  
O&M Grade: **0**  
Clock Start/From:  
Clock To:  
1st Value:  
2nd Value:  
Value Percent:  
Continuous Index:  
Within 8" of Joint: **NO**  
Remarks:

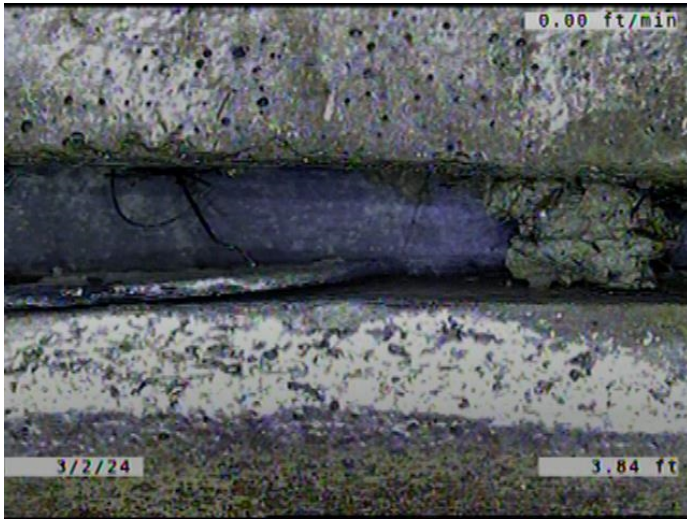
Code: **RFJ**  
Description: **Roots Fine Joint**

Distance (ft): **3.8**  
Structural Grade: **0**  
O&M Grade: **1**  
Clock Start/From: **8**  
Clock To: **4**  
1st Value:  
2nd Value:  
Value Percent:  
Continuous Index: **S03**  
Within 8" of Joint: **YES**  
Remarks:

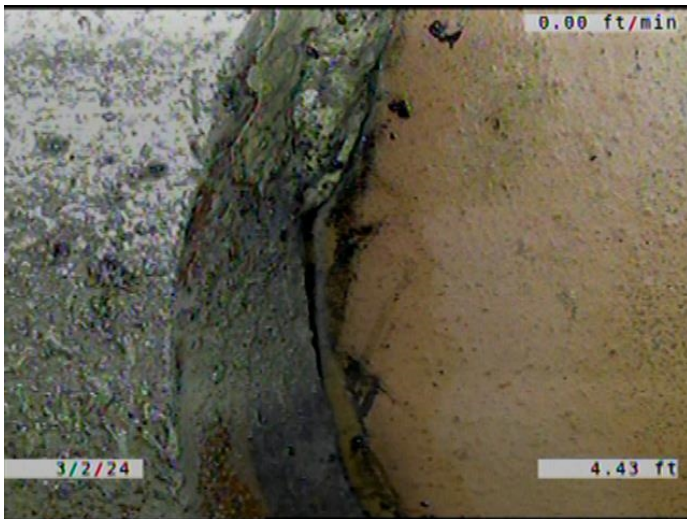
Code: **TFD**  
Description: **Tap Factory Defective**

Distance (ft): **4.4**  
Structural Grade: **0**  
O&M Grade: **3**  
Clock Start/From: **11**  
Clock To:  
1st Value: **6.000**  
2nd Value:  
Value Percent:  
Continuous Index:  
Within 8" of Joint: **YES**  
Remarks: **CAPPED. ENCRUSTATION COMING AROUND THE CAP INTO THE MAIN.**

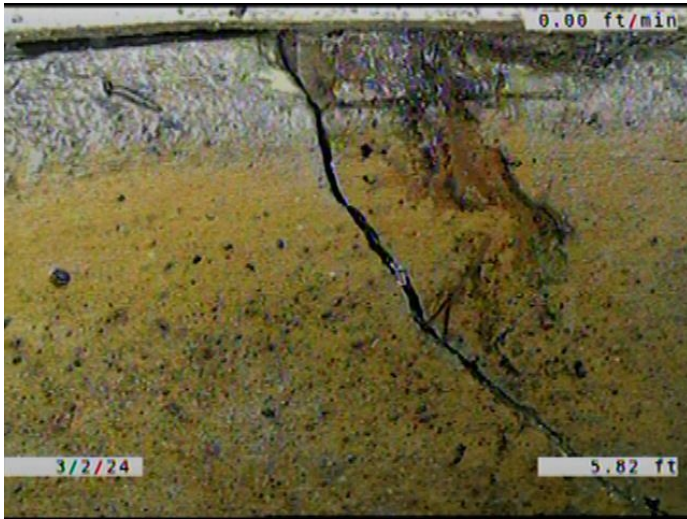
Code: **B**  
Description: **Broken**

Distance (ft): **5.8**  
Structural Grade: **4**  
O&M Grade: **0**  
Clock Start/From: **10**  
Clock To: **2**  
1st Value:  
2nd Value:  
Value Percent:  
Continuous Index:  
Within 8" of Joint: **YES**  
Remarks:

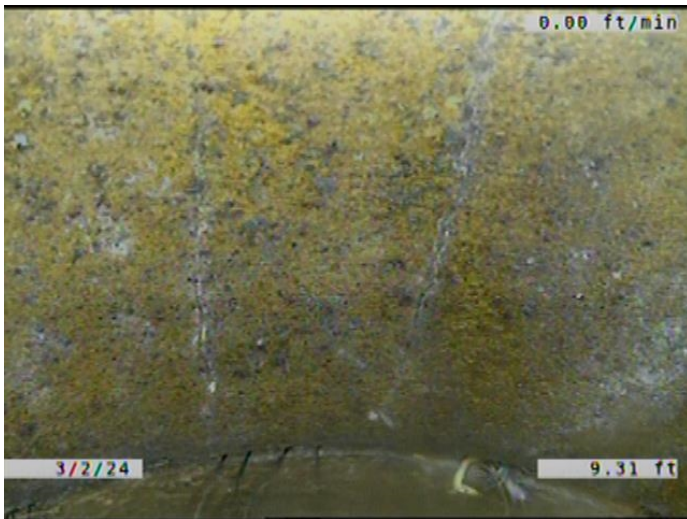
Code: **CM**  
Description: **Crack Multiple**

Distance (ft): **9.3**  
Structural Grade: **3**  
O&M Grade: **0**  
Clock Start/From: **11**  
Clock To: **1**  
1st Value:  
2nd Value:  
Value Percent:  
Continuous Index:  
Within 8" of Joint: **YES**  
Remarks:

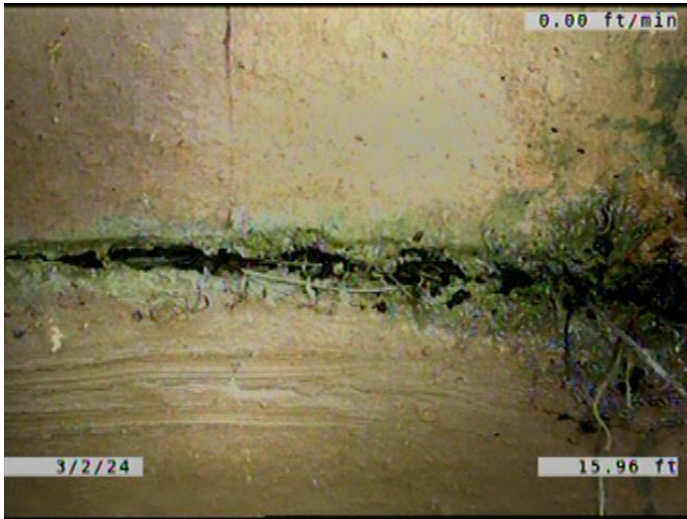
Code: **DAE**  
Description: **Deposits Attached Encrustation**

Distance (ft): **16.0**  
Structural Grade: **0**  
O&M Grade: **2**  
Clock Start/From: **10**  
Clock To: **2**  
1st Value:  
2nd Value:  
Value Percent: **5.000**  
Continuous Index:  
Within 8" of Joint: **YES**  
Remarks:

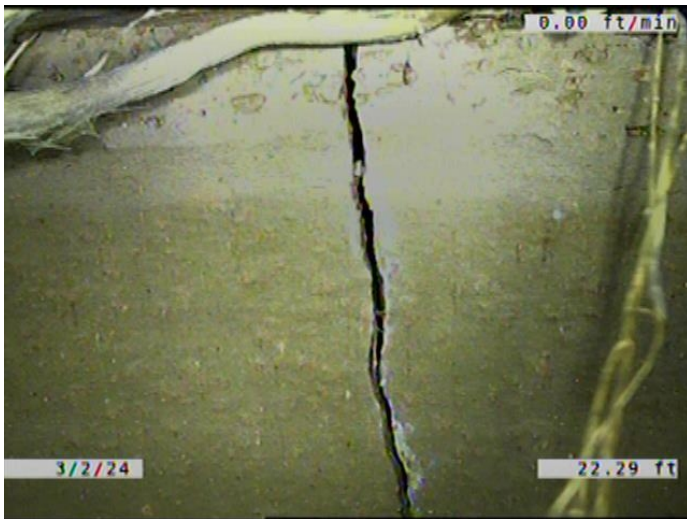
Code: **FM**  
Description: **Fracture Multiple**

Distance (ft): **22.3**  
Structural Grade: **4**  
O&M Grade: **0**  
Clock Start/From: **8**  
Clock To: **4**  
1st Value:  
2nd Value:  
Value Percent:  
Continuous Index: **S04**  
Within 8" of Joint: **YES**  
Remarks:

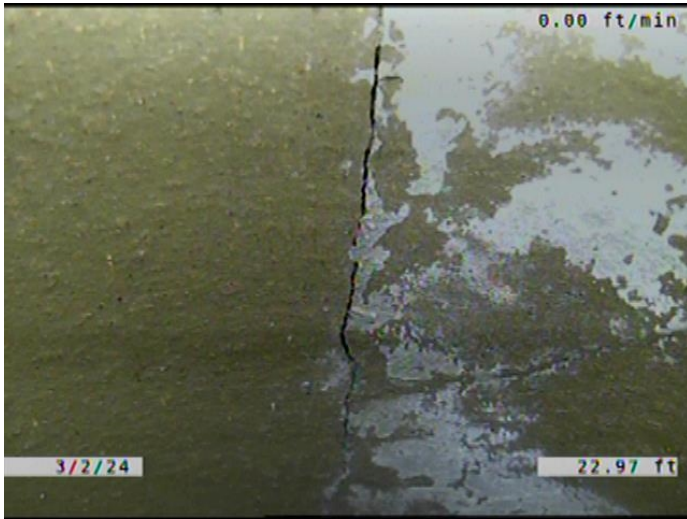
Code: **DAE**  
Description: **Deposits Attached Encrustation**

Distance (ft): **23.0**  
Structural Grade: **0**  
O&M Grade: **2**  
Clock Start/From: **8**  
Clock To: **4**  
1st Value:  
2nd Value:  
Value Percent: **5.000**  
Continuous Index: **S05**  
Within 8" of Joint: **YES**  
Remarks:

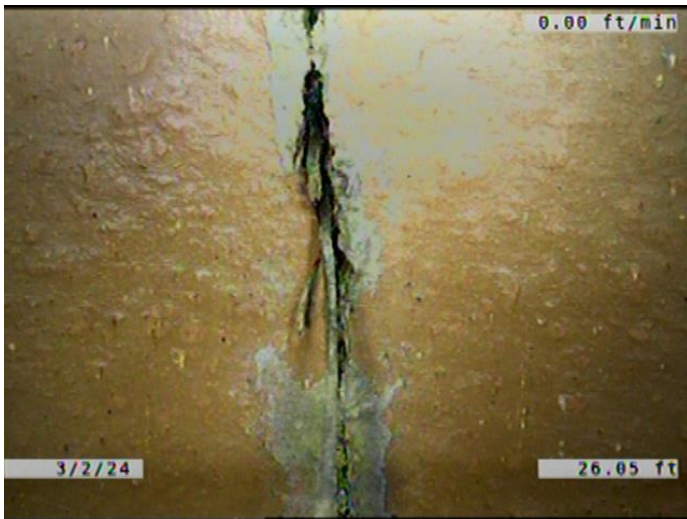
Code: **RFB**  
Description: **Roots Fine Barrel**

Distance (ft): **26.0**  
Structural Grade: **0**  
O&M Grade: **2**  
Clock Start/From: **11**  
Clock To: **1**  
1st Value:  
2nd Value:  
Value Percent:  
Continuous Index: **S06**  
Within 8" of Joint: **NO**  
Remarks:

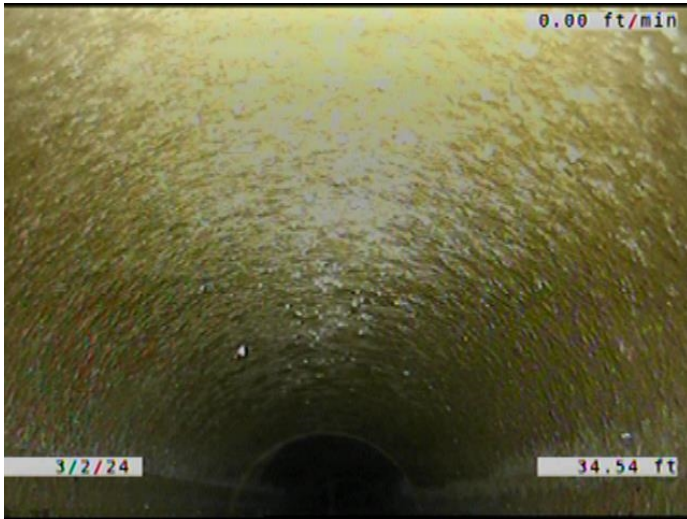
Code: **FM**  
Description: **Fracture Multiple**

Distance (ft): **34.5**  
Structural Grade: **4**  
O&M Grade: **0**  
Clock Start/From: **8**  
Clock To: **4**  
1st Value:  
2nd Value:  
Value Percent:  
Continuous Index: **F04**  
Within 8" of Joint: **YES**  
Remarks:

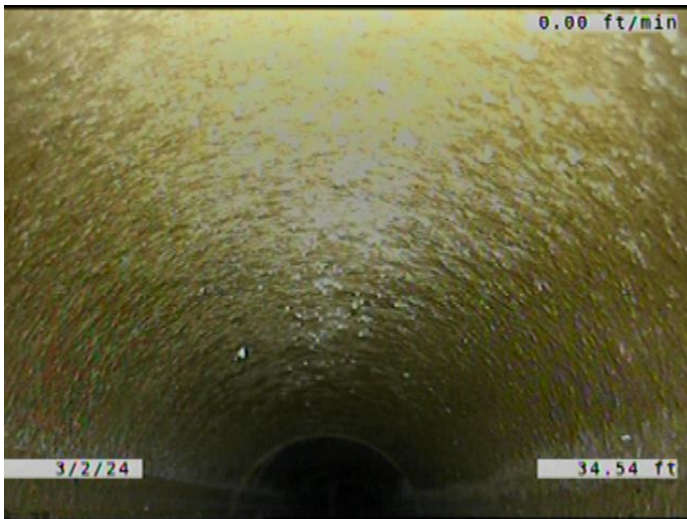
Code: **RFB**  
Description: **Roots Fine Barrel**

Distance (ft): **34.5**  
Structural Grade: **0**  
O&M Grade: **2**  
Clock Start/From: **11**  
Clock To: **1**  
1st Value:  
2nd Value:  
Value Percent:  
Continuous Index: **F06**  
Within 8" of Joint: **NO**  
Remarks:

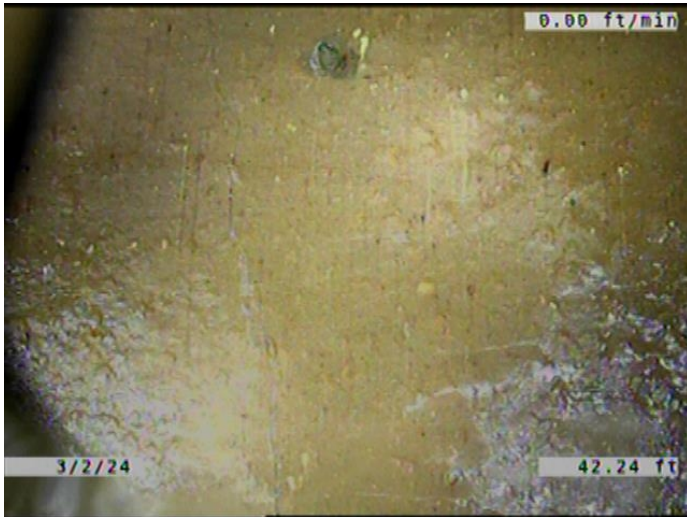
Code: **CS**  
Description: **Crack Spiral**

Distance (ft): **42.2**  
Structural Grade: **2**  
O&M Grade: **0**  
Clock Start/From: **11**  
Clock To: **12**  
1st Value:  
2nd Value:  
Value Percent:  
Continuous Index:  
Within 8" of Joint: **YES**  
Remarks:

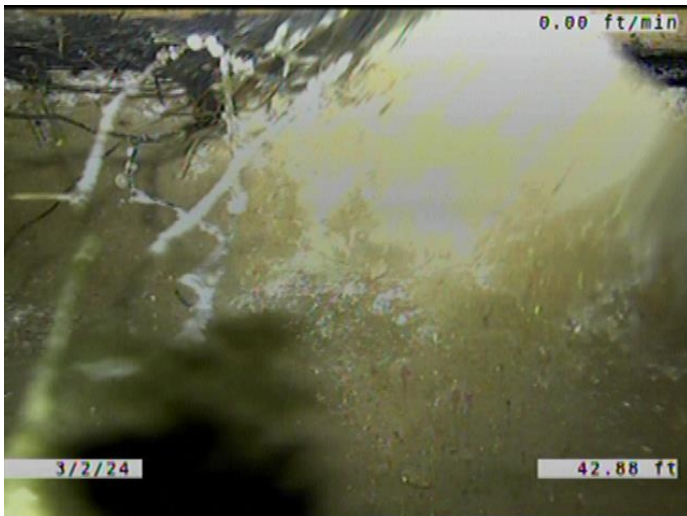
Code: **MCU**  
Description: **Miscellaneous Camera Underwater**

Distance (ft): **42.9**  
Structural Grade: **0**  
O&M Grade: **4**  
Clock Start/From:  
Clock To:  
1st Value:  
2nd Value:  
Value Percent:  
Continuous Index:  
Within 8" of Joint: **NO**  
Remarks: **Out at 43.4**

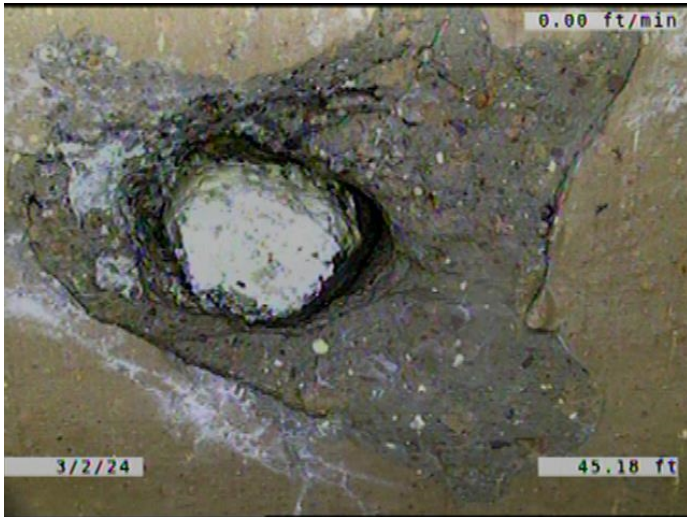
Code: **H**  
Description: **Hole**

Distance (ft): **45.2**  
Structural Grade: **4**  
O&M Grade: **0**  
Clock Start/From: **12**  
Clock To:  
1st Value:  
2nd Value:  
Value Percent:  
Continuous Index:  
Within 8" of Joint: **NO**  
Remarks:

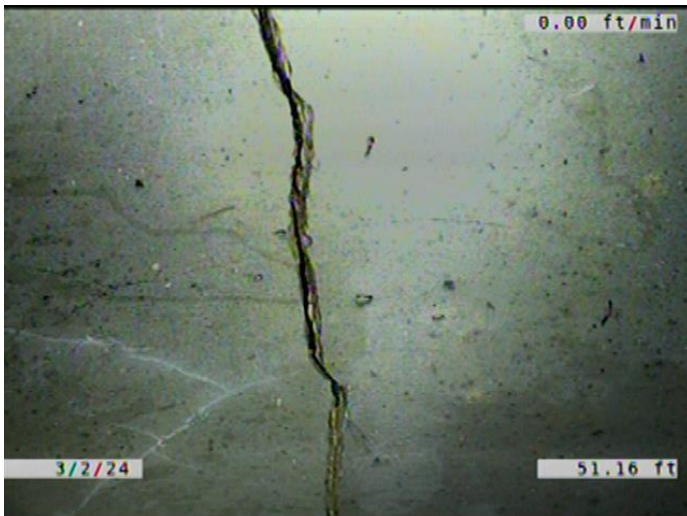
Code: **FM**  
Description: **Fracture Multiple**

Distance (ft): **51.2**  
Structural Grade: **4**  
O&M Grade: **0**  
Clock Start/From: **10**  
Clock To: **2**  
1st Value:  
2nd Value:  
Value Percent:  
Continuous Index:  
Within 8" of Joint: **YES**  
Remarks:

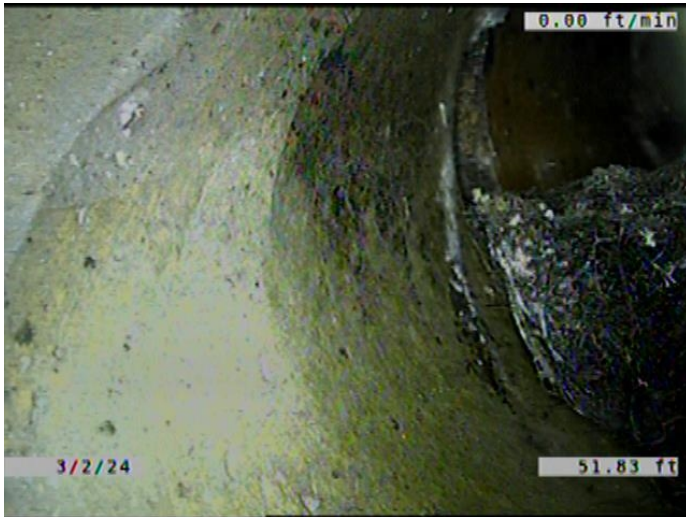
Code:	TFD
Description:	Tap Factory Defective
Distance (ft):	51.8
Structural Grade:	0
O&M Grade:	3
Clock Start/From:	1
Clock To:	
1st Value:	6.000
2nd Value:	
Value Percent:	
Continuous Index:	
Within 8" of Joint:	YES
Remarks:	TAP BROKEN. ROOTS GROWING FROM THE SERVICE TO MAIN CONN

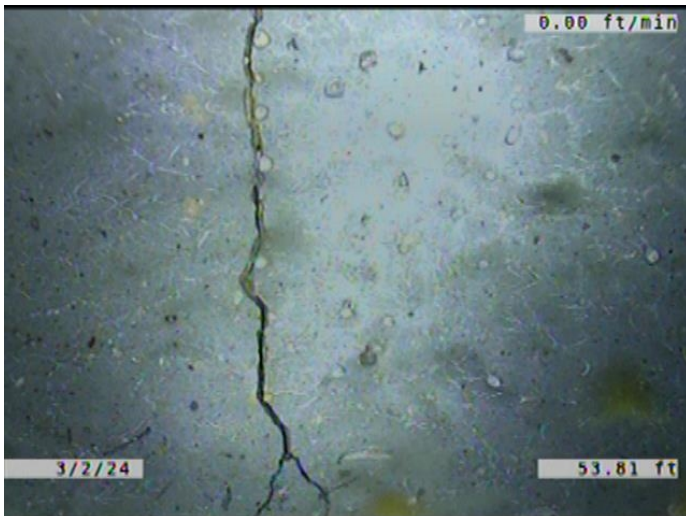
Code:	MCU
Description:	Miscellaneous Camera Underwater
Distance (ft):	53.8
Structural Grade:	0
O&M Grade:	4
Clock Start/From:	
Clock To:	
1st Value:	
2nd Value:	
Value Percent:	
Continuous Index:	S08
Within 8" of Joint:	NO
Remarks:

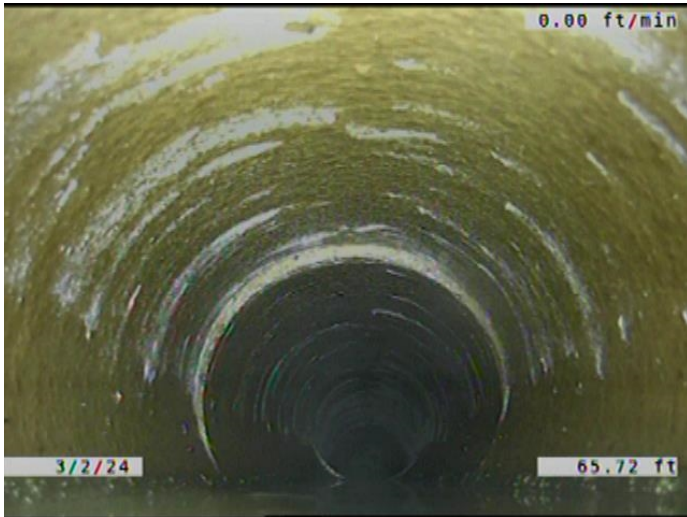
Code: **MCU**  
Description: **Miscellaneous Camera Underwater**

Distance (ft): **65.7**  
Structural Grade: **0**  
O&M Grade: **4**  
Clock Start/From:  
Clock To:  
1st Value:  
2nd Value:  
Value Percent:  
Continuous Index: **F08**  
Within 8" of Joint: **NO**  
Remarks:

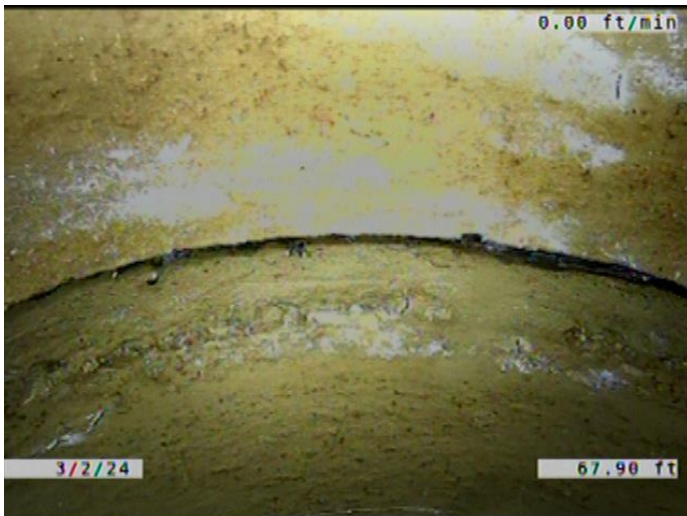
Code: **JOMD**  
Description: **Joint Offset Medium Defective**

Distance (ft): **67.9**  
Structural Grade: **3**  
O&M Grade: **0**  
Clock Start/From:  
Clock To:  
1st Value:  
2nd Value:  
Value Percent:  
Continuous Index:  
Within 8" of Joint: **NO**  
Remarks:

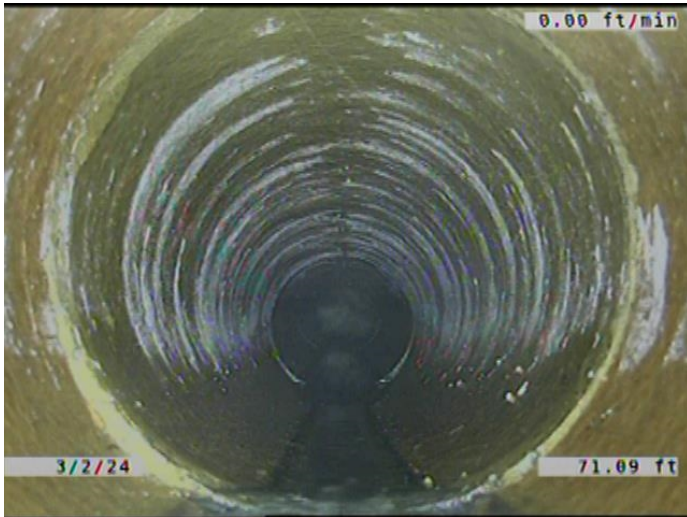
Code: **MWLS**  
Description: **Miscellaneous Water Level Sag**

Distance (ft): **71.1**  
Structural Grade: **3**  
O&M Grade: **0**  
Clock Start/From:  
Clock To:  
1st Value:  
2nd Value:  
Value Percent: **50.000**  
Continuous Index: **F02**  
Within 8" of Joint: **NO**  
Remarks:

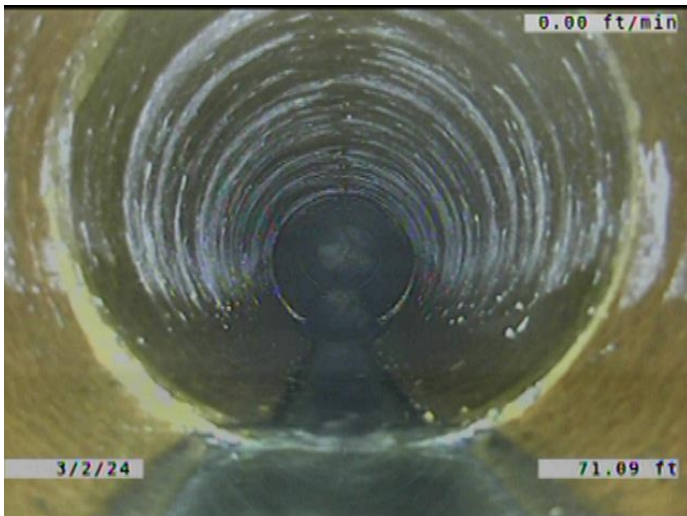
Code: **RFJ**  
Description: **Roots Fine Joint**

Distance (ft): **71.1**  
Structural Grade: **0**  
O&M Grade: **1**  
Clock Start/From: **8**  
Clock To: **4**  
1st Value:  
2nd Value:  
Value Percent:  
Continuous Index: **F03**  
Within 8" of Joint: **YES**  
Remarks:

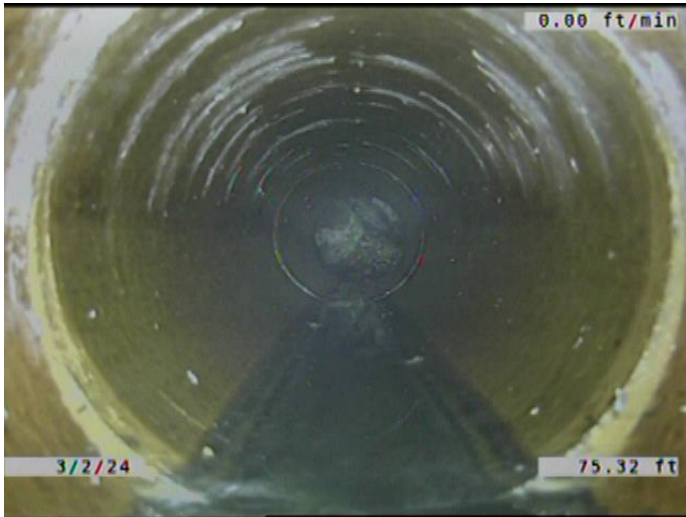
Code: **MWLS**  
Description: **Miscellaneous Water Level Sag**

Distance (ft): **75.3**  
Structural Grade: **2**  
O&M Grade: **0**  
Clock Start/From:  
Clock To:  
1st Value:  
2nd Value:  
Value Percent: **5.000**  
Continuous Index:  
Within 8" of Joint: **NO**  
Remarks:

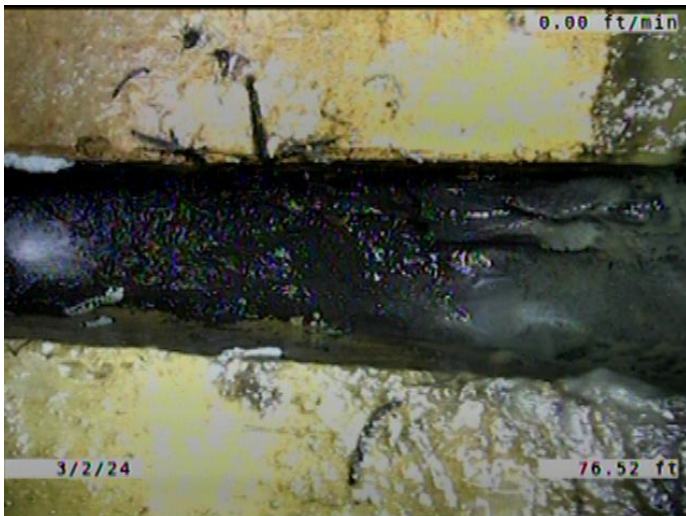
Code: **JAM**  
Description: **Joint Angular Medium**

Distance (ft): **76.5**  
Structural Grade: **3**  
O&M Grade: **0**  
Clock Start/From:  
Clock To:  
1st Value:  
2nd Value:  
Value Percent:  
Continuous Index:  
Within 8" of Joint: **NO**  
Remarks:

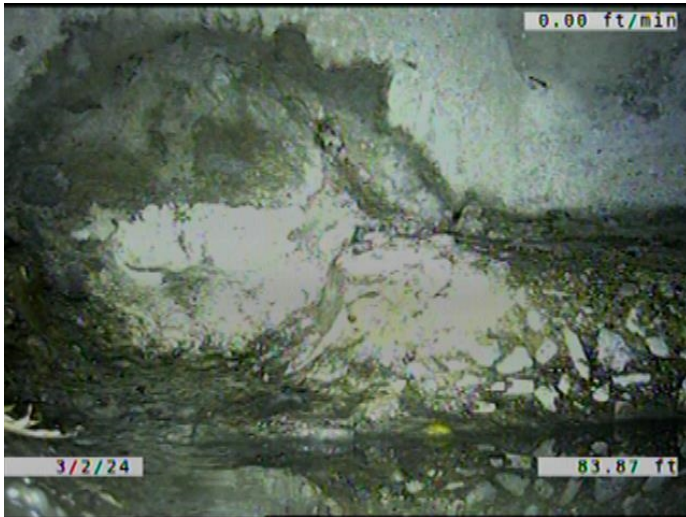
Code: **DSF**  
Description: **Deposits Settled Fine**

Distance (ft): **83.9**  
Structural Grade: **0**  
O&M Grade: **2**  
Clock Start/From: **5**  
Clock To: **7**  
1st Value:  
2nd Value:  
Value Percent: **5.000**  
Continuous Index: **F01**  
Within 8" of Joint: **YES**  
Remarks:

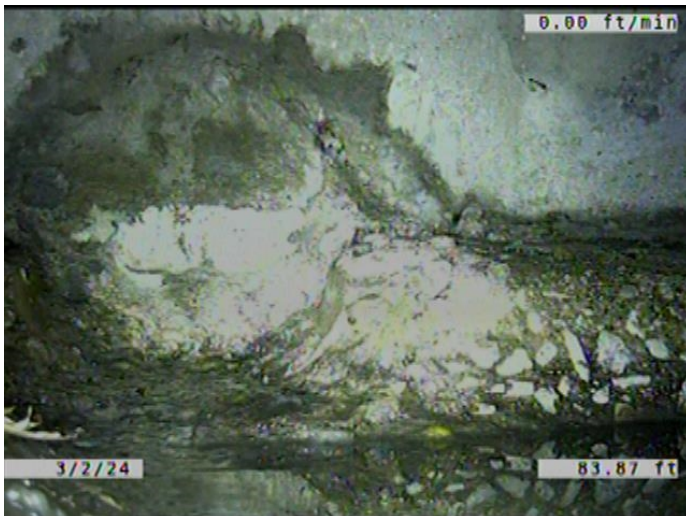
Code: **DAE**  
Description: **Deposits Attached Encrustation**

Distance (ft): **83.9**  
Structural Grade: **0**  
O&M Grade: **2**  
Clock Start/From: **8**  
Clock To: **4**  
1st Value:  
2nd Value:  
Value Percent: **5.000**  
Continuous Index: **F05**  
Within 8" of Joint: **YES**  
Remarks:

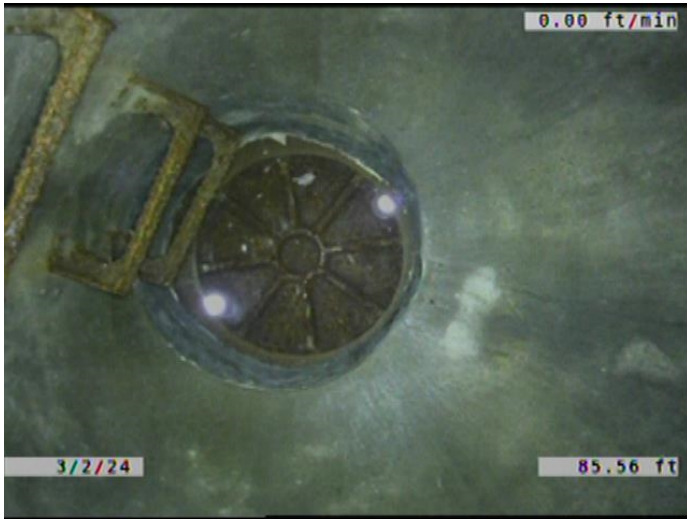
Code:	AMH
Description:	Manhole
Distance (ft):	85.6
Structural Grade:	0
O&M Grade:	0
Clock Start/From:	
Clock To:	
1st Value:	
2nd Value:	
Value Percent:	
Continuous Index:	
Within 8" of Joint:	NO
Remarks:	M-405-055
