## Profile/Photo Observation Report

Date:	<b>04/23/2018</b>	Weather:		Coding:	<b>PACP 6.0</b>
Pipe Length (ft):	<b>260.4</b>	Owner:	<b>NA</b>	Pre Clean:	<b>No Pre-Cleaning</b>
P.O.#:		Surveyor:	<b>Jen Costello</b>	PSR:	<b>P-405-059-057</b>
Customer:		Clean Date:	<b>01/01/1900</b>	Shape:	<b>C</b>

Street:	<b>ALLEY BETWEEN OAKWOOD DR &amp; S</b>	Flow Control:	<b>Not Controlled</b>
City:	<b>Hobart, IN</b>	Year Renewed:	
Location:	<b>Woods</b>	Tape/Media #:	
Purpose:	<b>Routine Assessment</b>	Dia/Height:	<b>10"</b>
Use:	<b>Sanitary</b>	Material:	<b>VCP</b>
Drain Area:	<b>NA</b>	Lining:	
Category:	<b>NA</b>		
Comment:	<b>P_C at 12 ft grit . Flow direction wrong</b>		
Location Details:		Direction of Survey:	<b>Upstream</b>
US MH:	<b>M-405-057</b>	DS MH:	<b>M-405-059</b>
		Total Length Surveyed (ft):	<b>12.7</b>

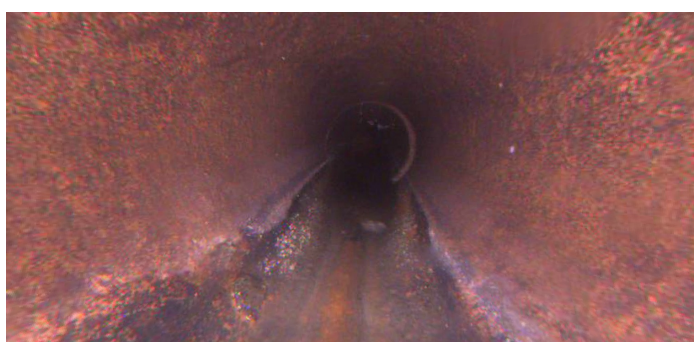
Code: **AMH**  
Description: **Manhole**

Distance (ft): **.0**  
Structural Grade: **0**  
O&M Grade: **0**  
Clock Start/From:  
Clock To:  
1st Value:  
2nd Value:  
Value Percent:  
Continuous Index:  
Within 8" of Joint: **NO**  
Remarks: **M-405-059**

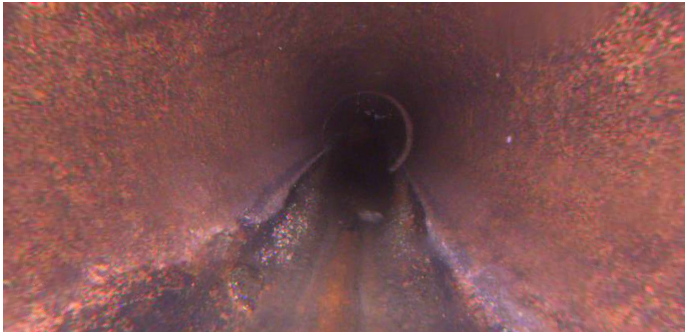
Code:	<b>MWL</b>
Description:	<b>Water Level</b>

Distance (ft):	<b>.0</b>
Structural Grade:	<b>0</b>
O&M Grade:	<b>0</b>
Clock Start/From:	
Clock To:	
1st Value:	
2nd Value:	
Value Percent:	<b>5.000</b>
Continuous Index:	
Within 8" of Joint:	<b>NO</b>
Remarks:

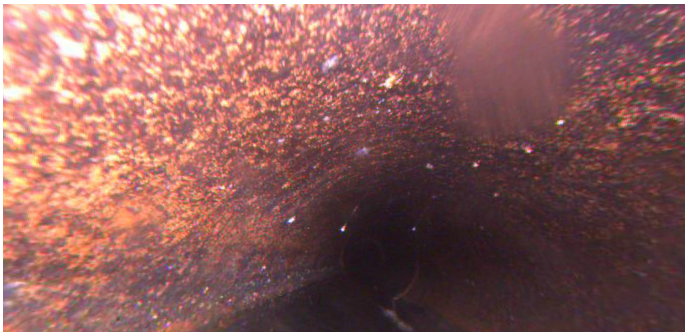
Code:	<b>MSA</b>
Description:	<b>Abandoned Survey</b>

Distance (ft):	<b>12.7</b>
Structural Grade:	<b>0</b>
O&M Grade:	<b>0</b>
Clock Start/From:	
Clock To:	
1st Value:	
2nd Value:	
Value Percent:	
Continuous Index:	
Within 8" of Joint:	<b>NO</b>
Remarks:	<b>UNKNOWN</b>
