Profile/Pho	to Observatior	n Report				RedZon
Date:	04/23/2018	Weather:			Coding:	PACP 6.0
Pipe Length (ft):	109.9	Owner:	NA		Pre Clean:	No Pre-Cleaning
P.O.#:		Surveyor:	Jen Coste	llo	PSR:	P-405-058-059
Customer:		Clean Date:	01/01/19	00	Shape:	С
Street:	reet: ALLEY BETWEEN OAKWOOD DR & S		S Flow Contro	Flow Control:		
City:	y: Hobart, IN		Year Renew	Year Renewed:		
Location:	ocation: Woods		Tape/Medi	Tape/Media #:		
Purpose:	ose: Routine Assessment		Dia/Height:		8"	
Use:	Sanitary		Material:		VCP	
Drain Area:	NA		Lining:			
Category:	NA

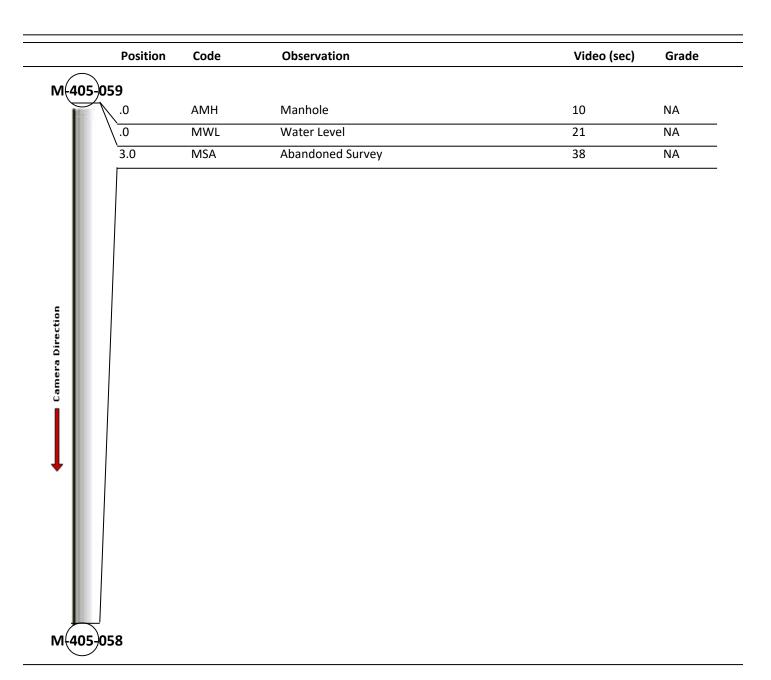
Comment:	F_S_P_C at 1 ft de	bris and grit . Flo	ow direction w	rong		
Location Details:			Direction o	f Survey:	Downstream	
US MH: N	Л-405-059	DS MH:	M-405-058	T	otal Length Surveyed (ft)	3.0
D&M Index:	0.00	O&M Quick:		0000	O&M Rating:	0.00
Structural Index:	0.00	Structural Q	uick:	0000	Structural Rating:	0.00
Overall Index:	0.00	Overall Quic	:k:	0000	Overall Rating:	0.00

Code:	MSA
Description:	Abandoned Survey
Distance (ft):	3.0
Structural Grade:	0
O&M Grade:	0
Clock Start/From:	
Clock To:	
1st Value:	
2nd Value:

DEBRIS UNDER WATER
