Profile/Photo Observation Report

Street:	FOXCROFT STREET	Flow Control:	Not Controlled
City:	Hobart, IN	Year Renewed:	
Location:	Woods	Tape/Media #:	
Purpose:	Routine Assessment	Dia/Height:	8"
Use:	Sanitary	Material:	VCP
Drain Area:	NA	Lining:	
Category:	NA		
Comment:	F_S_P_C at 1 ft debris and grit . Flow direction wrong		
Location Details:		Direction of Survey:	Downstream
US MH:	M-405-059	DS MH:	M-405-058
		Total Length Surveyed (ft):	3.0

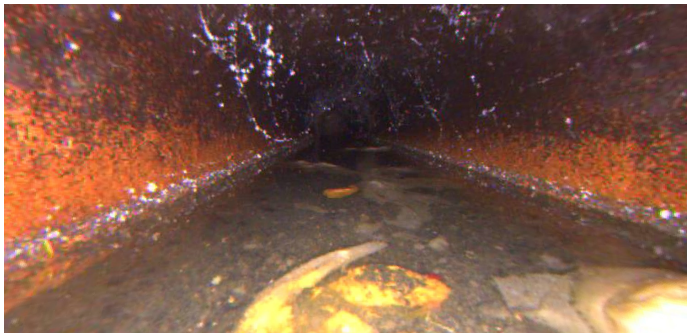
Code: **AMH**
Description: **Manhole**

Distance (ft): **.0**
Structural Grade: **0**
O&M Grade: **0**
Clock Start/From:
Clock To:
1st Value:
2nd Value:
Value Percent:
Continuous Index:
Within 8" of Joint: **NO**
Remarks: **M-405-059**

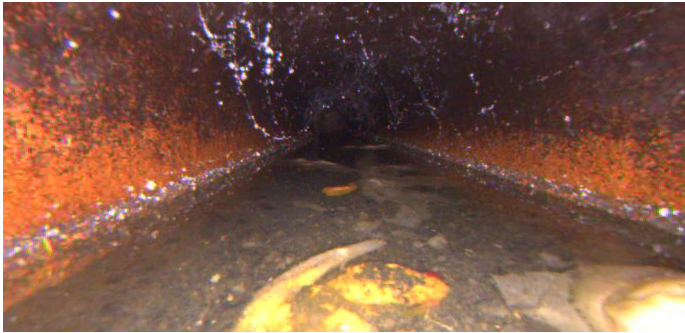
Code:	MWL
Description:	Water Level

Distance (ft):	.0
Structural Grade:	0
O&M Grade:	0
Clock Start/From:	
Clock To:	
1st Value:	
2nd Value:	
Value Percent:	40.000
Continuous Index:	
Within 8" of Joint:	NO
Remarks:

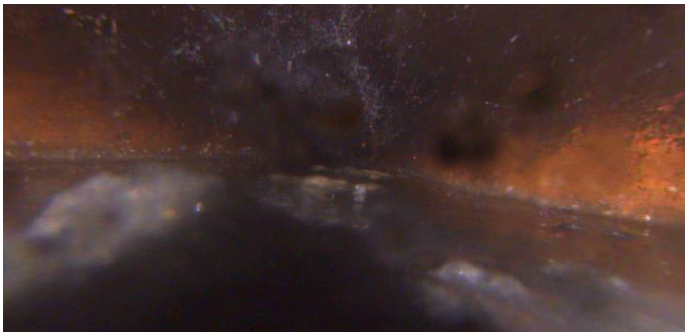
Code:	MSA
Description:	Abandoned Survey

Distance (ft):	3.0
Structural Grade:	0
O&M Grade:	0
Clock Start/From:	
Clock To:	
1st Value:	
2nd Value:	
Value Percent:	
Continuous Index:	
Within 8" of Joint:	NO
Remarks:	DEBRIS UNDER WATER
