Profile/Photo Observation Report

Date:	03/07/2024	Weather:		Coding:	PACP 7.0
Pipe Length (ft):	110.0	Owner:	City of Hobart	Pre Clean:	Heavy Cleaning
P.O.#:		Surveyor:	S. Bucklin	PSR:	P-405-058-059
Customer:	City of Hobart	Clean Date:	09/19/2023	Shape:	C

Street:	SOFTWOOD DR	Flow Control:	Not Controlled
City:	Hobart, IN	Year Renewed:	
Location:	Easement/Right of Way	Tape/Media #:	
Purpose:	Sewer System Evaluation Survey (SS	Dia/Height:	10"
Use:	Sanitary Sewage Pipe	Material:	VCP
Drain Area:		Lining:	None
Category:	NA		
Comment:			
Location Details:		Direction of Survey:	Downstream
US MH:	M-405-059	DS MH:	M-405-058
		Total Length Surveyed (ft):	68.8

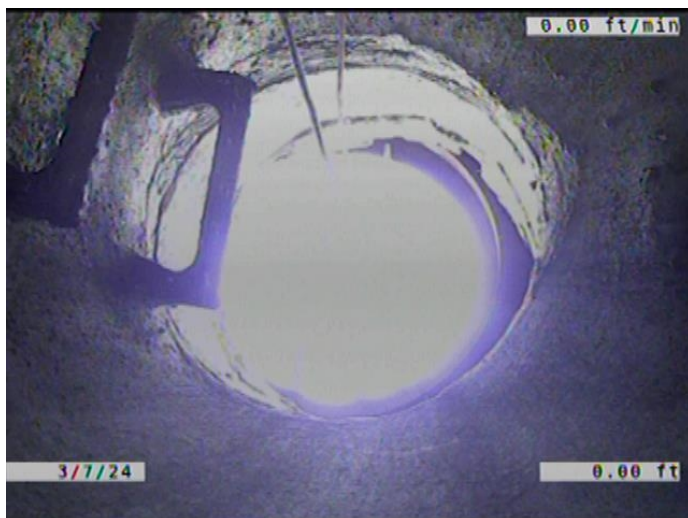
Code: **AMH**
 Description: **Manhole**

Distance (ft): **.0**
 Structural Grade: **0**
 O&M Grade: **0**
 Clock Start/From:
 Clock To:
 1st Value:
 2nd Value:
 Value Percent:
 Continuous Index:
 Within 8" of Joint: **NO**
 Remarks: **M-405-059**

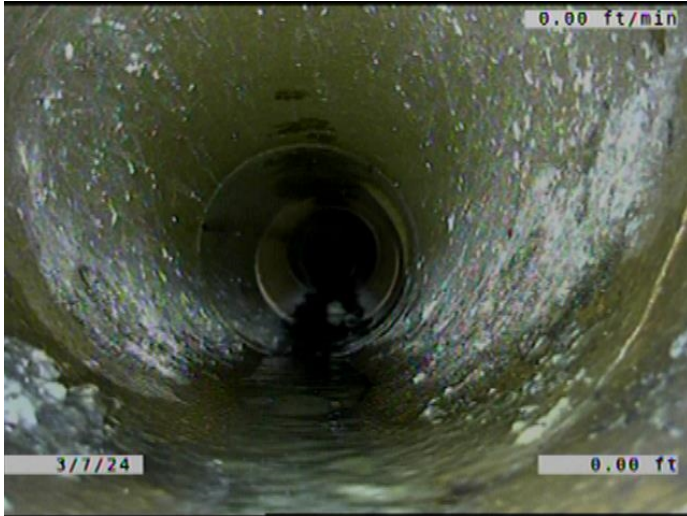
Code: **MWL**
Description: **Miscellaneous Water Level**

Distance (ft): **.0**
Structural Grade: **0**
O&M Grade: **0**
Clock Start/From:
Clock To:
1st Value:
2nd Value:
Value Percent: **5.000**
Continuous Index:
Within 8" of Joint: **NO**
Remarks:

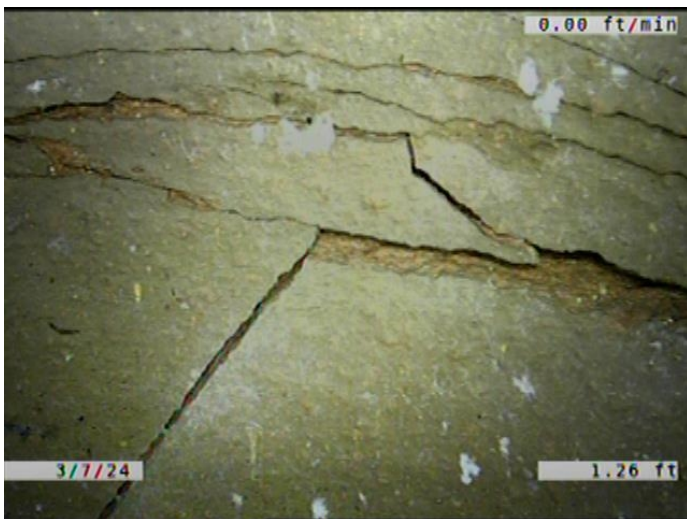
Code: **B**
Description: **Broken**

Distance (ft): **1.3**
Structural Grade: **4**
O&M Grade: **0**
Clock Start/From: **12**
Clock To: **12**
1st Value:
2nd Value:
Value Percent:
Continuous Index:
Within 8" of Joint: **YES**
Remarks:

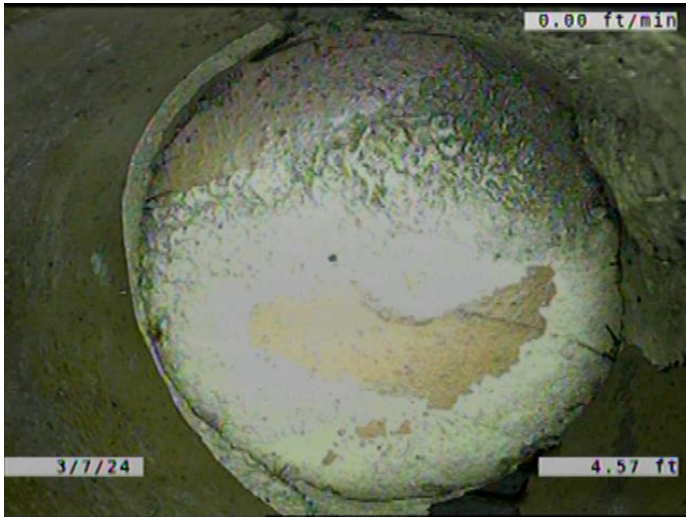
Code: **TFD**
 Description: **Tap Factory Defective**

Distance (ft): **4.6**
 Structural Grade: **0**
 O&M Grade: **3**
 Clock Start/From: **2**
 Clock To:
 1st Value: **6.000**
 2nd Value:
 Value Percent:
 Continuous Index:
 Within 8" of Joint: **YES**
 Remarks: **CAPPED. ENCRUSTATION COMING AROUND THE CAP INTO THE MAIN.**

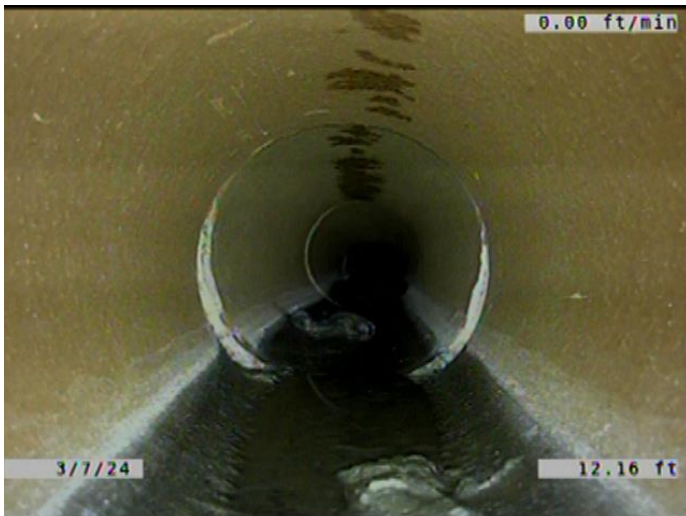
Code: **DSF**
 Description: **Deposits Settled Fine**

Distance (ft): **12.2**
 Structural Grade: **0**
 O&M Grade: **2**
 Clock Start/From: **5**
 Clock To: **7**
 1st Value:
 2nd Value:
 Value Percent: **5.000**
 Continuous Index: **S01**
 Within 8" of Joint: **YES**
 Remarks:

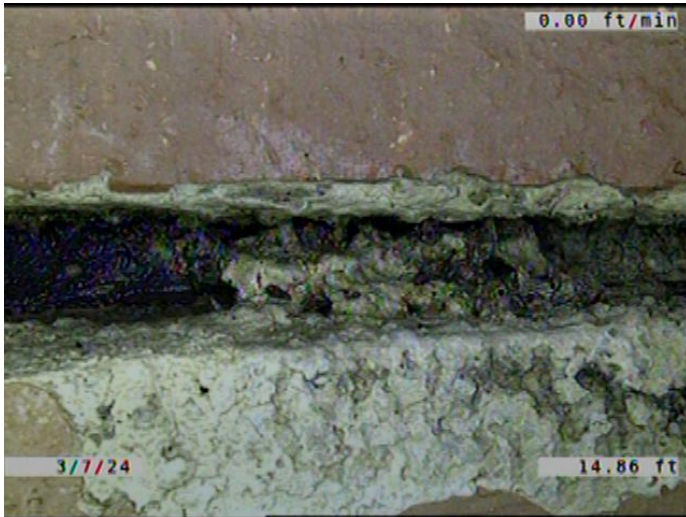
Code: **DAE**
Description: **Deposits Attached Encrustation**

Distance (ft): **14.9**
Structural Grade: **0**
O&M Grade: **2**
Clock Start/From: **7**
Clock To: **5**
1st Value:
2nd Value:
Value Percent: **5.000**
Continuous Index: **S02**
Within 8" of Joint: **YES**
Remarks:

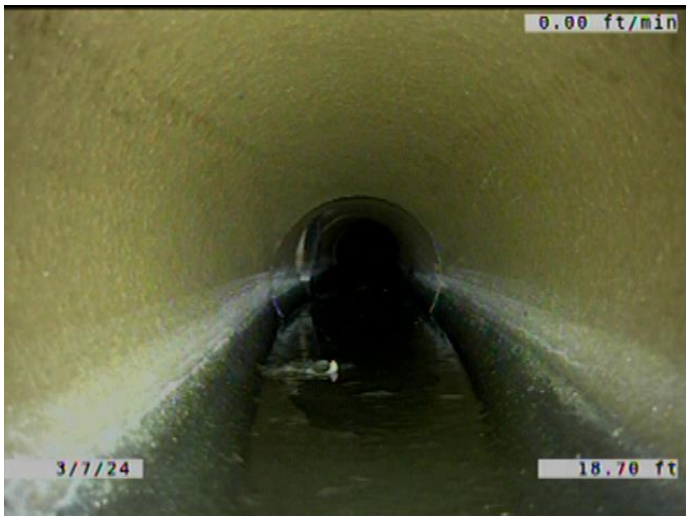
Code: **MWLS**
Description: **Miscellaneous Water Level Sag**

Distance (ft): **18.7**
Structural Grade: **3**
O&M Grade: **0**
Clock Start/From:
Clock To:
1st Value:
2nd Value:
Value Percent: **45.000**
Continuous Index: **S03**
Within 8" of Joint: **NO**
Remarks:

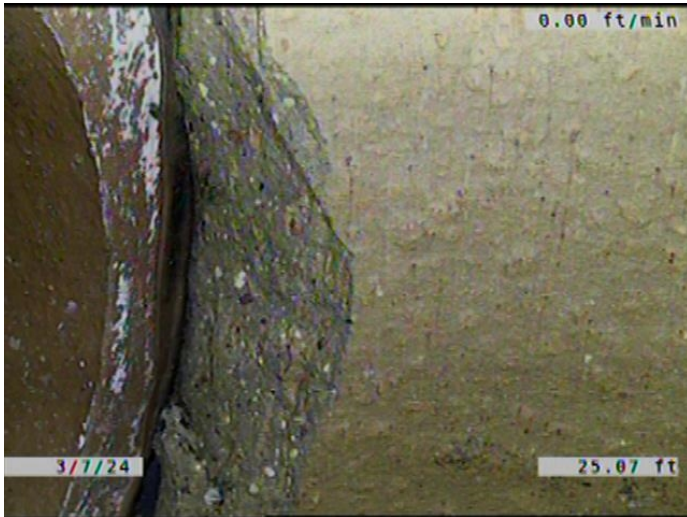
Code:	SSS
Description:	Surface Damage Surface Spalling
Distance (ft):	25.1
Structural Grade:	2
O&M Grade:	0
Clock Start/From:	8
Clock To:	10
1st Value:	
2nd Value:	
Value Percent:	
Continuous Index:	
Within 8" of Joint:	NO
Remarks:

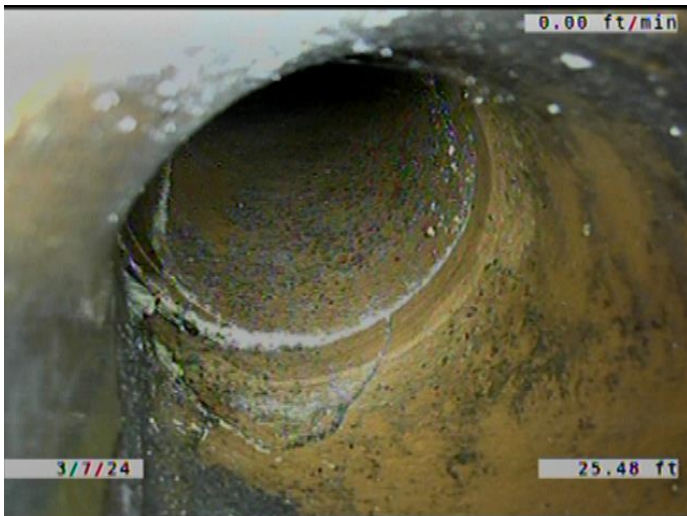
Code:	TBI
Description:	Tap Break-in Intruding
Distance (ft):	25.5
Structural Grade:	0
O&M Grade:	2
Clock Start/From:	10
Clock To:	
1st Value:	6.000
2nd Value:	3.000
Value Percent:	
Continuous Index:	
Within 8" of Joint:	YES
Remarks:	TAP BROKEN.

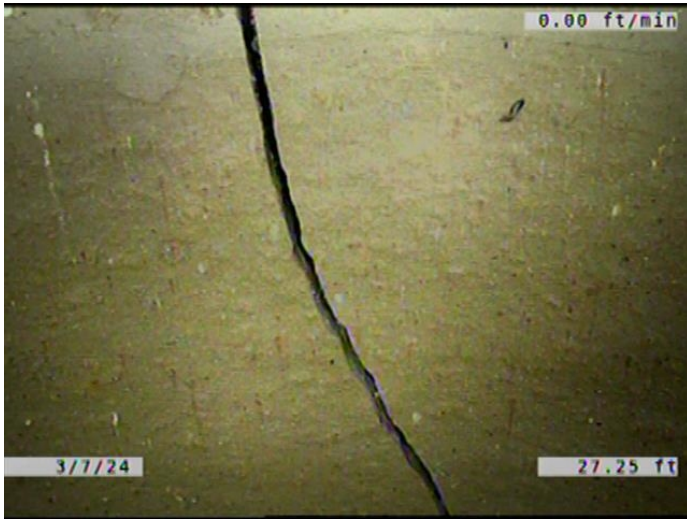
Code: **B**
Description: **Broken**

Distance (ft): **27.3**
Structural Grade: **4**
O&M Grade: **0**
Clock Start/From: **12**
Clock To: **5**
1st Value:
2nd Value:
Value Percent:
Continuous Index:
Within 8" of Joint: **YES**
Remarks:

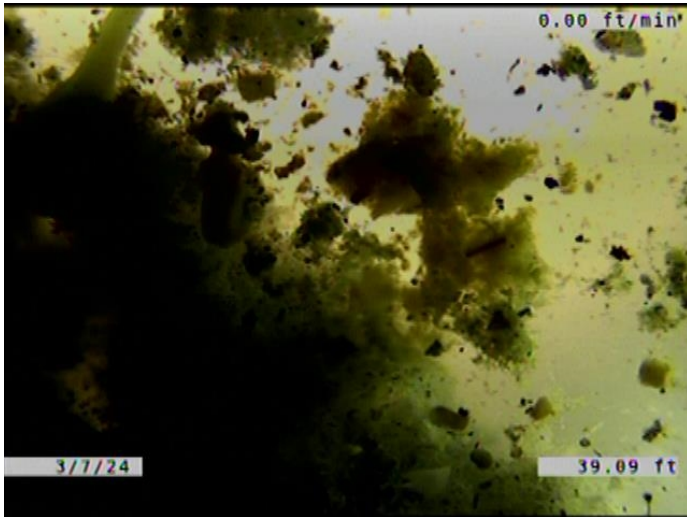
Code: **MCU**
Description: **Miscellaneous Camera Underwater**

Distance (ft): **39.1**
Structural Grade: **0**
O&M Grade: **4**
Clock Start/From:
Clock To:
1st Value:
2nd Value:
Value Percent:
Continuous Index:
Within 8" of Joint: **NO**
Remarks: **Out at 40.6**

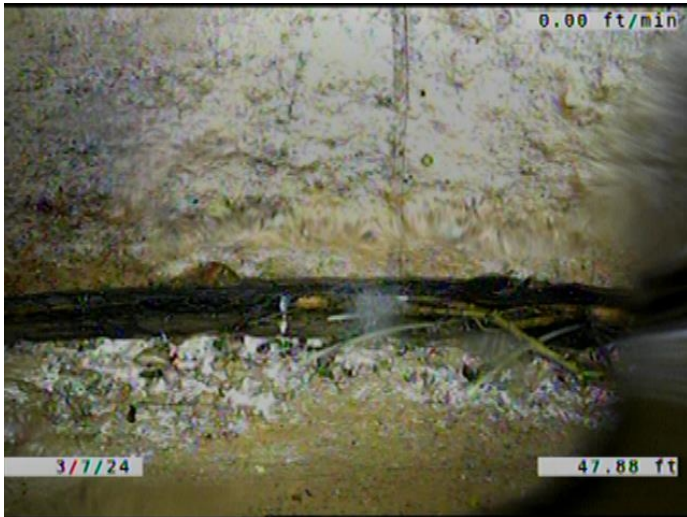
Code: **RFJ**
 Description: **Roots Fine Joint**

Distance (ft): **47.9**
 Structural Grade: **0**
 O&M Grade: **1**
 Clock Start/From: **10**
 Clock To: **2**
 1st Value:
 2nd Value:
 Value Percent:
 Continuous Index:
 Within 8" of Joint: **YES**
 Remarks:

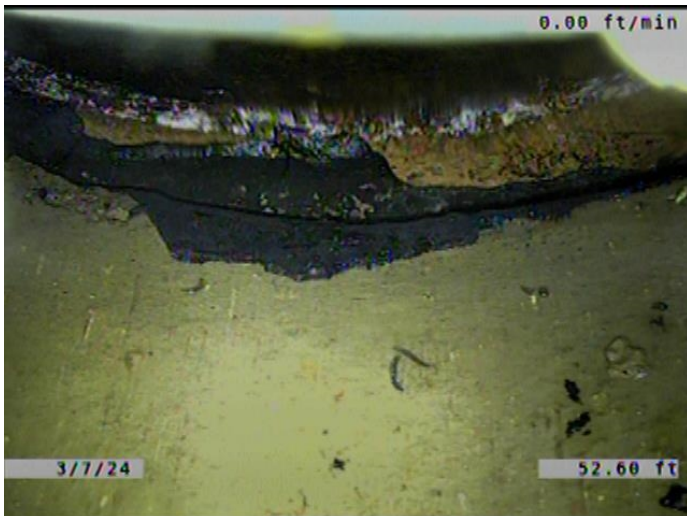
Code: **JOMD**
 Description: **Joint Offset Medium Defective**

Distance (ft): **52.6**
 Structural Grade: **3**
 O&M Grade: **0**
 Clock Start/From:
 Clock To:
 1st Value:
 2nd Value:
 Value Percent:
 Continuous Index:
 Within 8" of Joint: **NO**
 Remarks:

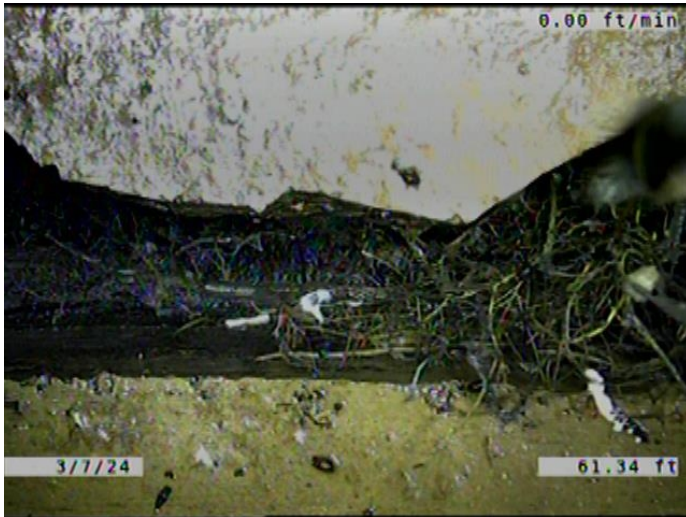
Code: **RFJ**
 Description: **Roots Fine Joint**

Distance (ft): **61.3**
 Structural Grade: **0**
 O&M Grade: **1**
 Clock Start/From: **7**
 Clock To: **5**
 1st Value:
 2nd Value:
 Value Percent:
 Continuous Index:
 Within 8" of Joint: **YES**
 Remarks:

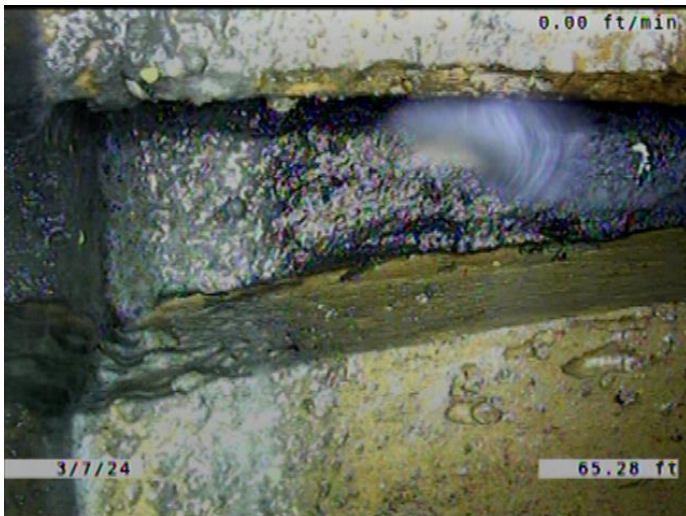
Code: **JAM**
 Description: **Joint Angular Medium**

Distance (ft): **65.3**
 Structural Grade: **3**
 O&M Grade: **0**
 Clock Start/From:
 Clock To:
 1st Value:
 2nd Value:
 Value Percent:
 Continuous Index:
 Within 8" of Joint: **NO**
 Remarks:

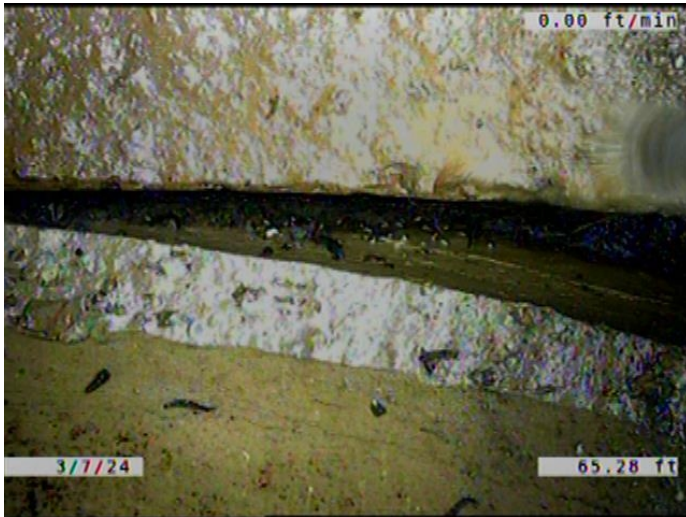
Code: **RFJ**
 Description: **Roots Fine Joint**

Distance (ft): **65.3**
 Structural Grade: **0**
 O&M Grade: **1**
 Clock Start/From: **2**
 Clock To: **3**
 1st Value:
 2nd Value:
 Value Percent:
 Continuous Index:
 Within 8" of Joint: **YES**
 Remarks:

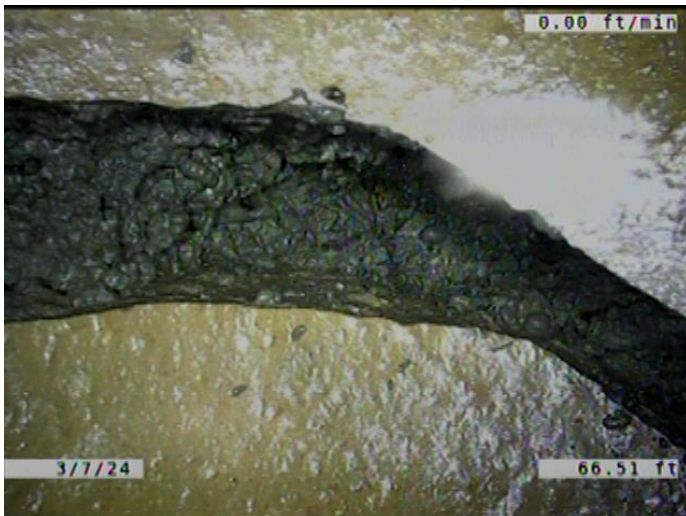
Code: **BSV**
 Description: **Broken Soil Visible**

Distance (ft): **66.5**
 Structural Grade: **5**
 O&M Grade: **0**
 Clock Start/From: **12**
 Clock To: **12**
 1st Value:
 2nd Value:
 Value Percent:
 Continuous Index:
 Within 8" of Joint: **YES**
 Remarks:

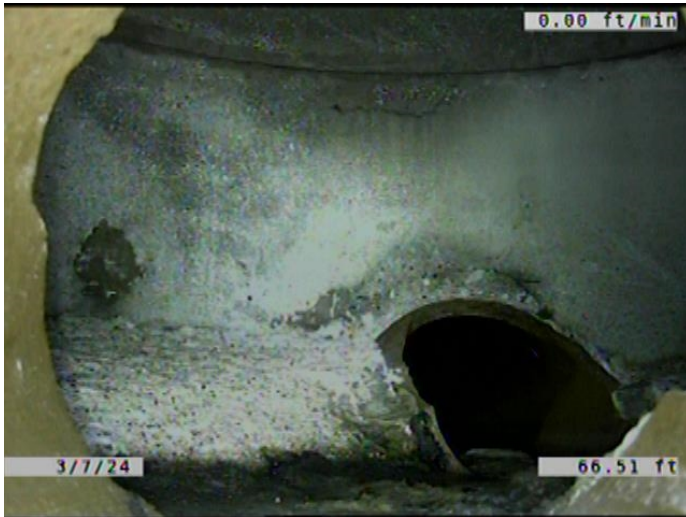
Code: **MWLS**
Description: **Miscellaneous Water Level Sag**

Distance (ft): **66.5**
Structural Grade: **3**
O&M Grade: **0**
Clock Start/From:
Clock To:
1st Value:
2nd Value:
Value Percent: **45.000**
Continuous Index: **F03**
Within 8" of Joint: **NO**
Remarks:

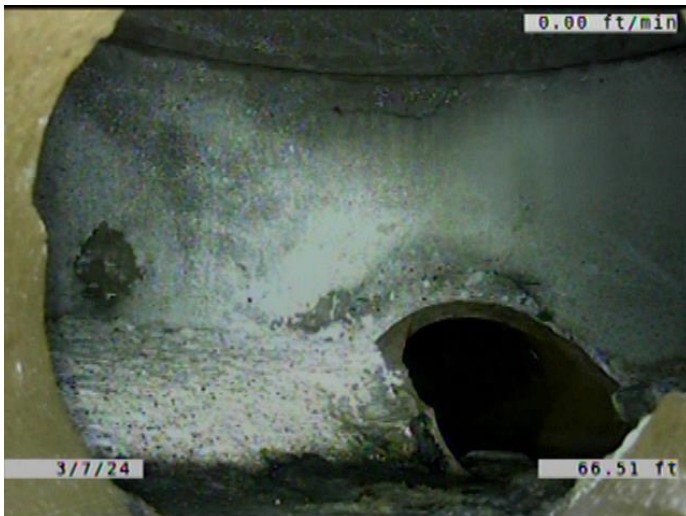
Code: **DSF**
Description: **Deposits Settled Fine**

Distance (ft): **66.5**
Structural Grade: **0**
O&M Grade: **2**
Clock Start/From: **5**
Clock To: **7**
1st Value:
2nd Value:
Value Percent: **5.000**
Continuous Index: **F01**
Within 8" of Joint: **YES**
Remarks:

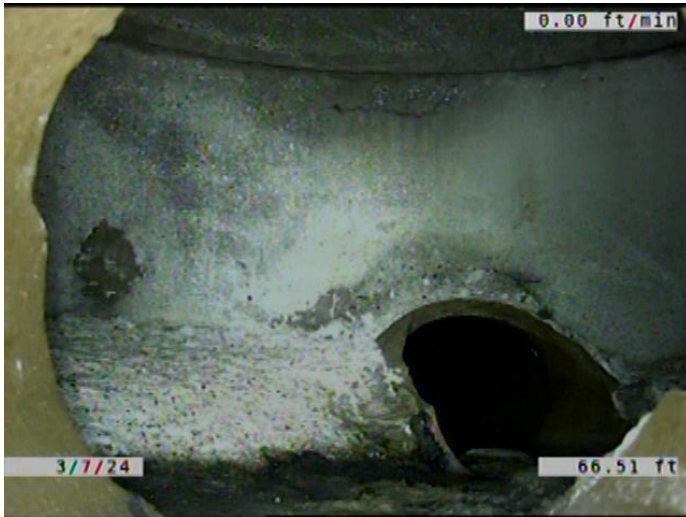
Code: **DAE**
 Description: **Deposits Attached Encrustation**

Distance (ft): **66.5**
 Structural Grade: **0**
 O&M Grade: **2**
 Clock Start/From: **7**
 Clock To: **5**
 1st Value:
 2nd Value:
 Value Percent: **5.000**
 Continuous Index: **F02**
 Within 8" of Joint: **YES**
 Remarks:

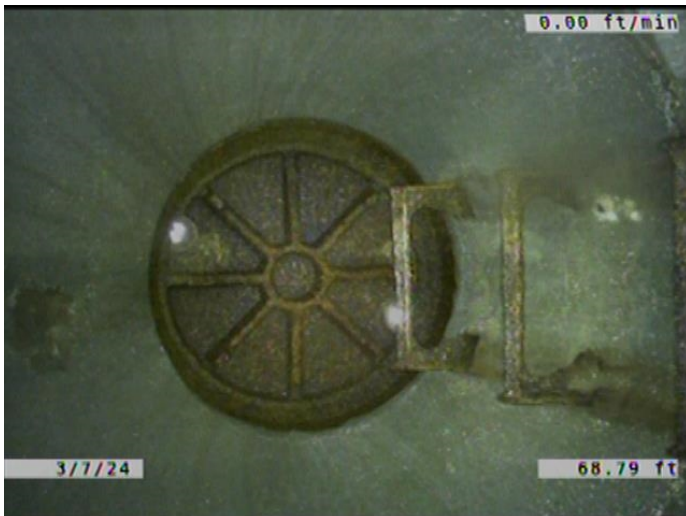
Code: **AMH**
 Description: **Manhole**

Distance (ft): **68.8**
 Structural Grade: **0**
 O&M Grade: **0**
 Clock Start/From:
 Clock To:
 1st Value:
 2nd Value:
 Value Percent:
 Continuous Index:
 Within 8" of Joint: **NO**
 Remarks: **M-405-058**
