## Profile/Photo Observation Report

Date:	<b>03/07/2024</b>	Weather:		Coding:	<b>PACP 7.0</b>
Pipe Length (ft):	<b>84.0</b>	Owner:	<b>City of Hobart</b>	Pre Clean:	<b>Heavy Cleaning</b>
P.O.#:		Surveyor:	<b>S. Bucklin</b>	PSR:	<b>P-405-060-059</b>
Customer:	<b>City of Hobart</b>	Clean Date:	<b>09/19/2023</b>	Shape:	<b>C</b>

Street:	<b>CRESTWOOD DR</b>	Flow Control:	<b>Not Controlled</b>
City:	<b>Hobart, IN</b>	Year Renewed:	
Location:	<b>Easement/Right of Way</b>	Tape/Media #:	
Purpose:	<b>Sewer System Evaluation Survey (SS</b>	Dia/Height:	<b>10"</b>
Use:	<b>Sanitary Sewage Pipe</b>	Material:	<b>VCP</b>
Drain Area:		Lining:	<b>None</b>
Category:	<b>NA</b>		
Comment:			
Location Details:		Direction of Survey:	<b>Upstream</b>
US MH:	<b>M-405-059</b>	DS MH:	<b>M-405-060</b>
		Total Length Surveyed (ft):	<b>82.4</b>

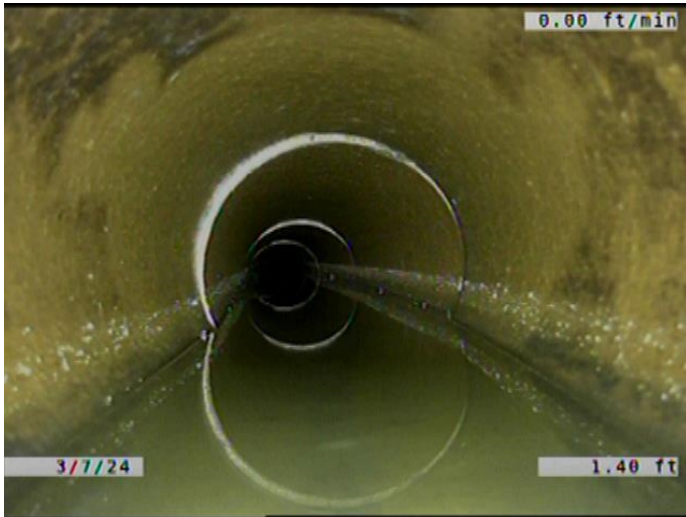
Code: **MWLS**  
Description: **Miscellaneous Water Level Sag**

Distance (ft): **1.4**  
Structural Grade: **2**  
O&M Grade: **0**  
Clock Start/From:  
Clock To:  
1st Value:  
2nd Value:  
Value Percent: **30.000**  
Continuous Index: **S01**  
Within 8" of Joint: **NO**  
Remarks:

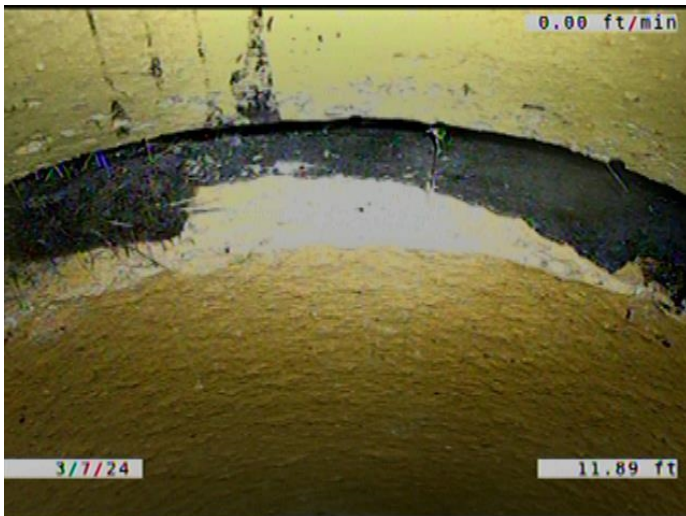
Code: **JOMD**  
Description: **Joint Offset Medium Defective**

Distance (ft): **11.9**  
Structural Grade: **3**  
O&M Grade: **0**  
Clock Start/From:  
Clock To:  
1st Value:  
2nd Value:  
Value Percent:  
Continuous Index:  
Within 8" of Joint: **NO**  
Remarks:

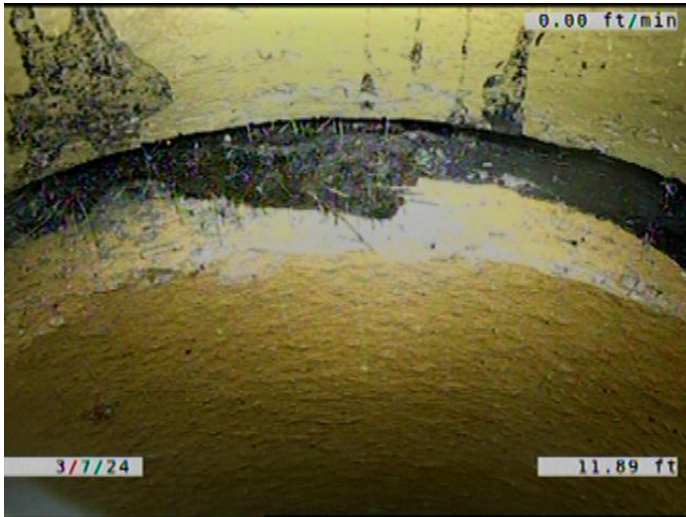
Code: **RFJ**  
Description: **Roots Fine Joint**

Distance (ft): **11.9**  
Structural Grade: **0**  
O&M Grade: **1**  
Clock Start/From: **11**  
Clock To:  
1st Value:  
2nd Value:  
Value Percent:  
Continuous Index:  
Within 8" of Joint: **YES**  
Remarks:

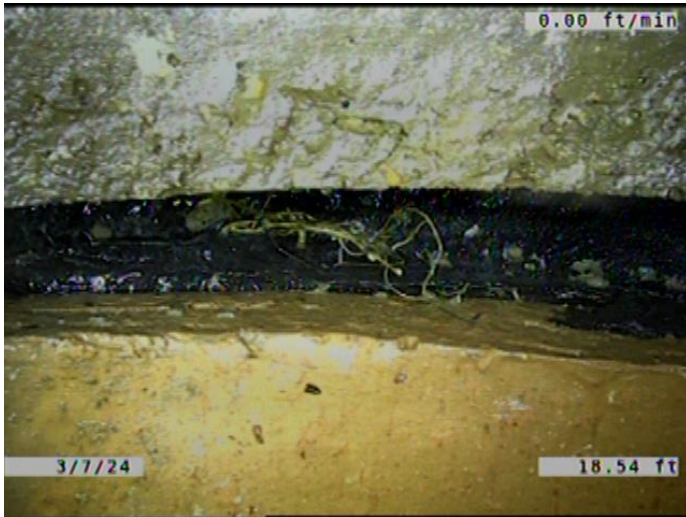
Code: **RFJ**  
Description: **Roots Fine Joint**

Distance (ft): **18.5**  
Structural Grade: **0**  
O&M Grade: **1**  
Clock Start/From: **9**  
Clock To: **11**  
1st Value:  
2nd Value:  
Value Percent:  
Continuous Index:  
Within 8" of Joint: **YES**  
Remarks:

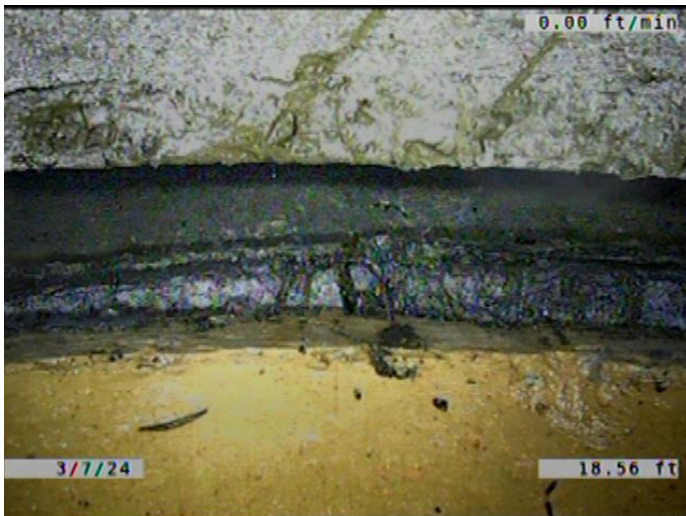
Code: **JAM**  
Description: **Joint Angular Medium**

Distance (ft): **18.6**  
Structural Grade: **3**  
O&M Grade: **0**  
Clock Start/From:  
Clock To:  
1st Value:  
2nd Value:  
Value Percent:  
Continuous Index:  
Within 8" of Joint: **NO**  
Remarks:

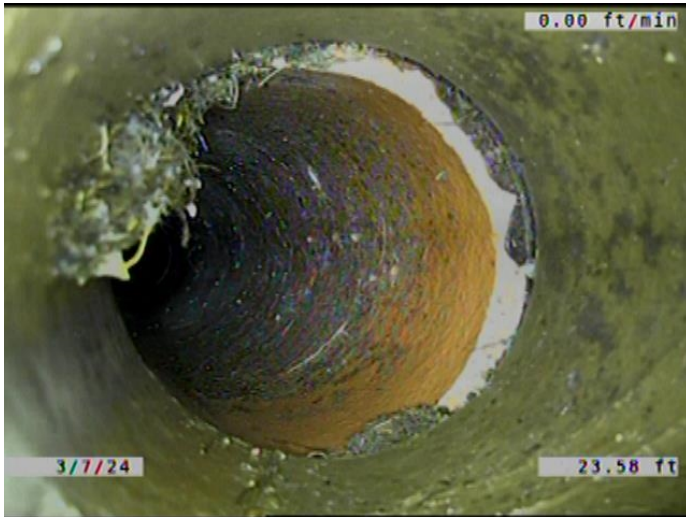
Code: **TF**  
Description: **Tap Factory**

Distance (ft): **23.6**  
Structural Grade: **0**  
O&M Grade: **0**  
Clock Start/From: **10**  
Clock To:  
1st Value: **6.000**

2nd Value:  
Value Percent:  
Continuous Index:  
Within 8" of Joint: **YES**  
Remarks: **ROOTS GROWING IN THE SERVICE TO MAIN CONNECTION.**

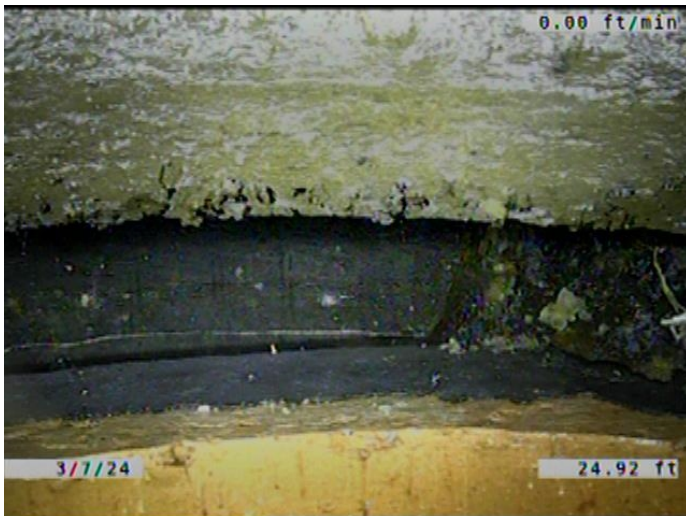
Code: **JAM**  
Description: **Joint Angular Medium**

Distance (ft): **24.9**  
Structural Grade: **3**  
O&M Grade: **0**  
Clock Start/From:  
Clock To:  
1st Value:  
2nd Value:  
Value Percent:

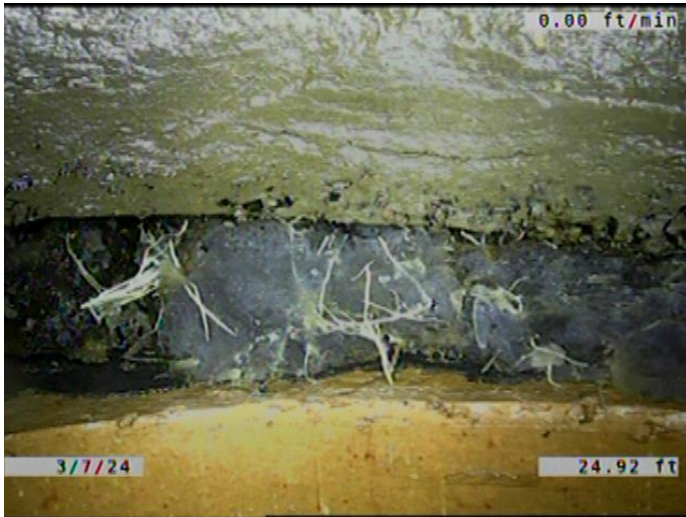
Code: **RFJ**  
Description: **Roots Fine Joint**

Distance (ft): **24.9**  
Structural Grade: **0**  
O&M Grade: **1**  
Clock Start/From: **8**  
Clock To: **4**  
1st Value:  
2nd Value:  
Value Percent:  
Continuous Index: **S02**  
Within 8" of Joint: **YES**  
Remarks:

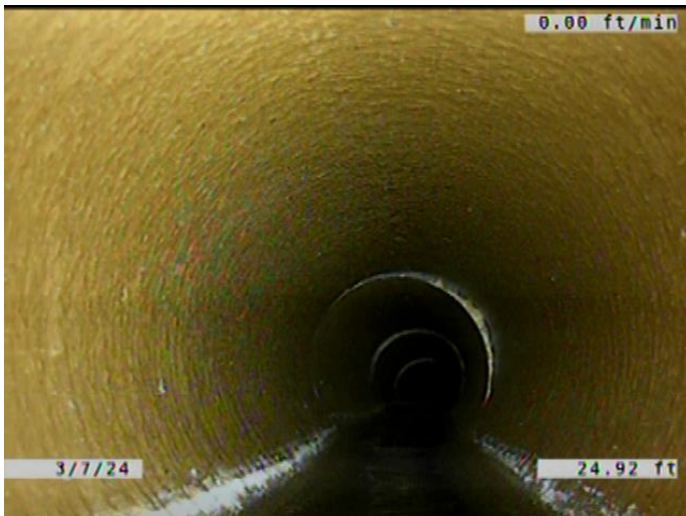
Code: **MWLS**  
Description: **Miscellaneous Water Level Sag**

Distance (ft): **24.9**  
Structural Grade: **2**  
O&M Grade: **0**  
Clock Start/From:  
Clock To:  
1st Value:  
2nd Value:  
Value Percent: **30.000**  
Continuous Index: **F01**  
Within 8" of Joint: **NO**  
Remarks:

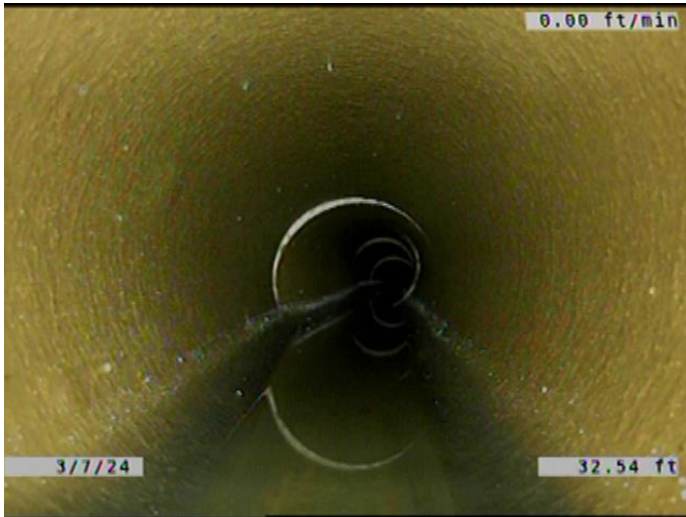
Code: **MWLS**  
Description: **Miscellaneous Water Level Sag**

Distance (ft): **32.5**  
Structural Grade: **2**  
O&M Grade: **0**  
Clock Start/From:  
Clock To:  
1st Value:  
2nd Value:  
Value Percent: **10.000**  
Continuous Index: **S03**  
Within 8" of Joint: **NO**  
Remarks:

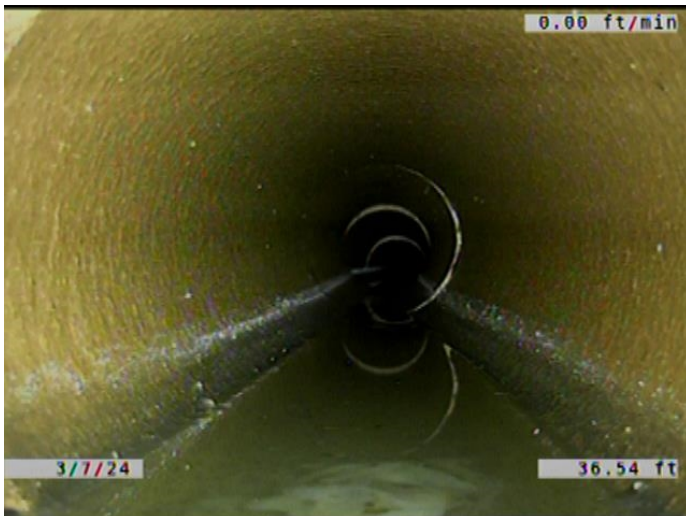
Code: **LR**  
Description: **Line Right**

Distance (ft): **36.5**  
Structural Grade: **0**  
O&M Grade: **1**  
Clock Start/From:  
Clock To:  
1st Value:  
2nd Value:  
Value Percent: **5.000**  
Continuous Index:  
Within 8" of Joint: **NO**  
Remarks:

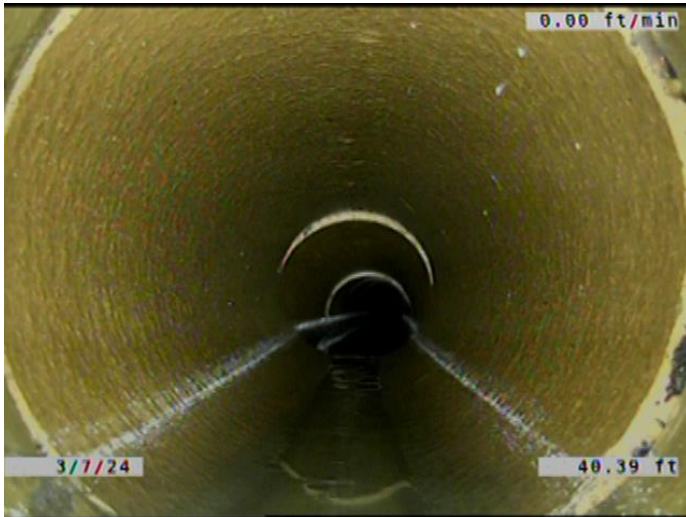
Code: **MWLS**  
Description: **Miscellaneous Water Level Sag**

Distance (ft): **40.4**  
Structural Grade: **2**  
O&M Grade: **0**  
Clock Start/From:  
Clock To:  
1st Value:  
2nd Value:  
Value Percent: **10.000**  
Continuous Index: **F03**  
Within 8" of Joint: **NO**  
Remarks:

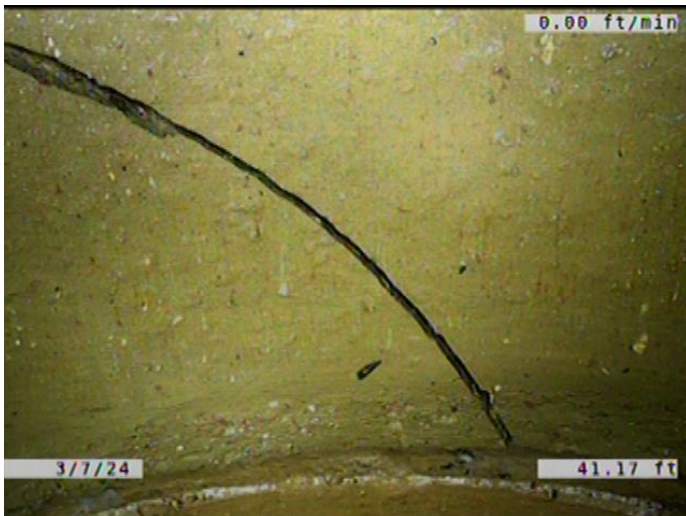
Code: **B**  
Description: **Broken**

Distance (ft): **41.2**  
Structural Grade: **4**  
O&M Grade: **0**  
Clock Start/From: **8**  
Clock To: **10**  
1st Value:  
2nd Value:  
Value Percent:  
Continuous Index:  
Within 8" of Joint: **YES**  
Remarks:

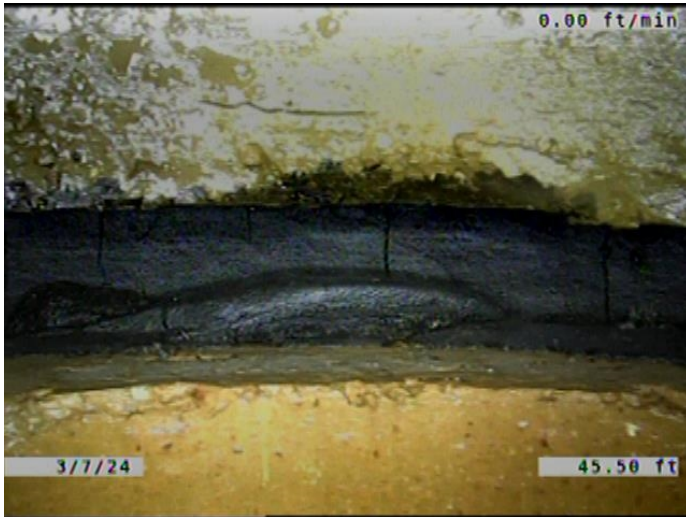
Code: **JAM**  
Description: **Joint Angular Medium**

Distance (ft): **45.5**  
Structural Grade: **3**  
O&M Grade: **0**  
Clock Start/From:  
Clock To:  
1st Value:  
2nd Value:  
Value Percent:  
Continuous Index:  
Within 8" of Joint: **NO**  
Remarks:

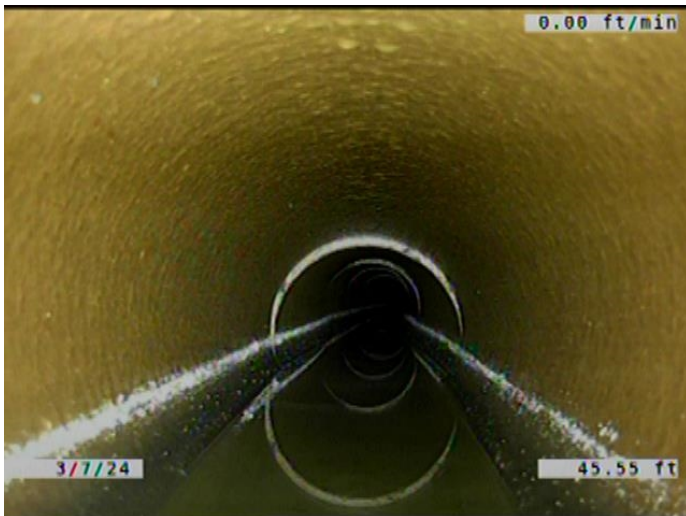
Code: **MWLS**  
Description: **Miscellaneous Water Level Sag**

Distance (ft): **45.6**  
Structural Grade: **2**  
O&M Grade: **0**  
Clock Start/From:  
Clock To:  
1st Value:  
2nd Value:  
Value Percent: **15.000**  
Continuous Index: **S04**  
Within 8" of Joint: **NO**  
Remarks:

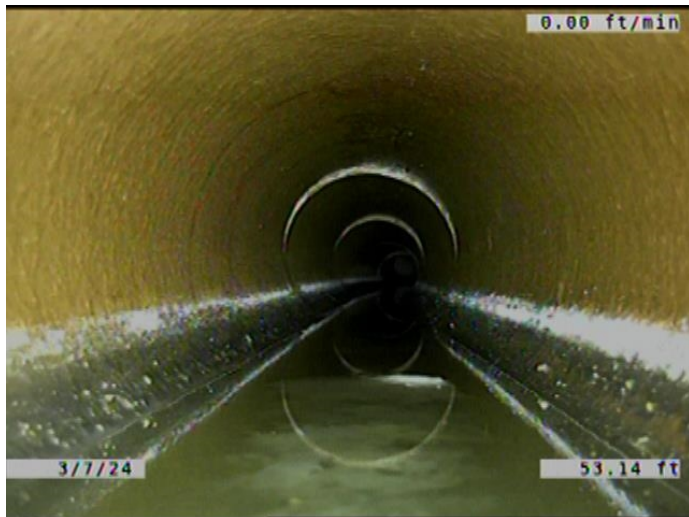
Code: **LR**  
 Description: **Line Right**

Distance (ft): **53.1**  
 Structural Grade: **0**  
 O&M Grade: **1**  
 Clock Start/From:  
 Clock To:  
 1st Value:  
 2nd Value:  
 Value Percent: **5.000**  
 Continuous Index:  
 Within 8" of Joint: **NO**  
 Remarks:

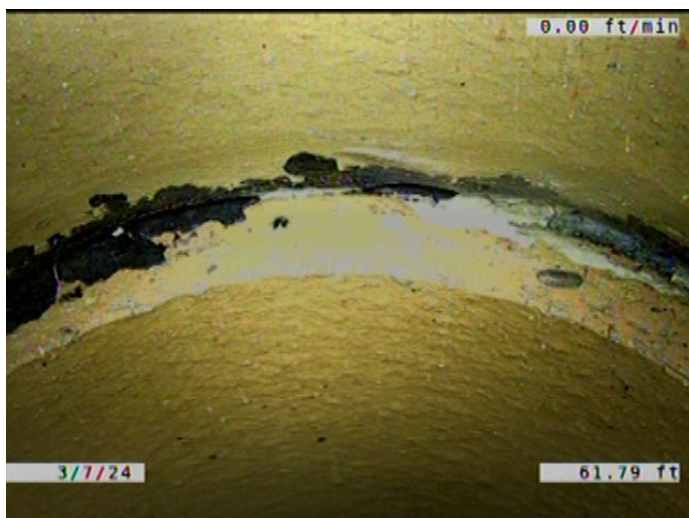
Code: **JOMD**  
 Description: **Joint Offset Medium Defective**

Distance (ft): **61.8**  
 Structural Grade: **3**  
 O&M Grade: **0**  
 Clock Start/From:  
 Clock To:  
 1st Value:  
 2nd Value:  
 Value Percent:  
 Continuous Index:  
 Within 8" of Joint: **NO**  
 Remarks:

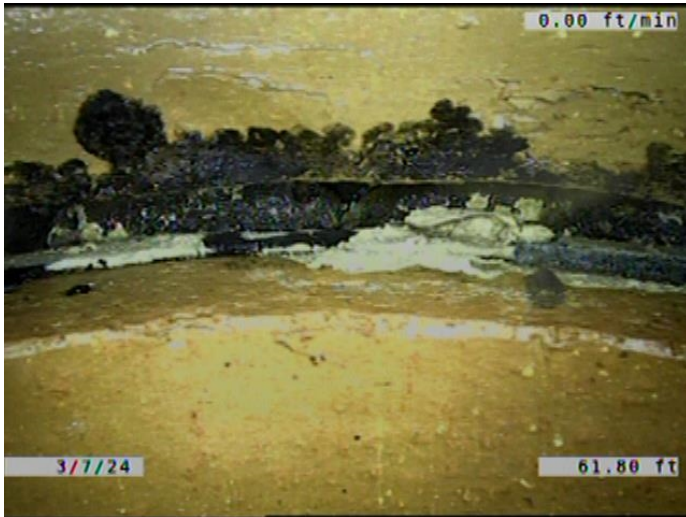
Code:	<b>DAE</b>
Description:	<b>Deposits Attached Encrustation</b>
Distance (ft):	<b>61.8</b>
Structural Grade:	<b>0</b>
O&M Grade:	<b>2</b>
Clock Start/From:	<b>7</b>
Clock To:	<b>5</b>
1st Value:	
2nd Value:	
Value Percent:	<b>5.000</b>
Continuous Index:	
Within 8" of Joint:	<b>YES</b>
Remarks:

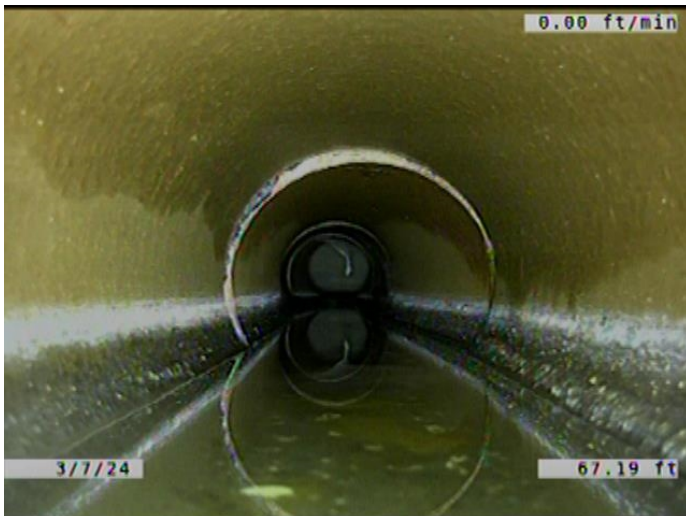
Code:	<b>DSF</b>
Description:	<b>Deposits Settled Fine</b>
Distance (ft):	<b>67.2</b>
Structural Grade:	<b>0</b>
O&M Grade:	<b>2</b>
Clock Start/From:	<b>5</b>
Clock To:	<b>7</b>
1st Value:	
2nd Value:	
Value Percent:	<b>5.000</b>
Continuous Index:	
Within 8" of Joint:	<b>YES</b>
Remarks:

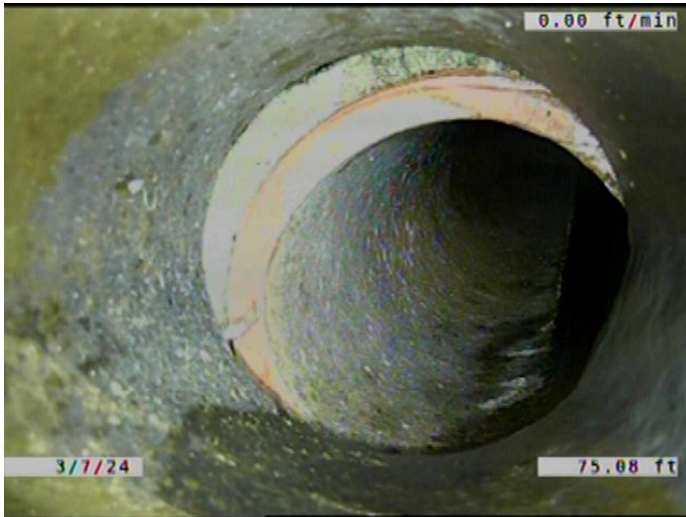
Code: **TFD**  
Description: **Tap Factory Defective**

Distance (ft): **75.1**  
Structural Grade: **0**  
O&M Grade: **3**  
Clock Start/From: **2**  
Clock To:  
1st Value: **6.000**  
2nd Value:  
Value Percent:  
Continuous Index:  
Within 8" of Joint: **YES**  
Remarks: **ACTIVITY. SERVICE LARGE OFFSET. SOIL VISIBLE. SERVICE CONSTANTLY**

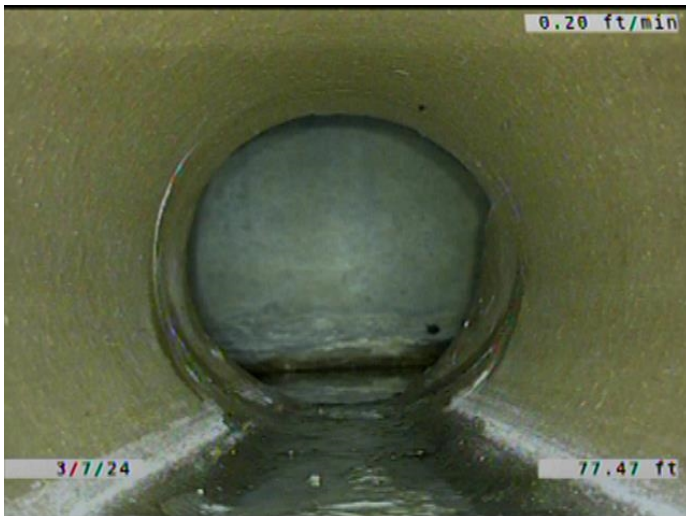
Code: **MWLS**  
Description: **Miscellaneous Water Level Sag**

Distance (ft): **77.5**  
Structural Grade: **2**  
O&M Grade: **0**  
Clock Start/From:  
Clock To:  
1st Value:  
2nd Value:  
Value Percent: **15.000**  
Continuous Index: **F04**  
Within 8" of Joint: **NO**  
Remarks:

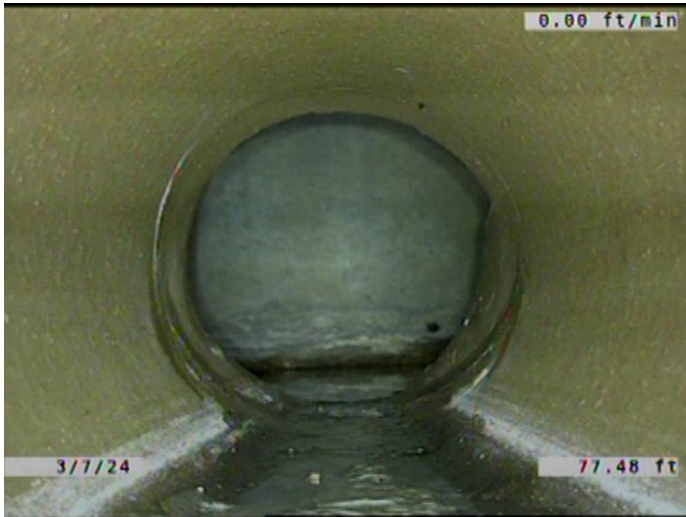
Code: **RFJ**  
Description: **Roots Fine Joint**

Distance (ft): **77.5**  
Structural Grade: **0**  
O&M Grade: **1**  
Clock Start/From: **8**  
Clock To: **4**  
1st Value:  
2nd Value:  
Value Percent:  
Continuous Index: **F02**  
Within 8" of Joint: **YES**  
Remarks:

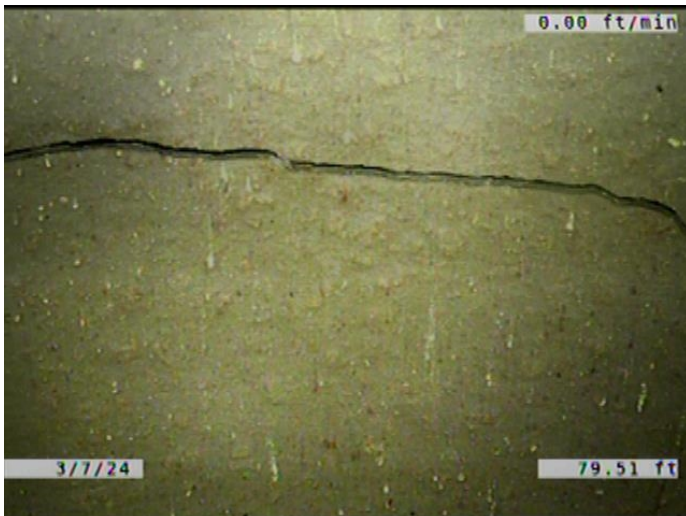
Code: **B**  
Description: **Broken**

Distance (ft): **79.5**  
Structural Grade: **4**  
O&M Grade: **0**  
Clock Start/From: **12**  
Clock To: **12**  
1st Value:  
2nd Value:  
Value Percent:  
Continuous Index:  
Within 8" of Joint: **YES**  
Remarks:

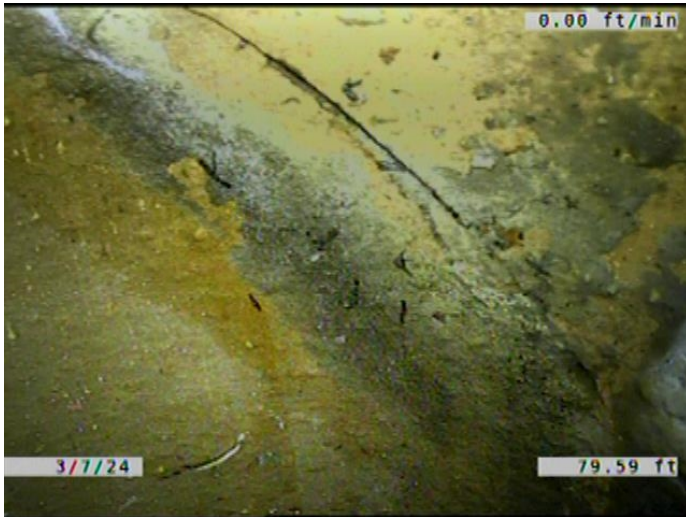
Code: **DAE**  
Description: **Deposits Attached Encrustation**

Distance (ft): **79.6**  
Structural Grade: **0**  
O&M Grade: **2**  
Clock Start/From: **2**  
Clock To: **6**  
1st Value:  
2nd Value:  
Value Percent: **5.000**  
Continuous Index:  
Within 8" of Joint: **YES**  
Remarks:

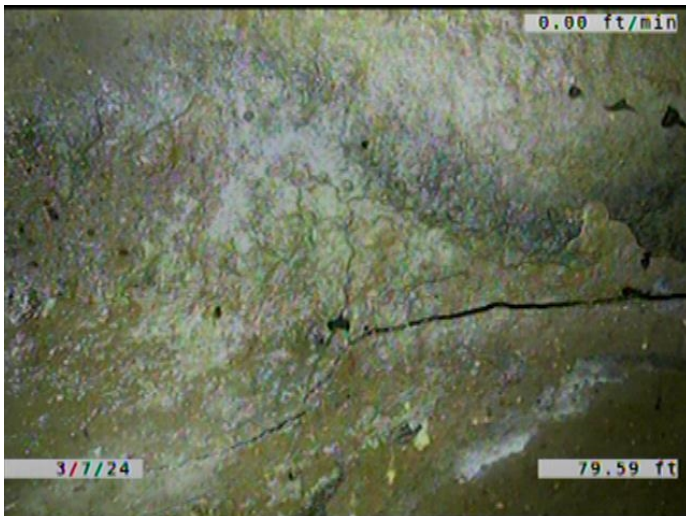
Code: **DAE**  
Description: **Deposits Attached Encrustation**

Distance (ft): **79.6**  
Structural Grade: **0**  
O&M Grade: **2**  
Clock Start/From: **7**  
Clock To: **11**  
1st Value:  
2nd Value:  
Value Percent: **5.000**  
Continuous Index:  
Within 8" of Joint: **YES**  
Remarks:
