Profile/Photo Observation Report

Street:	2nd Street	Flow Control:	Not Controlled
City:	Hobart, IN	Year Renewed:	
Location:	Light Highway	Tape/Media #:	DEP 110
Purpose:	Routine Assessment	Dia/Height:	6"
Use:	Sanitary	Material:	VCP
Drain Area:		Lining:	
Category:	NA		
Comment:	YES501824 Submittal 2		
Location Details:		Direction of Survey:	Upstream
US MH:	M-405-065	DS MH:	M-405-066
		Total Length Surveyed (ft):	7.5

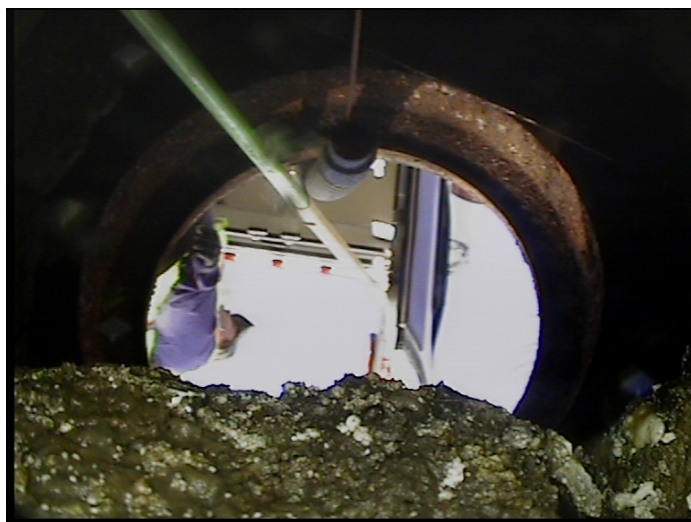
Code: **AMH**
Description: **Manhole**

Distance (ft): **.0**
Structural Grade: **0**
O&M Grade: **0**
Clock Start/From:
Clock To:
1st Value:
2nd Value:
Value Percent:
Continuous Index:
Within 8" of Joint: **NO**
Remarks: **M-405-066**

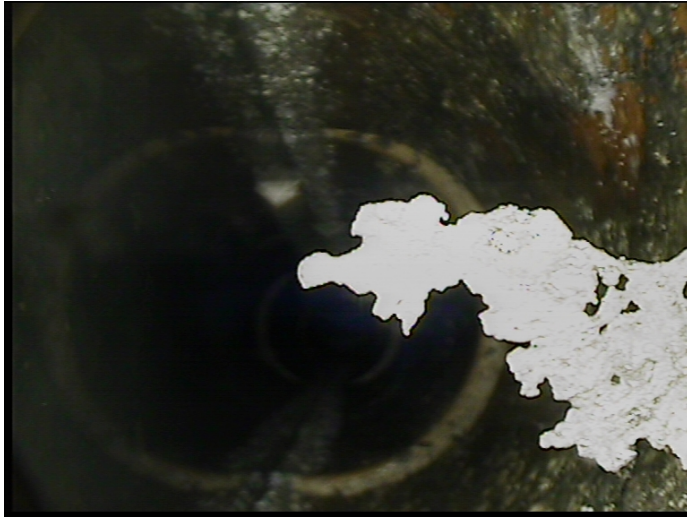
Code: **MWL**
Description: **Water Level**

Distance (ft): **.0**
Structural Grade: **0**
O&M Grade: **0**
Clock Start/From:
Clock To:
1st Value:
2nd Value:
Value Percent: **10.000**
Continuous Index:
Within 8" of Joint: **NO**
Remarks:

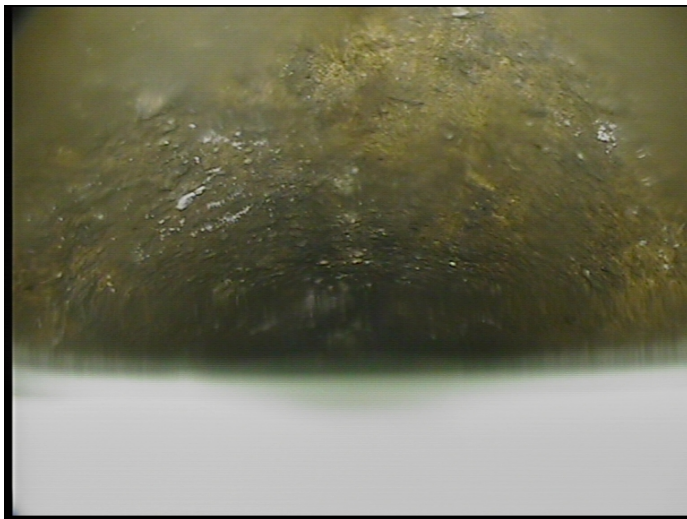
Code: **MSA**
Description: **Abandoned Survey**

Distance (ft): **7.3**
Structural Grade: **0**
O&M Grade: **0**
Clock Start/From:
Clock To:
1st Value:
2nd Value:
Value Percent:
Continuous Index:
Within 8" of Joint: **NO**
Remarks: **Underwater debris**
