Profile/Photo Observation Report

Date:	04/27/2018	Weather:		Coding:	PACP 6.0
Pipe Length (ft):		Owner:	City of Hobart	Pre Clean:	No Pre-Cleaning
P.O.#:	112	Surveyor:	M. Pielacha	PSR:	P-405-065-066
Customer:	City of Hobart	Clean Date:		Shape:	C

Street:	2nd Street	Flow Control:	Not Controlled
City:	Hobart, IN	Year Renewed:	
Location:	Light Highway	Tape/Media #:	DEP 112
Purpose:	Routine Assessment	Dia/Height:	6"
Use:	Sanitary	Material:	VCP
Drain Area:		Lining:	
Category:	NA		
Comment:	YES501824 Submittal 2		
Location Details:		Direction of Survey:	Downstream
US MH:	M-405-065	DS MH:	M-405-066
		Total Length Surveyed (ft):	5.5

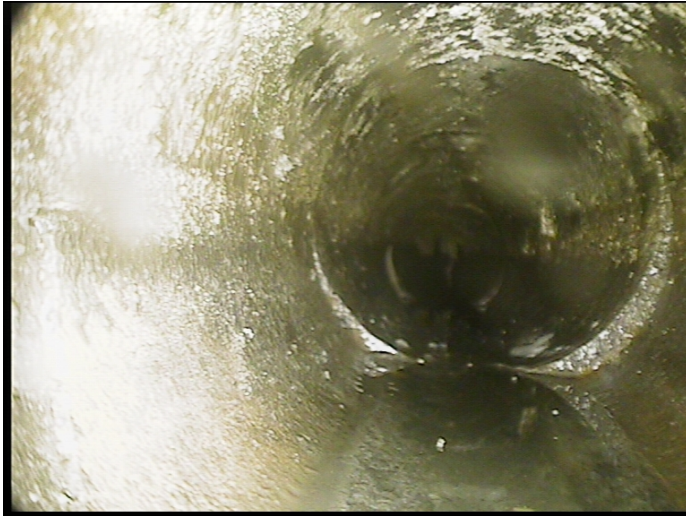
Code:	AMH
Description:	Manhole
Distance (ft):	.0
Structural Grade:	0
O&M Grade:	0
Clock Start/From:	
Clock To:	
1st Value:	
2nd Value:	
Value Percent:	
Continuous Index:	
Within 8" of Joint:	NO
Remarks:	M-405-065

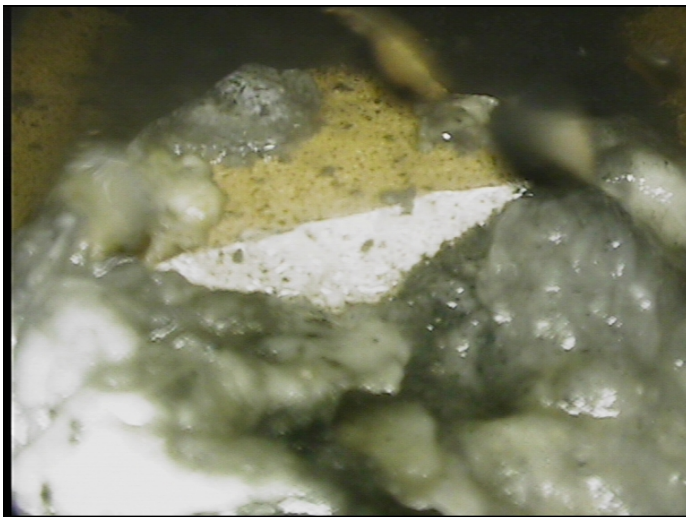
Code: **MWL**
Description: **Water Level**

Distance (ft): **.0**
Structural Grade: **0**
O&M Grade: **0**
Clock Start/From:
Clock To:
1st Value:
2nd Value:
Value Percent: **10.000**
Continuous Index:
Within 8" of Joint: **NO**
Remarks:

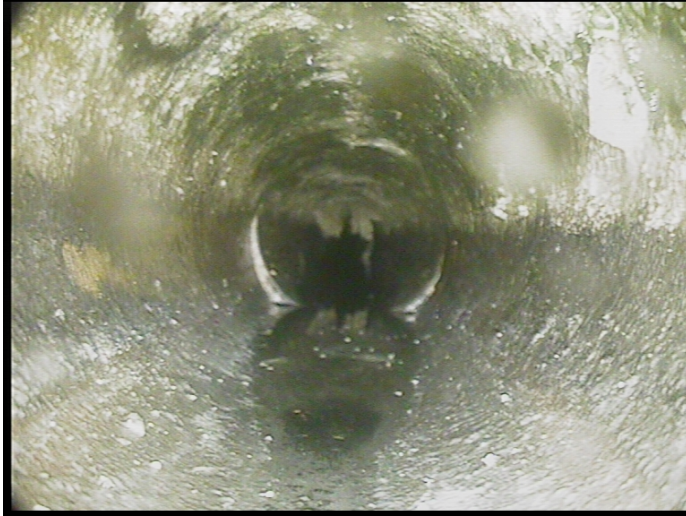
Code: **OBR**
Description: **Obstacle Rocks**

Distance (ft): **4.0**
Structural Grade: **0**
O&M Grade: **2**
Clock Start/From: **6**
Clock To:
1st Value:
2nd Value:
Value Percent: **10.000**
Continuous Index:
Within 8" of Joint: **NO**
Remarks:
