Profile/Photo Observation Report

Date:	11/04/2021	Weather:		Coding:	PACP 7.0
Pipe Length (ft):	98.1	Owner:	City of Hobart	Pre Clean:	Heavy Cleaning
P.O.#:	YES502259	Surveyor:	S. Bucklin	PSR:	P-405-065-066
Customer:	City of Hobart	Clean Date:	11/04/2021	Shape:	C

Street:	West 2nd Street	Flow Control:	Not Controlled
City:	Hobart, IN	Year Renewed:	
Location:		Tape/Media #:	
Purpose:	Routine Assessment	Dia/Height:	8"
Use:	Sanitary Sewage Pipe	Material:	VCP
Drain Area:		Lining:	None
Category:	NA		
Comment:			
Location Details:		Direction of Survey:	Downstream
US MH:	M-405-066	DS MH:	M-405-065
		Total Length Surveyed (ft):	98.1

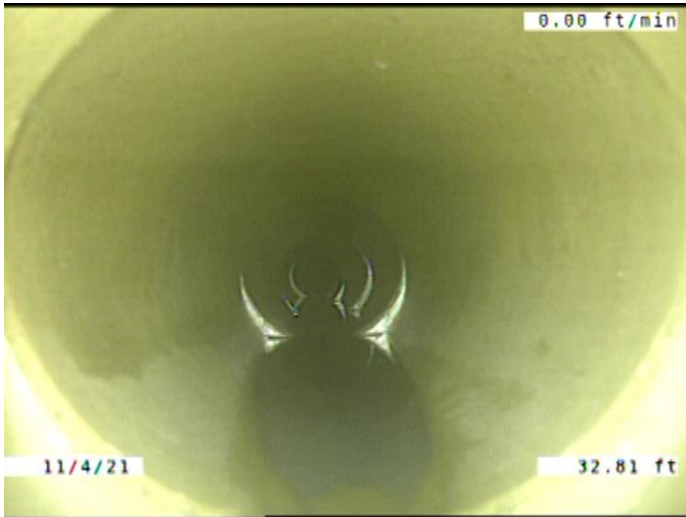
Code: **MWLS**
Description: **Miscellaneous Water Level Sag**

Distance (ft): **32.8**
Structural Grade: **2**
O&M Grade: **0**
Clock Start/From:
Clock To:
1st Value:
2nd Value:
Value Percent: **10.000**
Continuous Index: **F01**
Within 8" of Joint: **NO**
Remarks:

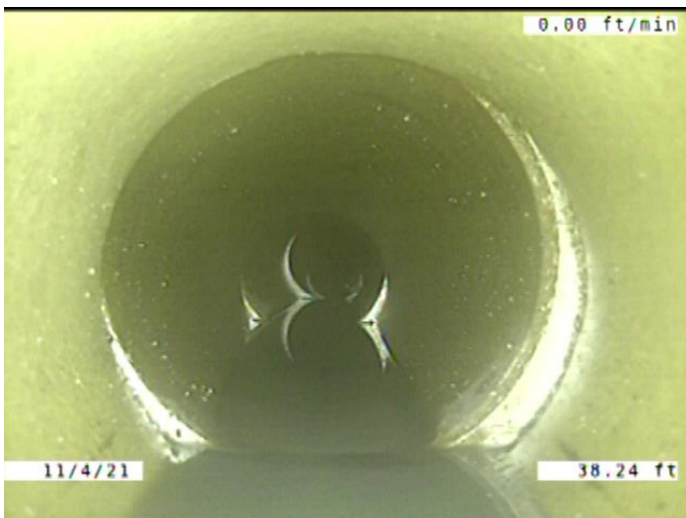
Code: **MWLS**
Description: **Miscellaneous Water Level Sag**

Distance (ft): **38.2**
Structural Grade: **2**
O&M Grade: **0**
Clock Start/From:
Clock To:
1st Value:
2nd Value:
Value Percent: **5.000**
Continuous Index: **S03**
Within 8" of Joint: **NO**
Remarks:

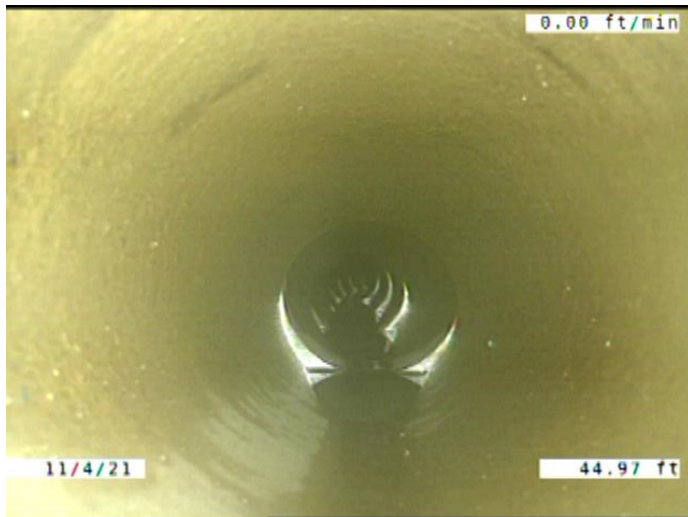
Code: **MWLS**
Description: **Miscellaneous Water Level Sag**

Distance (ft): **45.0**
Structural Grade: **2**
O&M Grade: **0**
Clock Start/From:
Clock To:
1st Value:
2nd Value:
Value Percent: **5.000**
Continuous Index: **F03**
Within 8" of Joint: **NO**
Remarks:

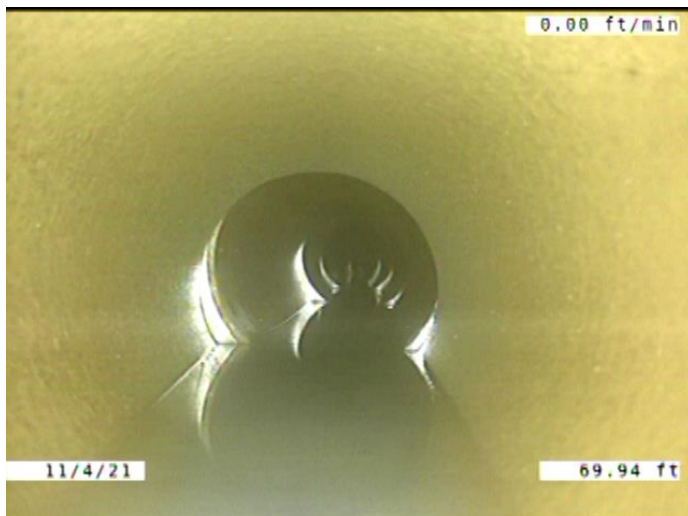
Code: **MWLS**
Description: **Miscellaneous Water Level Sag**

Distance (ft): **69.9**
Structural Grade: **2**
O&M Grade: **0**
Clock Start/From:
Clock To:
1st Value:
2nd Value:
Value Percent: **5.000**
Continuous Index: **S04**
Within 8" of Joint: **NO**
Remarks:

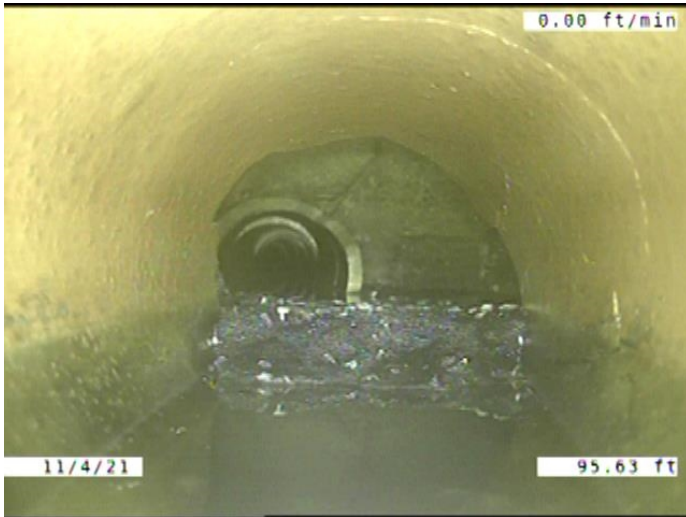
Code: **DSF**
Description: **Deposits Settled Fine**

Distance (ft): **95.6**
Structural Grade: **0**
O&M Grade: **2**
Clock Start/From: **5**
Clock To: **7**
1st Value:
2nd Value:
Value Percent: **5.000**
Continuous Index: **F02**
Within 8" of Joint: **YES**
Remarks:

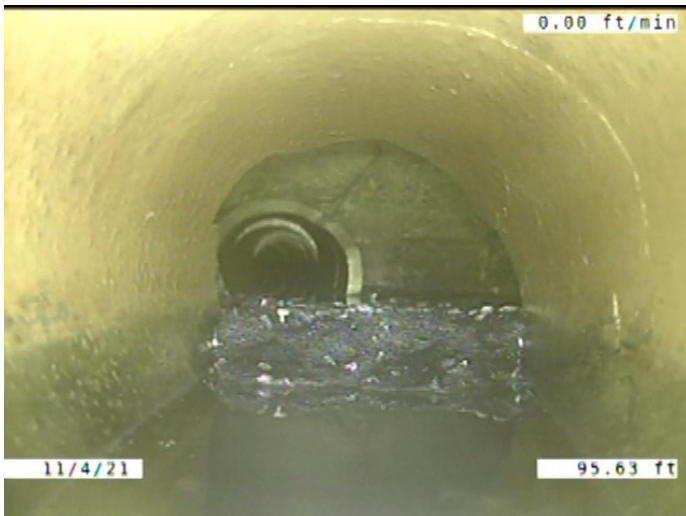
Code: **MWLS**
Description: **Miscellaneous Water Level Sag**

Distance (ft): **95.6**
Structural Grade: **2**
O&M Grade: **0**
Clock Start/From:
Clock To:
1st Value:
2nd Value:
Value Percent: **5.000**
Continuous Index: **F04**
Within 8" of Joint: **NO**
Remarks:

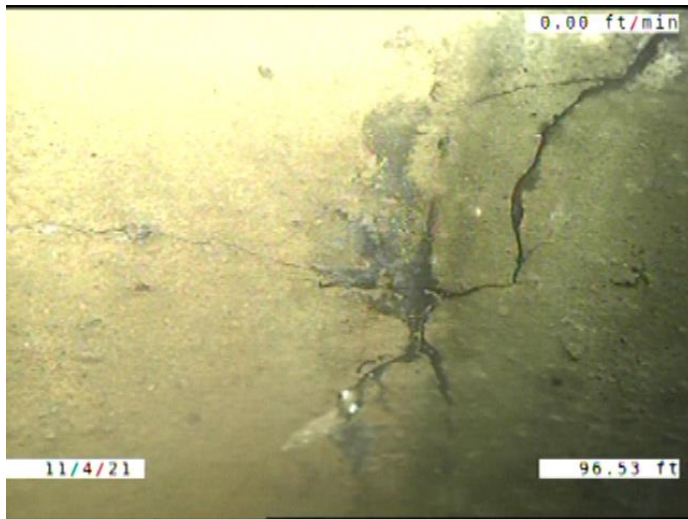
Code: **FM**
 Description: **Fracture Multiple**

Distance (ft): **96.5**
 Structural Grade: **4**
 O&M Grade: **0**
 Clock Start/From: **1**
 Clock To: **5**
 1st Value:
 2nd Value:
 Value Percent:
 Continuous Index:
 Within 8" of Joint: **YES**
 Remarks:

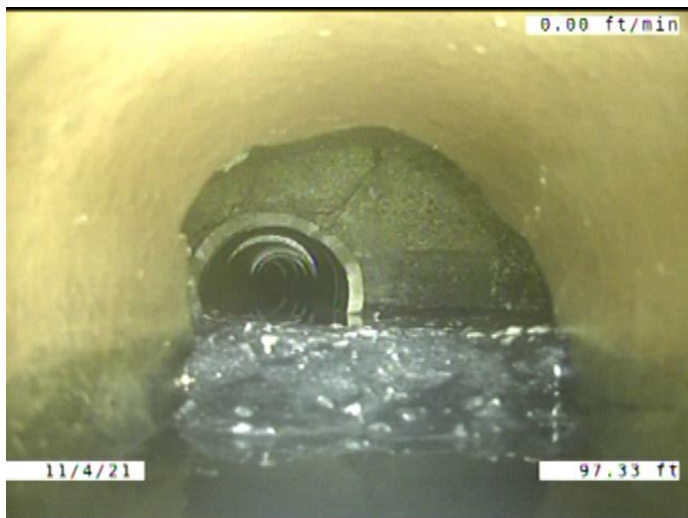
Code: **DSC**
 Description: **Deposits Settled Hard/Compacted**

Distance (ft): **97.3**
 Structural Grade: **0**
 O&M Grade: **4**
 Clock Start/From: **4**
 Clock To: **8**
 1st Value:
 2nd Value:
 Value Percent: **30.000**
 Continuous Index:
 Within 8" of Joint: **YES**
 Remarks:
