Profile/Photo Observation Report

Date:	11/04/2021	Weather:		Coding:	PACP 7.0
Pipe Length (ft):	98.1	Owner:	City of Hobart	Pre Clean:	Heavy Cleaning
P.O.#:	YES502259	Surveyor:	S. Bucklin	PSR:	P-405-065-066
Customer:	City of Hobart	Clean Date:	11/04/2021	Shape:	C

Street:	West 2nd Street	Flow Control:	Not Controlled
City:	Hobart, IN	Year Renewed:	
Location:		Tape/Media #:	
Purpose:	Routine Assessment	Dia/Height:	8"
Use:	Sanitary Sewage Pipe	Material:	VCP
Drain Area:		Lining:	None
Category:	NA		
Comment:			
Location Details:		Direction of Survey:	Downstream
US MH:	M-405-066	DS MH:	M-405-065
		Total Length Surveyed (ft):	98.1

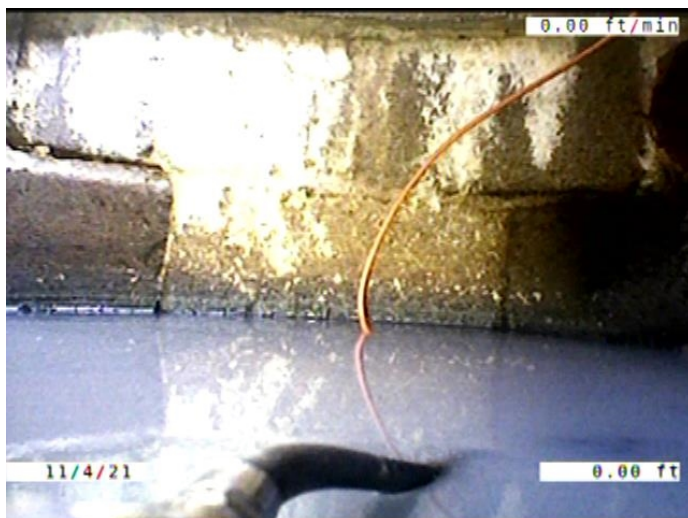
Code: **AMH**
 Description: **Manhole**

Distance (ft): **.0**
 Structural Grade: **0**
 O&M Grade: **0**
 Clock Start/From:
 Clock To:
 1st Value:
 2nd Value:
 Value Percent:
 Continuous Index:
 Within 8" of Joint: **NO**
 Remarks: **M-405-066**

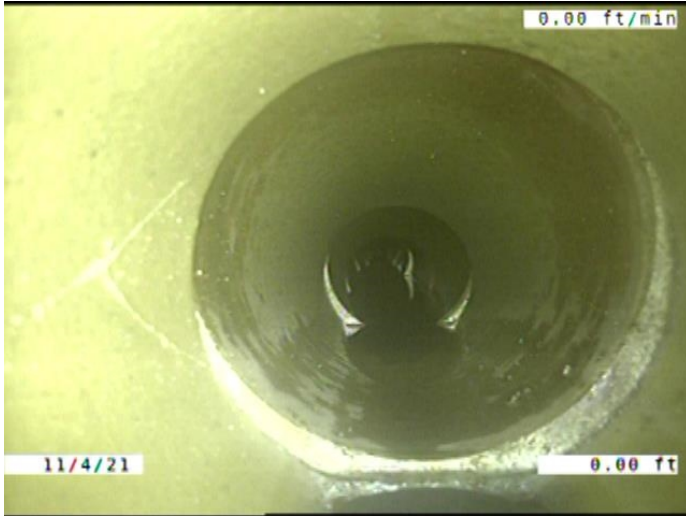
Code: **MWL**
Description: **Miscellaneous Water Level**

Distance (ft): **.0**
Structural Grade: **0**
O&M Grade: **0**
Clock Start/From:
Clock To:
1st Value:
2nd Value:
Value Percent: **5.000**
Continuous Index:
Within 8" of Joint: **NO**
Remarks:

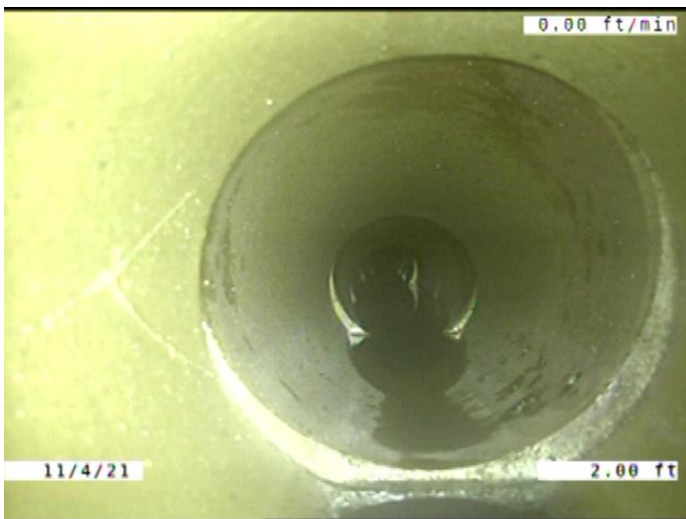
Code: **MGO**
Description: **Miscellaneous General Observation**

Distance (ft): **2.0**
Structural Grade: **0**
O&M Grade: **0**
Clock Start/From:
Clock To:
1st Value:
2nd Value:
Value Percent:
Continuous Index:
Within 8" of Joint: **NO**
Remarks: **DROP INTO THE MANHOLE. HAD TO START IN THE PIPE. RIGHT (NORTH)**

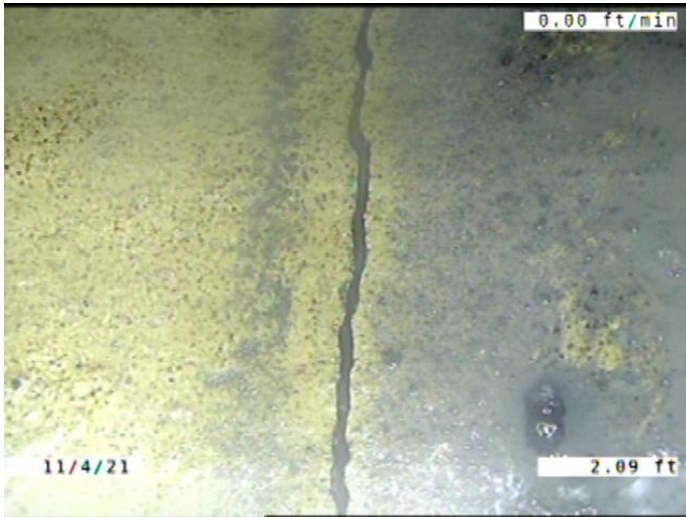
Code: **FM**
 Description: **Fracture Multiple**

Distance (ft): **2.1**
 Structural Grade: **4**
 O&M Grade: **0**
 Clock Start/From: **12**
 Clock To: **12**
 1st Value:
 2nd Value:
 Value Percent:
 Continuous Index:
 Within 8" of Joint: **YES**
 Remarks:

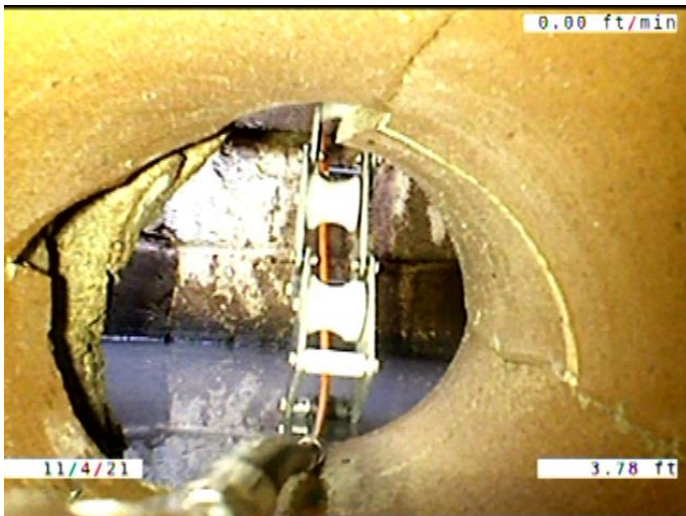
Code: **MGP**
 Description: **Miscellaneous General Photograph**

Distance (ft): **3.8**
 Structural Grade: **0**
 O&M Grade: **0**
 Clock Start/From: **12**
 Clock To: **6**
 1st Value:
 2nd Value:
 Value Percent:
 Continuous Index:
 Within 8" of Joint: **NO**
 Remarks: **BACK UP VIEW OF THE MANHOLE/
 MISSING PIPE WALL**

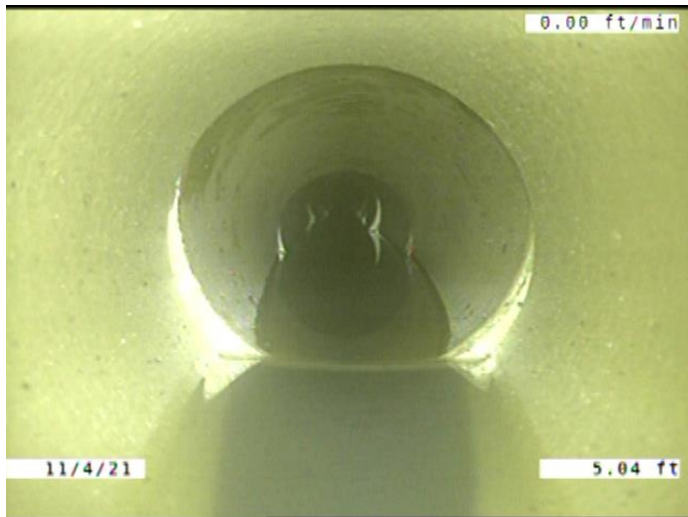
Code: **MWLS**
Description: **Miscellaneous Water Level Sag**

Distance (ft): **5.0**
Structural Grade: **2**
O&M Grade: **0**
Clock Start/From:
Clock To:
1st Value:
2nd Value:
Value Percent: **10.000**
Continuous Index: **S01**
Within 8" of Joint: **NO**
Remarks:

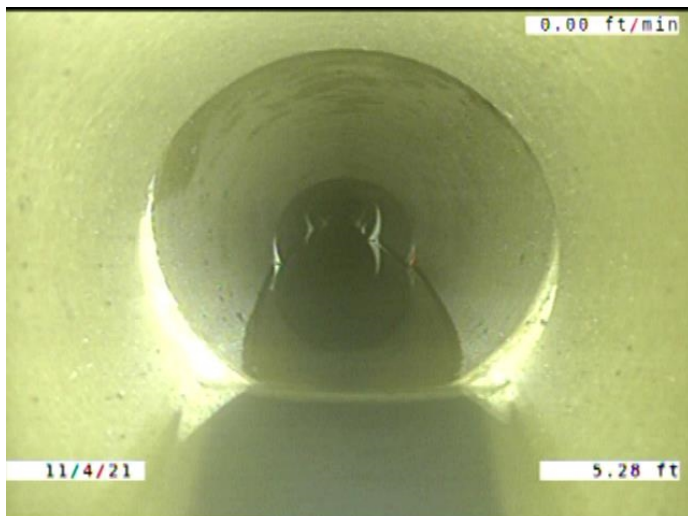
Code: **DSF**
Description: **Deposits Settled Fine**

Distance (ft): **5.3**
Structural Grade: **0**
O&M Grade: **2**
Clock Start/From: **5**
Clock To: **7**
1st Value:
2nd Value:
Value Percent: **5.000**
Continuous Index: **S02**
Within 8" of Joint: **YES**
Remarks:

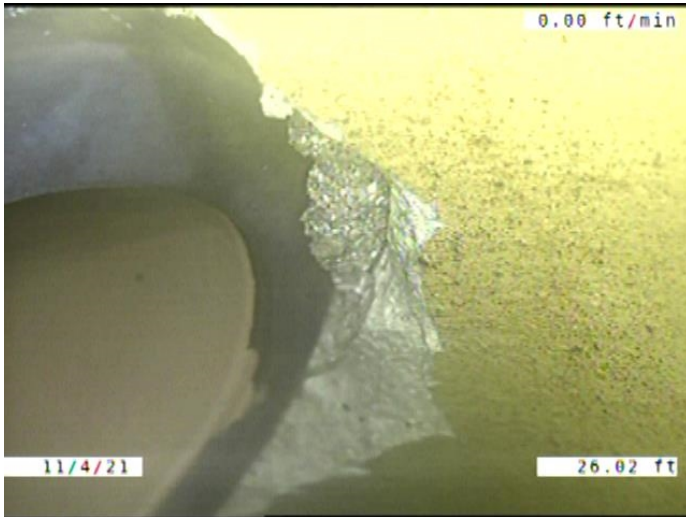
Code: **SSS**
Description: **Surface Damage Surface Spalling**

Distance (ft): **26.0**
Structural Grade: **2**
O&M Grade: **0**
Clock Start/From: **10**
Clock To:
1st Value:
2nd Value:
Value Percent:
Continuous Index:
Within 8" of Joint: **YES**
Remarks:

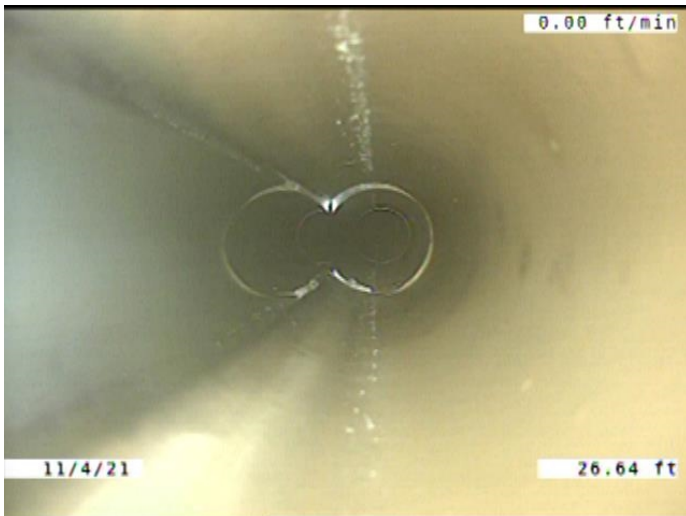
Code: **TBI**
Description: **Tap Break-in Intruding**

Distance (ft): **26.6**
Structural Grade: **0**
O&M Grade: **2**
Clock Start/From: **9**
Clock To:
1st Value: **6.000**
2nd Value: **1.000**
Value Percent:
Continuous Index:
Within 8" of Joint: **YES**
Remarks:

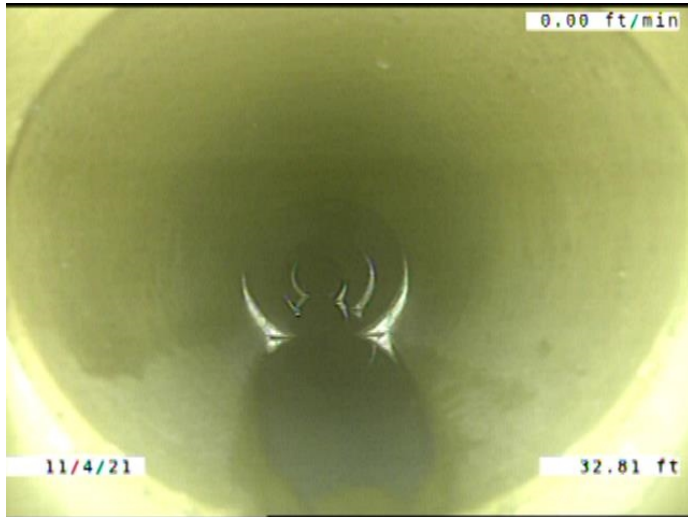
Code: **MWLS**
Description: **Miscellaneous Water Level Sag**

Distance (ft): **32.8**
Structural Grade: **2**
O&M Grade: **0**
Clock Start/From:
Clock To:
1st Value:
2nd Value:
Value Percent: **10.000**
Continuous Index: **F01**
Within 8" of Joint: **NO**
Remarks:

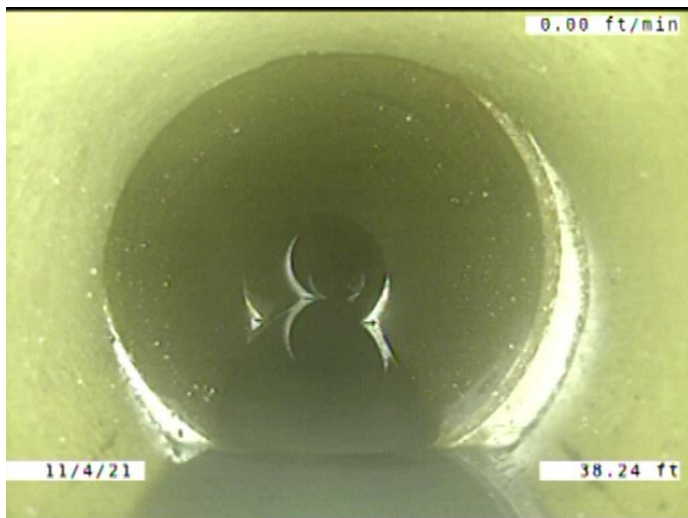
Code: **MWLS**
Description: **Miscellaneous Water Level Sag**

Distance (ft): **38.2**
Structural Grade: **2**
O&M Grade: **0**
Clock Start/From:
Clock To:
1st Value:
2nd Value:
Value Percent: **5.000**
Continuous Index: **S03**
Within 8" of Joint: **NO**
Remarks:

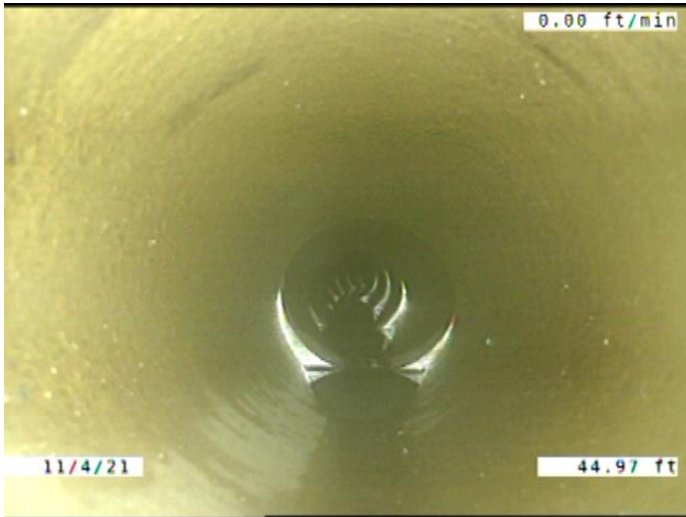
Code: **MWLS**
Description: **Miscellaneous Water Level Sag**

Distance (ft): **45.0**
Structural Grade: **2**
O&M Grade: **0**
Clock Start/From:
Clock To:
1st Value:
2nd Value:
Value Percent: **5.000**
Continuous Index: **F03**
Within 8" of Joint: **NO**
Remarks:

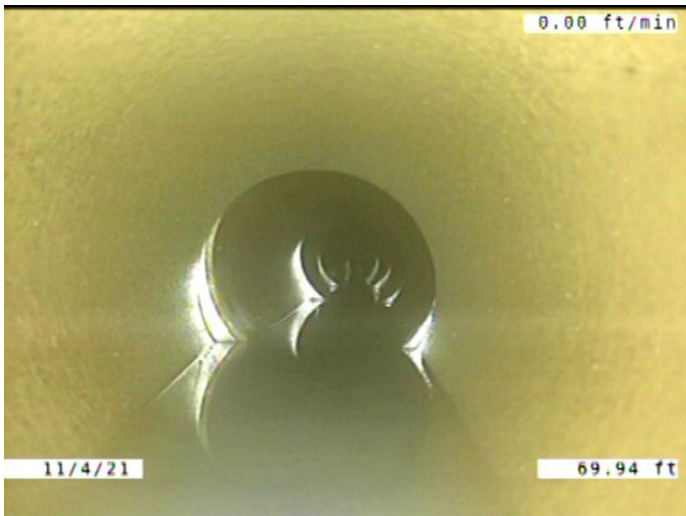
Code: **MWLS**
Description: **Miscellaneous Water Level Sag**

Distance (ft): **69.9**
Structural Grade: **2**
O&M Grade: **0**
Clock Start/From:
Clock To:
1st Value:
2nd Value:
Value Percent: **5.000**
Continuous Index: **S04**
Within 8" of Joint: **NO**
Remarks:

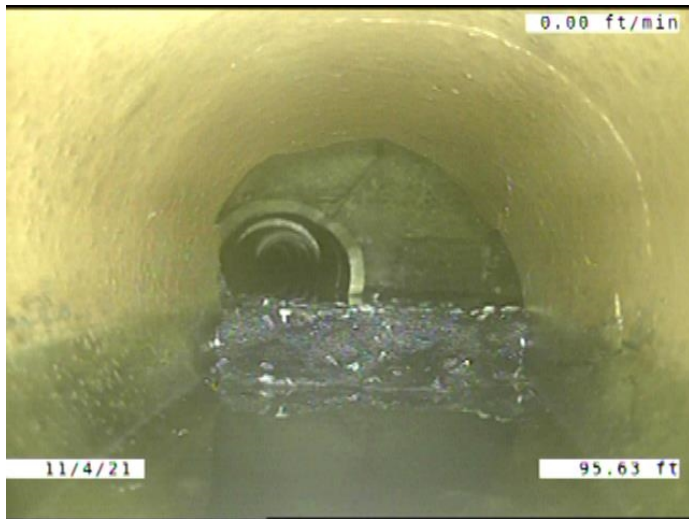
Code: **DSF**
 Description: **Deposits Settled Fine**

Distance (ft): **95.6**
 Structural Grade: **0**
 O&M Grade: **2**
 Clock Start/From: **5**
 Clock To: **7**
 1st Value:
 2nd Value:
 Value Percent: **5.000**
 Continuous Index: **F02**
 Within 8" of Joint: **YES**
 Remarks:

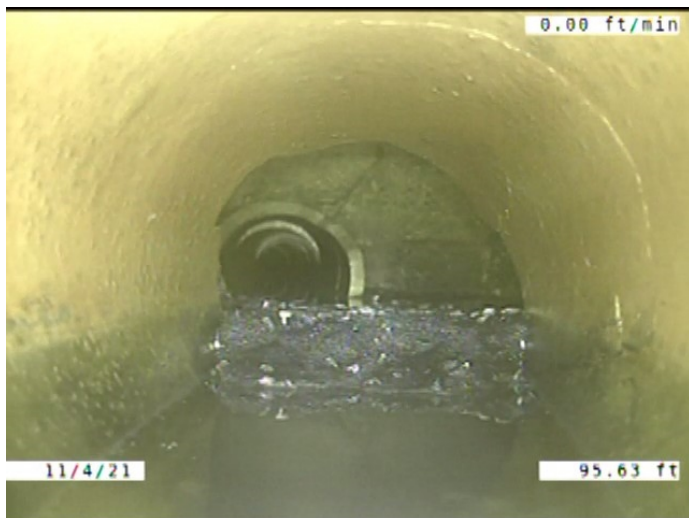
Code: **MWLS**
 Description: **Miscellaneous Water Level Sag**

Distance (ft): **95.6**
 Structural Grade: **2**
 O&M Grade: **0**
 Clock Start/From:
 Clock To:
 1st Value:
 2nd Value:
 Value Percent: **5.000**
 Continuous Index: **F04**
 Within 8" of Joint: **NO**
 Remarks:

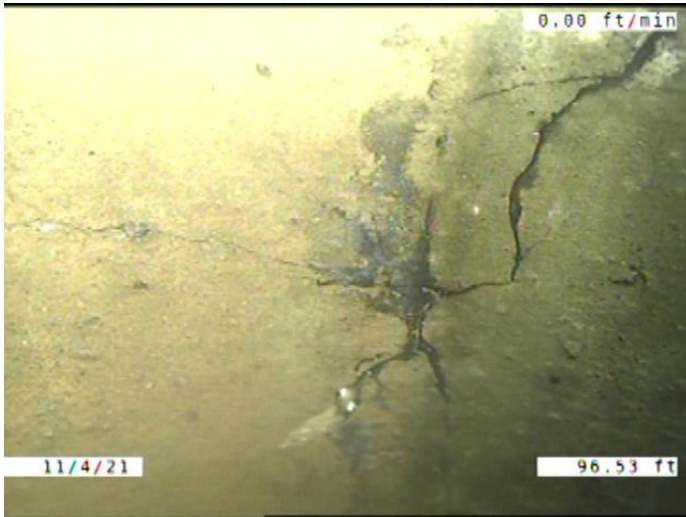
Code: **FM**
 Description: **Fracture Multiple**

Distance (ft): **96.5**
 Structural Grade: **4**
 O&M Grade: **0**
 Clock Start/From: **1**
 Clock To: **5**
 1st Value:
 2nd Value:
 Value Percent:
 Continuous Index:
 Within 8" of Joint: **YES**
 Remarks:

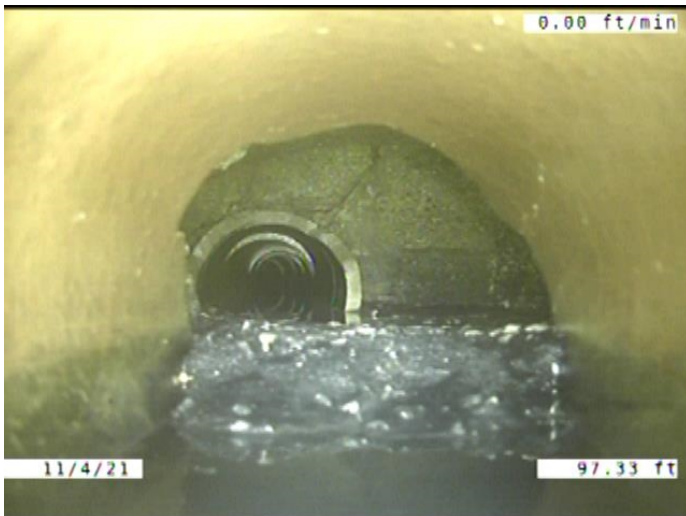
Code: **DSC**
 Description: **Deposits Settled Hard/Compacted**

Distance (ft): **97.3**
 Structural Grade: **0**
 O&M Grade: **4**
 Clock Start/From: **4**
 Clock To: **8**
 1st Value:
 2nd Value:
 Value Percent: **30.000**
 Continuous Index:
 Within 8" of Joint: **YES**
 Remarks:

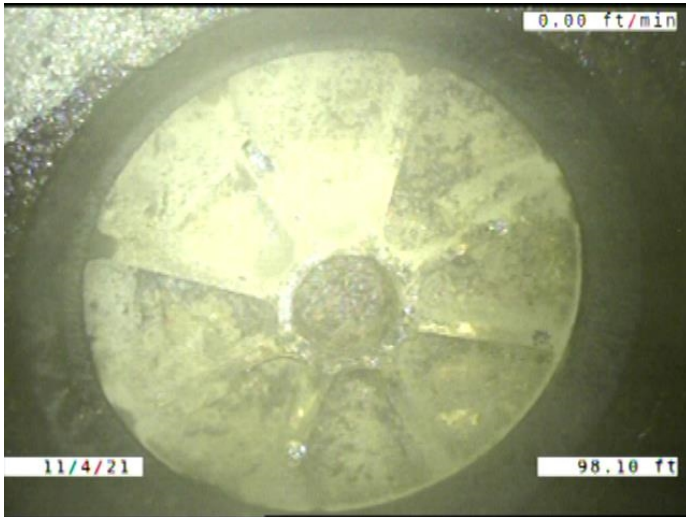
Code:	AMH
Description:	Manhole
Distance (ft):	98.1
Structural Grade:	0
O&M Grade:	0
Clock Start/From:	
Clock To:	
1st Value:	
2nd Value:	
Value Percent:	
Continuous Index:	
Within 8" of Joint:	NO
Remarks:	M-405-065
