## Profile/Photo Observation Report

Date:	<b>11/04/2021</b>	Weather:		Coding:	<b>PACP 7.0</b>
Pipe Length (ft):	<b>75.0</b>	Owner:	<b>City of Hobart</b>	Pre Clean:	<b>No Pre-Cleaning</b>
P.O.#:	<b>YES502259</b>	Surveyor:	<b>S. Bucklin</b>	PSR:	
Customer:	<b>City of Hobart</b>	Clean Date:		Shape:	<b>C</b>

Street:	<b>West 2nd Street</b>	Flow Control:	<b>Not Controlled</b>
City:	<b>Hobart, IN</b>	Year Renewed:	
Location:		Tape/Media #:	
Purpose:	<b>Routine Assessment</b>	Dia/Height:	<b>6"</b>
Use:	<b>Sanitary Sewage Pipe</b>	Material:	<b>PVC</b>
Drain Area:		Lining:	<b>None</b>
Category:	<b>NA</b>		
Comment:			
Location Details:		Direction of Survey:	<b>Upstream</b>
US MH:	<b>UNK S WILSON ST</b>	DS MH:	<b>M-405-065</b>
		Total Length Surveyed (ft):	<b>68.8</b>

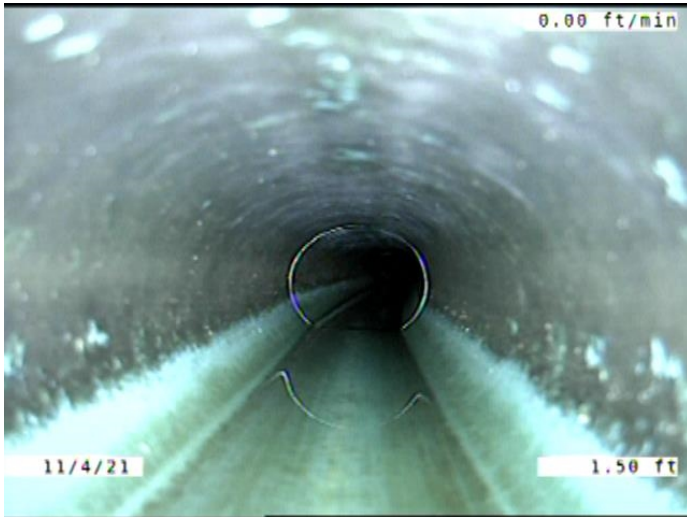
Code: **MGO**  
 Description: **Miscellaneous General Observation**

Distance (ft): **1.5**  
 Structural Grade: **0**  
 O&M Grade: **0**  
 Clock Start/From:  
 Clock To:  
 1st Value:  
 2nd Value:  
 Value Percent:  
 Continuous Index:  
 Within 8" of Joint: **NO**  
 Remarks: **DROP INTO THE MANHOLE. HAD TO START IN THE PIPE.**

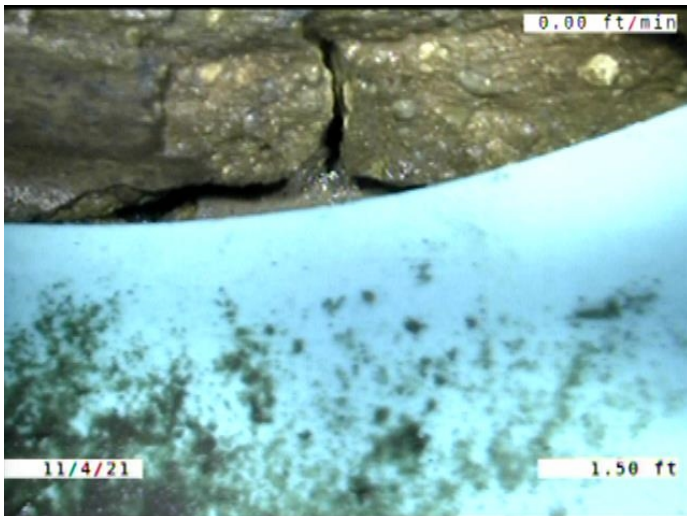
Code: **JOMD**  
 Description: **Joint Offset Medium Defective**

Distance (ft): **1.5**  
 Structural Grade: **3**  
 O&M Grade: **0**  
 Clock Start/From:  
 Clock To:  
 1st Value:  
 2nd Value:  
 Value Percent:  
 Continuous Index:  
 Within 8" of Joint: **NO**  
 Remarks:

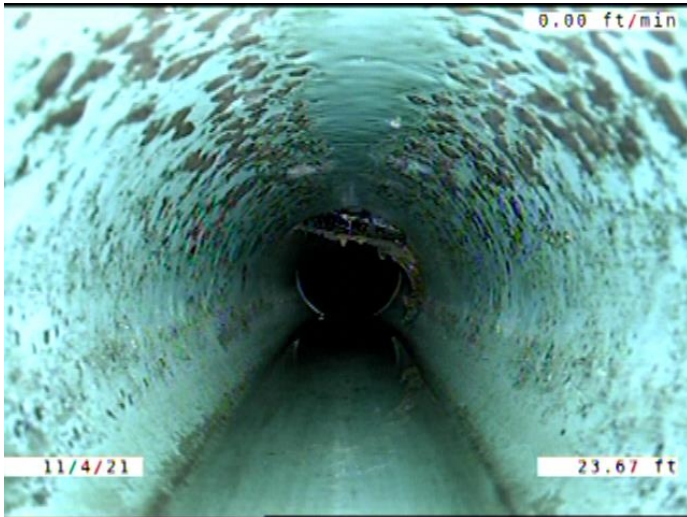
Code: **MWLS**  
 Description: **Miscellaneous Water Level Sag**

Distance (ft): **23.7**  
 Structural Grade: **2**  
 O&M Grade: **0**  
 Clock Start/From:  
 Clock To:  
 1st Value:  
 2nd Value:  
 Value Percent: **5.000**  
 Continuous Index: **S01**  
 Within 8" of Joint: **NO**  
 Remarks:

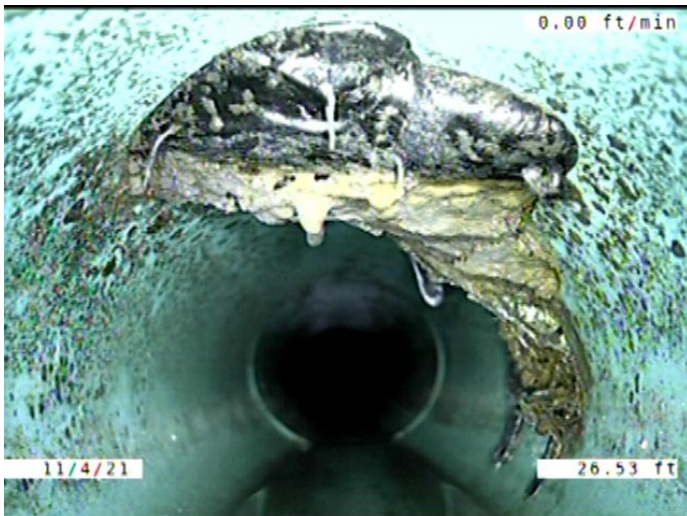
Code: **DAE**  
 Description: **Deposits Attached Encrustation**

Distance (ft): **26.5**  
 Structural Grade: **0**  
 O&M Grade: **3**  
 Clock Start/From: **11**  
 Clock To: **4**  
 1st Value:  
 2nd Value:  
 Value Percent: **15.000**  
 Continuous Index:  
 Within 8" of Joint: **NO**  
 Remarks:

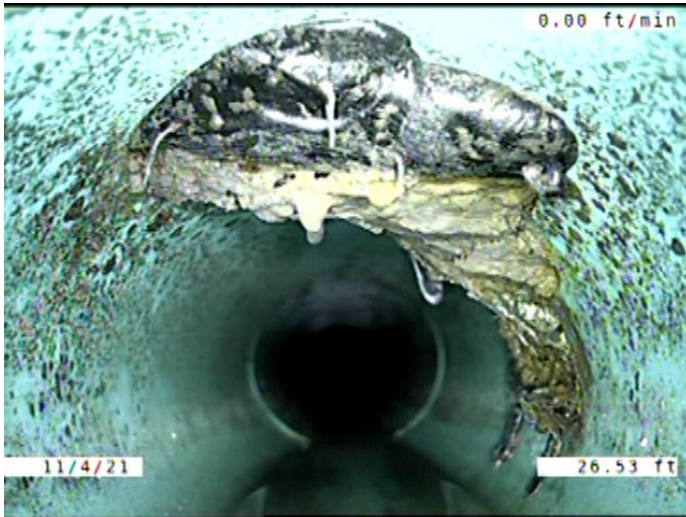
Code: **ISZ**  
 Description: **Intruding Sealing Material Other**

Distance (ft): **26.5**  
 Structural Grade: **0**  
 O&M Grade: **2**  
 Clock Start/From: **11**  
 Clock To: **5**  
 1st Value:  
 2nd Value:  
 Value Percent: **5.000**  
 Continuous Index:  
 Within 8" of Joint: **NO**  
 Remarks: **SEALER/ TAR**

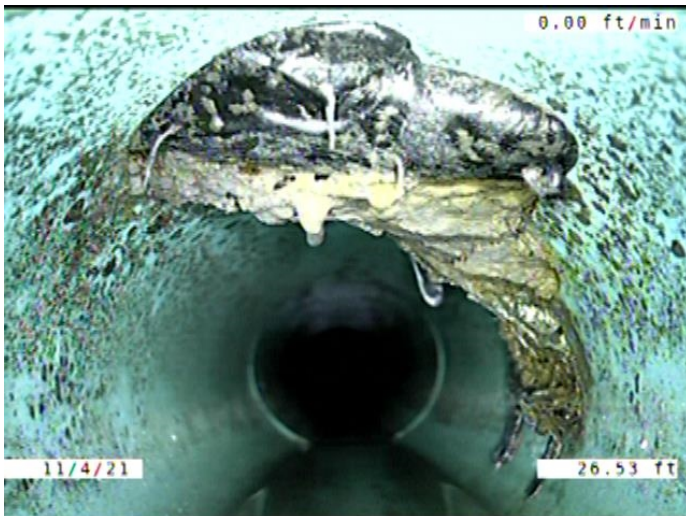
Code: **RPPD**  
 Description: **Point Repair Patch Patch Defective**

Distance (ft): **26.5**  
 Structural Grade: **4**  
 O&M Grade: **0**  
 Clock Start/From: **11**  
 Clock To: **2**  
 1st Value:  
 2nd Value:  
 Value Percent:  
 Continuous Index:  
 Within 8" of Joint: **NO**  
 Remarks: **Hole or abandoned tap filled with sealant. DAE leaking through.**

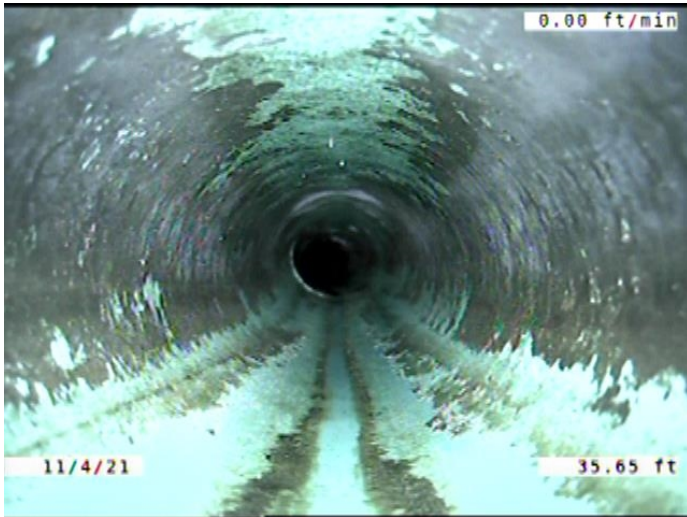
Code: **MWLS**  
 Description: **Miscellaneous Water Level Sag**

Distance (ft): **35.6**  
 Structural Grade: **2**  
 O&M Grade: **0**  
 Clock Start/From:  
 Clock To:  
 1st Value:  
 2nd Value:  
 Value Percent: **5.000**  
 Continuous Index: **F01**  
 Within 8" of Joint: **NO**  
 Remarks:

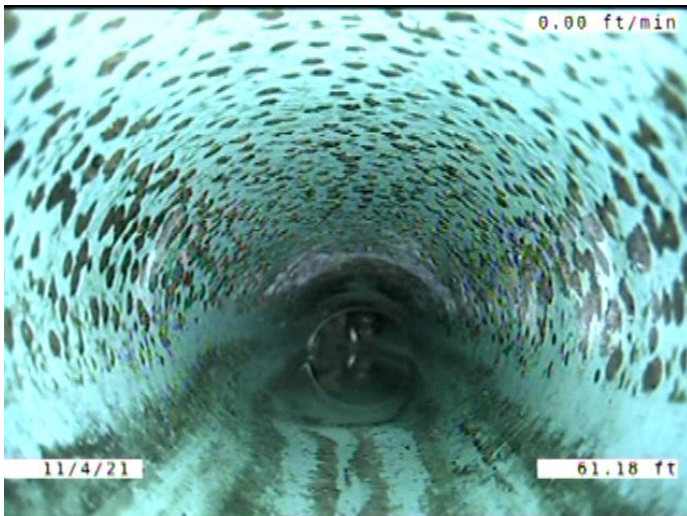
Code: **LD**  
 Description: **Line Down**

Distance (ft): **61.2**  
 Structural Grade: **0**  
 O&M Grade: **1**  
 Clock Start/From:  
 Clock To:  
 1st Value:  
 2nd Value:  
 Value Percent: **10.000**  
 Continuous Index:  
 Within 8" of Joint: **NO**  
 Remarks:

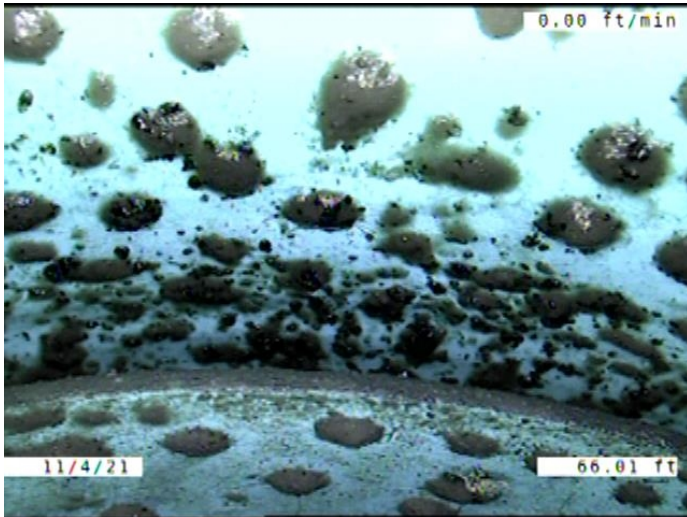
Code: **JAM**  
 Description: **Joint Angular Medium**

Distance (ft): **66.0**  
 Structural Grade: **3**  
 O&M Grade: **0**  
 Clock Start/From:  
 Clock To:  
 1st Value:  
 2nd Value:  
 Value Percent:  
 Continuous Index:  
 Within 8" of Joint: **NO**  
 Remarks:

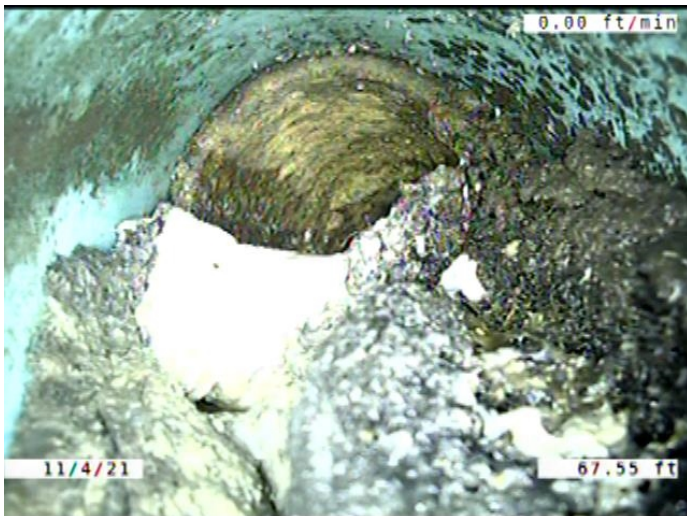
Code: **RMC**  
 Description: **Roots Medium Connection**

Distance (ft): **67.5**  
 Structural Grade: **0**  
 O&M Grade: **3**  
 Clock Start/From: **2**  
 Clock To: **8**  
 1st Value:  
 2nd Value:  
 Value Percent: **50.000**  
 Continuous Index:  
 Within 8" of Joint: **NO**  
 Remarks:

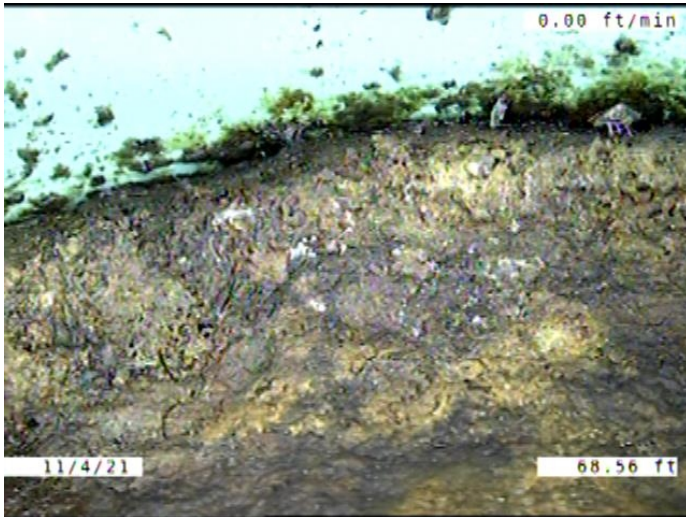
Code: **MMC**  
 Description: **Miscellaneous Material Change**

Distance (ft): **68.6**  
 Structural Grade: **0**  
 O&M Grade: **0**  
 Clock Start/From:  
 Clock To:  
 1st Value:  
 2nd Value:  
 Value Percent:  
 Continuous Index:  
 Within 8" of Joint: **NO**  
 Remarks: **PVC TO CAST IRON**

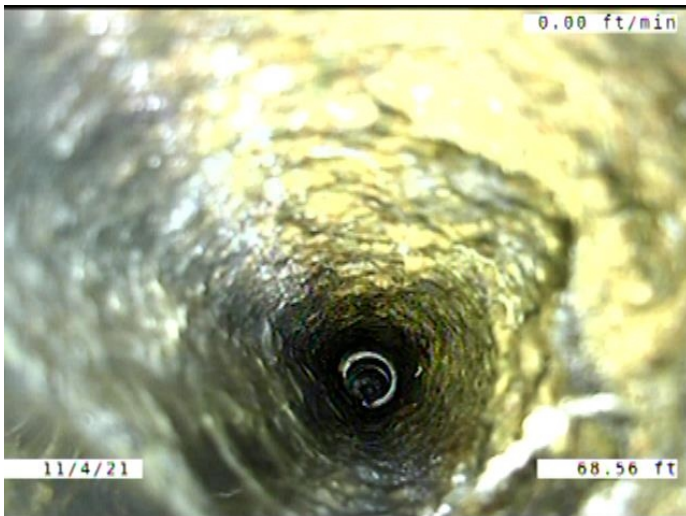
Code: **MSC**  
 Description: **Miscellaneous Shape/Size Change**

Distance (ft): **68.6**  
 Structural Grade: **0**  
 O&M Grade: **0**  
 Clock Start/From:  
 Clock To:  
 1st Value: **4.000**  
 2nd Value:  
 Value Percent:  
 Continuous Index:  
 Within 8" of Joint: **NO**  
 Remarks:
