## Profile/Photo Observation Report

Date:	<b>04/27/2018</b>	Weather:		Coding:	<b>PACP 6.0</b>
Pipe Length (ft):		Owner:	<b>City of Hobart</b>	Pre Clean:	<b>No Pre-Cleaning</b>
P.O.#:	<b>109</b>	Surveyor:	<b>M. Pielacha</b>	PSR:	<b>P-405-067-066</b>
Customer:	<b>City of Hobart</b>	Clean Date:		Shape:	<b>C</b>

Street:	<b>2nd Street</b>	Flow Control:	<b>Not Controlled</b>
City:	<b>Hobart, IN</b>	Year Renewed:	
Location:	<b>Light Highway</b>	Tape/Media #:	<b>DEP 109</b>
Purpose:	<b>Routine Assessment</b>	Dia/Height:	<b>6"</b>
Use:	<b>Sanitary</b>	Material:	<b>VCP</b>
Drain Area:		Lining:	
Category:	<b>NA</b>		
Comment:	<b>YES501824 Submittal 2</b>		
Location Details:		Direction of Survey:	<b>Downstream</b>
US MH:	<b>M-405-066</b>	DS MH:	<b>M-405-067</b>
		Total Length Surveyed (ft):	<b>2.5</b>

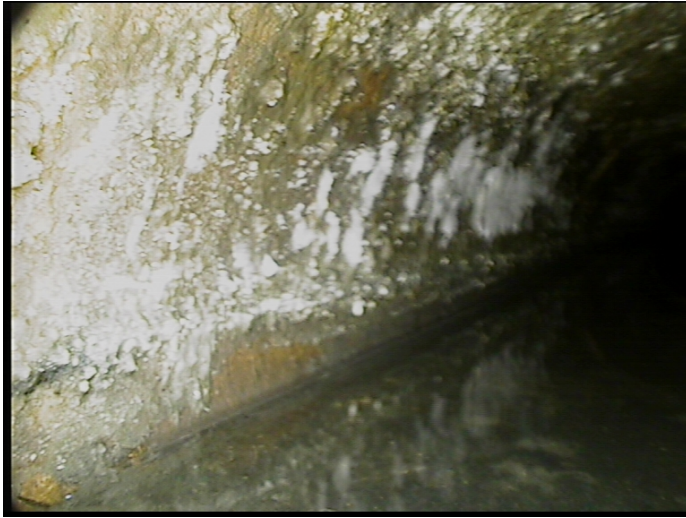
Code:	AMH
Description:	Manhole
Distance (ft):	.0
Structural Grade:	0
O&M Grade:	0
Clock Start/From:	
Clock To:	
1st Value:	
2nd Value:	
Value Percent:	
Continuous Index:	
Within 8" of Joint:	NO
Remarks:	M-405-066

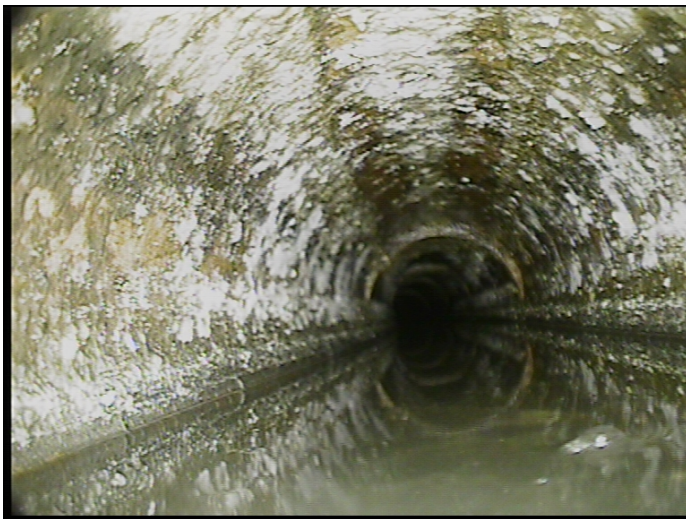
Code: **MWL**  
Description: **Water Level**

Distance (ft): **.0**  
Structural Grade: **0**  
O&M Grade: **0**  
Clock Start/From:  
Clock To:  
1st Value:  
2nd Value:  
Value Percent: **10.000**  
Continuous Index:  
Within 8" of Joint: **NO**  
Remarks:

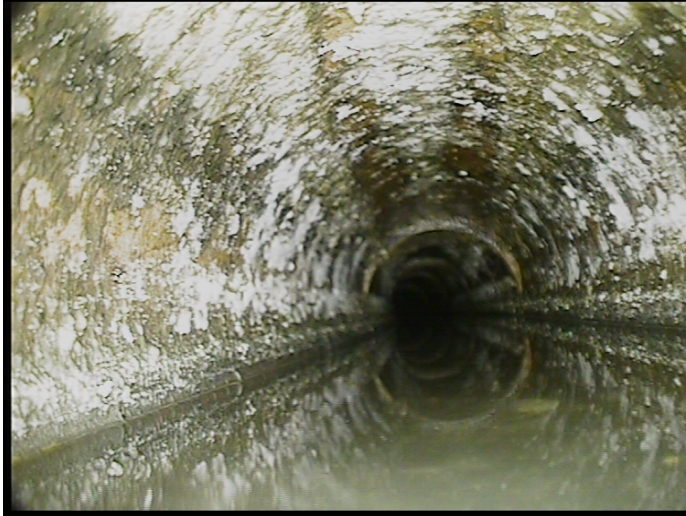
Code: **DSF**  
Description: **Deposits Settled Fine**

Distance (ft): **2.3**  
Structural Grade: **0**  
O&M Grade: **2**  
Clock Start/From: **5**  
Clock To: **7**  
1st Value:  
2nd Value:  
Value Percent: **10.000**  
Continuous Index:  
Within 8" of Joint: **YES**  
Remarks:
