Profile/Photo Observation Report

Street:	2nd Street	Flow Control:	Not Controlled
City:	Hobart, IN	Year Renewed:	
Location:	Light Highway	Tape/Media #:	DEP 111
Purpose:	Routine Assessment	Dia/Height:	6"
Use:	Sanitary	Material:	VCP
Drain Area:		Lining:	
Category:	NA		
Comment:	YES501824 Submittal 2		
Location Details:		Direction of Survey:	Upstream
US MH:	M-405-066	DS MH:	M-405-067
		Total Length Surveyed (ft):	11.2

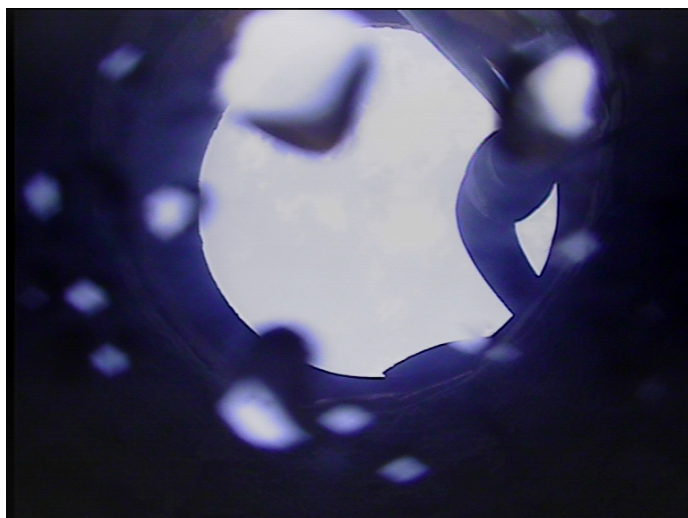
Code: **AMH**
Description: **Manhole**

Distance (ft): **.0**
Structural Grade: **0**
O&M Grade: **0**
Clock Start/From:
Clock To:
1st Value:
2nd Value:
Value Percent:
Continuous Index:
Within 8" of Joint: **NO**
Remarks: **M-405-067**

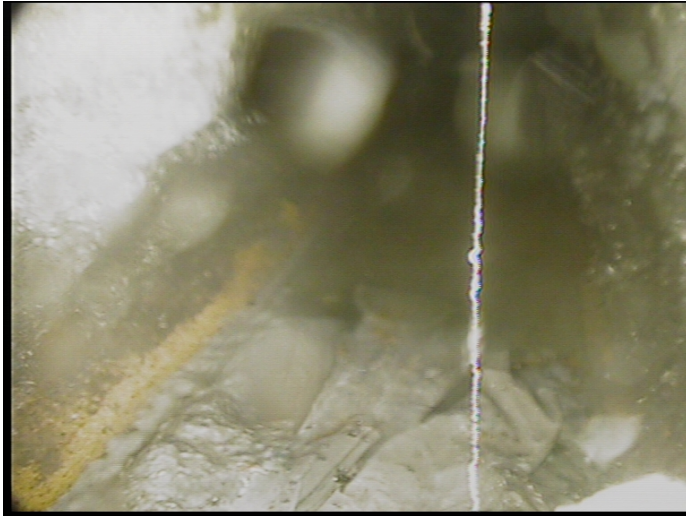
Code: **MWL**
Description: **Water Level**

Distance (ft): **.0**
Structural Grade: **0**
O&M Grade: **0**
Clock Start/From:
Clock To:
1st Value:
2nd Value:
Value Percent: **10.000**
Continuous Index:
Within 8" of Joint: **NO**
Remarks:

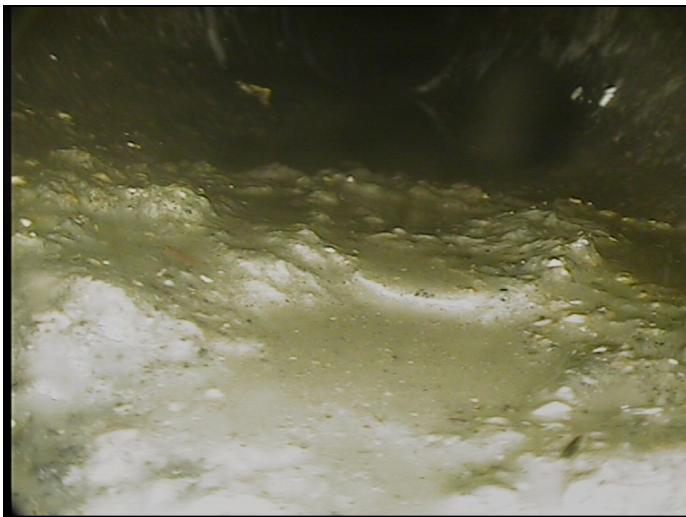
Code: **DSC**
Description: **Deposits Settled Compacted**

Distance (ft): **3.0**
Structural Grade: **0**
O&M Grade: **2**
Clock Start/From: **5**
Clock To: **7**
1st Value:
2nd Value:
Value Percent: **10.000**
Continuous Index:
Within 8" of Joint: **YES**
Remarks:

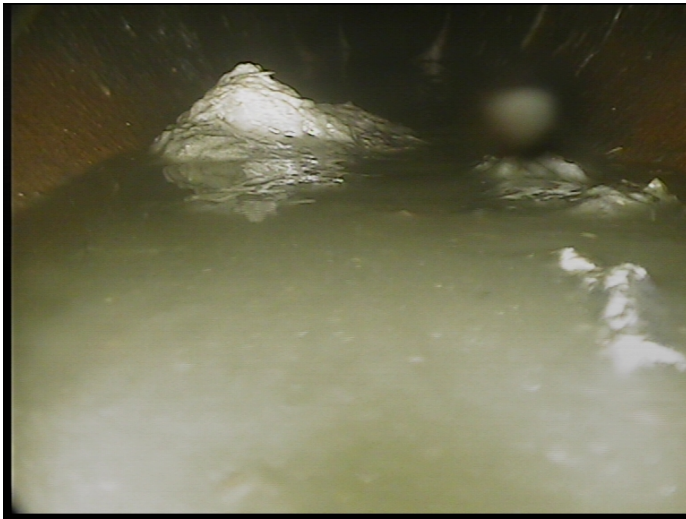
Code: **OBZ**
Description: **Obstacle Other**

Distance (ft): **10.3**
Structural Grade: **0**
O&M Grade: **2**
Clock Start/From: **5**
Clock To: **7**
1st Value:
2nd Value:
Value Percent: **10.000**
Continuous Index:
Within 8" of Joint: **NO**
Remarks: **Debris**

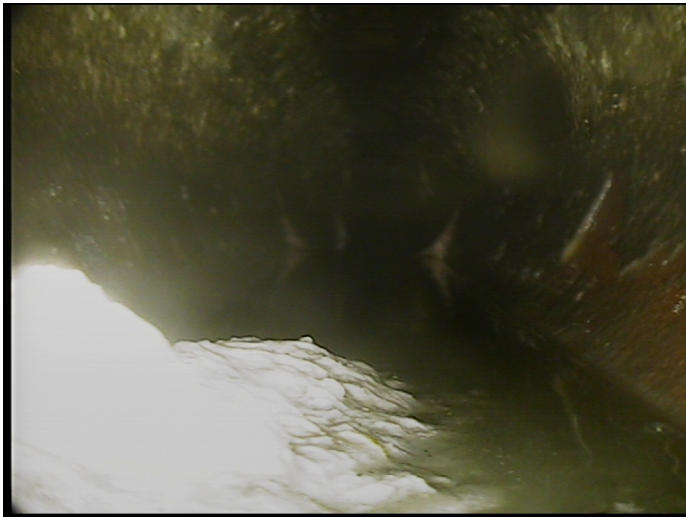
Code: **MSA**
Description: **Abandoned Survey**

Distance (ft): **10.3**
Structural Grade: **0**
O&M Grade: **0**
Clock Start/From:
Clock To:
1st Value:
2nd Value:
Value Percent:
Continuous Index:
Within 8" of Joint: **NO**
Remarks: **debris**
