Profile/Photo Observation Report

Date:	11/03/2021	Weather:		Coding:	PACP 7.0
Pipe Length (ft):	98.1	Owner:	City of Hobart	Pre Clean:	Heavy Cleaning
P.O.#:	YES502259	Surveyor:	S. Bucklin	PSR:	P-405-067-066
Customer:	City of Hobart	Clean Date:	10/29/2021	Shape:	C

Street:	West 2nd Street	Flow Control:	Not Controlled
City:	Hobart, IN	Year Renewed:	
Location:	Local rural streets with light traffic, t	Tape/Media #:	
Purpose:	Routine Assessment	Dia/Height:	8"
Use:	Sanitary Sewage Pipe	Material:	CT
Drain Area:		Lining:	None
Category:	NA		
Comment:

Location Details:		Direction of Survey:	Upstream
US MH:	M-405-066	DS MH:	M-405-067
		Total Length Surveyed (ft):	98.1

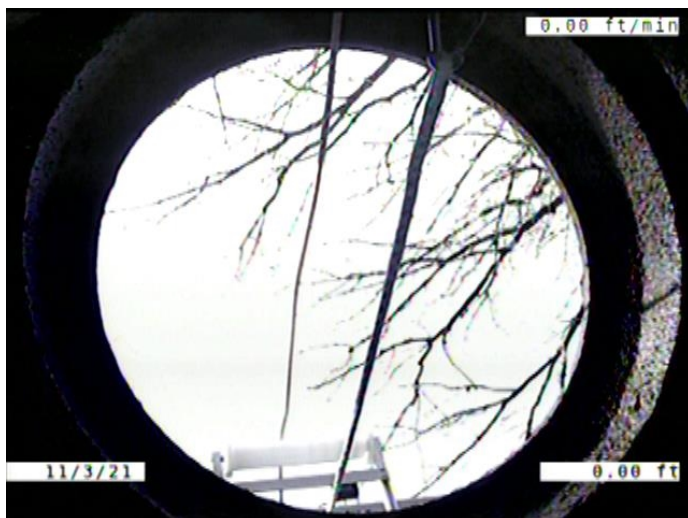
Code: **AMH**
 Description: **Manhole**

Distance (ft): **.0**
 Structural Grade: **0**
 O&M Grade: **0**
 Clock Start/From:
 Clock To:
 1st Value:
 2nd Value:
 Value Percent:
 Continuous Index:
 Within 8" of Joint: **NO**
 Remarks: **M-405-067**

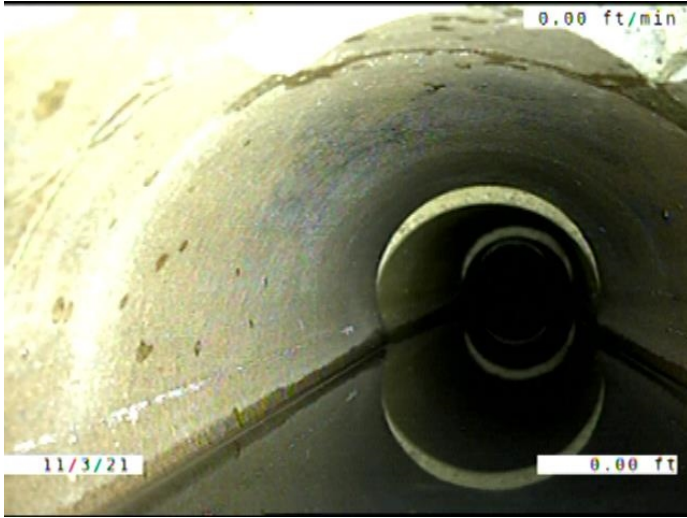
Code: **MWL**
Description: **Miscellaneous Water Level**

Distance (ft): **.0**
Structural Grade: **0**
O&M Grade: **0**
Clock Start/From:
Clock To:
1st Value:
2nd Value:
Value Percent: **15.000**
Continuous Index:
Within 8" of Joint: **NO**
Remarks:

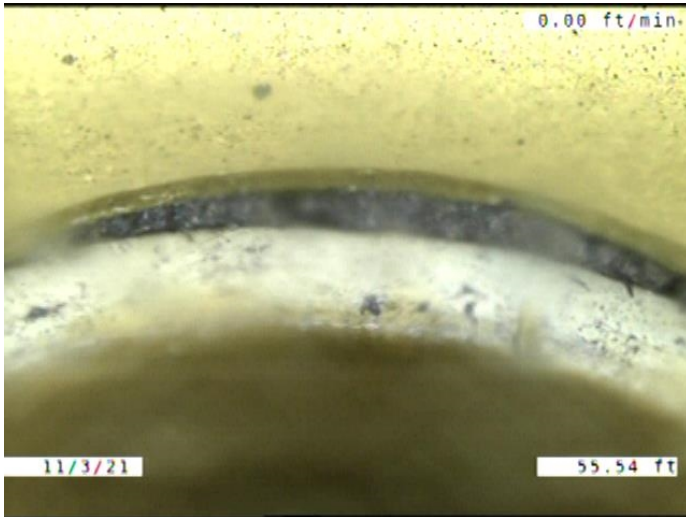
Code: **JOSD**
Description: **Joint Offset Small Defective**

Distance (ft): **55.5**
Structural Grade: **0**
O&M Grade: **0**
Clock Start/From:
Clock To:
1st Value:
2nd Value:
Value Percent:
Continuous Index:
Within 8" of Joint: **NO**
Remarks:

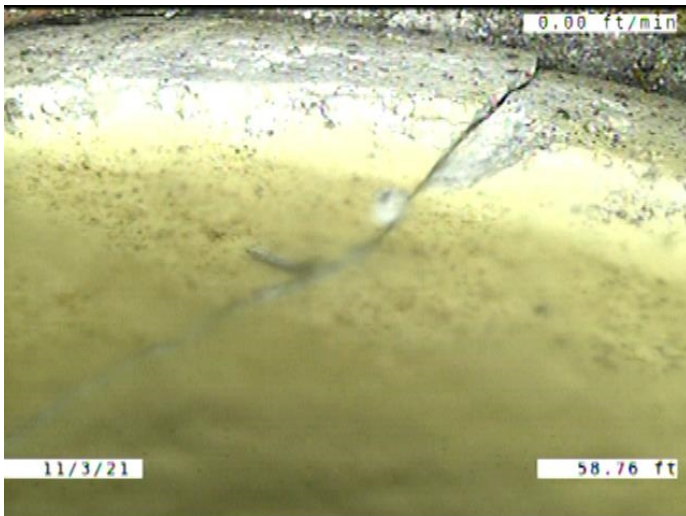
Code: **B**
Description: **Broken**

Distance (ft): **58.8**
Structural Grade: **4**
O&M Grade: **0**
Clock Start/From: **8**
Clock To: **11**
1st Value:
2nd Value:
Value Percent:
Continuous Index:
Within 8" of Joint: **YES**
Remarks:

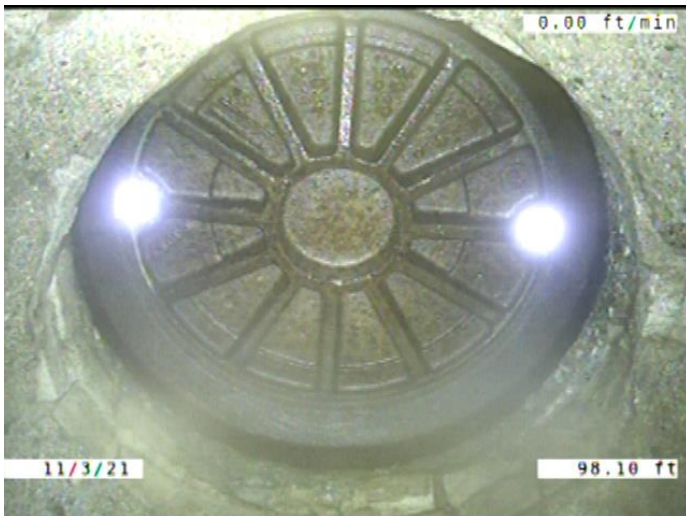
Code: **AMH**
 Description: **Manhole**

Distance (ft): **98.1**
 Structural Grade: **0**
 O&M Grade: **0**
 Clock Start/From:
 Clock To:
 1st Value:
 2nd Value:
 Value Percent:
 Continuous Index:
 Within 8" of Joint: **NO**
 Remarks: **M-405-066**
