Profile/Photo Observation Report

Date:	11/03/2021	Weather:		Coding:	PACP 7.0
Pipe Length (ft):	98.1	Owner:	City of Hobart	Pre Clean:	Heavy Cleaning
P.O.#:	YES502259	Surveyor:	S. Bucklin	PSR:	P-405-067-066
Customer:	City of Hobart	Clean Date:	10/29/2021	Shape:	C

Street:	West 2nd Street	Flow Control:	Not Controlled
City:	Hobart, IN	Year Renewed:	
Location:	Local rural streets with light traffic, t	Tape/Media #:	
Purpose:	Routine Assessment	Dia/Height:	8"
Use:	Sanitary Sewage Pipe	Material:	CT
Drain Area:		Lining:	None
Category:	NA		
Comment:			
Location Details:		Direction of Survey:	Upstream
US MH:	M-405-066	DS MH:	M-405-067
		Total Length Surveyed (ft):	98.1

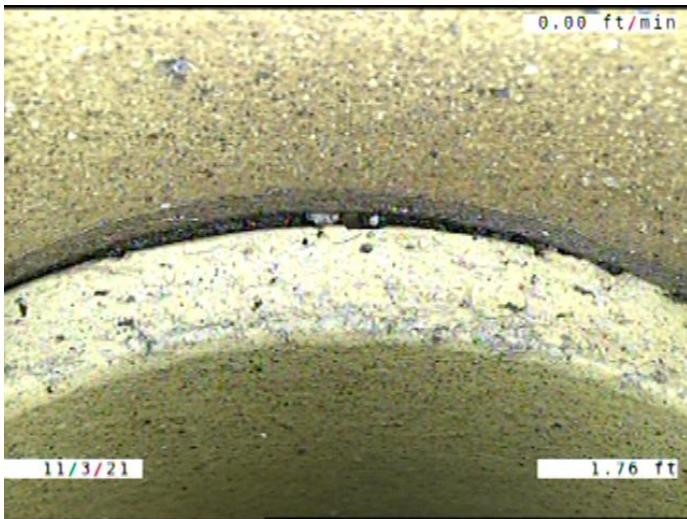
Code: **JOM**
Description: **Joint Offset Medium**

Distance (ft): **1.8**
Structural Grade: **3**
O&M Grade: **0**
Clock Start/From:
Clock To:
1st Value:
2nd Value:
Value Percent:
Continuous Index: **S01**
Within 8" of Joint: **NO**
Remarks:

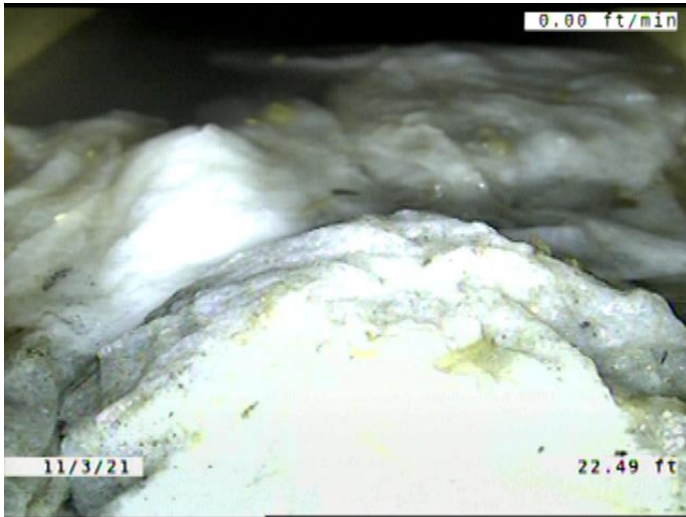
Code: **DAR**
 Description: **Deposits Attached Ragging**

Distance (ft): **22.5**
 Structural Grade: **0**
 O&M Grade: **2**
 Clock Start/From: **5**
 Clock To: **7**
 1st Value:
 2nd Value:
 Value Percent: **5.000**
 Continuous Index:
 Within 8" of Joint: **YES**
 Remarks:

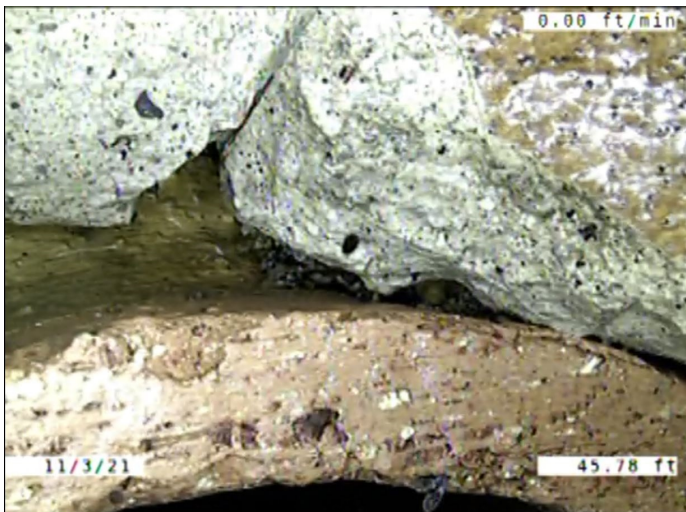
Code: **FL**
 Description: **Fracture Longitudinal**

Distance (ft): **45.8**
 Structural Grade: **3**
 O&M Grade: **0**
 Clock Start/From: **9**
 Clock To:
 1st Value:
 2nd Value:
 Value Percent:
 Continuous Index:
 Within 8" of Joint: **YES**
 Remarks:

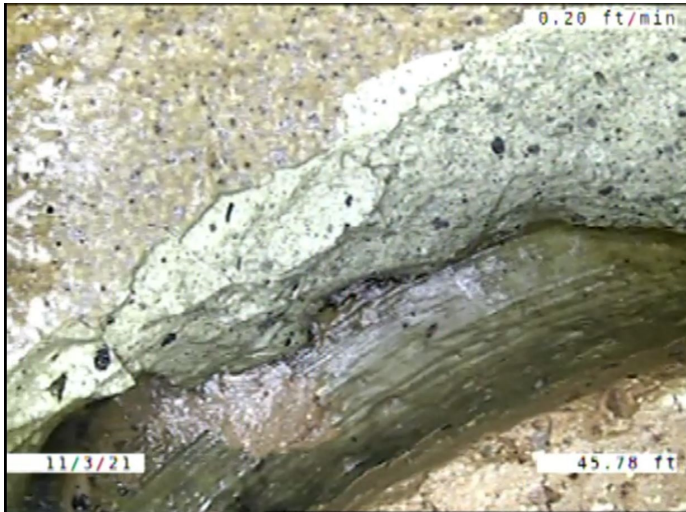
Code: **SSS**
Description: **Surface Damage Surface Spalling**

Distance (ft): **45.8**
Structural Grade: **2**
O&M Grade: **0**
Clock Start/From: **8**
Clock To: **9**
1st Value:
2nd Value:
Value Percent:
Continuous Index:
Within 8" of Joint: **NO**
Remarks:

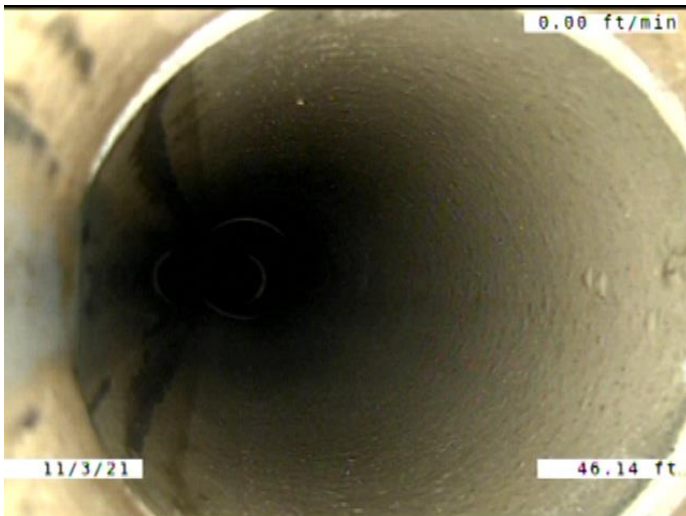
Code: **TBI**
Description: **Tap Break-in Intruding**

Distance (ft): **46.1**
Structural Grade: **0**
O&M Grade: **2**
Clock Start/From: **10**
Clock To:
1st Value: **4.000**
2nd Value: **1.000**
Value Percent:
Continuous Index:
Within 8" of Joint: **YES**
Remarks:

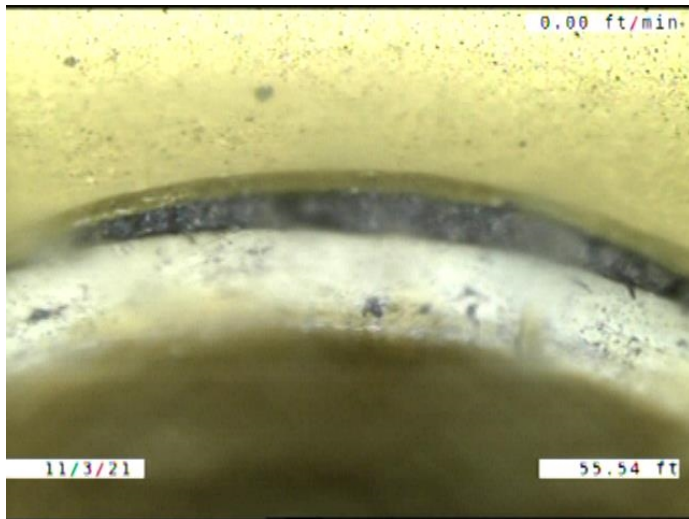
Code: **JOSD**
 Description: **Joint Offset Small Defective**

Distance (ft): **55.5**
 Structural Grade: **0**
 O&M Grade: **0**
 Clock Start/From:
 Clock To:
 1st Value:
 2nd Value:
 Value Percent:
 Continuous Index:
 Within 8" of Joint: **NO**
 Remarks:

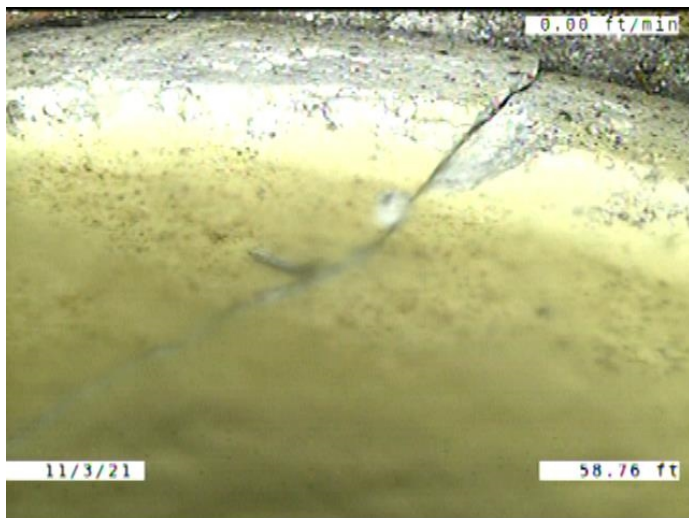
Code: **B**
 Description: **Broken**

Distance (ft): **58.8**
 Structural Grade: **4**
 O&M Grade: **0**
 Clock Start/From: **8**
 Clock To: **11**
 1st Value:
 2nd Value:
 Value Percent:
 Continuous Index:
 Within 8" of Joint: **YES**
 Remarks:

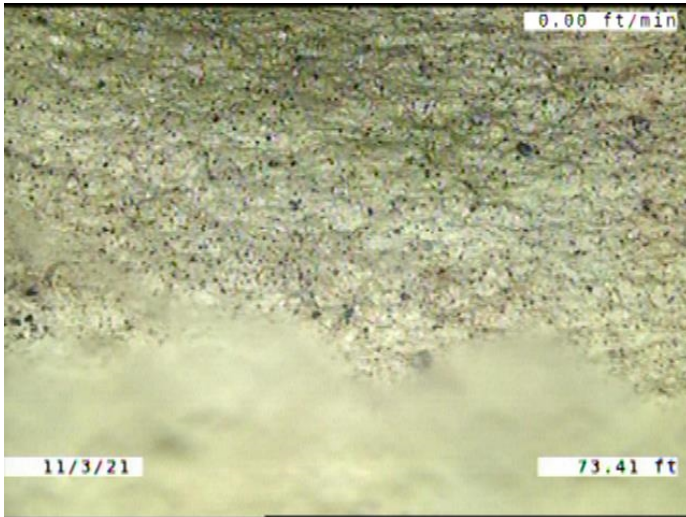
Code: **SSS**
 Description: **Surface Damage Surface Spalling**

Distance (ft): **73.4**
 Structural Grade: **2**
 O&M Grade: **0**
 Clock Start/From: **3**
 Clock To: **6**
 1st Value:
 2nd Value:
 Value Percent:
 Continuous Index:
 Within 8" of Joint: **YES**
 Remarks:

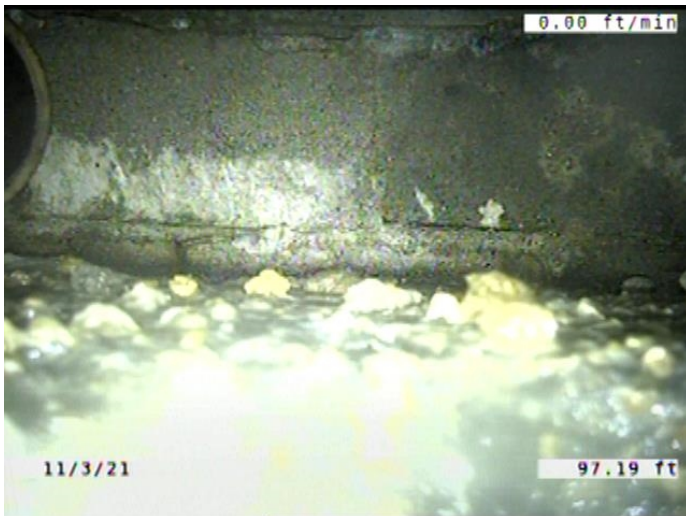
Code: **DSC**
 Description: **Deposits Settled Hard/Compacted**

Distance (ft): **97.2**
 Structural Grade: **0**
 O&M Grade: **4**
 Clock Start/From: **4**
 Clock To: **8**
 1st Value:
 2nd Value:
 Value Percent: **30.000**
 Continuous Index:
 Within 8" of Joint: **YES**
 Remarks:

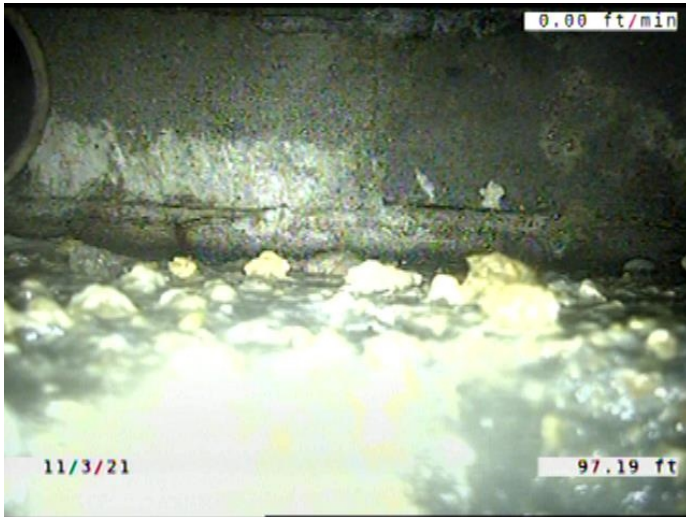
Code: **JOM**
 Description: **Joint Offset Medium**

Distance (ft): **97.2**
 Structural Grade: **3**
 O&M Grade: **0**
 Clock Start/From:
 Clock To:
 1st Value:
 2nd Value:
 Value Percent:
 Continuous Index: **F01**
 Within 8" of Joint: **NO**
 Remarks:
