Profile/Photo Observation Report

Date:	04/22/2018	Weather:		Coding:	PACP 6.0
Pipe Length (ft):	330.1	Owner:	NA	Pre Clean:	No Pre-Cleaning
P.O.#:		Surveyor:	Jen Costello	PSR:	P-405-066-068
Customer:		Clean Date:	01/01/1900	Shape:	C

Street:	W 2ND ST	Flow Control:	Not Controlled
City:	Hobart, IN	Year Renewed:	
Location:	Light Highway	Tape/Media #:	
Purpose:	Routine Assessment	Dia/Height:	10"
Use:	Sanitary	Material:	VCP
Drain Area:	NA	Lining:	
Category:	NA		
Comment:	P_C at 19 ft debris. Flow direction wrong		
Location Details:		Direction of Survey:	Upstream
US MH:	M-405-068	DS MH:	M-405-066
		Total Length Surveyed (ft):	20.4

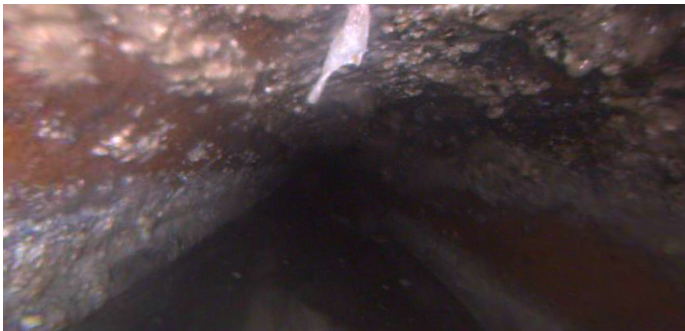
Code: **AMH**
Description: **Manhole**

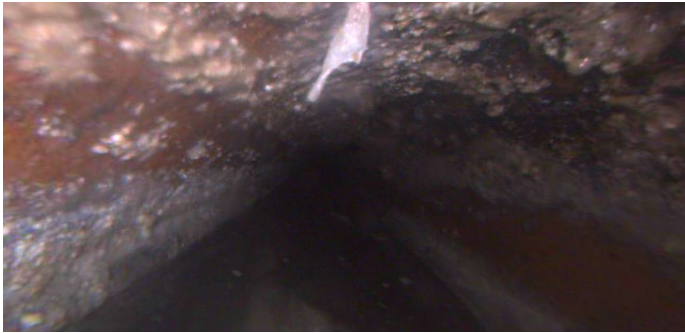
Code:	MWL
Description:	Water Level

Distance (ft):	.0
Structural Grade:	0
O&M Grade:	0
Clock Start/From:	
Clock To:	
1st Value:	
2nd Value:	
Value Percent:	10.000
Continuous Index:	
Within 8" of Joint:	NO
Remarks:

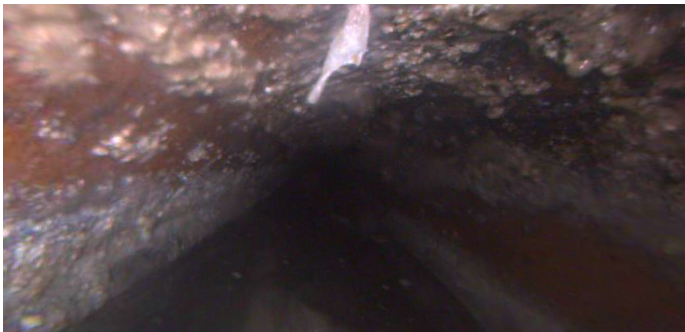
Code:	DAGS
Description:	Deposits Attached Grease

Distance (ft):	.0
Structural Grade:	0
O&M Grade:	2
Clock Start/From:	8
Clock To:	4
1st Value:	
2nd Value:	
Value Percent:	5.000
Continuous Index:	S01
Within 8" of Joint:	NO
Remarks:

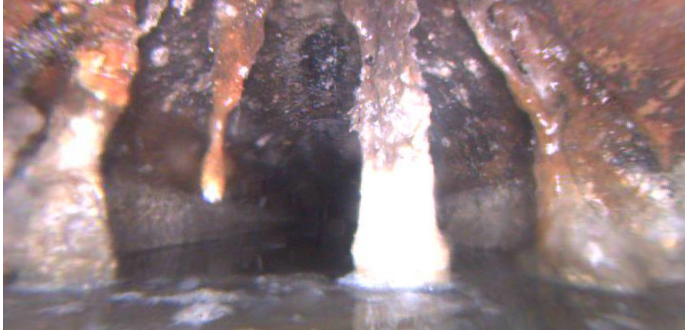
Code: **RMJ**
Description: **Roots Medium Joint**

Distance (ft): **14.8**
Structural Grade: **0**
O&M Grade: **3**
Clock Start/From: **8**
Clock To: **4**
1st Value:
2nd Value:
Value Percent: **10.000**
Continuous Index:
Within 8" of Joint: **YES**
Remarks:

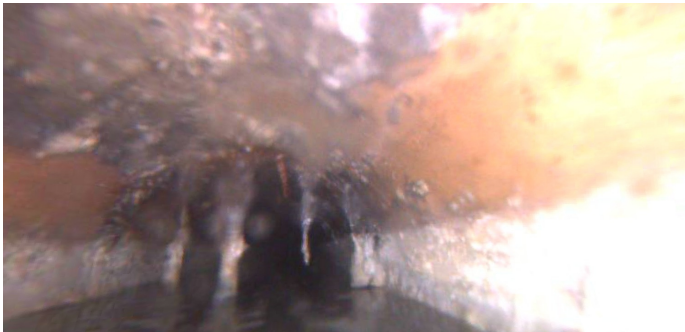
Code: **RMJ**
Description: **Roots Medium Joint**

Distance (ft): **18.1**
Structural Grade: **0**
O&M Grade: **3**
Clock Start/From: **8**
Clock To: **4**
1st Value:
2nd Value:
Value Percent: **10.000**
Continuous Index:
Within 8" of Joint: **YES**
Remarks:

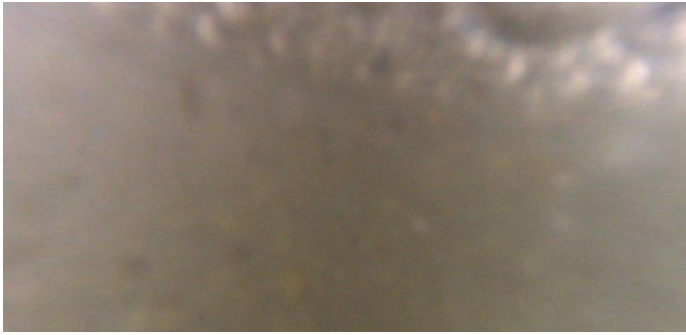
Code: **MCU**
Description: **Camera Underwater**

Distance (ft): **20.4**
Structural Grade: **0**
O&M Grade: **4**
Clock Start/From:
Clock To:
1st Value:
2nd Value:
Value Percent:
Continuous Index:
Within 8" of Joint: **NO**
Remarks:

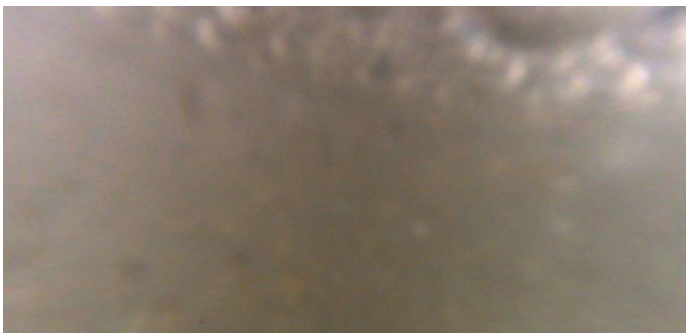
Code: **MWL**
Description: **Water Level**

Distance (ft): **20.4**
Structural Grade: **0**
O&M Grade: **0**
Clock Start/From:
Clock To:
1st Value:
2nd Value:
Value Percent: **100.000**
Continuous Index:
Within 8" of Joint: **NO**
Remarks:

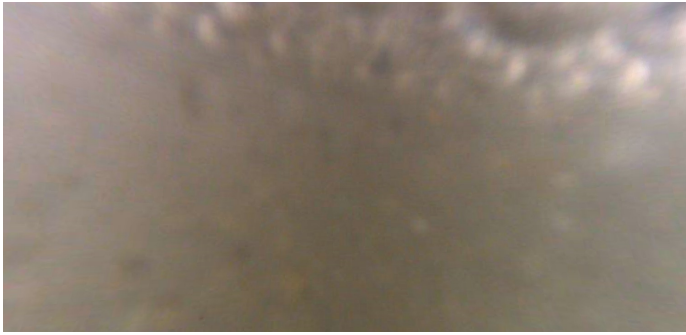
Code: **DAGS**
Description: **Deposits Attached Grease**

Distance (ft): **20.4**
Structural Grade: **0**
O&M Grade: **2**
Clock Start/From: **8**
Clock To: **4**
1st Value:
2nd Value:
Value Percent: **5.000**
Continuous Index: **F01**
Within 8" of Joint: **NO**
Remarks:

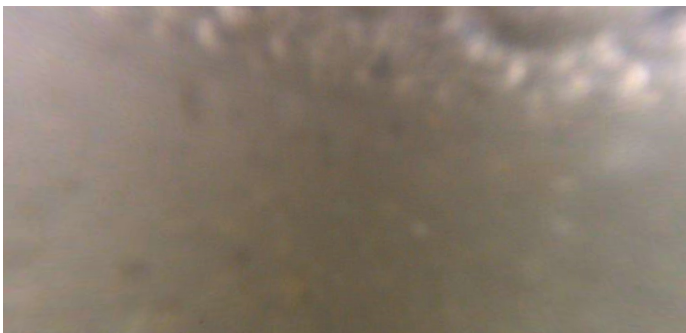
Code: **MSA**
Description: **Abandoned Survey**

Distance (ft): **20.4**
Structural Grade: **0**
O&M Grade: **0**
Clock Start/From:
Clock To:
1st Value:
2nd Value:
Value Percent:
Continuous Index:
Within 8" of Joint: **NO**
Remarks: **MCU**
