## Profile/Photo Observation Report

Date:	<b>11/03/2021</b>	Weather:		Coding:	<b>PACP 7.0</b>
Pipe Length (ft):	<b>330.0</b>	Owner:	<b>City of Hobart</b>	Pre Clean:	<b>Heavy Cleaning</b>
P.O.#:	<b>YES502259</b>	Surveyor:	<b>S. Bucklin</b>	PSR:	<b>P-405-066-068</b>
Customer:	<b>City of Hobart</b>	Clean Date:	<b>10/29/2021</b>	Shape:	<b>C</b>

Street:	<b>South Wabash Street</b>	Flow Control:	<b>Not Controlled</b>
City:	<b>Hobart, IN</b>	Year Renewed:	
Location:	<b>Alley</b>	Tape/Media #:	
Purpose:	<b>Routine Assessment</b>	Dia/Height:	<b>10"</b>
Use:	<b>Sanitary Sewage Pipe</b>	Material:	<b>VCP</b>
Drain Area:		Lining:	<b>None</b>
Category:	<b>NA</b>		
Comment:

Location Details:		Direction of Survey:	<b>Downstream</b>
US MH:	<b>M-405-068</b>	DS MH:	<b>M-405-066</b>
		Total Length Surveyed (ft):	<b>52.4</b>

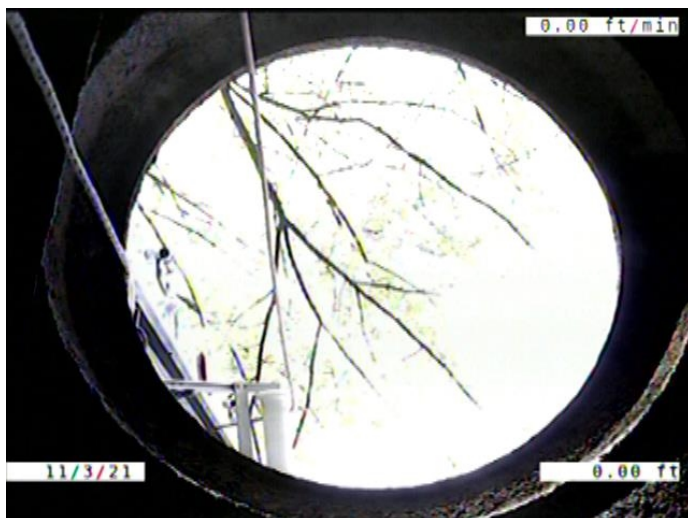
Code: **AMH**  
Description: **Manhole**

Distance (ft): **.0**  
Structural Grade: **0**  
O&M Grade: **0**  
Clock Start/From:  
Clock To:  
1st Value:  
2nd Value:  
Value Percent:  
Continuous Index:  
Within 8" of Joint: **NO**  
Remarks: **M-405-068**

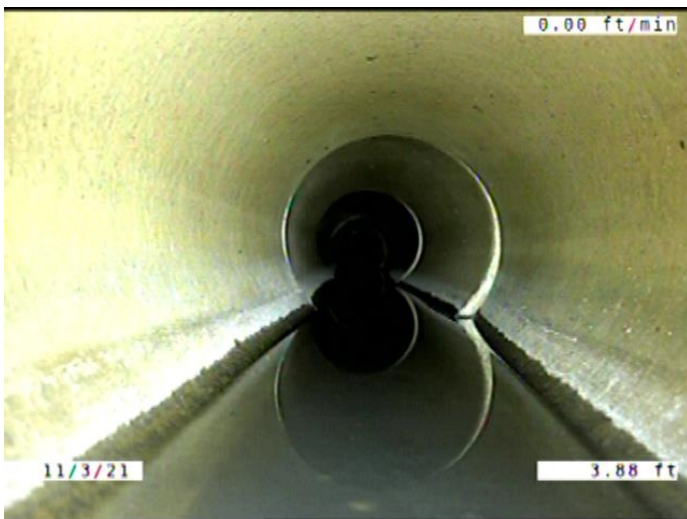
Code: **DSF**  
Description: **Deposits Settled Fine**

Distance (ft): **3.9**  
Structural Grade: **0**  
O&M Grade: **2**  
Clock Start/From: **5**  
Clock To: **7**  
1st Value:  
2nd Value:  
Value Percent: **5.000**  
Continuous Index: **S01**  
Within 8" of Joint: **YES**  
Remarks:

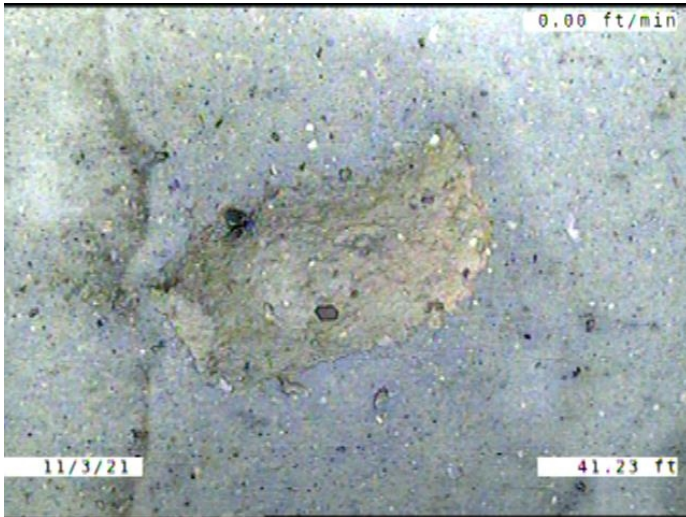
Code:	<b>SSS</b>
Description:	<b>Surface Damage Surface Spalling</b>
Distance (ft):	<b>41.2</b>
Structural Grade:	<b>2</b>
O&M Grade:	<b>0</b>
Clock Start/From:	<b>9</b>
Clock To:	
1st Value:	
2nd Value:	
Value Percent:	
Continuous Index:	
Within 8" of Joint:	<b>NO</b>
Remarks:

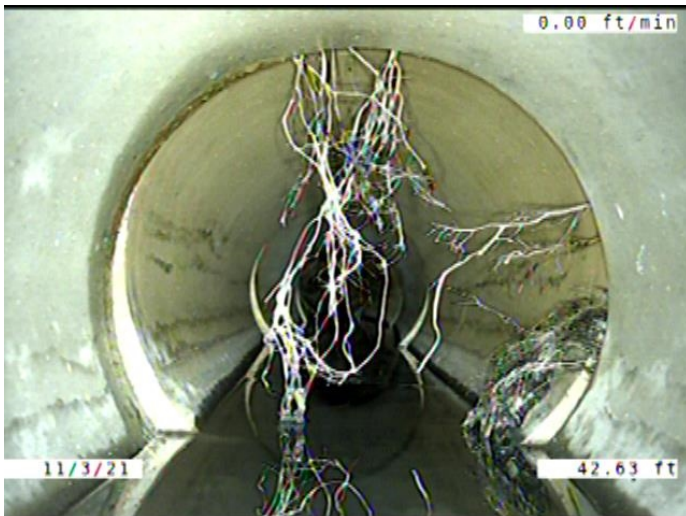
Code:	<b>RMJ</b>
Description:	<b>Roots Medium Joint</b>
Distance (ft):	<b>42.6</b>
Structural Grade:	<b>0</b>
O&M Grade:	<b>3</b>
Clock Start/From:	<b>11</b>
Clock To:	<b>4</b>
1st Value:	
2nd Value:	
Value Percent:	<b>5.000</b>
Continuous Index:	
Within 8" of Joint:	<b>YES</b>
Remarks:

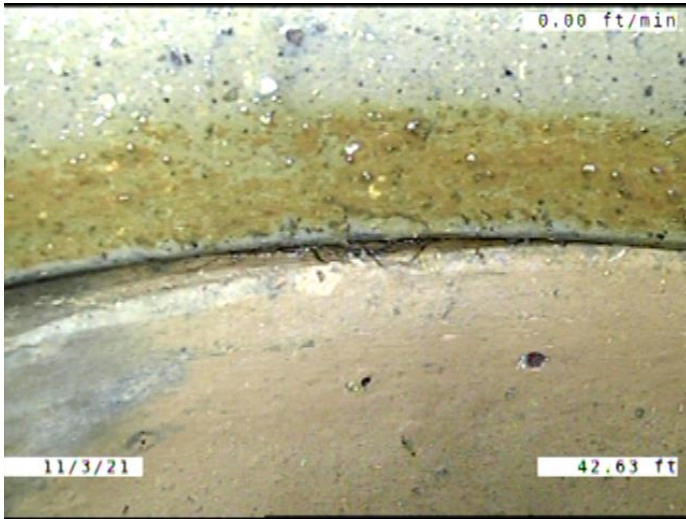
Code: **ISJ**  
Description: **Infiltration Stain Joint**

Distance (ft): **42.6**  
Structural Grade: **0**  
O&M Grade: **1**  
Clock Start/From: **8**  
Clock To: **12**  
1st Value:  
2nd Value:  
Value Percent:  
Continuous Index:  
Within 8" of Joint: **YES**  
Remarks:

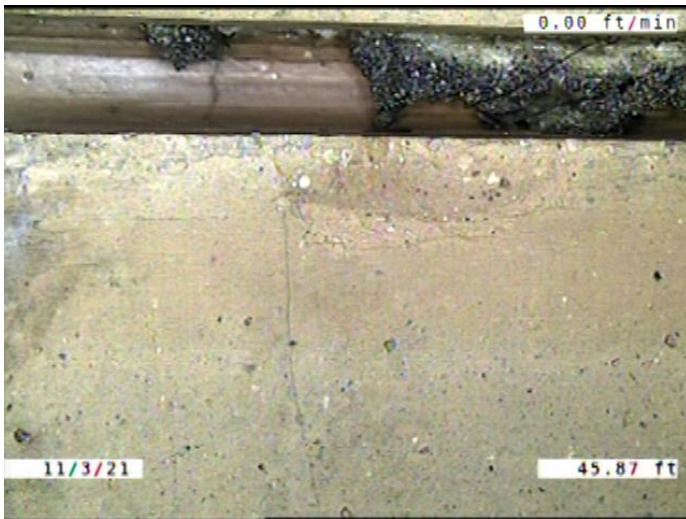
Code: **CL**  
Description: **Crack Longitudinal**

Distance (ft): **45.9**  
Structural Grade: **2**  
O&M Grade: **0**  
Clock Start/From: **10**  
Clock To:  
1st Value:  
2nd Value:  
Value Percent:  
Continuous Index:  
Within 8" of Joint: **YES**  
Remarks:

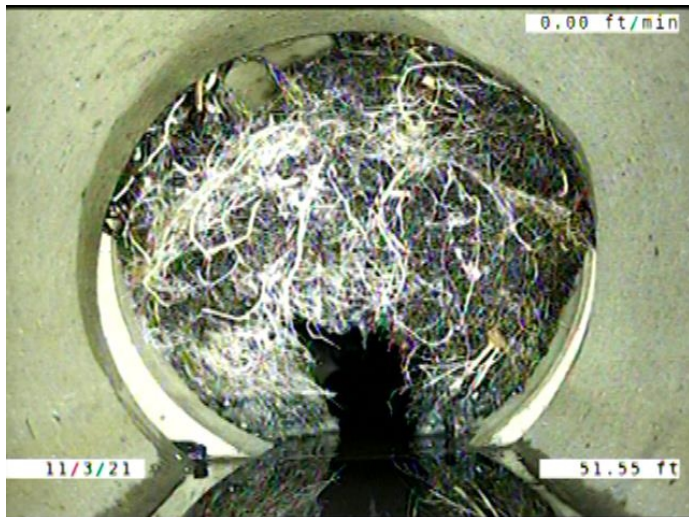
Code: **RBJ**  
 Description: **Roots Ball Joint**

Distance (ft): **51.5**  
 Structural Grade: **0**  
 O&M Grade: **4**  
 Clock Start/From: **9**  
 Clock To: **3**  
 1st Value:  
 2nd Value:  
 Value Percent: **95.000**  
 Continuous Index:  
 Within 8" of Joint: **YES**  
 Remarks:

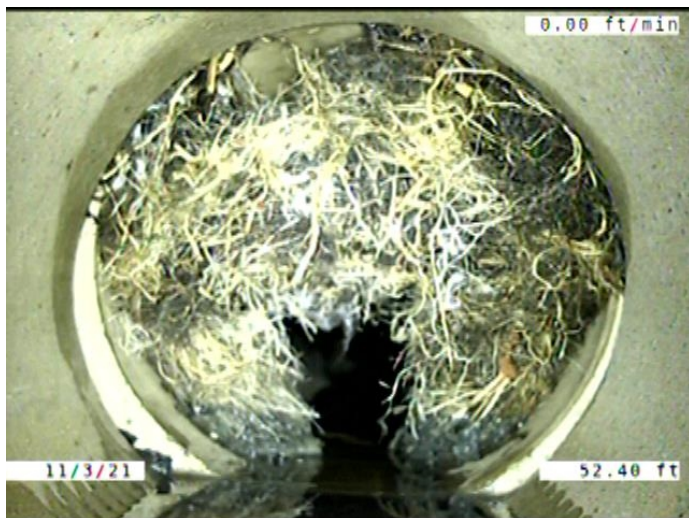
Code: **DSF**  
 Description: **Deposits Settled Fine**

Distance (ft): **52.4**  
 Structural Grade: **0**  
 O&M Grade: **2**  
 Clock Start/From: **5**  
 Clock To: **7**  
 1st Value:  
 2nd Value:  
 Value Percent: **5.000**  
 Continuous Index: **F01**  
 Within 8" of Joint: **YES**  
 Remarks:

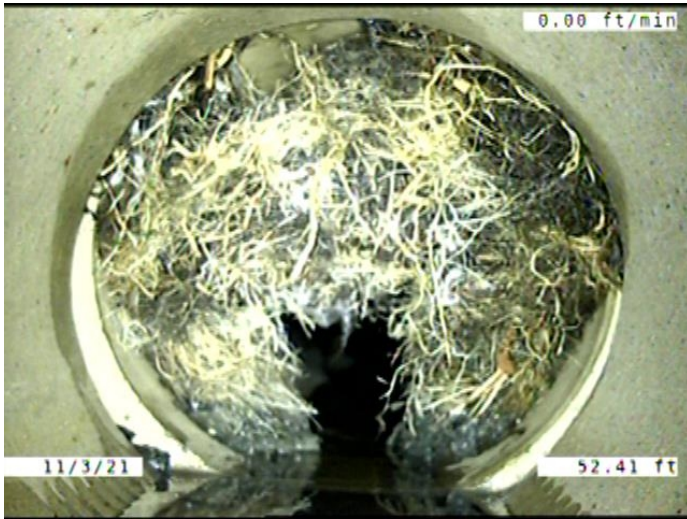
Code:	<b>MSA</b>
Description:	<b>Miscellaneous Survey Abandoned</b>
Distance (ft):	<b>52.4</b>
Structural Grade:	<b>0</b>
O&M Grade:	<b>0</b>
Clock Start/From:	
Clock To:	
1st Value:	
2nd Value:	
Value Percent:	
Continuous Index:	
Within 8" of Joint:	<b>NO</b>
Remarks:	<b>CAMERA CANT MAKE IT PAST ROOTS</b>
