Profile/Photo Observation Report

Date:	11/03/2021	Weather:		Coding:	PACP 7.0
Pipe Length (ft):	330.0	Owner:	City of Hobart	Pre Clean:	Heavy Cleaning
P.O.#:	YES502259	Surveyor:	S. Bucklin	PSR:	P-405-066-068
Customer:	City of Hobart	Clean Date:	10/29/2021	Shape:	C

Street:	South Wabash Street	Flow Control:	Not Controlled
City:	Hobart, IN	Year Renewed:	
Location:	Alley	Tape/Media #:	
Purpose:	Routine Assessment	Dia/Height:	10"
Use:	Sanitary Sewage Pipe	Material:	VCP
Drain Area:		Lining:	None
Category:	NA		
Comment:

Location Details:		Direction of Survey:	Downstream
US MH:	M-405-068	DS MH:	M-405-066
		Total Length Surveyed (ft):	52.4

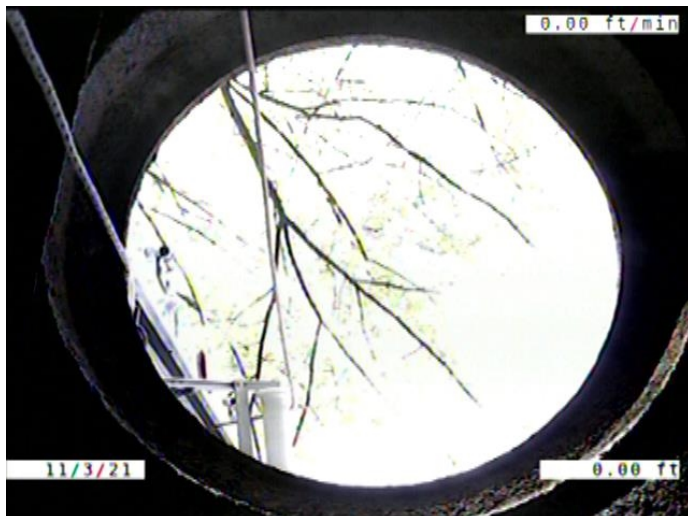
Code: **AMH**
Description: **Manhole**

Distance (ft): **.0**
Structural Grade: **0**
O&M Grade: **0**
Clock Start/From:
Clock To:
1st Value:
2nd Value:
Value Percent:
Continuous Index:
Within 8" of Joint: **NO**
Remarks: **M-405-068**

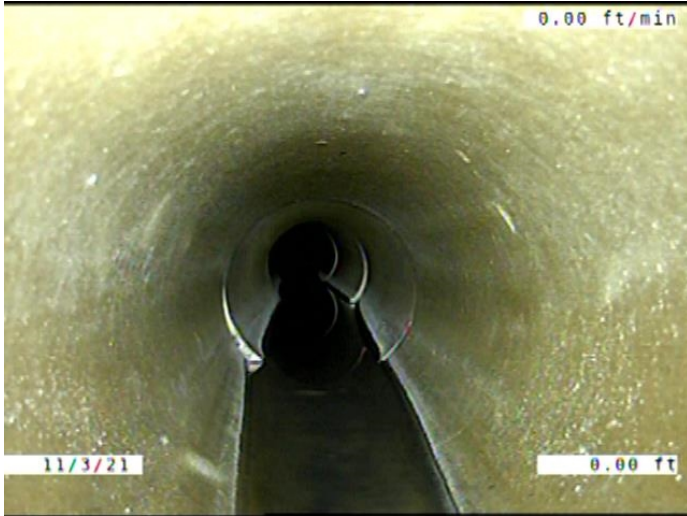
Code: **MWL**
Description: **Miscellaneous Water Level**

Distance (ft): **.0**
Structural Grade: **0**
O&M Grade: **0**
Clock Start/From:
Clock To:
1st Value:
2nd Value:
Value Percent: **5.000**
Continuous Index:
Within 8" of Joint: **NO**
Remarks:

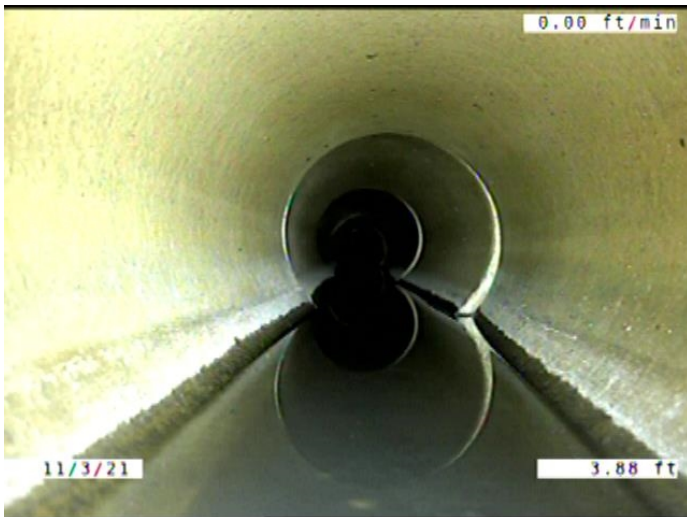
Code: **DSF**
Description: **Deposits Settled Fine**

Distance (ft): **3.9**
Structural Grade: **0**
O&M Grade: **2**
Clock Start/From: **5**
Clock To: **7**
1st Value:
2nd Value:
Value Percent: **5.000**
Continuous Index: **S01**
Within 8" of Joint: **YES**
Remarks:

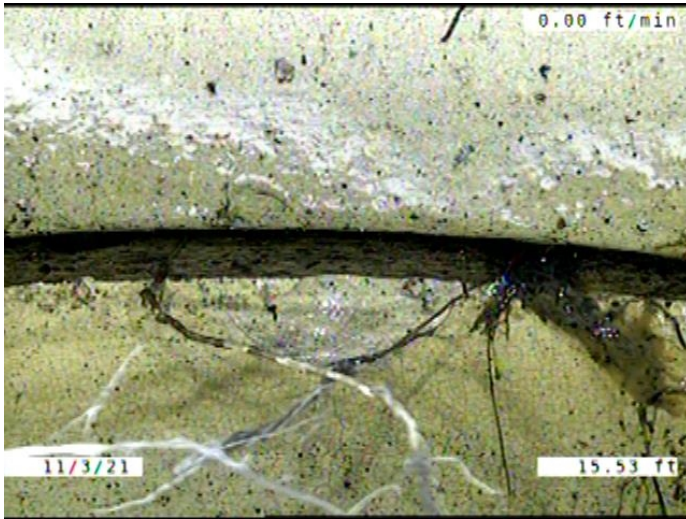
Code: **RFJ**
 Description: **Roots Fine Joint**

Distance (ft): **15.5**
 Structural Grade: **0**
 O&M Grade: **1**
 Clock Start/From: **12**
 Clock To: **1**
 1st Value:
 2nd Value:
 Value Percent:
 Continuous Index:
 Within 8" of Joint: **YES**
 Remarks:

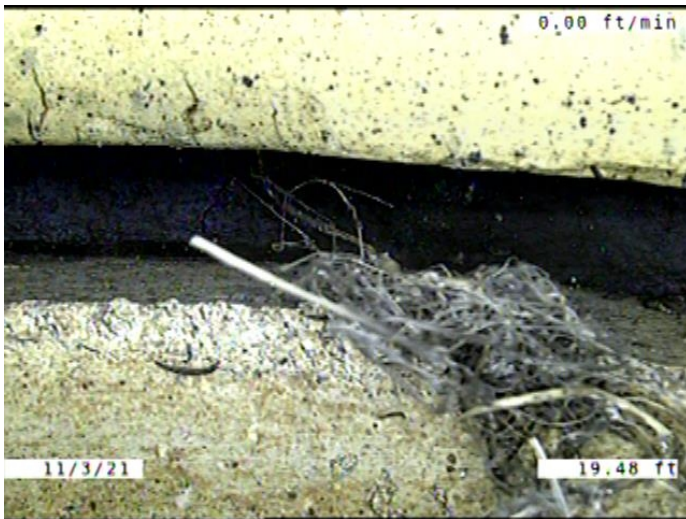
Code: **RFJ**
 Description: **Roots Fine Joint**

Distance (ft): **19.5**
 Structural Grade: **0**
 O&M Grade: **1**
 Clock Start/From: **11**
 Clock To: **2**
 1st Value:
 2nd Value:
 Value Percent:
 Continuous Index:
 Within 8" of Joint: **YES**
 Remarks:

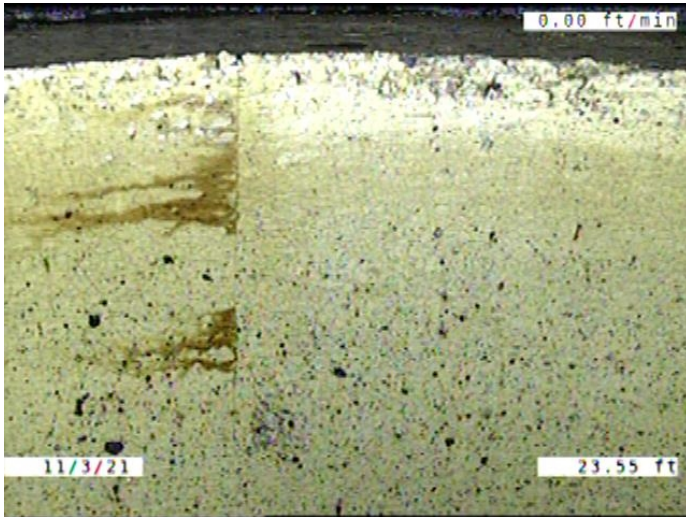
Code: **CL**
Description: **Crack Longitudinal**

Distance (ft): **23.5**
Structural Grade: **2**
O&M Grade: **0**
Clock Start/From: **10**
Clock To:
1st Value:
2nd Value:
Value Percent:
Continuous Index:
Within 8" of Joint: **YES**
Remarks:

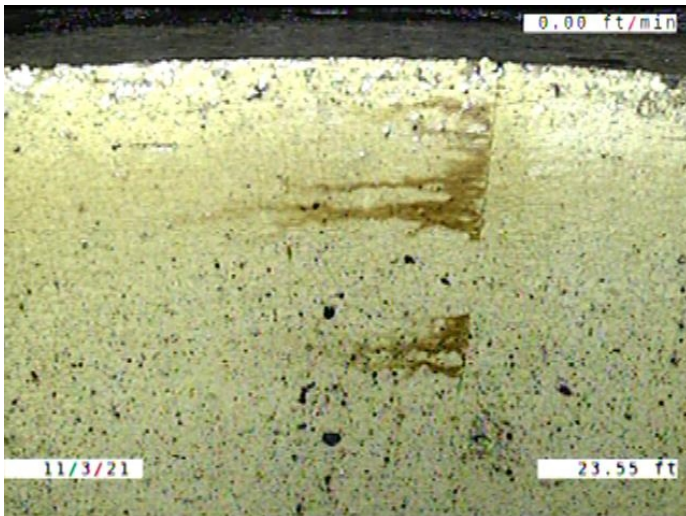
Code: **ISB**
Description: **Infiltration Stain Barrel**

Distance (ft): **23.5**
Structural Grade: **0**
O&M Grade: **1**
Clock Start/From: **10**
Clock To:
1st Value:
2nd Value:
Value Percent:
Continuous Index:
Within 8" of Joint: **YES**
Remarks:

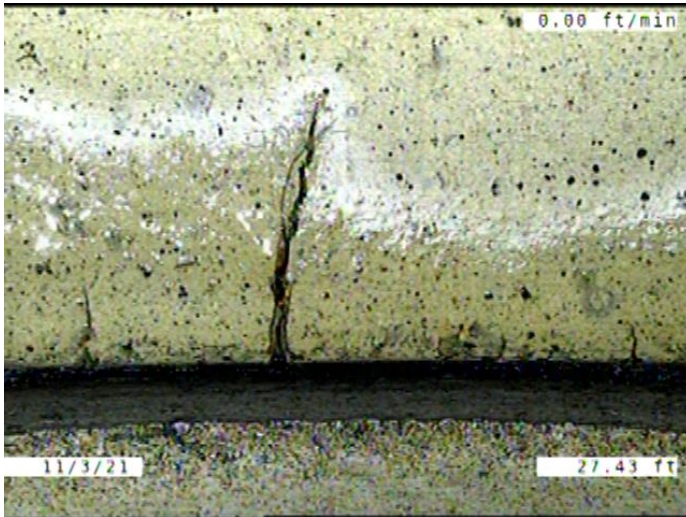
Code: **RFJ**
Description: **Roots Fine Joint**

Distance (ft): **27.4**
Structural Grade: **0**
O&M Grade: **1**
Clock Start/From: **12**
Clock To:
1st Value:
2nd Value:
Value Percent:
Continuous Index:
Within 8" of Joint: **YES**
Remarks:

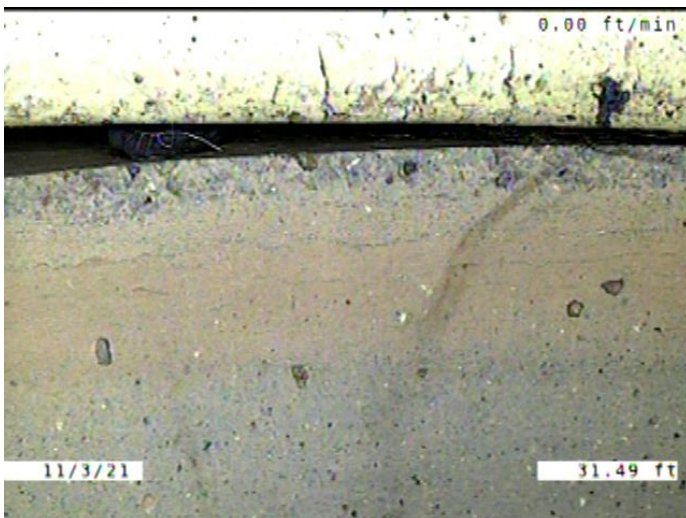
Code: **RFJ**
Description: **Roots Fine Joint**

Distance (ft): **31.5**
Structural Grade: **0**
O&M Grade: **1**
Clock Start/From: **10**
Clock To: **11**
1st Value:
2nd Value:
Value Percent:
Continuous Index:
Within 8" of Joint: **YES**
Remarks:

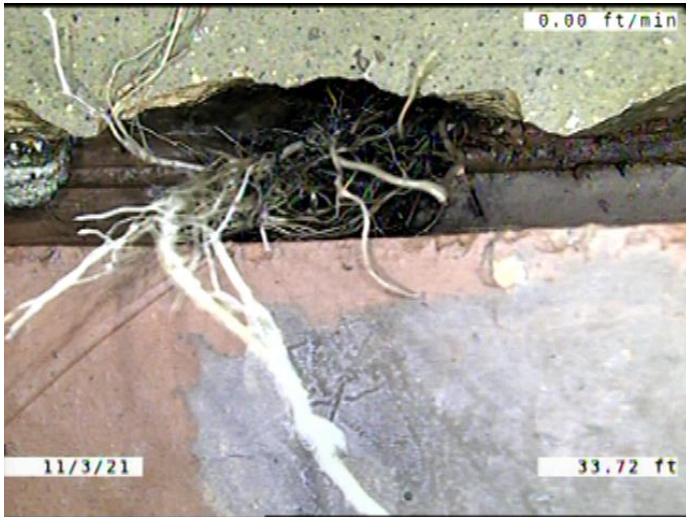
Code: **RFJ**
Description: **Roots Fine Joint**

Distance (ft): **33.7**
Structural Grade: **0**
O&M Grade: **1**
Clock Start/From: **9**
Clock To: **3**
1st Value:
2nd Value:
Value Percent:
Continuous Index:
Within 8" of Joint: **YES**
Remarks:

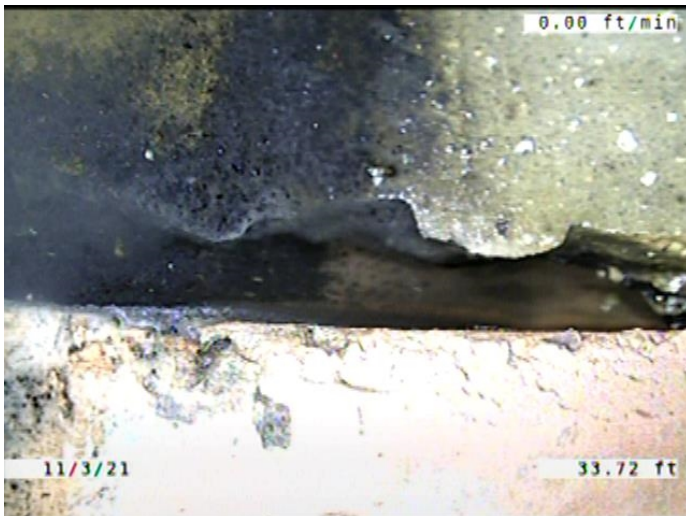
Code: **SZ**
Description: **Surface Damage Other**

Distance (ft): **33.7**
Structural Grade: **0**
O&M Grade: **0**
Clock Start/From: **12**
Clock To: **12**
1st Value:
2nd Value:
Value Percent:
Continuous Index:
Within 8" of Joint: **YES**
Remarks: **PIPE WORN AWAY ALL THE WAY
AROUND THE JOINT**

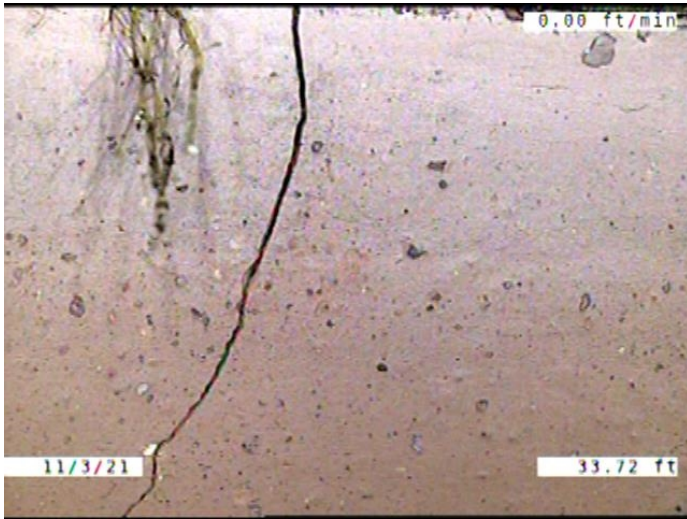
Code: **FM**
 Description: **Fracture Multiple**

Distance (ft): **33.7**
 Structural Grade: **4**
 O&M Grade: **0**
 Clock Start/From: **9**
 Clock To: **12**
 1st Value:
 2nd Value:
 Value Percent:
 Continuous Index:
 Within 8" of Joint: **YES**
 Remarks:

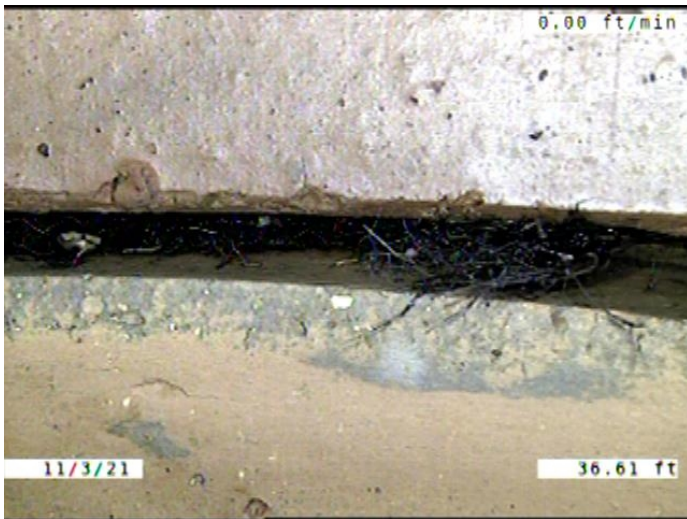
Code: **RFJ**
 Description: **Roots Fine Joint**

Distance (ft): **36.6**
 Structural Grade: **0**
 O&M Grade: **1**
 Clock Start/From: **9**
 Clock To: **3**
 1st Value:
 2nd Value:
 Value Percent:
 Continuous Index:
 Within 8" of Joint: **YES**
 Remarks:

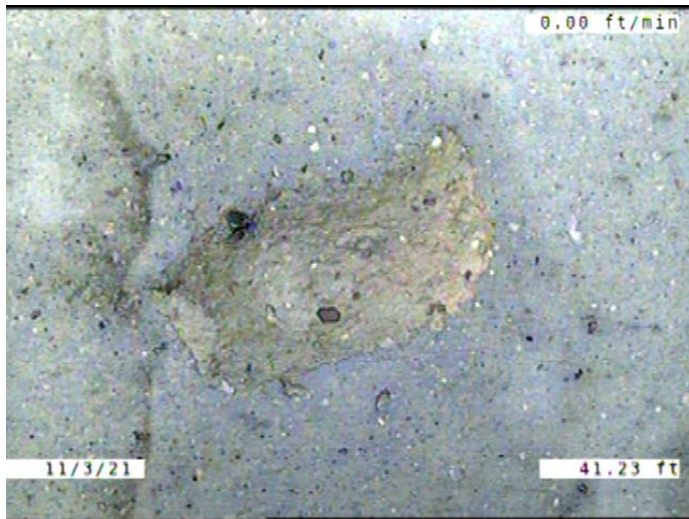
Code: **SSS**
 Description: **Surface Damage Surface Spalling**

Distance (ft): **41.2**
 Structural Grade: **2**
 O&M Grade: **0**
 Clock Start/From: **9**
 Clock To:
 1st Value:
 2nd Value:
 Value Percent:
 Continuous Index:
 Within 8" of Joint: **NO**
 Remarks:

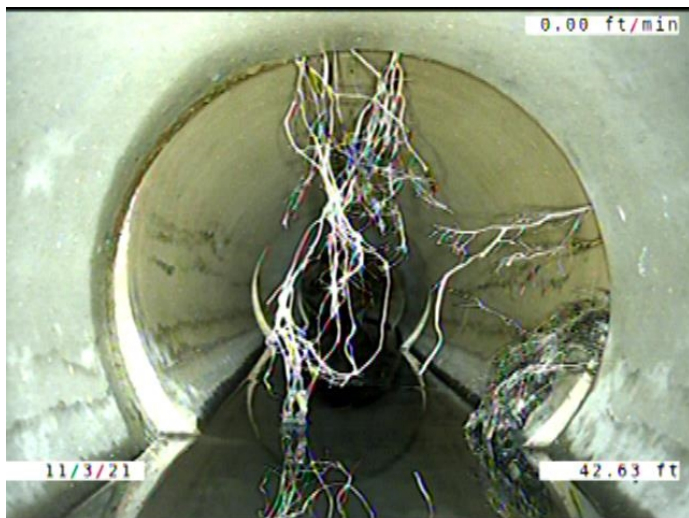
Code: **RMJ**
 Description: **Roots Medium Joint**

Distance (ft): **42.6**
 Structural Grade: **0**
 O&M Grade: **3**
 Clock Start/From: **11**
 Clock To: **4**
 1st Value:
 2nd Value:
 Value Percent: **5.000**
 Continuous Index:
 Within 8" of Joint: **YES**
 Remarks:

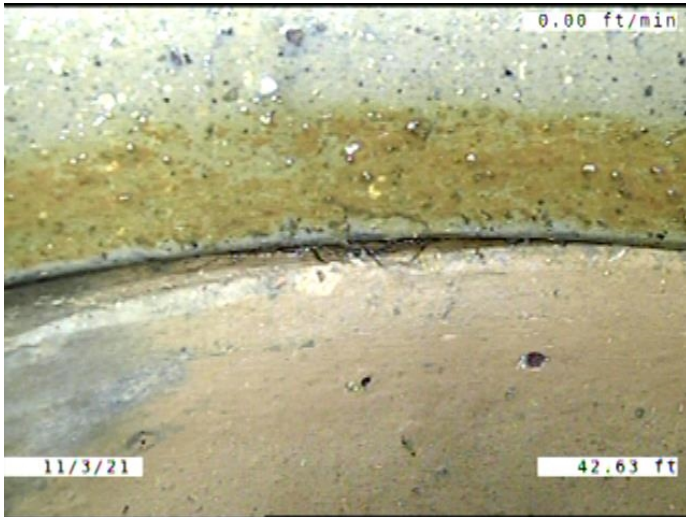
Code: **ISJ**
Description: **Infiltration Stain Joint**

Distance (ft): **42.6**
Structural Grade: **0**
O&M Grade: **1**
Clock Start/From: **8**
Clock To: **12**
1st Value:
2nd Value:
Value Percent:
Continuous Index:
Within 8" of Joint: **YES**
Remarks:

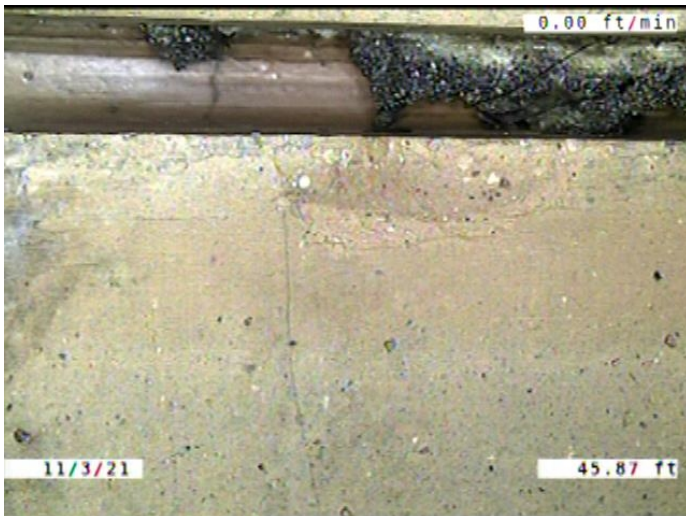
Code: **CL**
Description: **Crack Longitudinal**

Distance (ft): **45.9**
Structural Grade: **2**
O&M Grade: **0**
Clock Start/From: **10**
Clock To:
1st Value:
2nd Value:
Value Percent:
Continuous Index:
Within 8" of Joint: **YES**
Remarks:

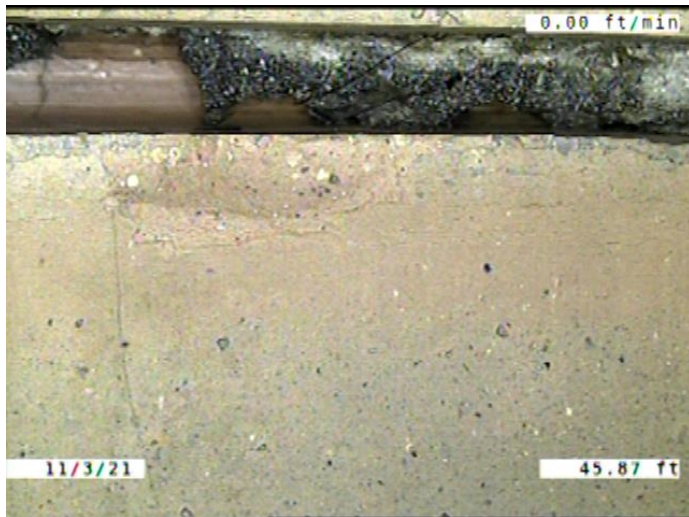
Code: **SZ**
 Description: **Surface Damage Other**

Distance (ft): **45.9**
 Structural Grade: **0**
 O&M Grade: **0**
 Clock Start/From: **10**
 Clock To:
 1st Value:
 2nd Value:
 Value Percent:
 Continuous Index:
 Within 8" of Joint: **YES**
 Remarks: **A PIECE CHIPPED OFF THE JOINT**

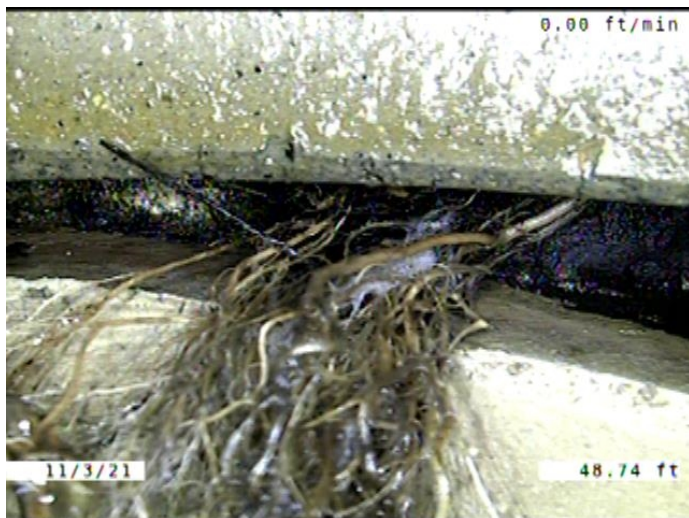
Code: **RMJ**
 Description: **Roots Medium Joint**

Distance (ft): **48.7**
 Structural Grade: **0**
 O&M Grade: **3**
 Clock Start/From: **9**
 Clock To: **3**
 1st Value:
 2nd Value:
 Value Percent: **5.000**
 Continuous Index:
 Within 8" of Joint: **YES**
 Remarks:

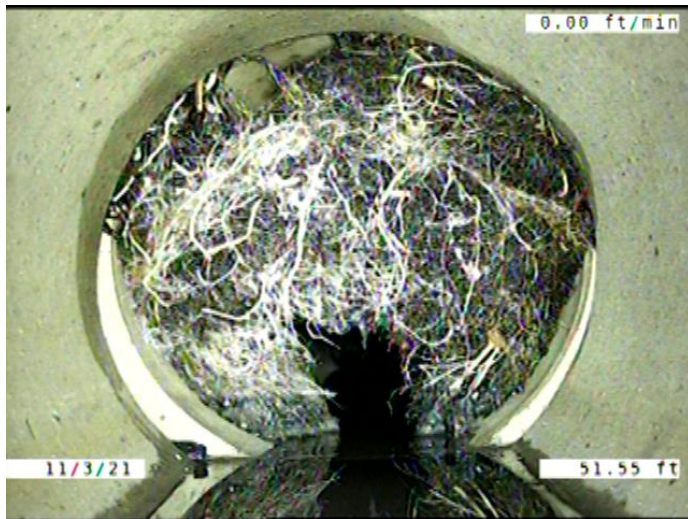
Code: **RBJ**
 Description: **Roots Ball Joint**

Distance (ft): **51.5**
 Structural Grade: **0**
 O&M Grade: **4**
 Clock Start/From: **9**
 Clock To: **3**
 1st Value:
 2nd Value:
 Value Percent: **95.000**
 Continuous Index:
 Within 8" of Joint: **YES**
 Remarks:

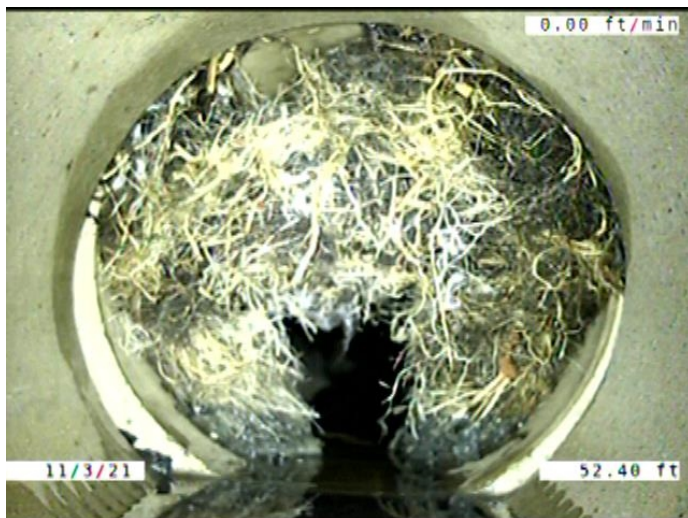
Code: **DSF**
 Description: **Deposits Settled Fine**

Distance (ft): **52.4**
 Structural Grade: **0**
 O&M Grade: **2**
 Clock Start/From: **5**
 Clock To: **7**
 1st Value:
 2nd Value:
 Value Percent: **5.000**
 Continuous Index: **F01**
 Within 8" of Joint: **YES**
 Remarks:

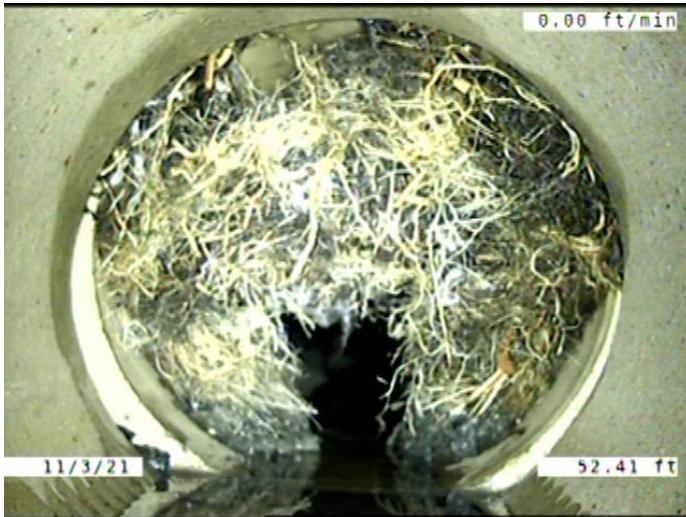
MSA

Miscellaneous Survey Abandoned

52.4

CAMERA CANT MAKE IT PAST ROOTS
