RedZone
ROBOTICS

Street:	South Wabash Street	Flow Control:	Not Controlled
City:	Hobart, IN	Year Renewed:	
Location:	Alley	Tape/Media #:	
Purpose:	Routine Assessment	Dia/Height:	10"
Use:	Sanitary Sewage Pipe	Material:	VCP
Drain Area:		Lining:	None
Category:	NA		
Comment:			
Location Details:		Direction of Survey:	Upstream
US MH:	M-405-068	DS MH:	M-405-066
		Total Length Surveyed (ft):	322.9

Tuesday, April 25, 2023

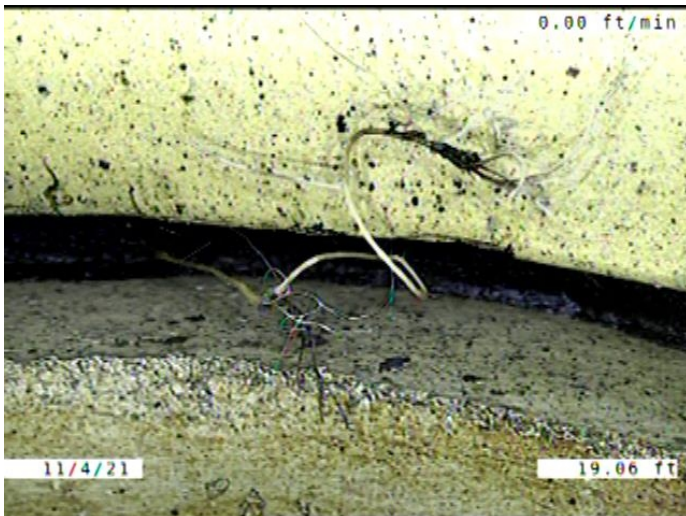
Code: **RFJ**
Description: **Roots Fine Joint**

Distance (ft): **19.1**
Structural Grade: **0**
O&M Grade: **1**
Clock Start/From: **11**
Clock To: **3**
1st Value:
2nd Value:
Value Percent:
Continuous Index:
Within 8" of Joint: **YES**
Remarks:

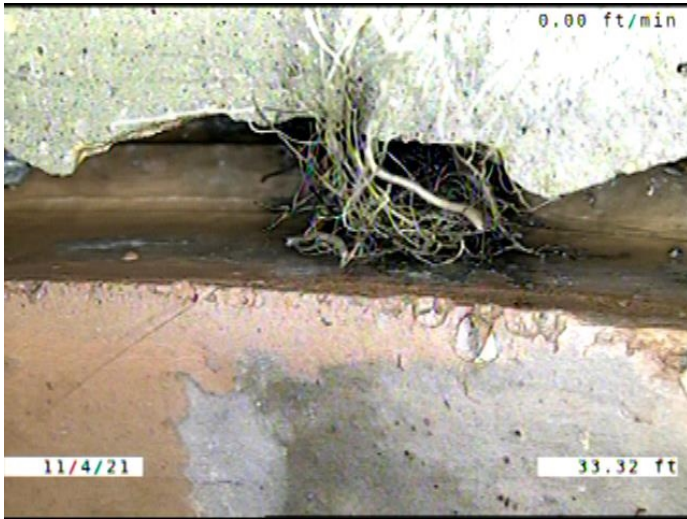
Code: **RFJ**
 Description: **Roots Fine Joint**

Distance (ft): **33.3**
 Structural Grade: **0**
 O&M Grade: **1**
 Clock Start/From: **10**
 Clock To: **3**
 1st Value:
 2nd Value:
 Value Percent:
 Continuous Index:
 Within 8" of Joint: **YES**
 Remarks:

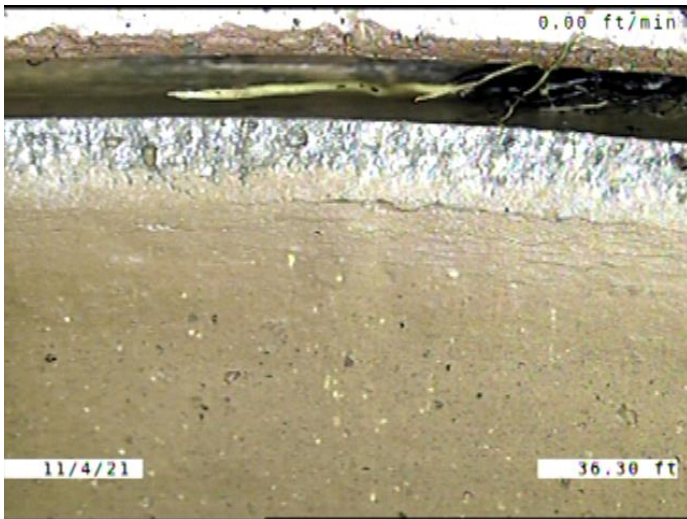
Code: **RFJ**
 Description: **Roots Fine Joint**

Distance (ft): **36.3**
 Structural Grade: **0**
 O&M Grade: **1**
 Clock Start/From: **9**
 Clock To: **3**
 1st Value:
 2nd Value:
 Value Percent:
 Continuous Index:
 Within 8" of Joint: **YES**
 Remarks:

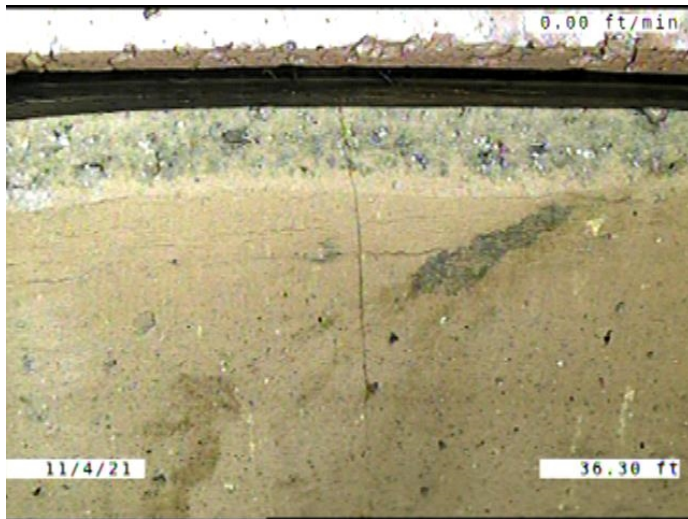
Code: **CL**
 Description: **Crack Longitudinal**

Distance (ft): **36.3**
 Structural Grade: **2**
 O&M Grade: **0**
 Clock Start/From: **9**
 Clock To:
 1st Value:
 2nd Value:
 Value Percent:
 Continuous Index:
 Within 8" of Joint: **YES**
 Remarks:

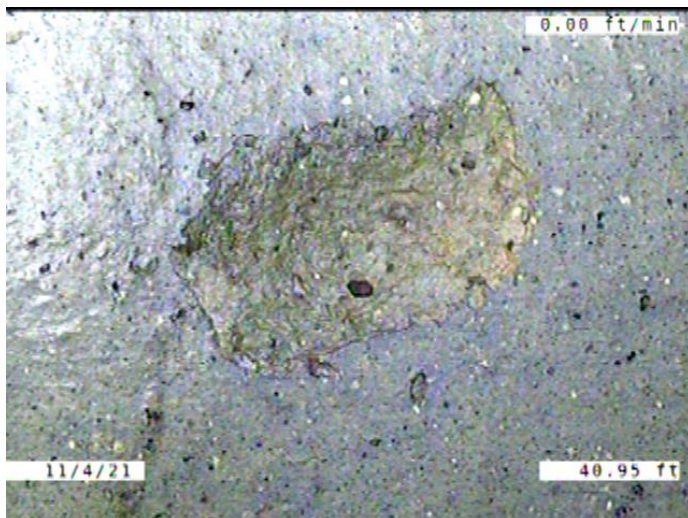
Code: **SSS**
 Description: **Surface Damage Surface Spalling**

Distance (ft): **41.0**
 Structural Grade: **2**
 O&M Grade: **0**
 Clock Start/From: **9**
 Clock To:
 1st Value:
 2nd Value:
 Value Percent:
 Continuous Index:
 Within 8" of Joint: **NO**
 Remarks:

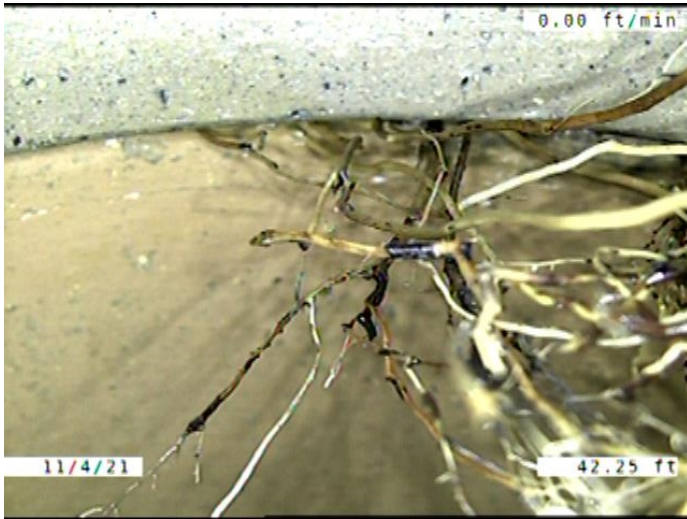
Code: **RMJ**
 Description: **Roots Medium Joint**

Distance (ft): **42.3**
 Structural Grade: **0**
 O&M Grade: **3**
 Clock Start/From: **11**
 Clock To: **4**
 1st Value:
 2nd Value:
 Value Percent: **5.000**
 Continuous Index:
 Within 8" of Joint: **YES**
 Remarks:

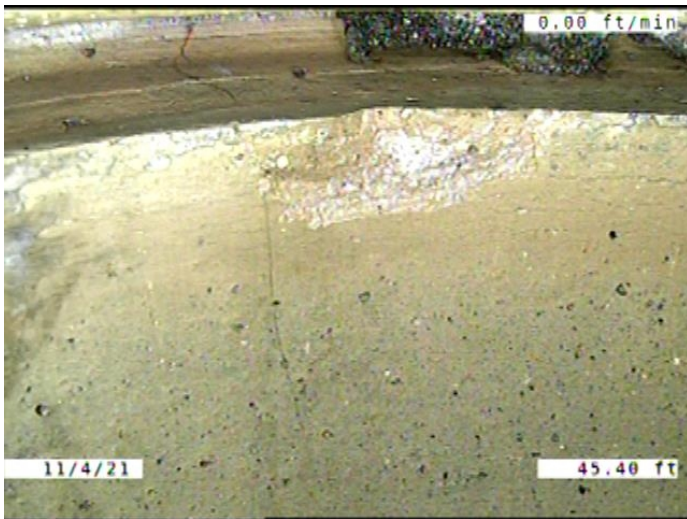
Code: **CL**
 Description: **Crack Longitudinal**

Distance (ft): **45.4**
 Structural Grade: **2**
 O&M Grade: **0**
 Clock Start/From: **10**
 Clock To:
 1st Value:
 2nd Value:
 Value Percent:
 Continuous Index:
 Within 8" of Joint: **YES**
 Remarks:

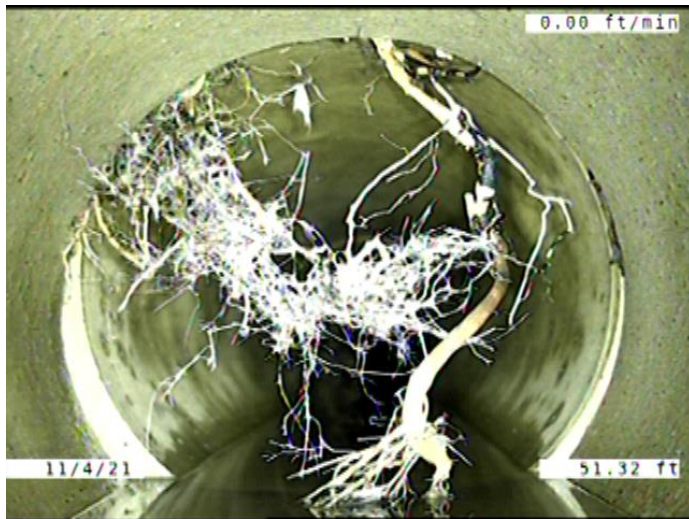
Code: **RMJ**
 Description: **Roots Medium Joint**

Distance (ft): **51.3**
 Structural Grade: **0**
 O&M Grade: **3**
 Clock Start/From: **9**
 Clock To: **1**
 1st Value:
 2nd Value:
 Value Percent: **5.000**
 Continuous Index:
 Within 8" of Joint: **YES**
 Remarks:

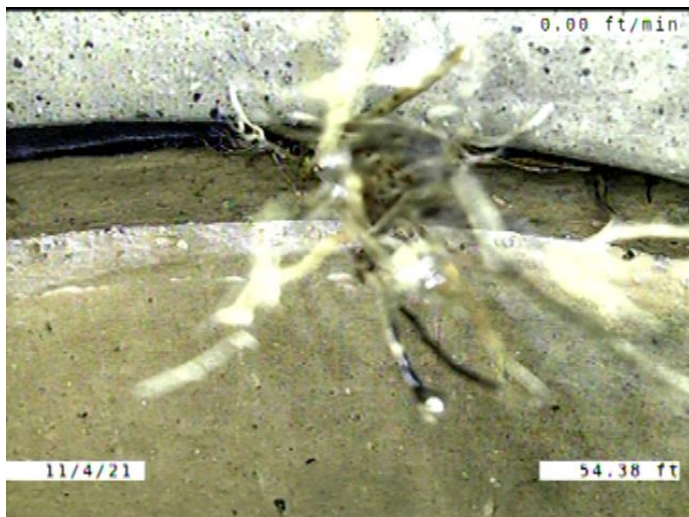
Code: **RFJ**
 Description: **Roots Fine Joint**

Distance (ft): **54.4**
 Structural Grade: **0**
 O&M Grade: **1**
 Clock Start/From: **2**
 Clock To:
 1st Value:
 2nd Value:
 Value Percent:
 Continuous Index:
 Within 8" of Joint: **YES**
 Remarks:

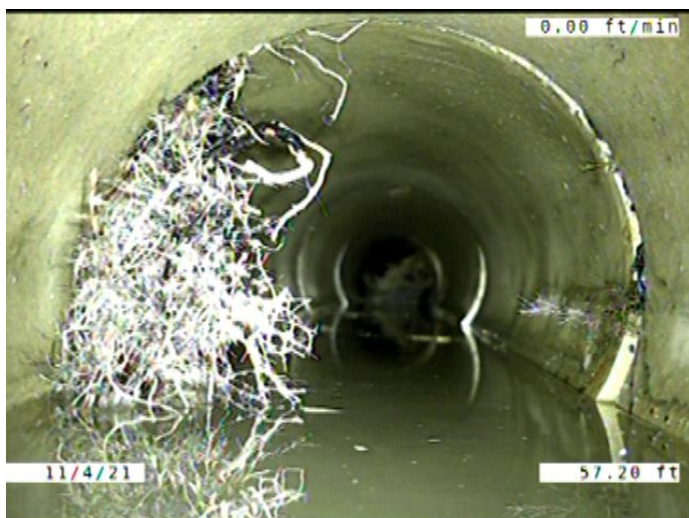
Code: **RMJ**
 Description: **Roots Medium Joint**

Distance (ft): **57.2**
 Structural Grade: **0**
 O&M Grade: **3**
 Clock Start/From: **7**
 Clock To: **4**
 1st Value:
 2nd Value:
 Value Percent: **15.000**
 Continuous Index:
 Within 8" of Joint: **YES**
 Remarks:

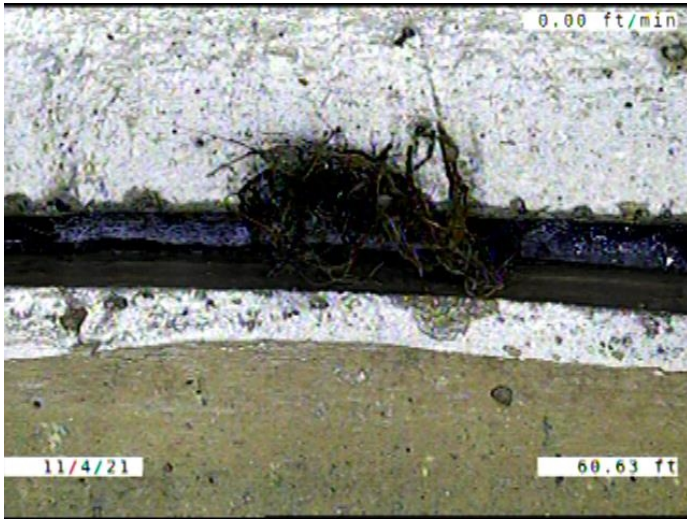
Code: **RFJ**
 Description: **Roots Fine Joint**

Distance (ft): **60.6**
 Structural Grade: **0**
 O&M Grade: **1**
 Clock Start/From: **10**
 Clock To: **12**
 1st Value:
 2nd Value:
 Value Percent:
 Continuous Index:
 Within 8" of Joint: **YES**
 Remarks:

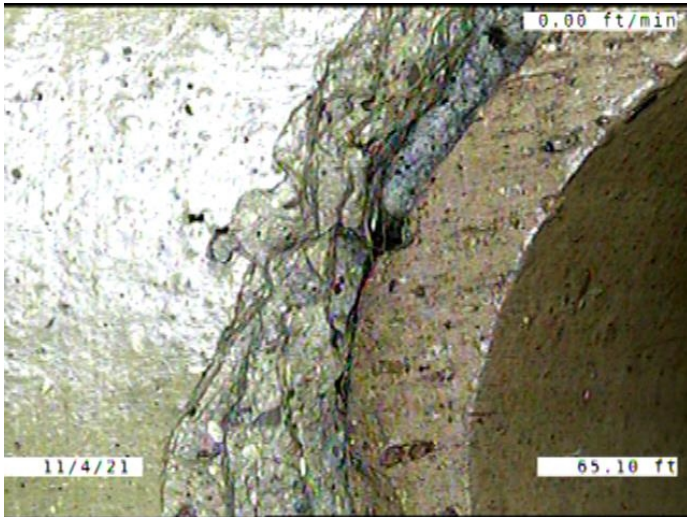
Code: **SSS**
 Description: **Surface Damage Surface Spalling**

Distance (ft): **65.1**
 Structural Grade: **2**
 O&M Grade: **0**
 Clock Start/From: **12**
 Clock To: **3**
 1st Value:
 2nd Value:
 Value Percent:
 Continuous Index:
 Within 8" of Joint: **YES**
 Remarks:

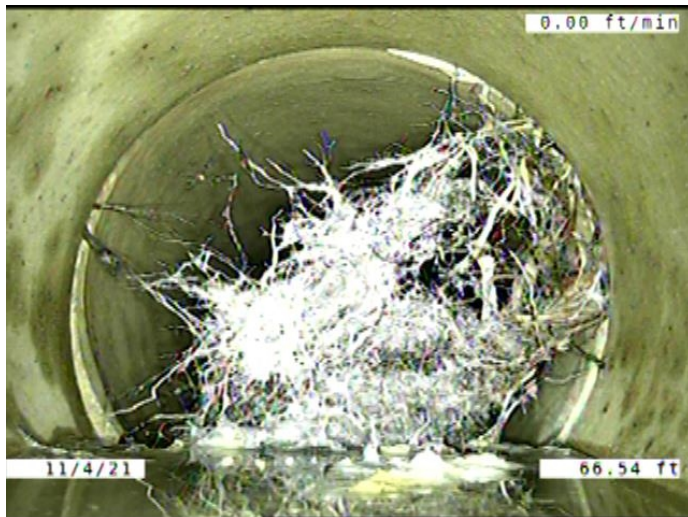
Code: **RBJ**
 Description: **Roots Ball Joint**

Distance (ft): **66.5**
 Structural Grade: **0**
 O&M Grade: **4**
 Clock Start/From: **1**
 Clock To: **10**
 1st Value:
 2nd Value:
 Value Percent: **65.000**
 Continuous Index:
 Within 8" of Joint: **YES**
 Remarks:

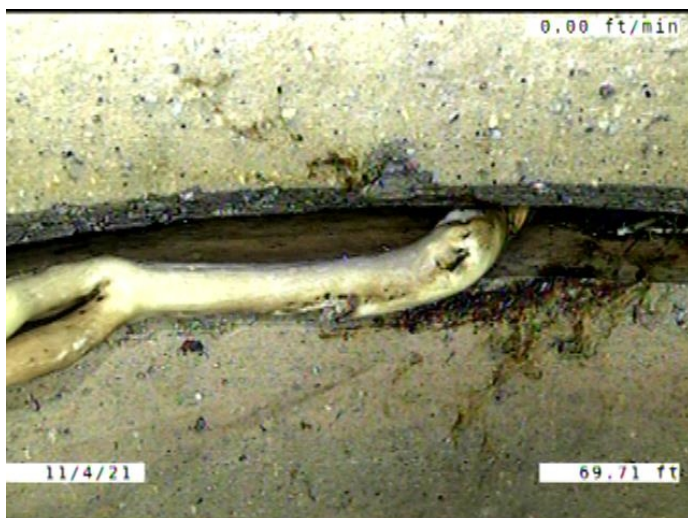
Code: **RTJ**
 Description: **Roots Tap Joint**

Distance (ft): **69.7**
 Structural Grade: **0**
 O&M Grade: **2**
 Clock Start/From: **8**
 Clock To: **3**
 1st Value:
 2nd Value:
 Value Percent: **5.000**
 Continuous Index:
 Within 8" of Joint: **YES**
 Remarks:

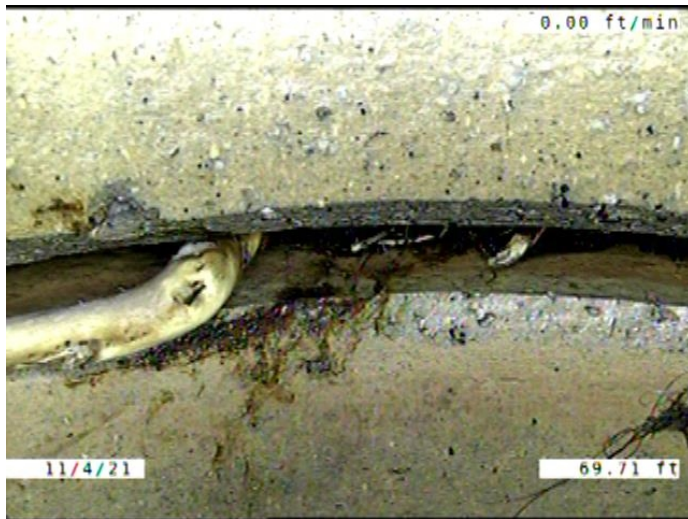
Code: **ISJ**
 Description: **Infiltration Stain Joint**

Distance (ft): **69.7**
 Structural Grade: **0**
 O&M Grade: **1**
 Clock Start/From: **11**
 Clock To:
 1st Value:
 2nd Value:
 Value Percent:
 Continuous Index:
 Within 8" of Joint: **YES**
 Remarks:

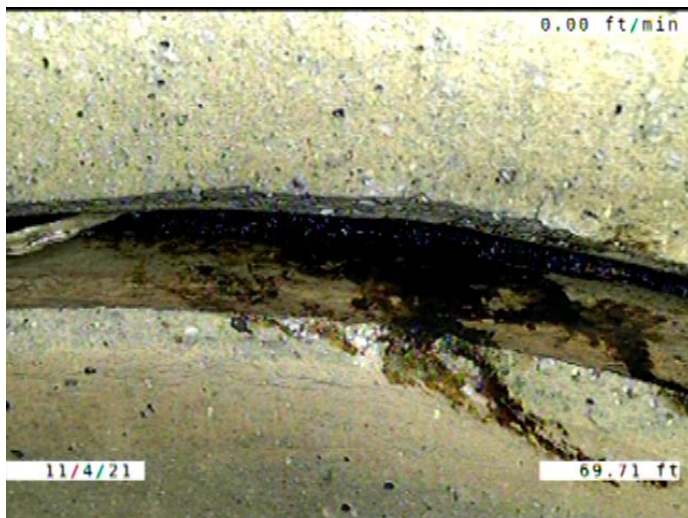
Code: **ISJ**
 Description: **Infiltration Stain Joint**

Distance (ft): **69.7**
 Structural Grade: **0**
 O&M Grade: **1**
 Clock Start/From: **2**
 Clock To: **3**
 1st Value:
 2nd Value:
 Value Percent:
 Continuous Index:
 Within 8" of Joint: **YES**
 Remarks:

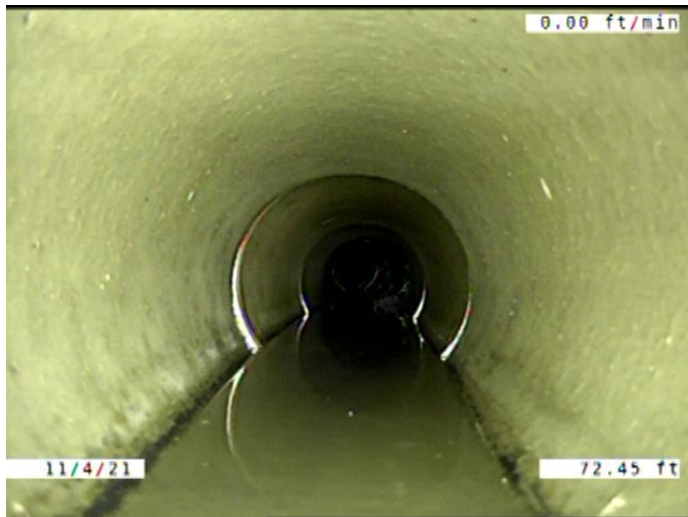
Code: **MWLS**
 Description: **Miscellaneous Water Level Sag**

Distance (ft): **72.4**
 Structural Grade: **2**
 O&M Grade: **0**
 Clock Start/From:
 Clock To:
 1st Value:
 2nd Value:
 Value Percent: **10.000**
 Continuous Index: **S02**
 Within 8" of Joint: **NO**
 Remarks:

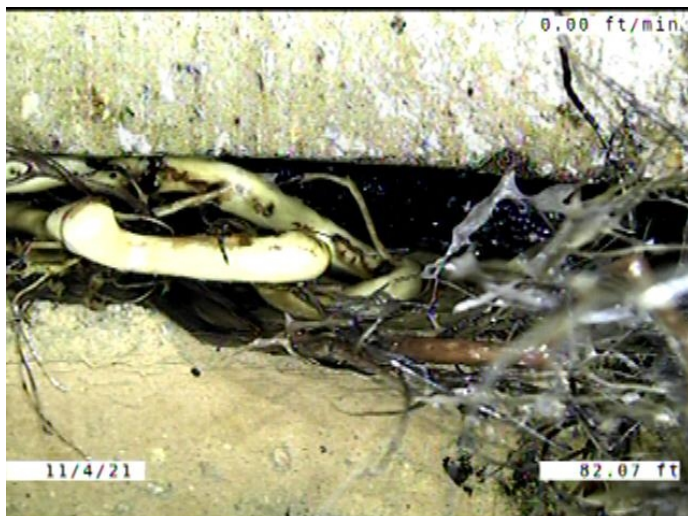
Code: **RFJ**
 Description: **Roots Fine Joint**

Distance (ft): **82.1**
 Structural Grade: **0**
 O&M Grade: **1**
 Clock Start/From: **9**
 Clock To: **3**
 1st Value:
 2nd Value:
 Value Percent:
 Continuous Index: **S03**
 Within 8" of Joint: **YES**
 Remarks:

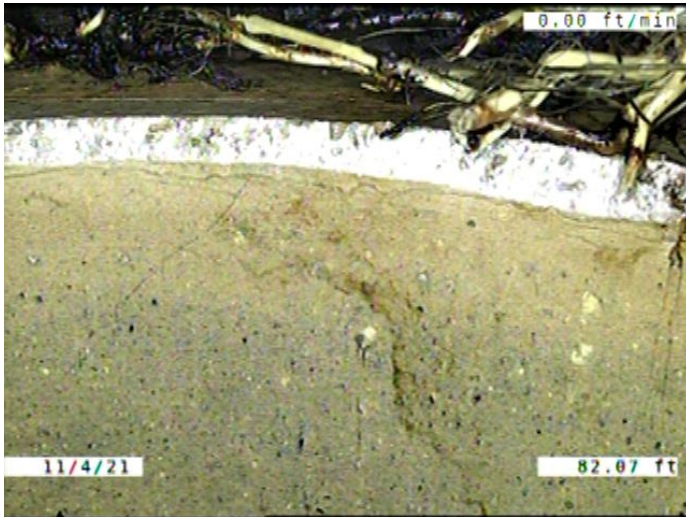
Code: **ISB**
 Description: **Infiltration Stain Barrel**

Distance (ft): **82.1**
 Structural Grade: **0**
 O&M Grade: **1**
 Clock Start/From: **2**
 Clock To: **4**
 1st Value:
 2nd Value:
 Value Percent:
 Continuous Index: **S04**
 Within 8" of Joint: **YES**
 Remarks:

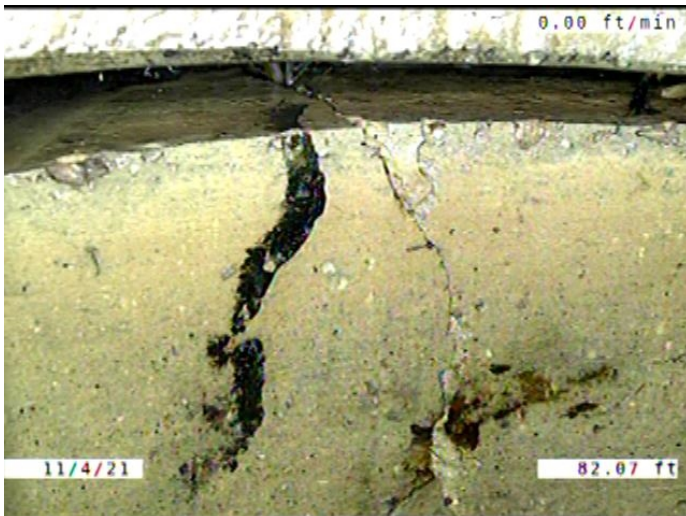
Code: **ISB**
 Description: **Infiltration Stain Barrel**

Distance (ft): **82.1**
 Structural Grade: **0**
 O&M Grade: **1**
 Clock Start/From: **8**
 Clock To: **10**
 1st Value:
 2nd Value:
 Value Percent:
 Continuous Index: **S05**
 Within 8" of Joint: **YES**
 Remarks:

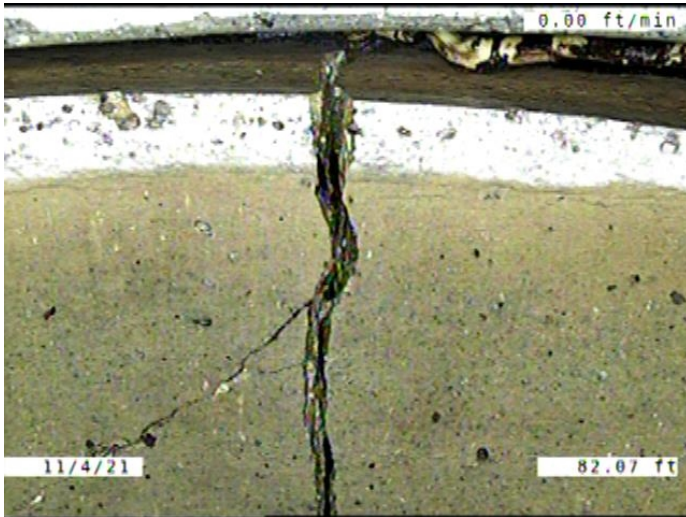
Code: **FM**
 Description: **Fracture Multiple**

Distance (ft): **82.1**
 Structural Grade: **4**
 O&M Grade: **0**
 Clock Start/From: **12**
 Clock To: **12**
 1st Value:
 2nd Value:
 Value Percent:
 Continuous Index: **S06**
 Within 8" of Joint: **YES**
 Remarks:

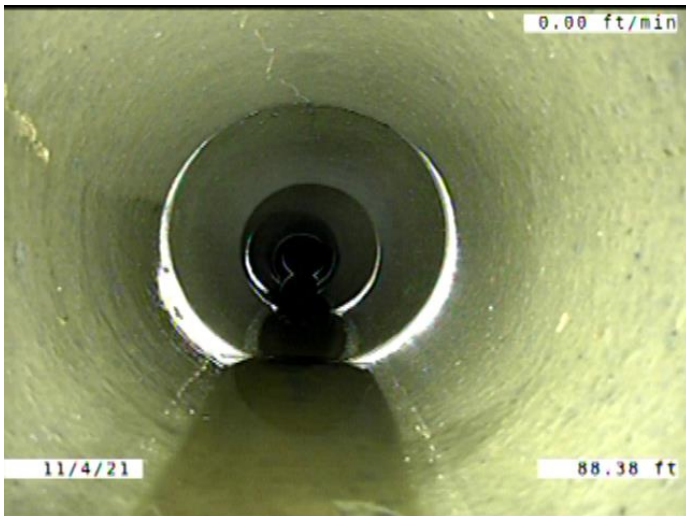
Code: **MWLS**
 Description: **Miscellaneous Water Level Sag**

Distance (ft): **88.4**
 Structural Grade: **2**
 O&M Grade: **0**
 Clock Start/From:
 Clock To:
 1st Value:
 2nd Value:
 Value Percent: **10.000**
 Continuous Index: **F02**
 Within 8" of Joint: **NO**
 Remarks:

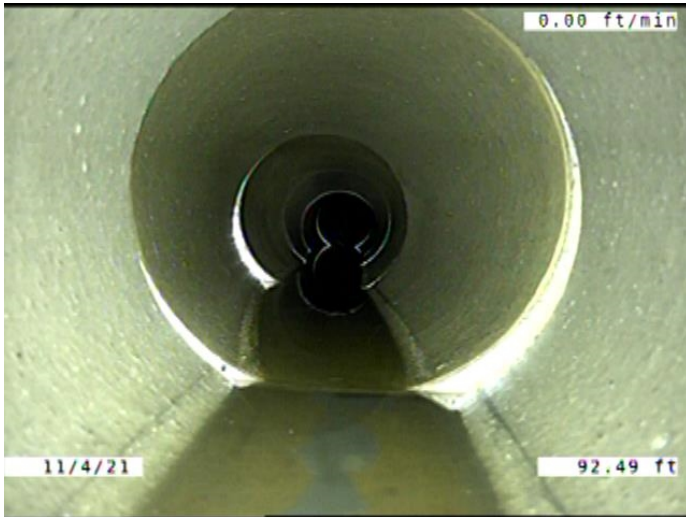
Code: **RFJ**
Description: **Roots Fine Joint**

Distance (ft): **92.5**
Structural Grade: **0**
O&M Grade: **1**
Clock Start/From: **9**
Clock To: **3**
1st Value:
2nd Value:
Value Percent:
Continuous Index: **F03**
Within 8" of Joint: **YES**
Remarks:

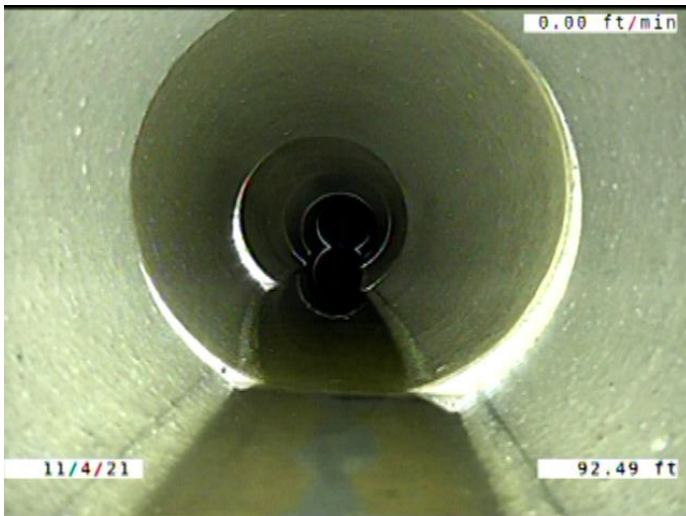
Code: **ISB**
Description: **Infiltration Stain Barrel**

Distance (ft): **92.5**
Structural Grade: **0**
O&M Grade: **1**
Clock Start/From: **2**
Clock To: **4**
1st Value:
2nd Value:
Value Percent:
Continuous Index: **F04**
Within 8" of Joint: **YES**
Remarks:

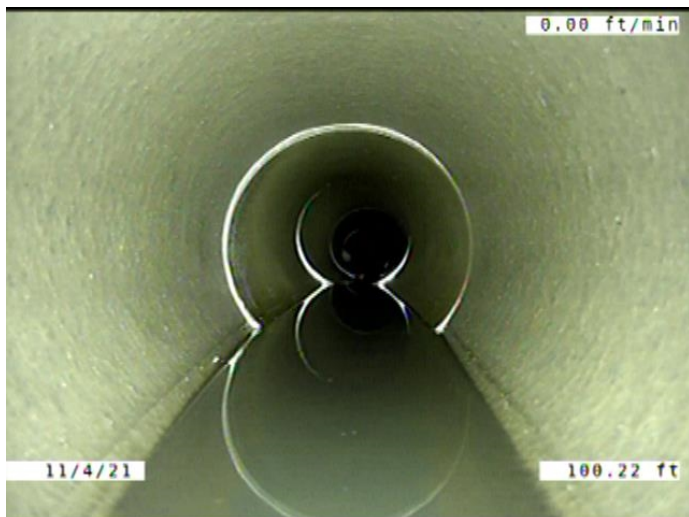
Code: **MWLS**
Description: **Miscellaneous Water Level Sag**

Distance (ft): **100.2**
Structural Grade: **2**
O&M Grade: **0**
Clock Start/From:
Clock To:
1st Value:
2nd Value:
Value Percent: **10.000**
Continuous Index: **S07**
Within 8" of Joint: **NO**
Remarks:

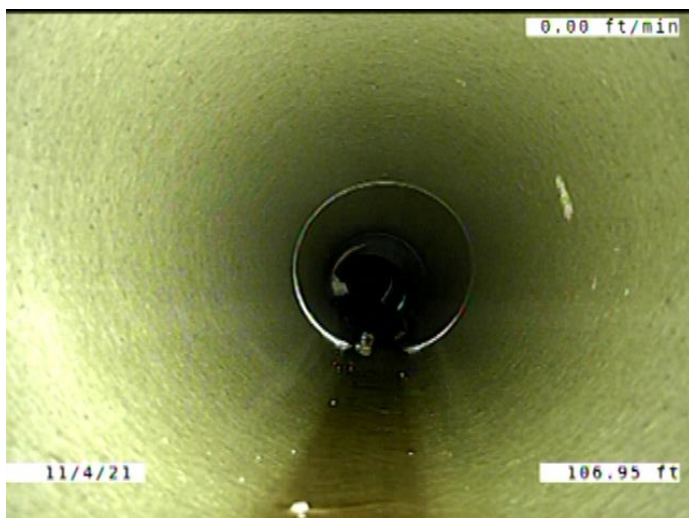
Code: **MWLS**
Description: **Miscellaneous Water Level Sag**

Distance (ft): **106.9**
Structural Grade: **2**
O&M Grade: **0**
Clock Start/From:
Clock To:
1st Value:
2nd Value:
Value Percent: **10.000**
Continuous Index: **F07**
Within 8" of Joint: **NO**
Remarks:

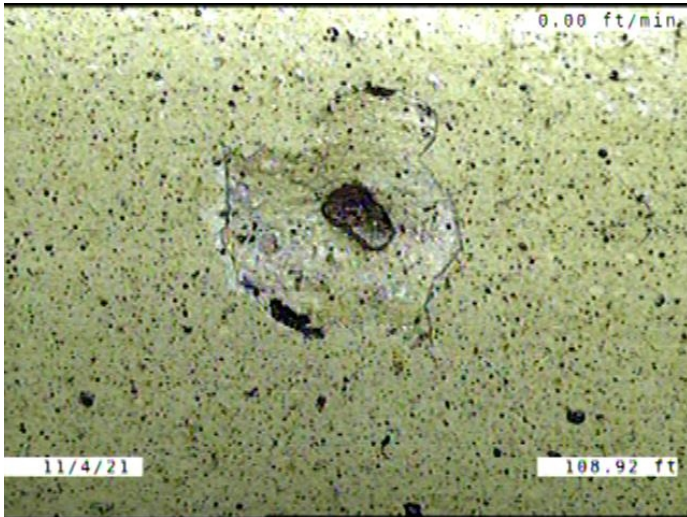
Code: **SSS**
Description: **Surface Damage Surface Spalling**

Distance (ft): **108.9**
Structural Grade: **2**
O&M Grade: **0**
Clock Start/From: **2**
Clock To:
1st Value:
2nd Value:
Value Percent:
Continuous Index:
Within 8" of Joint: **NO**
Remarks:

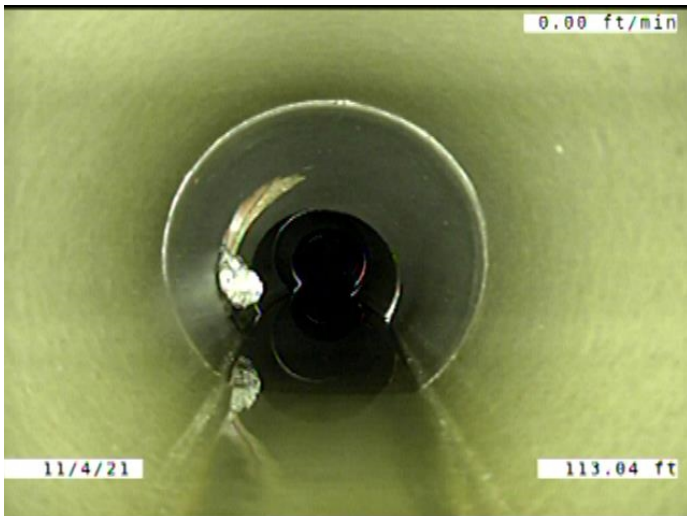
Code: **MWLS**
Description: **Miscellaneous Water Level Sag**

Distance (ft): **113.0**
Structural Grade: **2**
O&M Grade: **0**
Clock Start/From:
Clock To:
1st Value:
2nd Value:
Value Percent: **5.000**
Continuous Index: **S08**
Within 8" of Joint: **NO**
Remarks:

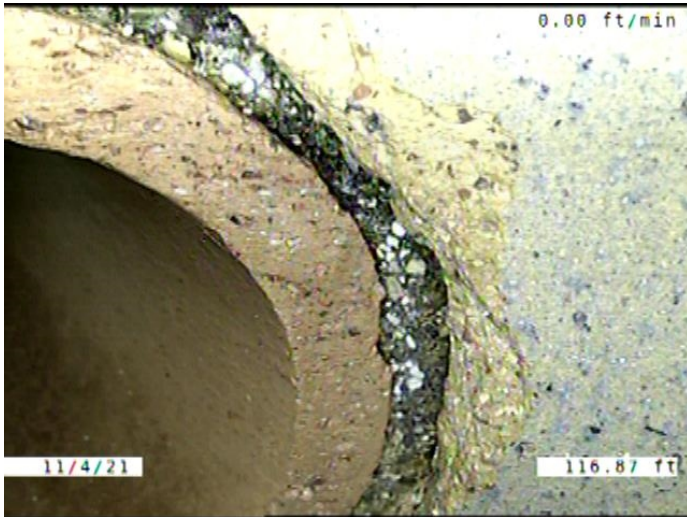
Code: **SSS**
 Description: **Surface Damage Surface Spalling**

Distance (ft): **116.9**
 Structural Grade: **2**
 O&M Grade: **0**
 Clock Start/From: **9**
 Clock To: **12**
 1st Value:
 2nd Value:
 Value Percent:
 Continuous Index:
 Within 8" of Joint: **YES**
 Remarks:

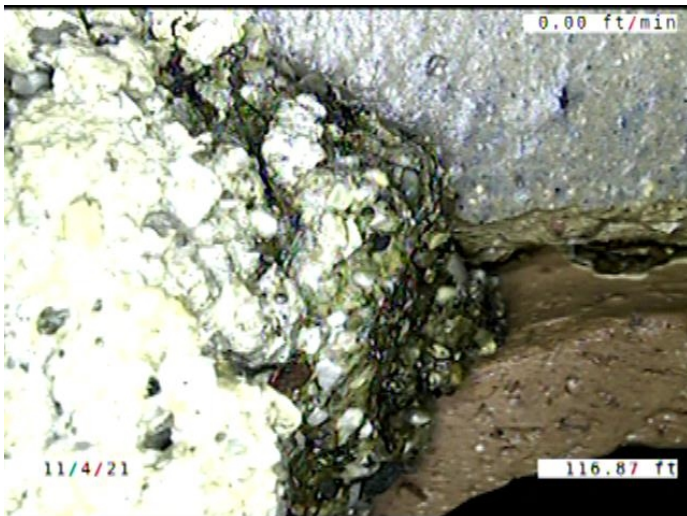
Code: **ISGT**
 Description: **Intruding Sealing Material Grout**

Distance (ft): **116.9**
 Structural Grade: **0**
 O&M Grade: **2**
 Clock Start/From: **9**
 Clock To: **10**
 1st Value:
 2nd Value:
 Value Percent: **5.000**
 Continuous Index:
 Within 8" of Joint: **NO**
 Remarks:

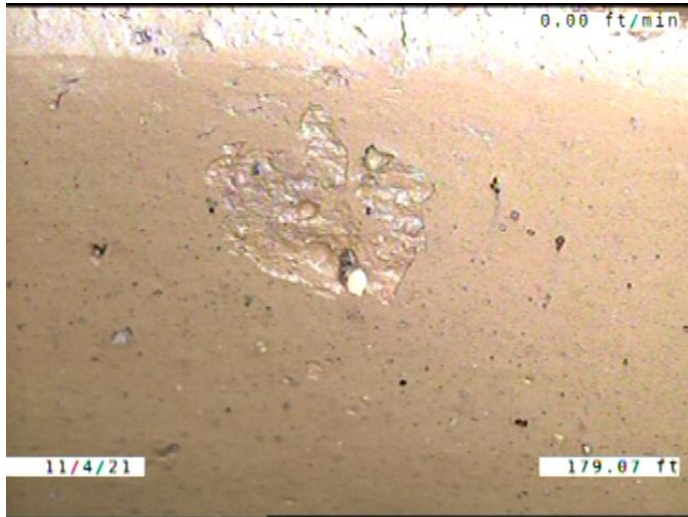
Code: **SSS**
 Description: **Surface Damage Surface Spalling**

Distance (ft): **179.1**
 Structural Grade: **2**
 O&M Grade: **0**
 Clock Start/From: **2**
 Clock To:
 1st Value:
 2nd Value:
 Value Percent:
 Continuous Index:
 Within 8" of Joint: **YES**
 Remarks:

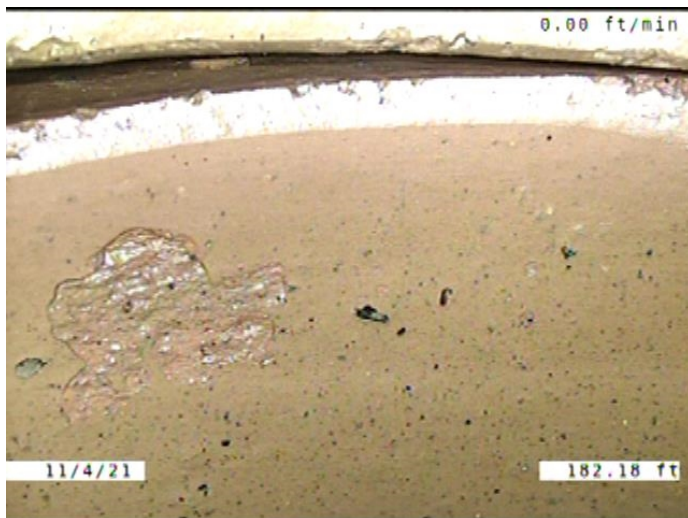
Code: **SSS**
 Description: **Surface Damage Surface Spalling**

Distance (ft): **182.2**
 Structural Grade: **2**
 O&M Grade: **0**
 Clock Start/From: **10**
 Clock To: **12**
 1st Value:
 2nd Value:
 Value Percent:
 Continuous Index:
 Within 8" of Joint: **YES**
 Remarks:

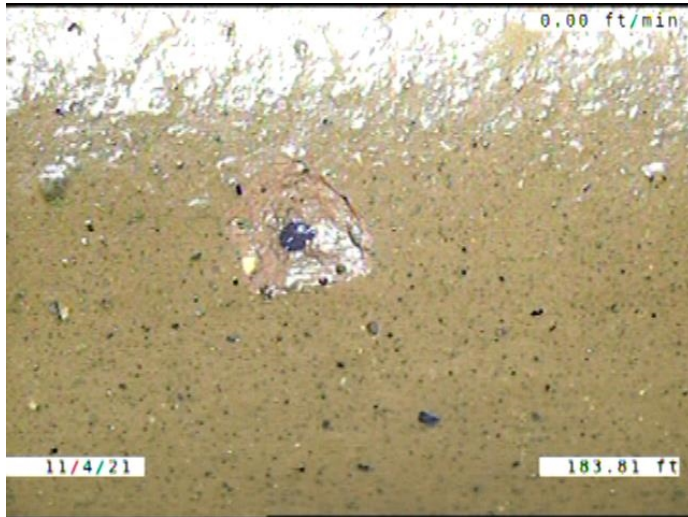
Code: **SSS**
 Description: **Surface Damage Surface Spalling**

Distance (ft): **183.8**
 Structural Grade: **2**
 O&M Grade: **0**
 Clock Start/From: **10**
 Clock To: **11**
 1st Value:
 2nd Value:
 Value Percent:
 Continuous Index:
 Within 8" of Joint: **YES**
 Remarks:

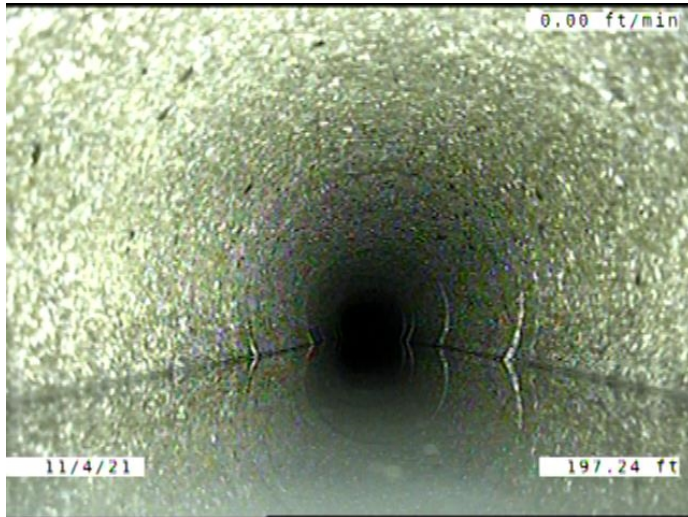
Code: **MWLS**
Description: **Miscellaneous Water Level Sag**

Distance (ft): **197.2**
Structural Grade: **2**
O&M Grade: **0**
Clock Start/From:
Clock To:
1st Value:
2nd Value:
Value Percent: **15.000**
Continuous Index: **S10**
Within 8" of Joint: **NO**
Remarks:

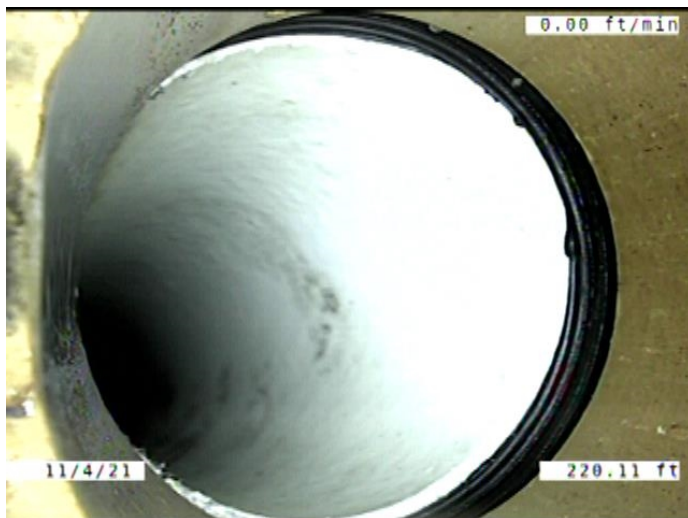
Code: **TBD**
Description: **Tap Break-in/Hammer Defective**

Distance (ft): **220.1**
Structural Grade: **0**
O&M Grade: **3**
Clock Start/From: **10**
Clock To:
1st Value: **4.000**
2nd Value:
Value Percent:
Continuous Index:
Within 8" of Joint: **YES**
Remarks: **Soild visible around top edge**

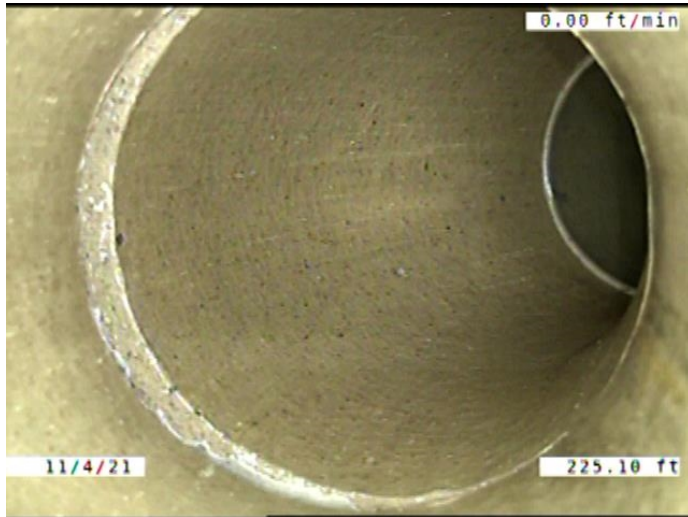
Code: **TBI**
Description: **Tap Break-in Intruding**

Distance (ft): **225.1**
Structural Grade: **0**
O&M Grade: **2**
Clock Start/From: **2**
Clock To:
1st Value: **6.000**
2nd Value: **1.000**
Value Percent:
Continuous Index:
Within 8" of Joint: **YES**
Remarks: **CONSTANTLY RUNNING WATER**

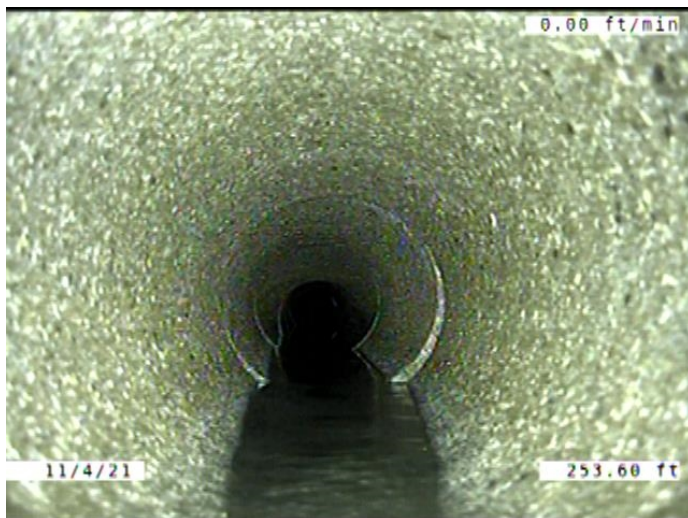
Code: **MWLS**
Description: **Miscellaneous Water Level Sag**

Distance (ft): **253.6**
Structural Grade: **2**
O&M Grade: **0**
Clock Start/From:
Clock To:
1st Value:
2nd Value:
Value Percent: **15.000**
Continuous Index: **F10**
Within 8" of Joint: **NO**
Remarks:
