Profile/Photo Observation Report

Date:	11/04/2021	Weather:		Coding:	PACP 7.0
Pipe Length (ft):	330.0	Owner:	City of Hobart	Pre Clean:	Heavy Cleaning
P.O.#:	YES502259	Surveyor:	S. Bucklin	PSR:	P-405-066-068
Customer:	City of Hobart	Clean Date:	11/04/2021	Shape:	C

Street:	South Wabash Street	Flow Control:	Not Controlled
City:	Hobart, IN	Year Renewed:	
Location:	Alley	Tape/Media #:	
Purpose:	Routine Assessment	Dia/Height:	10"
Use:	Sanitary Sewage Pipe	Material:	VCP
Drain Area:		Lining:	None
Category:	NA		
Comment:			
Location Details:		Direction of Survey:	Upstream
US MH:	M-405-068	DS MH:	M-405-066
		Total Length Surveyed (ft):	322.9

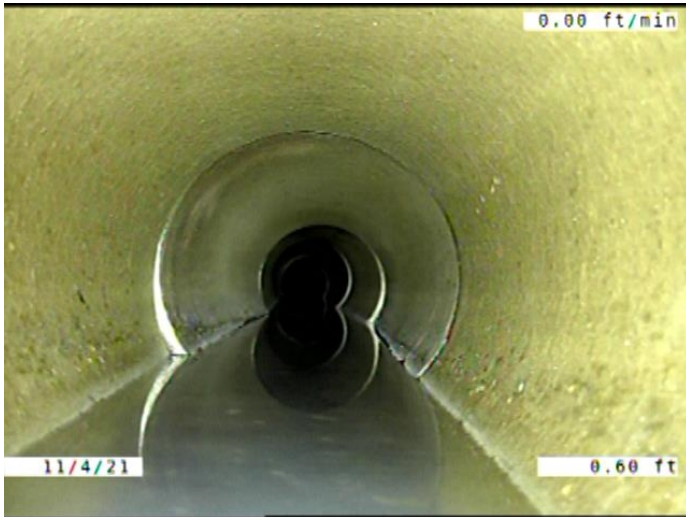
Code: **DSF**
 Description: **Deposits Settled Fine**

Distance (ft): **.6**
 Structural Grade: **0**
 O&M Grade: **2**
 Clock Start/From: **5**
 Clock To: **7**
 1st Value:
 2nd Value:
 Value Percent: **5.000**
 Continuous Index: **S01**
 Within 8" of Joint: **YES**
 Remarks:

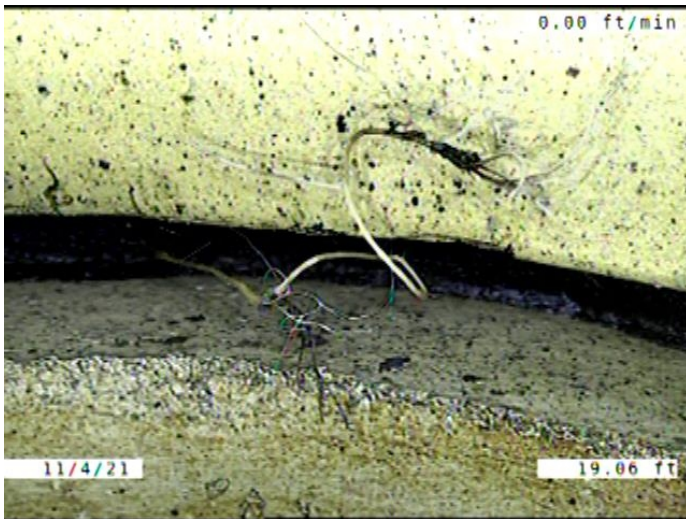
Code: **RFJ**
 Description: **Roots Fine Joint**

Distance (ft): **19.1**
 Structural Grade: **0**
 O&M Grade: **1**
 Clock Start/From: **11**
 Clock To: **3**
 1st Value:
 2nd Value:
 Value Percent:
 Continuous Index:
 Within 8" of Joint: **YES**
 Remarks:

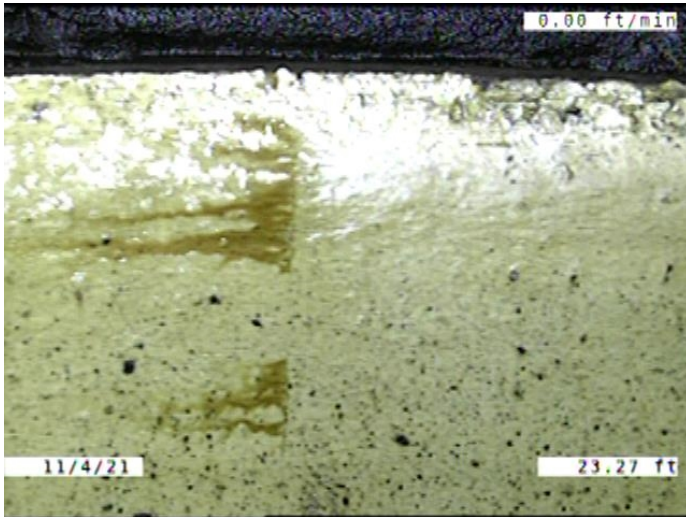
Code: **CL**
 Description: **Crack Longitudinal**

Distance (ft): **23.3**
 Structural Grade: **2**
 O&M Grade: **0**
 Clock Start/From: **10**
 Clock To:
 1st Value:
 2nd Value:
 Value Percent:
 Continuous Index:
 Within 8" of Joint: **YES**
 Remarks:

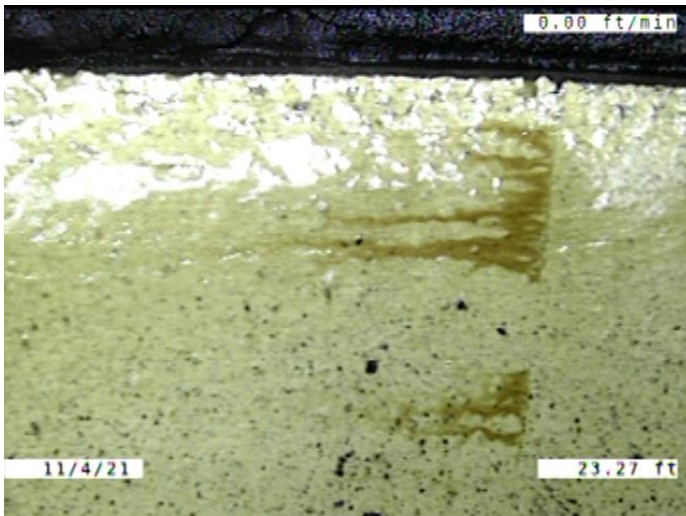
Code: **ISB**
 Description: **Infiltration Stain Barrel**

Distance (ft): **23.3**
 Structural Grade: **0**
 O&M Grade: **1**
 Clock Start/From: **9**
 Clock To: **10**
 1st Value:
 2nd Value:
 Value Percent:
 Continuous Index:
 Within 8" of Joint: **YES**
 Remarks:

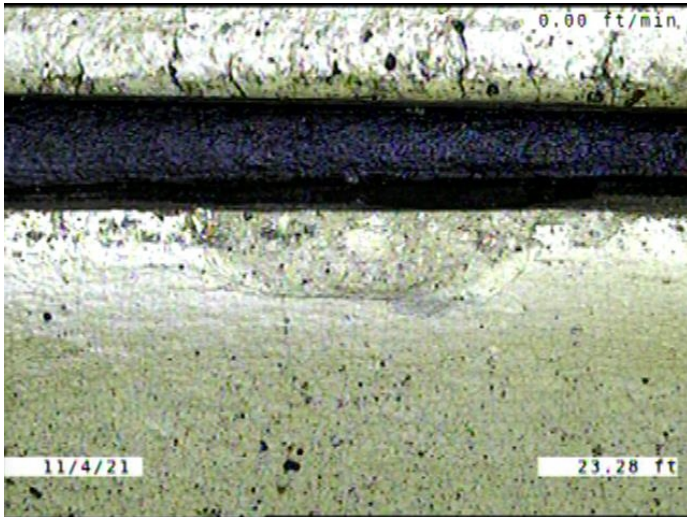
Code: **SSS**
 Description: **Surface Damage Surface Spalling**

Distance (ft): **23.3**
 Structural Grade: **2**
 O&M Grade: **0**
 Clock Start/From: **1**
 Clock To:
 1st Value:
 2nd Value:
 Value Percent:
 Continuous Index:
 Within 8" of Joint: **YES**
 Remarks:

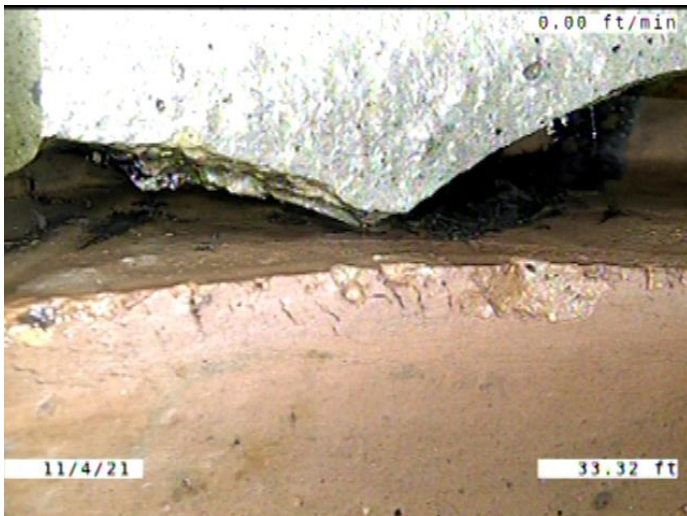
Code: **IDJ**
 Description: **Infiltration Dripper Joint**

Distance (ft): **33.3**
 Structural Grade: **0**
 O&M Grade: **3**
 Clock Start/From: **9**
 Clock To:
 1st Value:
 2nd Value:
 Value Percent:
 Continuous Index:
 Within 8" of Joint: **YES**
 Remarks:

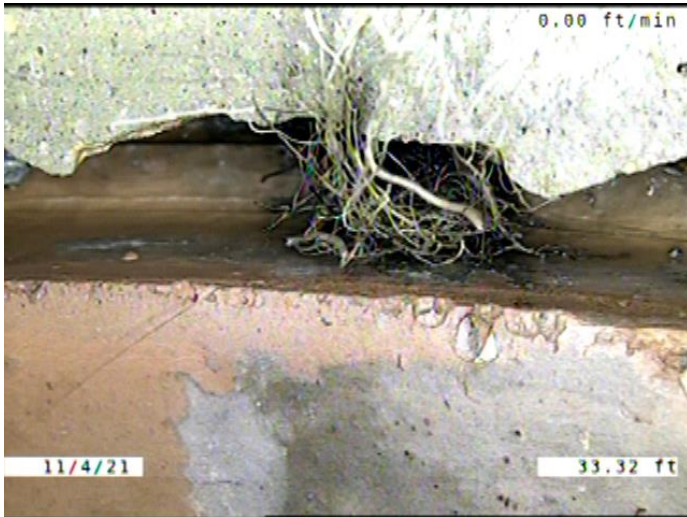
Code: **RFJ**
Description: **Roots Fine Joint**

Distance (ft): **33.3**
Structural Grade: **0**
O&M Grade: **1**
Clock Start/From: **10**
Clock To: **3**
1st Value:
2nd Value:
Value Percent:
Continuous Index:
Within 8" of Joint: **YES**
Remarks:

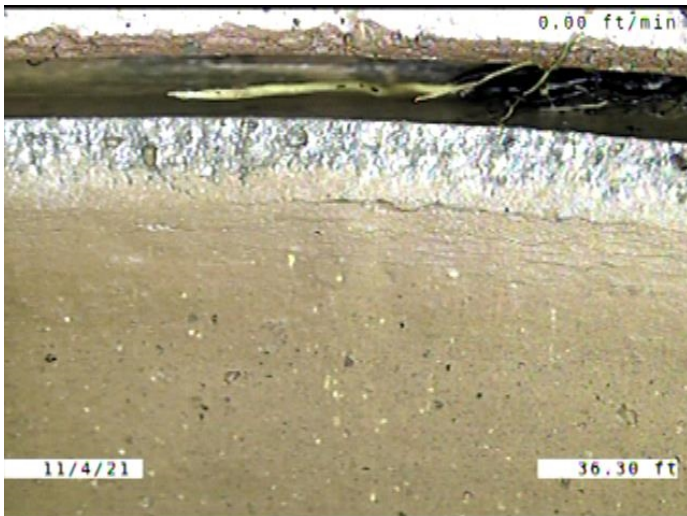
Code: **RFJ**
Description: **Roots Fine Joint**

Distance (ft): **36.3**
Structural Grade: **0**
O&M Grade: **1**
Clock Start/From: **9**
Clock To: **3**
1st Value:
2nd Value:
Value Percent:
Continuous Index:
Within 8" of Joint: **YES**
Remarks:

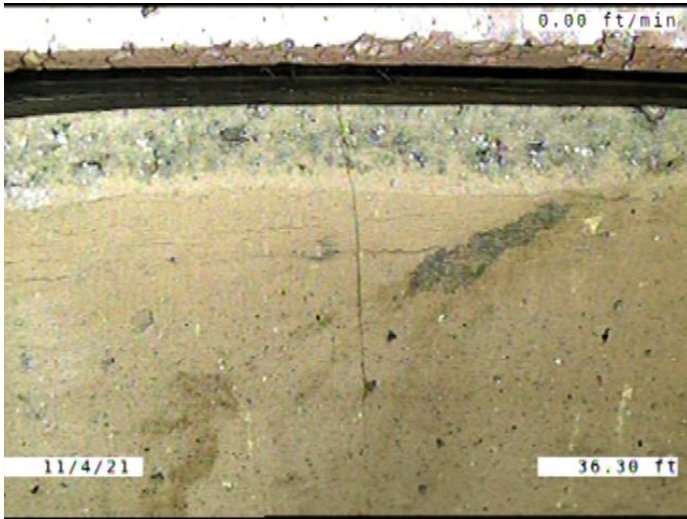
Code: **CL**
 Description: **Crack Longitudinal**

Distance (ft): **36.3**
 Structural Grade: **2**
 O&M Grade: **0**
 Clock Start/From: **9**
 Clock To:
 1st Value:
 2nd Value:
 Value Percent:
 Continuous Index:
 Within 8" of Joint: **YES**
 Remarks:

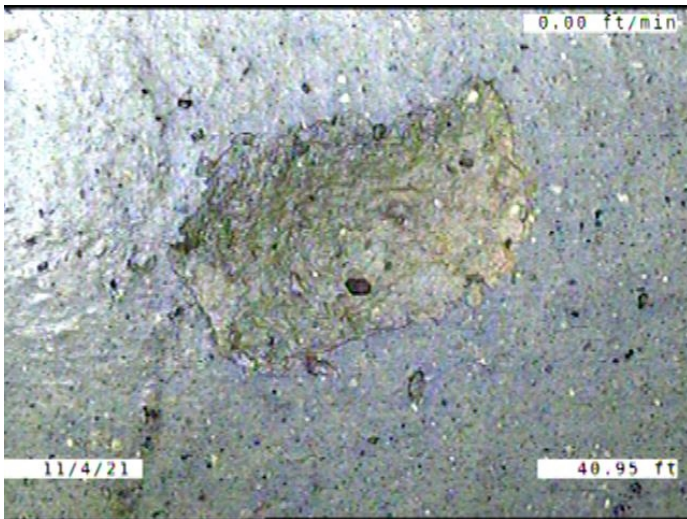
Code: **SSS**
 Description: **Surface Damage Surface Spalling**

Distance (ft): **41.0**
 Structural Grade: **2**
 O&M Grade: **0**
 Clock Start/From: **9**
 Clock To:
 1st Value:
 2nd Value:
 Value Percent:
 Continuous Index:
 Within 8" of Joint: **NO**
 Remarks:

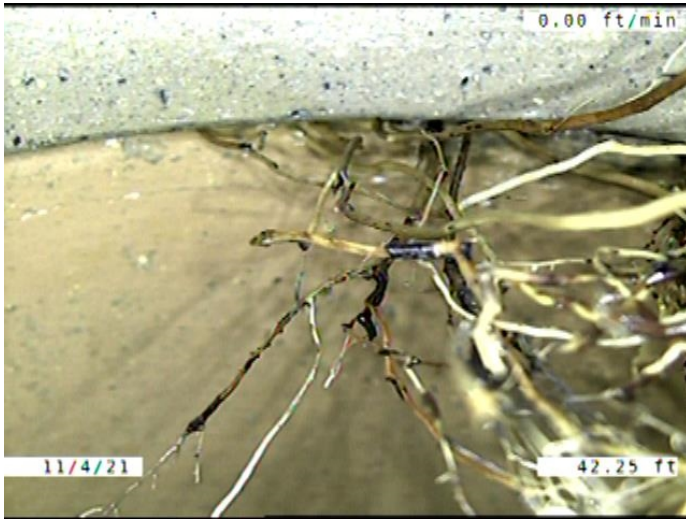
Code: **RMJ**
 Description: **Roots Medium Joint**

Distance (ft): **42.3**
 Structural Grade: **0**
 O&M Grade: **3**
 Clock Start/From: **11**
 Clock To: **4**
 1st Value:
 2nd Value:
 Value Percent: **5.000**
 Continuous Index:
 Within 8" of Joint: **YES**
 Remarks:

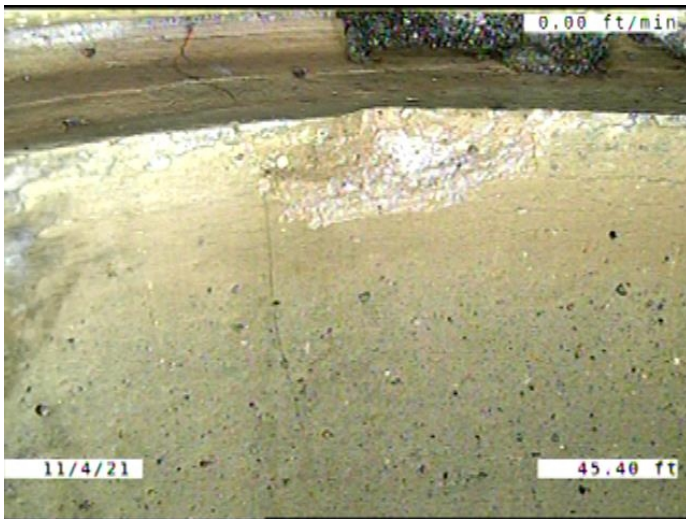
Code: **CL**
 Description: **Crack Longitudinal**

Distance (ft): **45.4**
 Structural Grade: **2**
 O&M Grade: **0**
 Clock Start/From: **10**
 Clock To:
 1st Value:
 2nd Value:
 Value Percent:
 Continuous Index:
 Within 8" of Joint: **YES**
 Remarks:

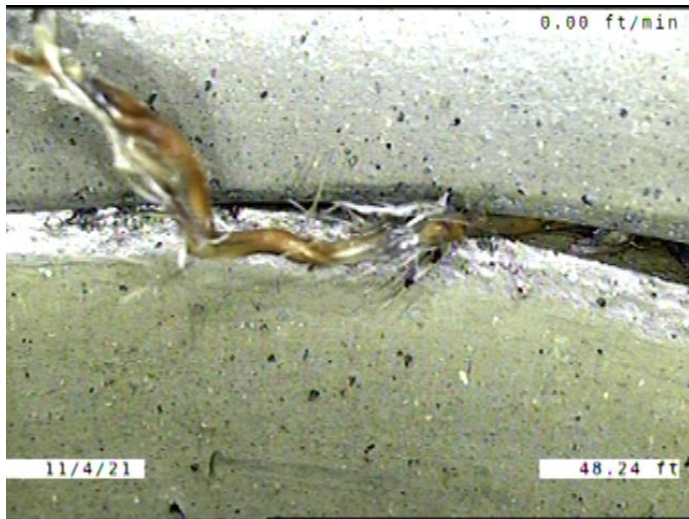
Code: **RFJ**
 Description: **Roots Fine Joint**

Distance (ft): **48.2**
 Structural Grade: **0**
 O&M Grade: **1**
 Clock Start/From: **10**
 Clock To: **3**
 1st Value:
 2nd Value:
 Value Percent:
 Continuous Index:
 Within 8" of Joint: **YES**
 Remarks:

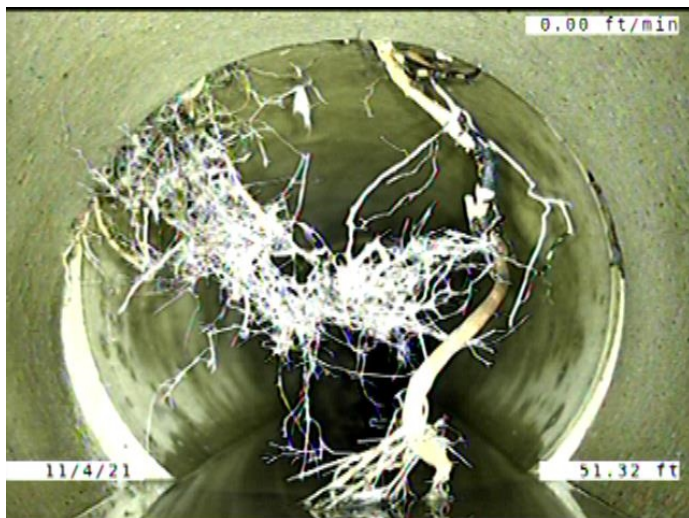
Code: **RMJ**
 Description: **Roots Medium Joint**

Distance (ft): **51.3**
 Structural Grade: **0**
 O&M Grade: **3**
 Clock Start/From: **9**
 Clock To: **1**
 1st Value:
 2nd Value:
 Value Percent: **5.000**
 Continuous Index:
 Within 8" of Joint: **YES**
 Remarks:

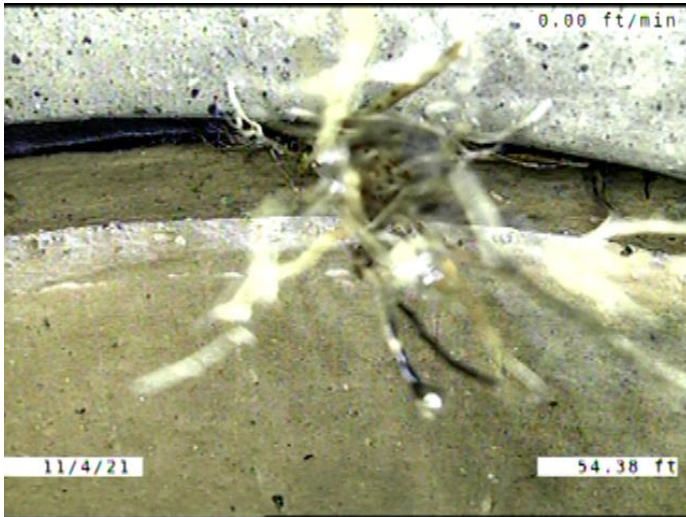
Code: **RFJ**
 Description: **Roots Fine Joint**

Distance (ft): **54.4**
 Structural Grade: **0**
 O&M Grade: **1**
 Clock Start/From: **2**
 Clock To:
 1st Value:
 2nd Value:
 Value Percent:
 Continuous Index:
 Within 8" of Joint: **YES**
 Remarks:

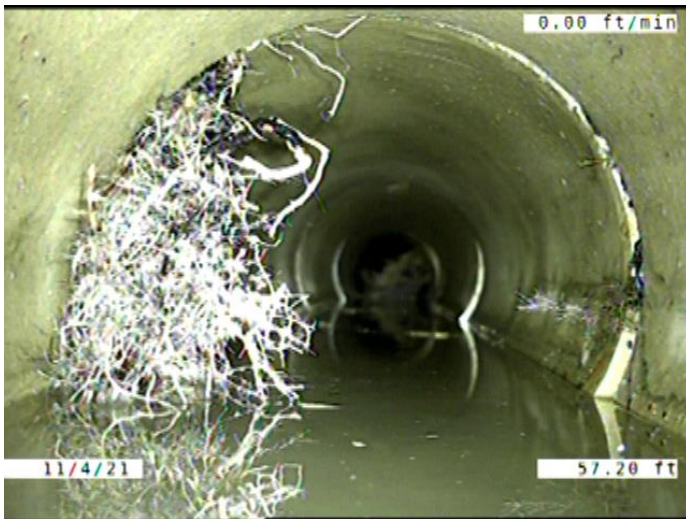
Code: **RMJ**
 Description: **Roots Medium Joint**

Distance (ft): **57.2**
 Structural Grade: **0**
 O&M Grade: **3**
 Clock Start/From: **7**
 Clock To: **4**
 1st Value:
 2nd Value:
 Value Percent: **15.000**
 Continuous Index:
 Within 8" of Joint: **YES**
 Remarks:

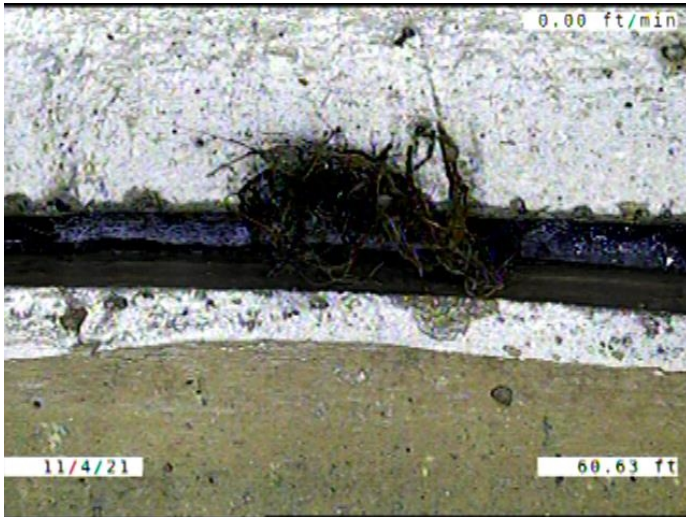
Code: **RFJ**
 Description: **Roots Fine Joint**

Distance (ft): **60.6**
 Structural Grade: **0**
 O&M Grade: **1**
 Clock Start/From: **10**
 Clock To: **12**
 1st Value:
 2nd Value:
 Value Percent:
 Continuous Index:
 Within 8" of Joint: **YES**
 Remarks:

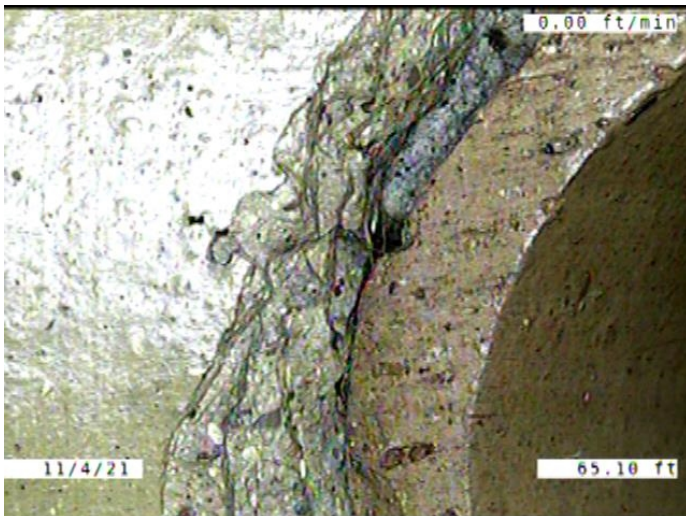
Code: **SSS**
 Description: **Surface Damage Surface Spalling**

Distance (ft): **65.1**
 Structural Grade: **2**
 O&M Grade: **0**
 Clock Start/From: **12**
 Clock To: **3**
 1st Value:
 2nd Value:
 Value Percent:
 Continuous Index:
 Within 8" of Joint: **YES**
 Remarks:

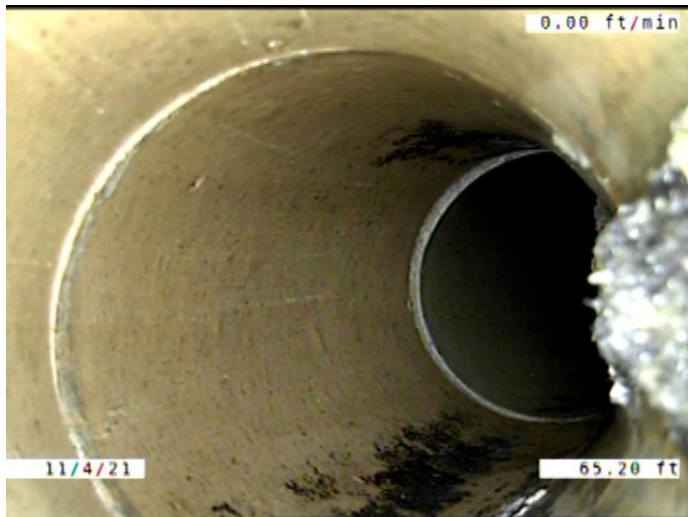
Code:	TBI
Description:	Tap Break-in Intruding
Distance (ft):	65.2
Structural Grade:	0
O&M Grade:	2
Clock Start/From:	2
Clock To:	
1st Value:	4.000
2nd Value:	1.000
Value Percent:	
Continuous Index:	
Within 8" of Joint:	YES
Remarks:	CONSTANTLY RUNNING WATER. ROOTS GROWING FROM THE TAP IN

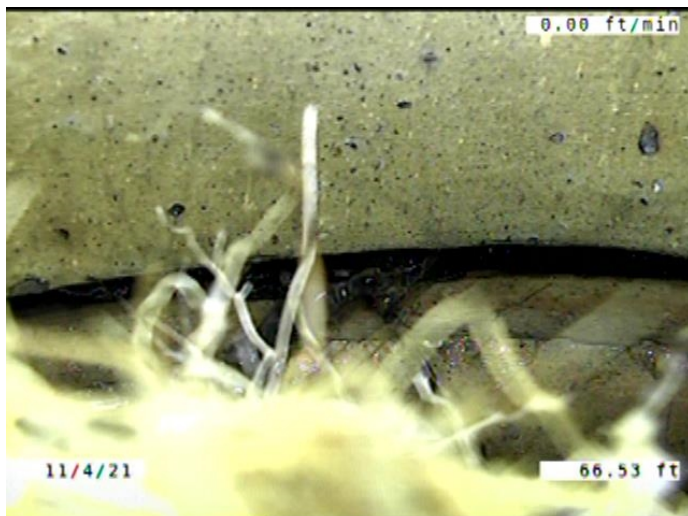
Code:	IRJ
Description:	Infiltration Runner Joint
Distance (ft):	66.5
Structural Grade:	0
O&M Grade:	4
Clock Start/From:	10
Clock To:	
1st Value:	
2nd Value:	
Value Percent:	
Continuous Index:	
Within 8" of Joint:	YES
Remarks:

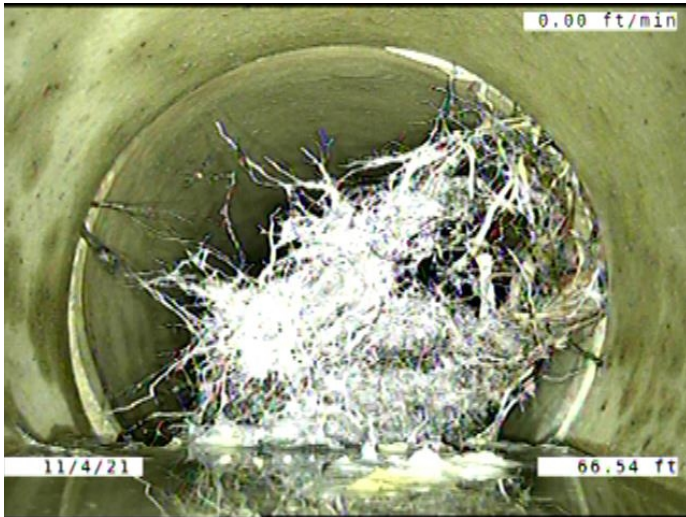
Code: **RBJ**
 Description: **Roots Ball Joint**

Distance (ft): **66.5**
 Structural Grade: **0**
 O&M Grade: **4**
 Clock Start/From: **1**
 Clock To: **10**
 1st Value:
 2nd Value:
 Value Percent: **65.000**
 Continuous Index:
 Within 8" of Joint: **YES**
 Remarks:

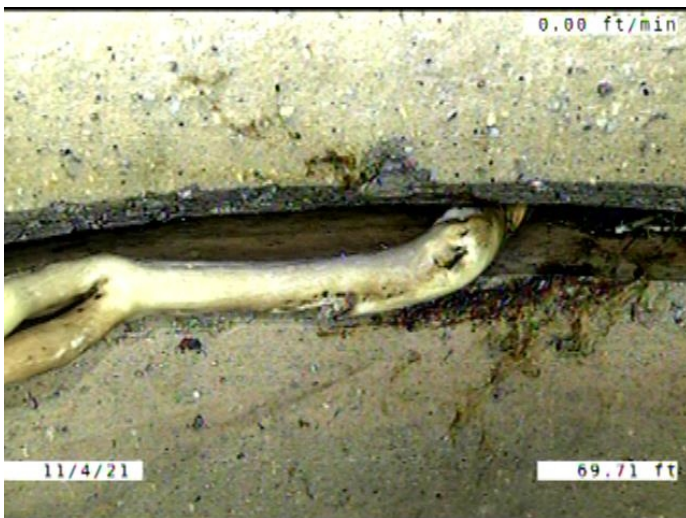
Code: **RTJ**
 Description: **Roots Tap Joint**

Distance (ft): **69.7**
 Structural Grade: **0**
 O&M Grade: **2**
 Clock Start/From: **8**
 Clock To: **3**
 1st Value:
 2nd Value:
 Value Percent: **5.000**
 Continuous Index:
 Within 8" of Joint: **YES**
 Remarks:

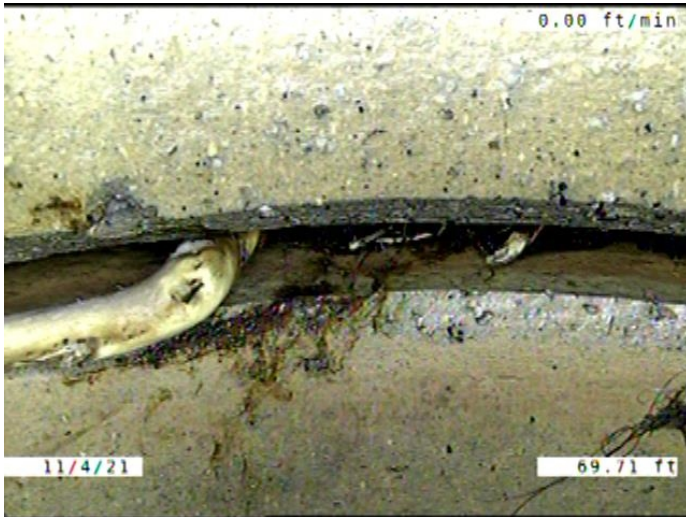
Code: **ISJ**
 Description: **Infiltration Stain Joint**

Distance (ft): **69.7**
 Structural Grade: **0**
 O&M Grade: **1**
 Clock Start/From: **11**
 Clock To:
 1st Value:
 2nd Value:
 Value Percent:
 Continuous Index:
 Within 8" of Joint: **YES**
 Remarks:

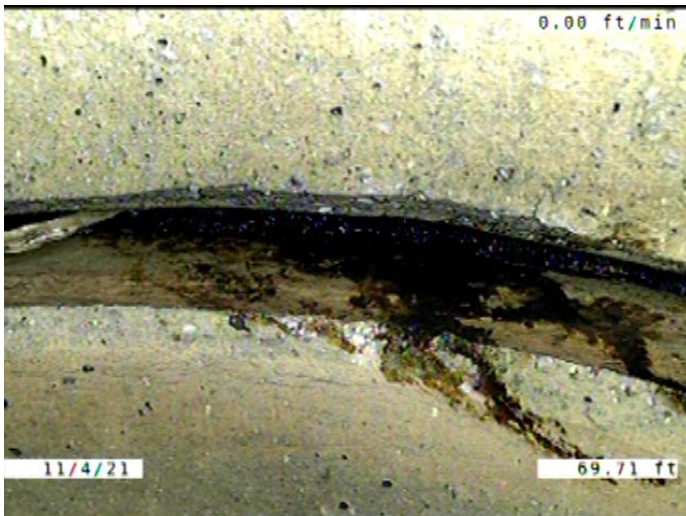
Code: **ISJ**
 Description: **Infiltration Stain Joint**

Distance (ft): **69.7**
 Structural Grade: **0**
 O&M Grade: **1**
 Clock Start/From: **2**
 Clock To: **3**
 1st Value:
 2nd Value:
 Value Percent:
 Continuous Index:
 Within 8" of Joint: **YES**
 Remarks:

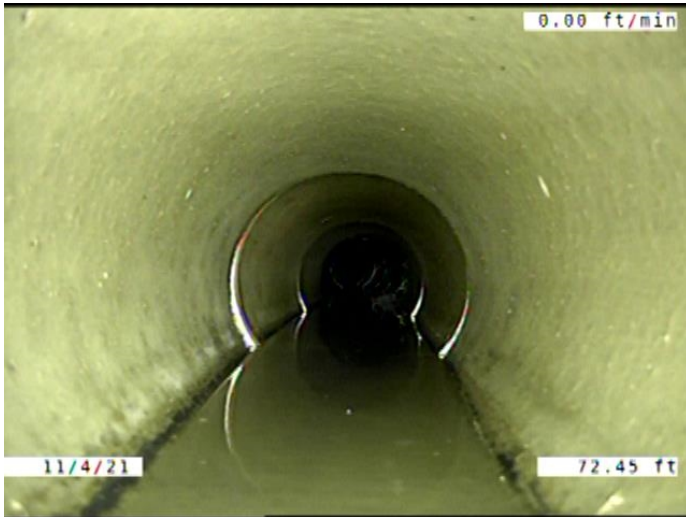
Code: **MWLS**
 Description: **Miscellaneous Water Level Sag**

Distance (ft): **72.4**
 Structural Grade: **2**
 O&M Grade: **0**
 Clock Start/From:
 Clock To:
 1st Value:
 2nd Value:
 Value Percent: **10.000**
 Continuous Index: **S02**
 Within 8" of Joint: **NO**
 Remarks:

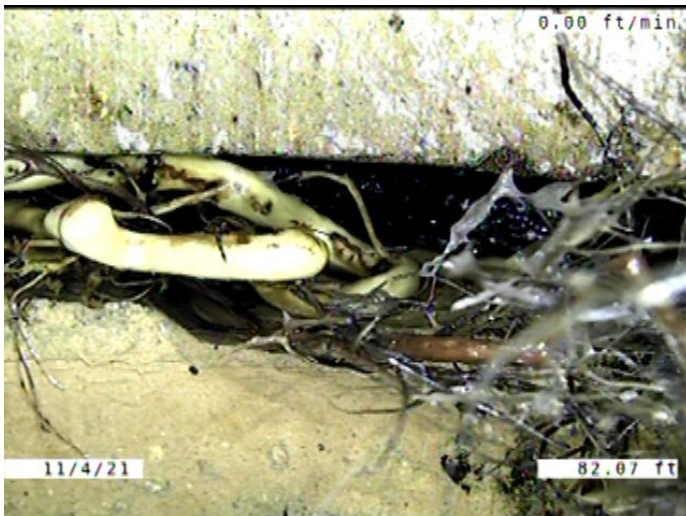
Code: **RFJ**
 Description: **Roots Fine Joint**

Distance (ft): **82.1**
 Structural Grade: **0**
 O&M Grade: **1**
 Clock Start/From: **9**
 Clock To: **3**
 1st Value:
 2nd Value:
 Value Percent:
 Continuous Index: **S03**
 Within 8" of Joint: **YES**
 Remarks:

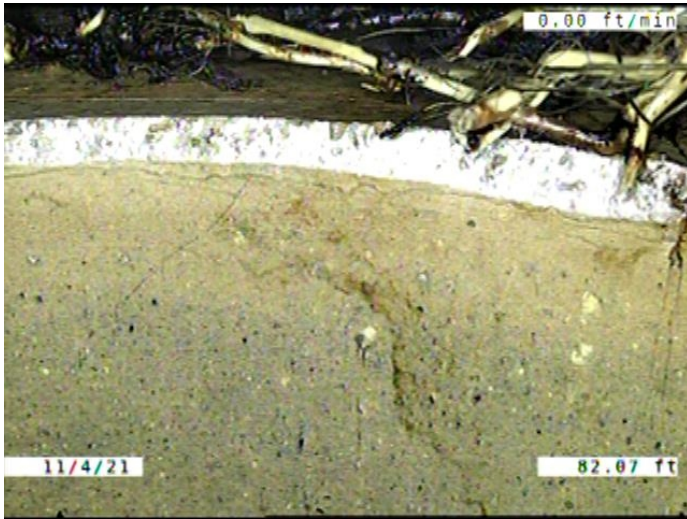
Code: **ISB**
 Description: **Infiltration Stain Barrel**

Distance (ft): **82.1**
 Structural Grade: **0**
 O&M Grade: **1**
 Clock Start/From: **2**
 Clock To: **4**
 1st Value:
 2nd Value:
 Value Percent:
 Continuous Index: **S04**
 Within 8" of Joint: **YES**
 Remarks:

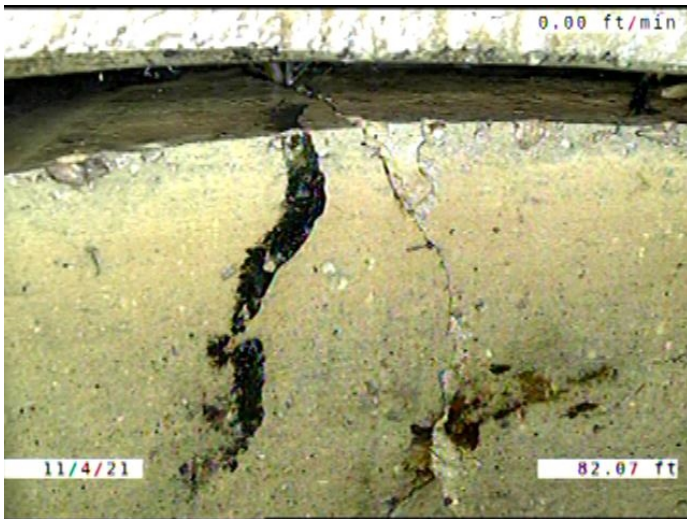
Code: **ISB**
 Description: **Infiltration Stain Barrel**

Distance (ft): **82.1**
 Structural Grade: **0**
 O&M Grade: **1**
 Clock Start/From: **8**
 Clock To: **10**
 1st Value:
 2nd Value:
 Value Percent:
 Continuous Index: **S05**
 Within 8" of Joint: **YES**
 Remarks:

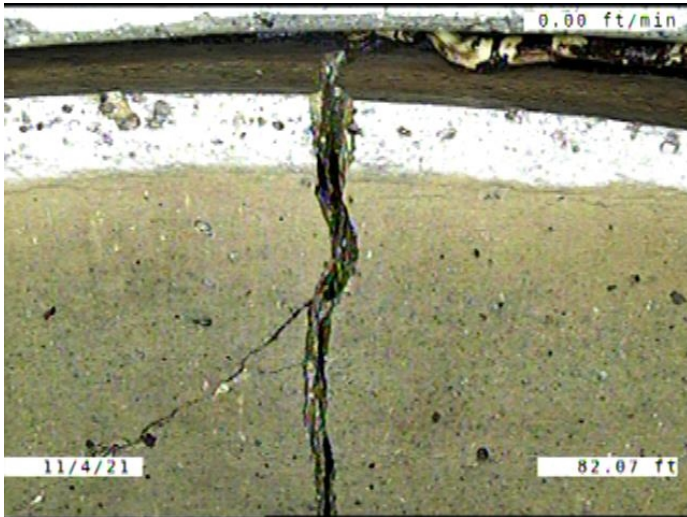
Code: **FM**
 Description: **Fracture Multiple**

Distance (ft): **82.1**
 Structural Grade: **4**
 O&M Grade: **0**
 Clock Start/From: **12**
 Clock To: **12**
 1st Value:
 2nd Value:
 Value Percent:
 Continuous Index: **S06**
 Within 8" of Joint: **YES**
 Remarks:

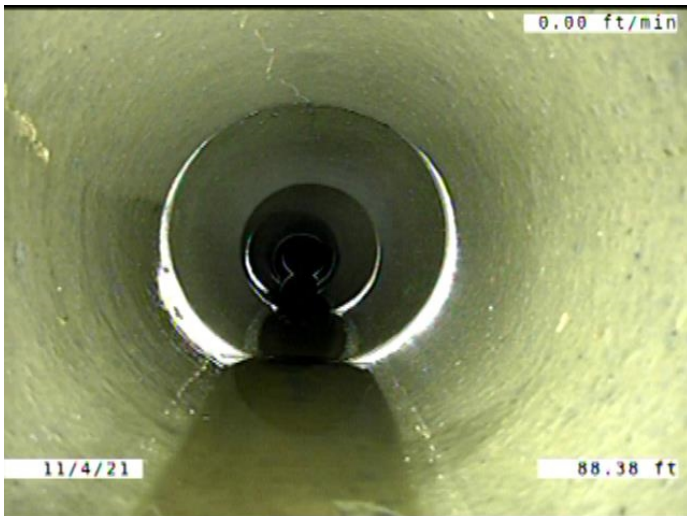
Code: **MWLS**
 Description: **Miscellaneous Water Level Sag**

Distance (ft): **88.4**
 Structural Grade: **2**
 O&M Grade: **0**
 Clock Start/From:
 Clock To:
 1st Value:
 2nd Value:
 Value Percent: **10.000**
 Continuous Index: **F02**
 Within 8" of Joint: **NO**
 Remarks:

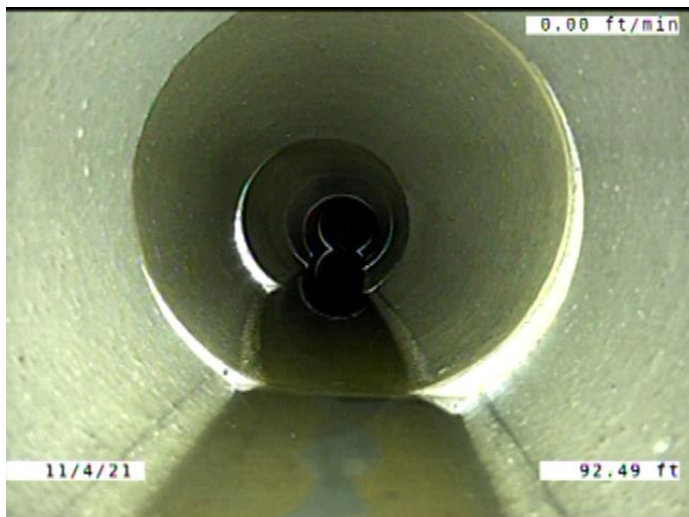
Code: **RFJ**
Description: **Roots Fine Joint**

Distance (ft): **92.5**
Structural Grade: **0**
O&M Grade: **1**
Clock Start/From: **9**
Clock To: **3**
1st Value:
2nd Value:
Value Percent:
Continuous Index: **F03**
Within 8" of Joint: **YES**
Remarks:

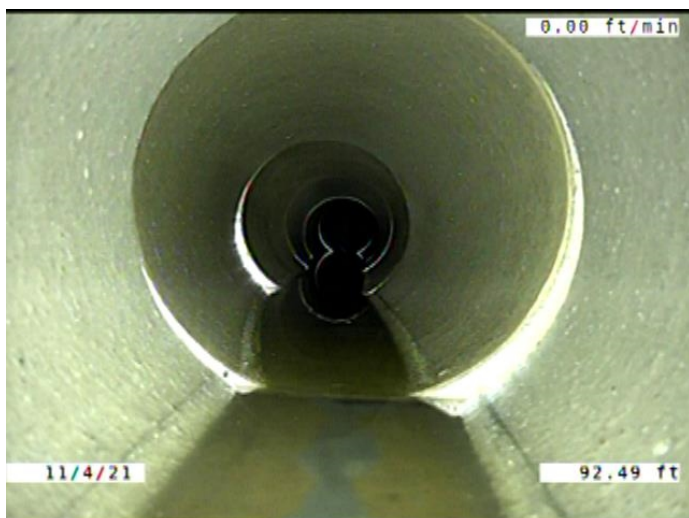
Code: **ISB**
Description: **Infiltration Stain Barrel**

Distance (ft): **92.5**
Structural Grade: **0**
O&M Grade: **1**
Clock Start/From: **2**
Clock To: **4**
1st Value:
2nd Value:
Value Percent:
Continuous Index: **F04**
Within 8" of Joint: **YES**
Remarks:

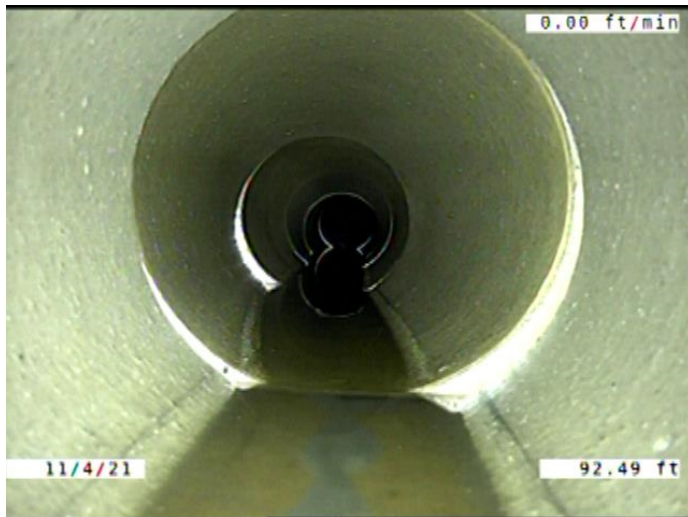
Code: **ISB**
 Description: **Infiltration Stain Barrel**

Distance (ft): **92.5**
 Structural Grade: **0**
 O&M Grade: **1**
 Clock Start/From: **8**
 Clock To: **10**
 1st Value:
 2nd Value:
 Value Percent:
 Continuous Index: **F05**
 Within 8" of Joint: **YES**
 Remarks:

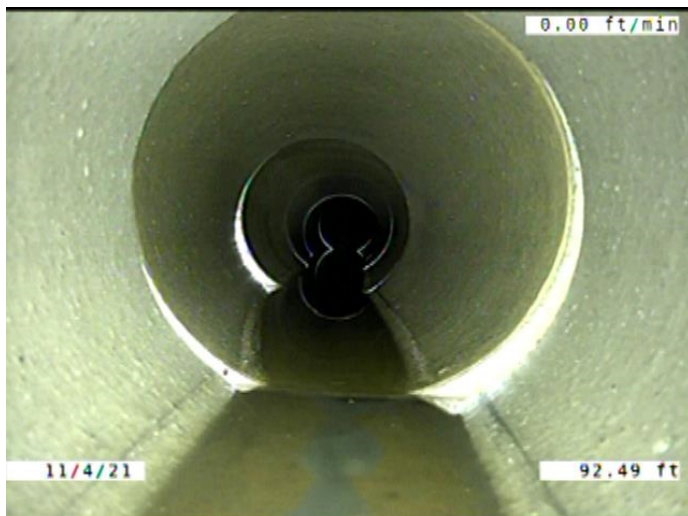
Code: **FM**
 Description: **Fracture Multiple**

Distance (ft): **92.5**
 Structural Grade: **4**
 O&M Grade: **0**
 Clock Start/From: **12**
 Clock To: **12**
 1st Value:
 2nd Value:
 Value Percent:
 Continuous Index: **F06**
 Within 8" of Joint: **YES**
 Remarks:

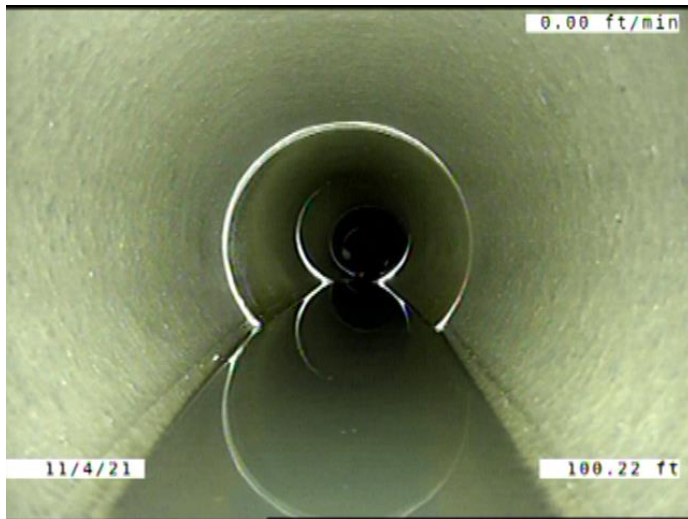
Code: **MWLS**
Description: **Miscellaneous Water Level Sag**

Distance (ft): **100.2**
Structural Grade: **2**
O&M Grade: **0**
Clock Start/From:
Clock To:
1st Value:
2nd Value:
Value Percent: **10.000**
Continuous Index: **S07**
Within 8" of Joint: **NO**
Remarks:

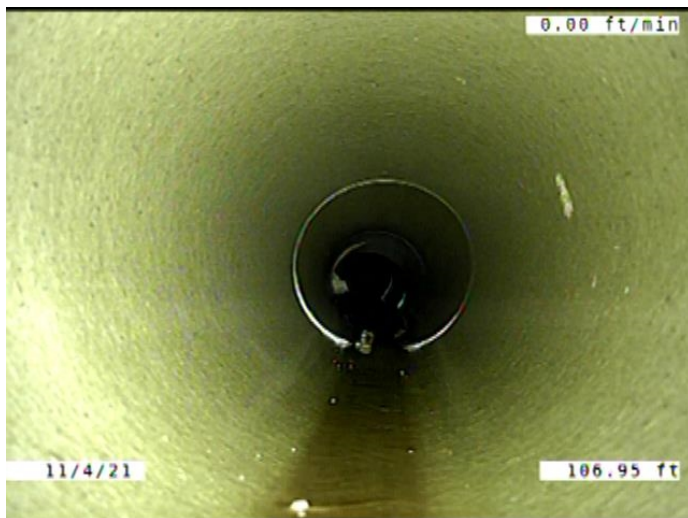
Code: **MWLS**
Description: **Miscellaneous Water Level Sag**

Distance (ft): **106.9**
Structural Grade: **2**
O&M Grade: **0**
Clock Start/From:
Clock To:
1st Value:
2nd Value:
Value Percent: **10.000**
Continuous Index: **F07**
Within 8" of Joint: **NO**
Remarks:

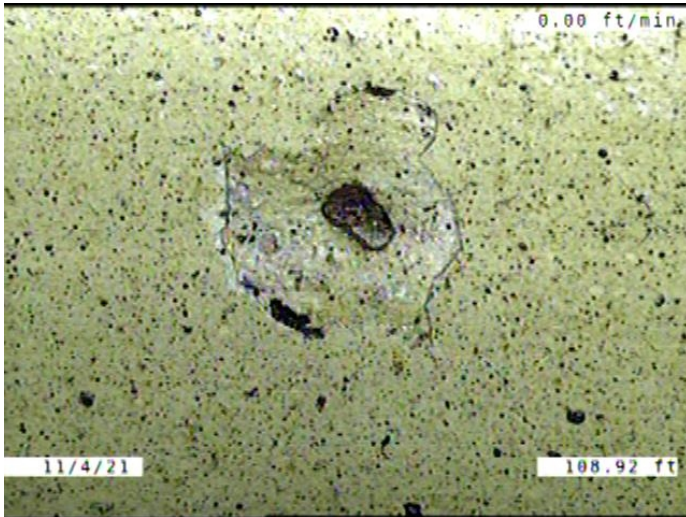
Code: **SSS**
Description: **Surface Damage Surface Spalling**

Distance (ft): **108.9**
Structural Grade: **2**
O&M Grade: **0**
Clock Start/From: **2**
Clock To:
1st Value:
2nd Value:
Value Percent:
Continuous Index:
Within 8" of Joint: **NO**
Remarks:

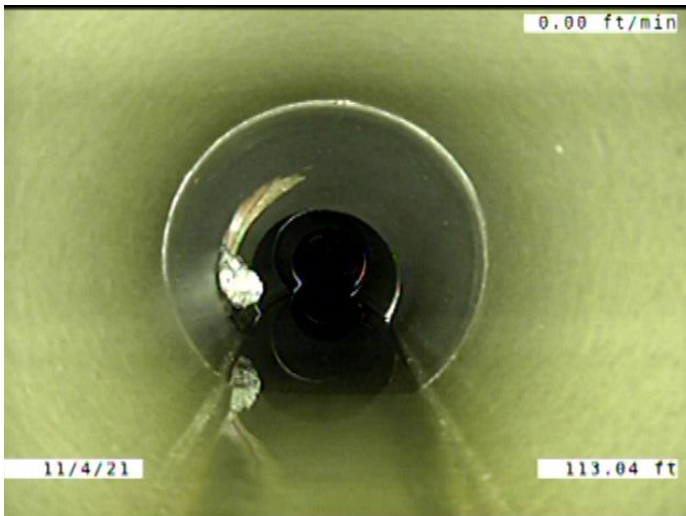
Code: **MWLS**
Description: **Miscellaneous Water Level Sag**

Distance (ft): **113.0**
Structural Grade: **2**
O&M Grade: **0**
Clock Start/From:
Clock To:
1st Value:
2nd Value:
Value Percent: **5.000**
Continuous Index: **S08**
Within 8" of Joint: **NO**
Remarks:

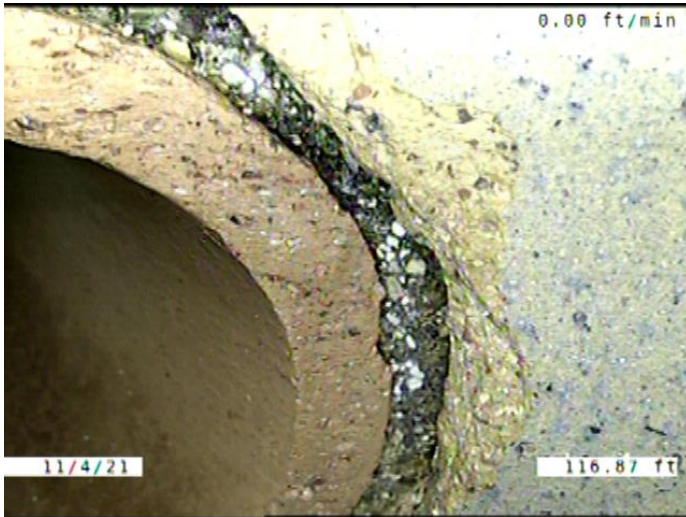
Code: **SSS**
 Description: **Surface Damage Surface Spalling**

Distance (ft): **116.9**
 Structural Grade: **2**
 O&M Grade: **0**
 Clock Start/From: **9**
 Clock To: **12**
 1st Value:
 2nd Value:
 Value Percent:
 Continuous Index:
 Within 8" of Joint: **YES**
 Remarks:

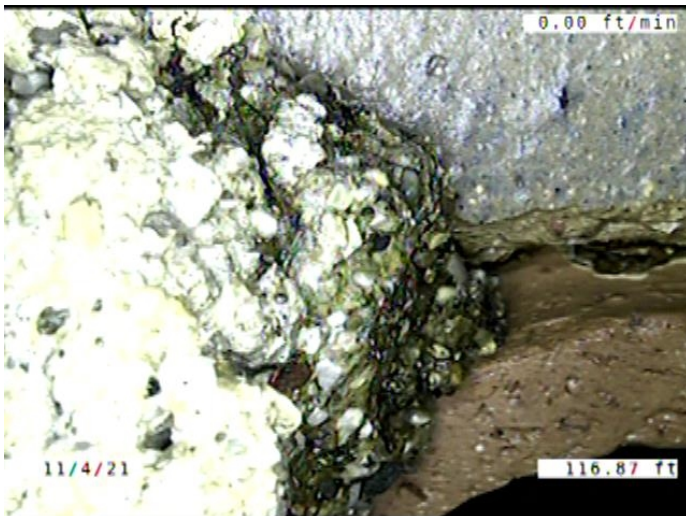
Code: **ISGT**
 Description: **Intruding Sealing Material Grout**

Distance (ft): **116.9**
 Structural Grade: **0**
 O&M Grade: **2**
 Clock Start/From: **9**
 Clock To: **10**
 1st Value:
 2nd Value:
 Value Percent: **5.000**
 Continuous Index:
 Within 8" of Joint: **NO**
 Remarks:

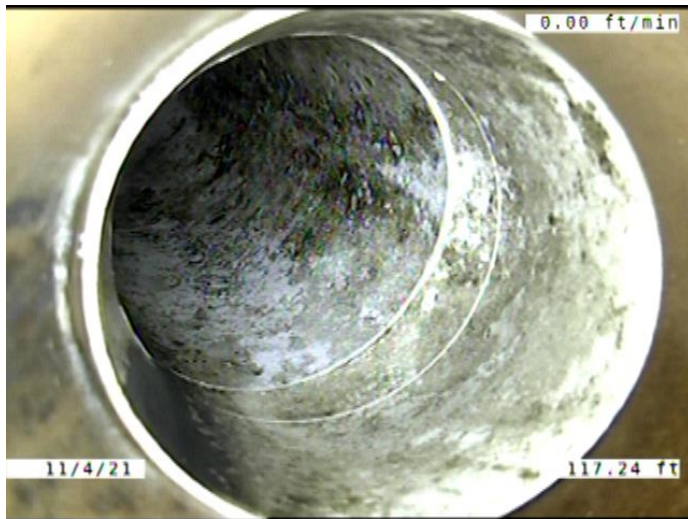
Code: **TBI**
 Description: **Tap Break-in Intruding**

Distance (ft): **117.2**
 Structural Grade: **0**
 O&M Grade: **2**
 Clock Start/From: **10**
 Clock To:
 1st Value: **4.000**
 2nd Value: **2.000**
 Value Percent:
 Continuous Index:
 Within 8" of Joint: **YES**
 Remarks:

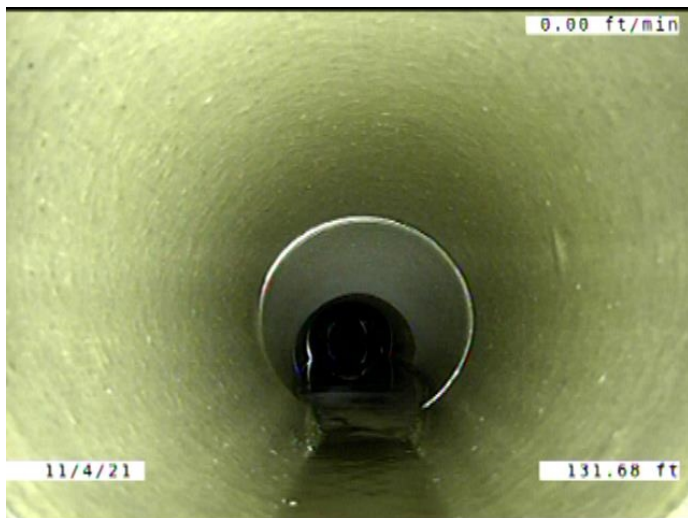
Code: **MWLS**
 Description: **Miscellaneous Water Level Sag**

Distance (ft): **131.7**
 Structural Grade: **2**
 O&M Grade: **0**
 Clock Start/From:
 Clock To:
 1st Value:
 2nd Value:
 Value Percent: **5.000**
 Continuous Index: **F08**
 Within 8" of Joint: **NO**
 Remarks:

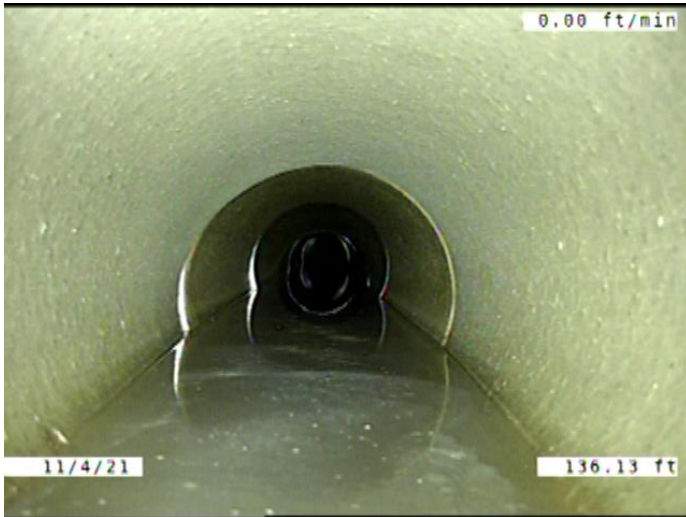
Code: **MWLS**
 Description: **Miscellaneous Water Level Sag**

Distance (ft): **136.1**
 Structural Grade: **2**
 O&M Grade: **0**
 Clock Start/From:
 Clock To:
 1st Value:
 2nd Value:
 Value Percent: **20.000**
 Continuous Index: **S09**
 Within 8" of Joint: **NO**
 Remarks:

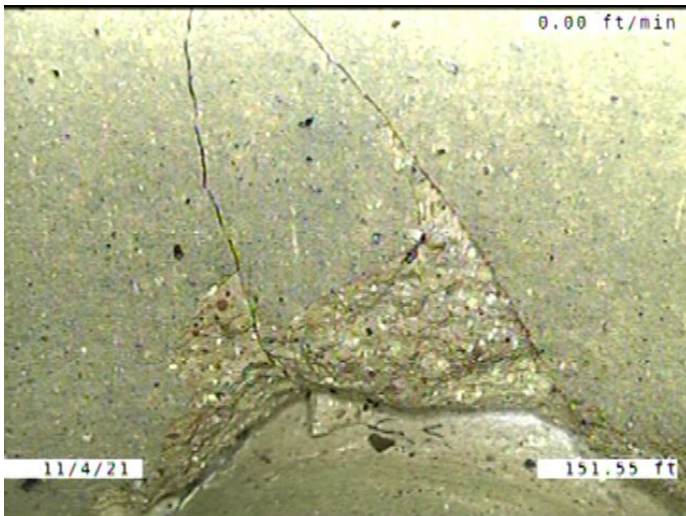
Code: **SSS**
 Description: **Surface Damage Surface Spalling**

Distance (ft): **151.5**
 Structural Grade: **2**
 O&M Grade: **0**
 Clock Start/From: **12**
 Clock To: **3**
 1st Value:
 2nd Value:
 Value Percent:
 Continuous Index:
 Within 8" of Joint: **YES**
 Remarks:

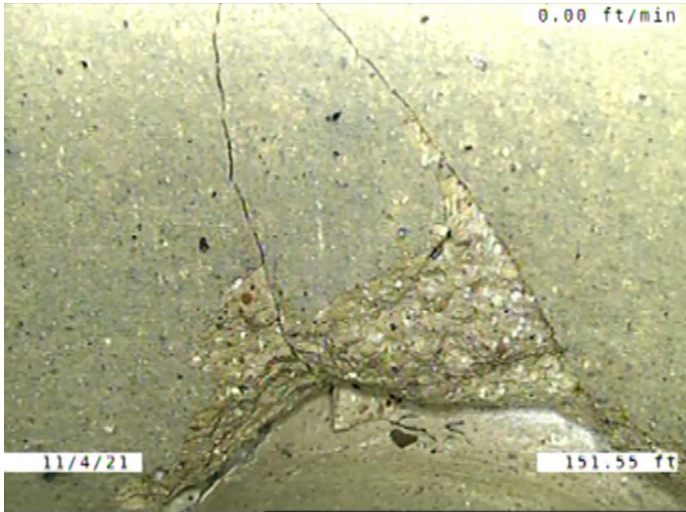
Code: **CM**
 Description: **Crack Multiple**

Distance (ft): **151.6**
 Structural Grade: **3**
 O&M Grade: **0**
 Clock Start/From: **1**
 Clock To: **2**
 1st Value:
 2nd Value:
 Value Percent:
 Continuous Index:
 Within 8" of Joint: **NO**
 Remarks:

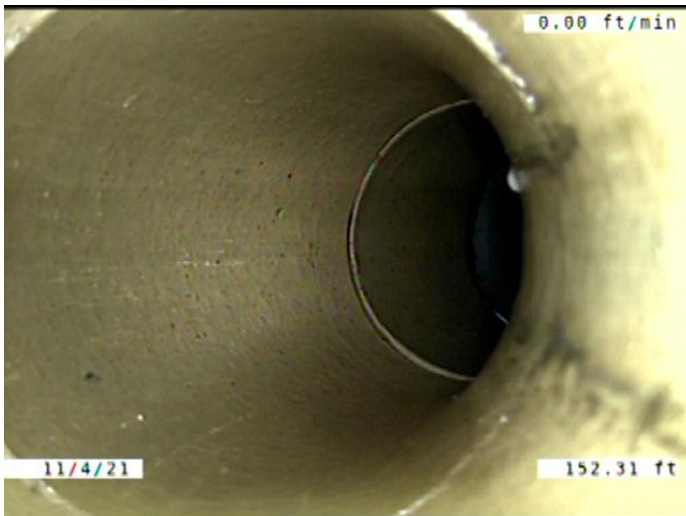
Code: **TBI**
 Description: **Tap Break-in Intruding**

Distance (ft): **152.3**
 Structural Grade: **0**
 O&M Grade: **2**
 Clock Start/From: **1**
 Clock To:
 1st Value: **4.000**
 2nd Value: **1.000**
 Value Percent:
 Continuous Index:
 Within 8" of Joint: **YES**
 Remarks:

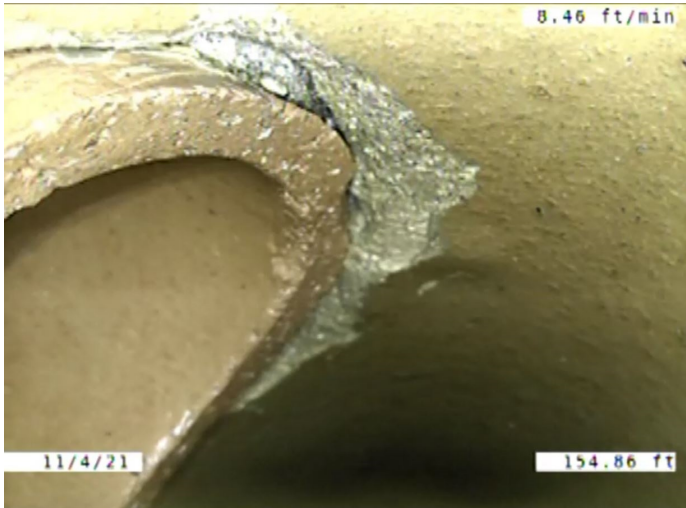
Code:	SSS
Description:	Surface Damage Surface Spalling
Distance (ft):	154.9
Structural Grade:	2
O&M Grade:	0
Clock Start/From:	9
Clock To:	12
1st Value:	
2nd Value:	
Value Percent:	
Continuous Index:	
Within 8" of Joint:	NO
Remarks:

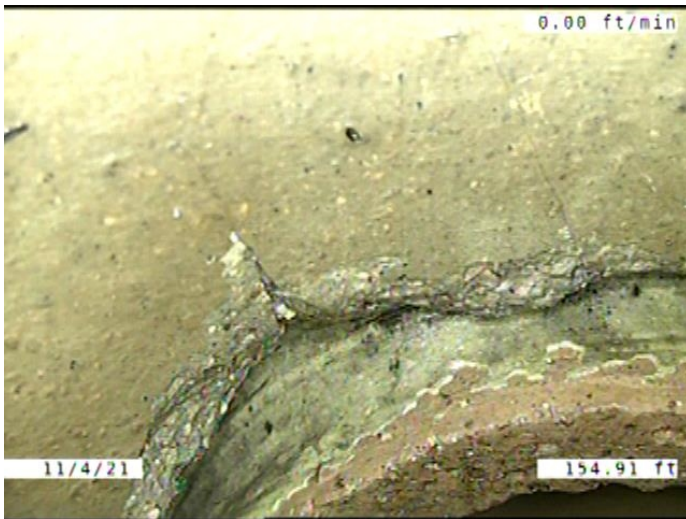
Code:	CM
Description:	Crack Multiple
Distance (ft):	154.9
Structural Grade:	3
O&M Grade:	0
Clock Start/From:	9
Clock To:	10
1st Value:	
2nd Value:	
Value Percent:	
Continuous Index:	
Within 8" of Joint:	YES
Remarks:

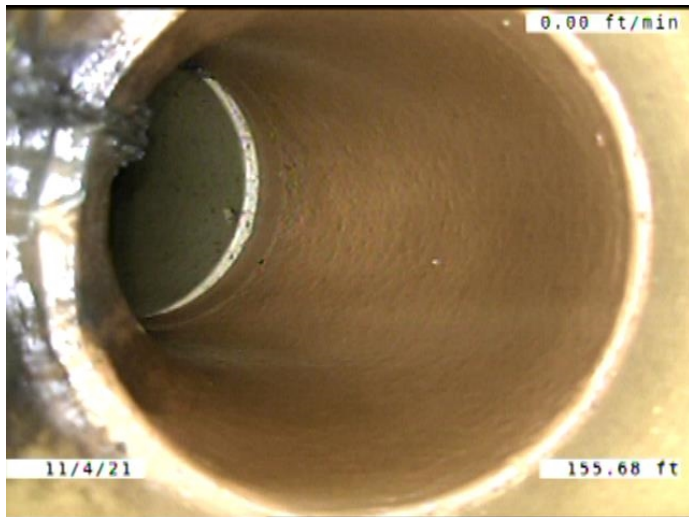
Code:	TBI
Description:	Tap Break-in Intruding
Distance (ft):	155.7
Structural Grade:	0
O&M Grade:	2
Clock Start/From:	10
Clock To:	
1st Value:	4.000
2nd Value:	1.000
Value Percent:	
Continuous Index:	
Within 8" of Joint:	YES
Remarks:	ROOTS GROWING OUT THE JOINTS

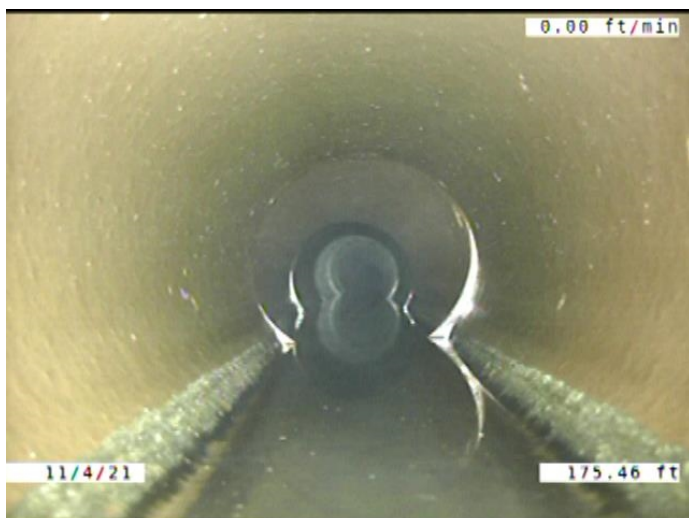
Code:	MWLS
Description:	Miscellaneous Water Level Sag
Distance (ft):	175.5
Structural Grade:	2
O&M Grade:	0
Clock Start/From:	
Clock To:	
1st Value:	
2nd Value:	
Value Percent:	20.000
Continuous Index:	F09
Within 8" of Joint:	NO
Remarks:

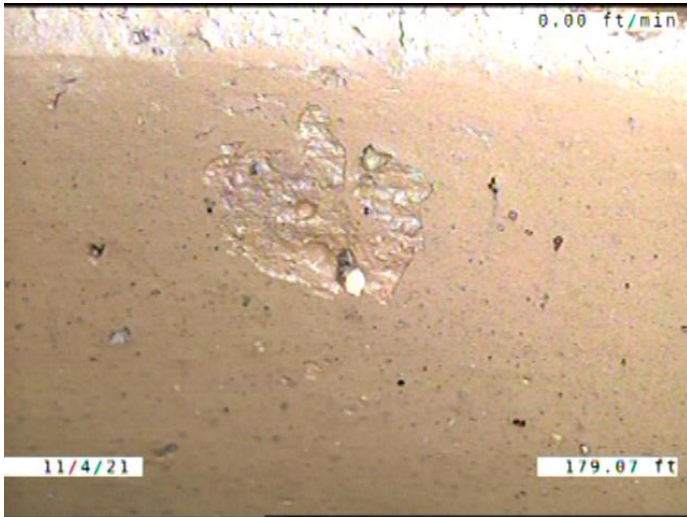
Code: **SSS**
 Description: **Surface Damage Surface Spalling**

Distance (ft): **179.1**
 Structural Grade: **2**
 O&M Grade: **0**
 Clock Start/From: **2**
 Clock To:
 1st Value:
 2nd Value:
 Value Percent:
 Continuous Index:
 Within 8" of Joint: **YES**
 Remarks:

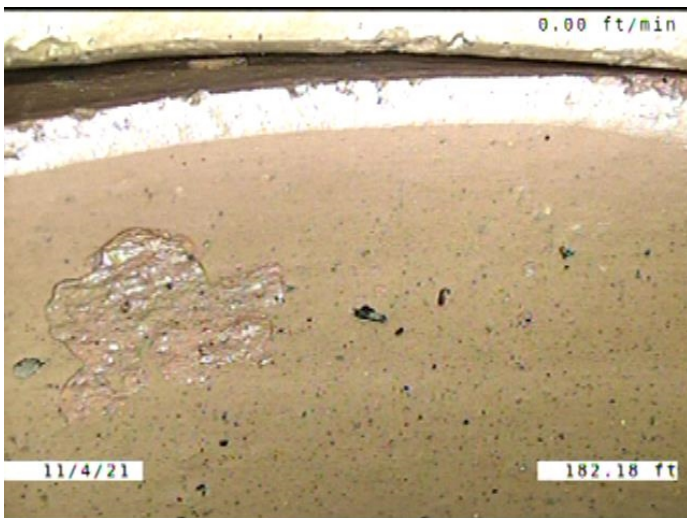
Code: **SSS**
 Description: **Surface Damage Surface Spalling**

Distance (ft): **182.2**
 Structural Grade: **2**
 O&M Grade: **0**
 Clock Start/From: **10**
 Clock To: **12**
 1st Value:
 2nd Value:
 Value Percent:
 Continuous Index:
 Within 8" of Joint: **YES**
 Remarks:

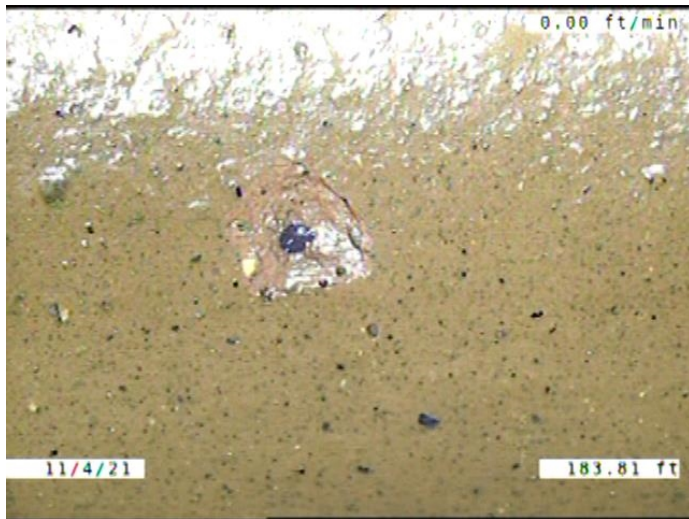
Code: **SSS**
 Description: **Surface Damage Surface Spalling**

Distance (ft): **183.8**
 Structural Grade: **2**
 O&M Grade: **0**
 Clock Start/From: **10**
 Clock To: **11**
 1st Value:
 2nd Value:
 Value Percent:
 Continuous Index:
 Within 8" of Joint: **YES**
 Remarks:
