Profile/Photo Observation Report

Date:	11/04/2021	Weather:		Coding:	PACP 7.0
Pipe Length (ft):	330.0	Owner:	City of Hobart	Pre Clean:	Heavy Cleaning
P.O.#:	YES502259	Surveyor:	S. Bucklin	PSR:	P-405-066-068
Customer:	City of Hobart	Clean Date:	11/04/2021	Shape:	C

Street:	South Wabash Street	Flow Control:	Not Controlled
City:	Hobart, IN	Year Renewed:	
Location:	Alley	Tape/Media #:	
Purpose:	Routine Assessment	Dia/Height:	10"
Use:	Sanitary Sewage Pipe	Material:	VCP
Drain Area:		Lining:	None
Category:	NA		
Comment:			
Location Details:		Direction of Survey:	Upstream
US MH:	M-405-068	DS MH:	M-405-066
		Total Length Surveyed (ft):	322.9

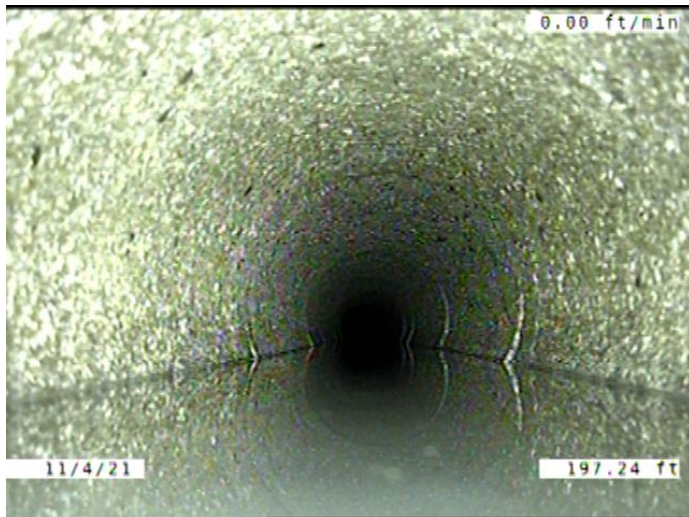
Code: **MWLS**
 Description: **Miscellaneous Water Level Sag**

Distance (ft): **197.2**
 Structural Grade: **2**
 O&M Grade: **0**
 Clock Start/From:
 Clock To:
 1st Value:
 2nd Value:
 Value Percent: **15.000**
 Continuous Index: **S10**
 Within 8" of Joint: **NO**
 Remarks:

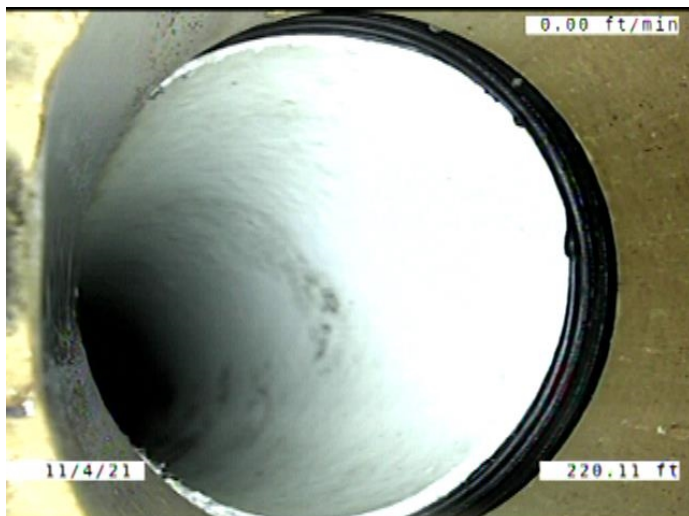
Code: **TBD**
 Description: **Tap Break-in/Hammer Defective**

Distance (ft): **220.1**
 Structural Grade: **0**
 O&M Grade: **3**
 Clock Start/From: **10**
 Clock To:
 1st Value: **4.000**
 2nd Value:
 Value Percent:
 Continuous Index:
 Within 8" of Joint: **YES**
 Remarks: **Soild visible around top edge**

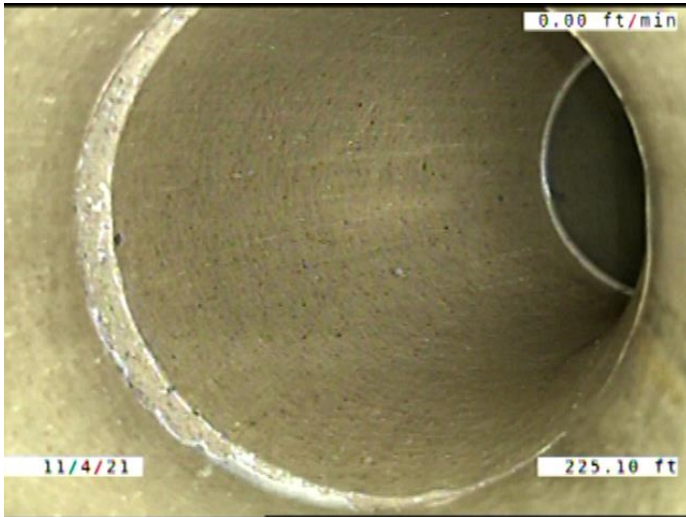
Code: **TBI**
 Description: **Tap Break-in Intruding**

Distance (ft): **225.1**
 Structural Grade: **0**
 O&M Grade: **2**
 Clock Start/From: **2**
 Clock To:
 1st Value: **6.000**
 2nd Value: **1.000**
 Value Percent:
 Continuous Index:
 Within 8" of Joint: **YES**
 Remarks: **CONSTANTLY RUNNING WATER**

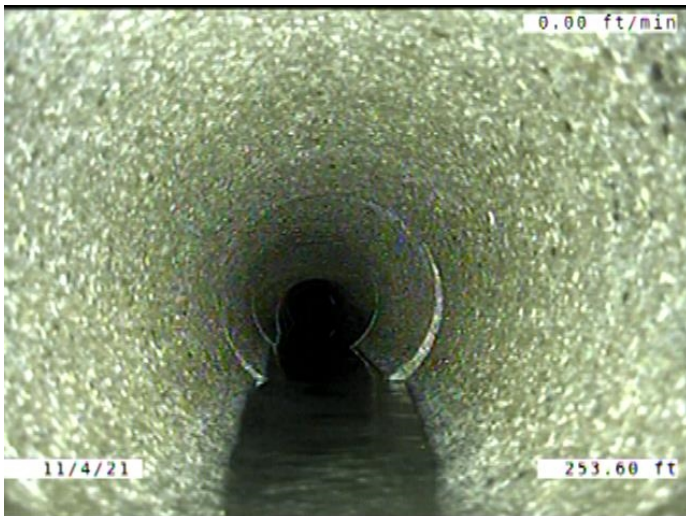
Code: **MWLS**
 Description: **Miscellaneous Water Level Sag**

Distance (ft): **253.6**
 Structural Grade: **2**
 O&M Grade: **0**
 Clock Start/From:
 Clock To:
 1st Value:
 2nd Value:
 Value Percent: **15.000**
 Continuous Index: **F10**
 Within 8" of Joint: **NO**
 Remarks:

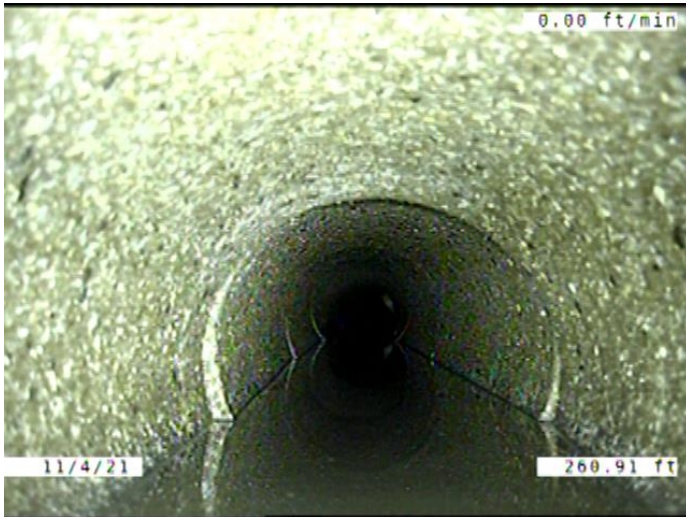
Code: **MWLS**
 Description: **Miscellaneous Water Level Sag**

Distance (ft): **260.9**
 Structural Grade: **2**
 O&M Grade: **0**
 Clock Start/From:
 Clock To:
 1st Value:
 2nd Value:
 Value Percent: **10.000**
 Continuous Index: **S11**
 Within 8" of Joint: **NO**
 Remarks:

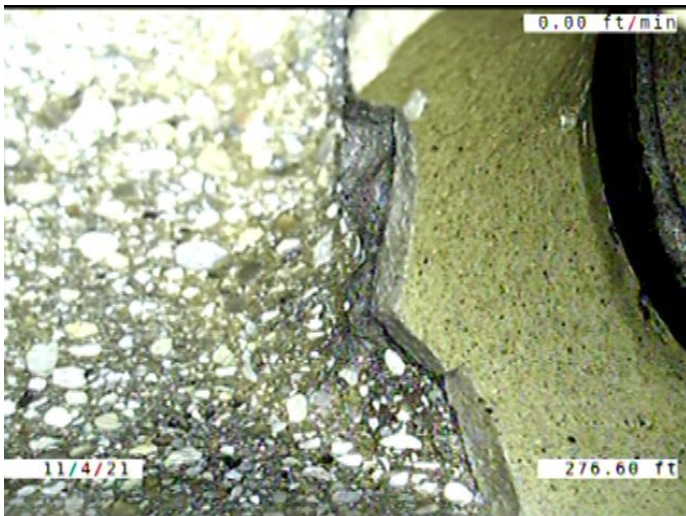
Code: **CC**
 Description: **Crack Circumferential**

Distance (ft): **276.6**
 Structural Grade: **1**
 O&M Grade: **0**
 Clock Start/From: **1**
 Clock To: **3**
 1st Value:
 2nd Value:
 Value Percent:
 Continuous Index:
 Within 8" of Joint: **YES**
 Remarks:

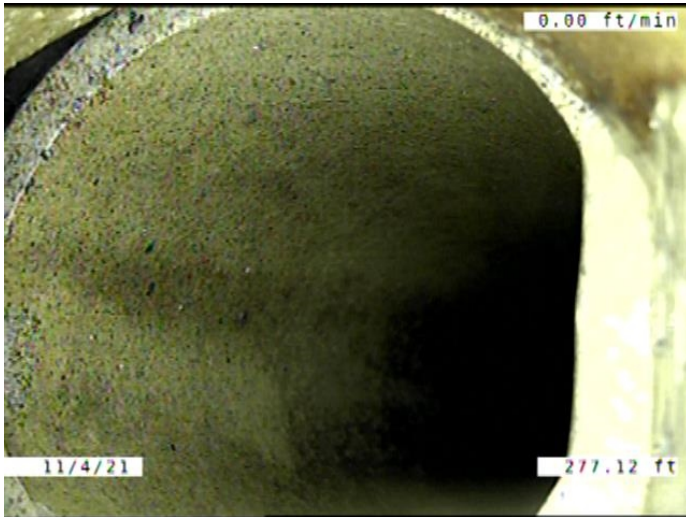
Code: **TBI**
Description: **Tap Break-in Intruding**

Distance (ft): **277.1**
Structural Grade: **0**
O&M Grade: **2**
Clock Start/From: **2**
Clock To:
1st Value: **4.000**
2nd Value: **1.000**
Value Percent:
Continuous Index:
Within 8" of Joint: **YES**
Remarks: **CONSTANTLY RUNNING WATER**

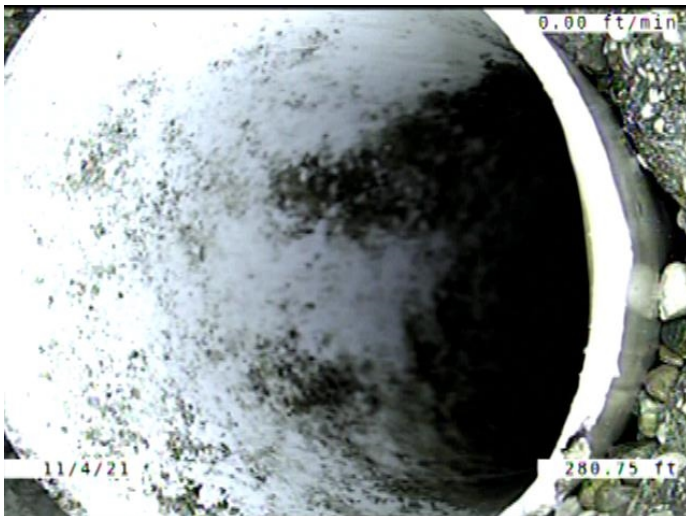
Code: **TBI**
Description: **Tap Break-in Intruding**

Distance (ft): **280.8**
Structural Grade: **0**
O&M Grade: **2**
Clock Start/From: **1**
Clock To:
1st Value: **4.000**
2nd Value: **1.000**
Value Percent:
Continuous Index:
Within 8" of Joint: **YES**
Remarks: **CONSTANTLY DRIPPING WATER**

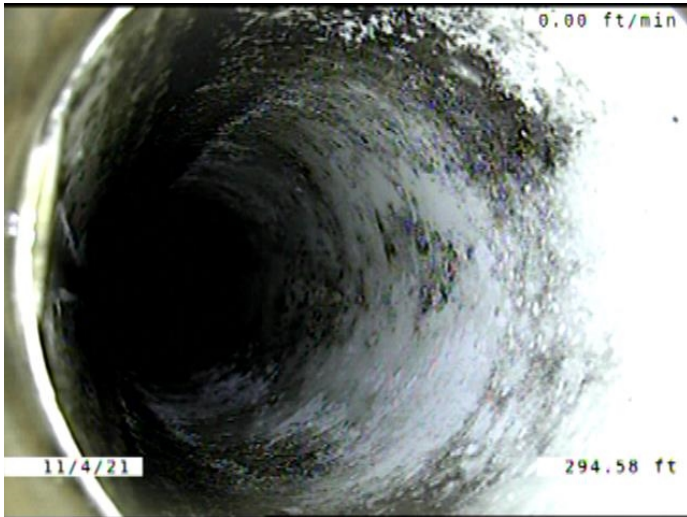
Code: **TBI**
 Description: **Tap Break-in Intruding**

Distance (ft): **294.6**
 Structural Grade: **0**
 O&M Grade: **2**
 Clock Start/From: **10**
 Clock To:
 1st Value: **4.000**
 2nd Value: **1.000**
 Value Percent:
 Continuous Index:
 Within 8" of Joint: **YES**
 Remarks:

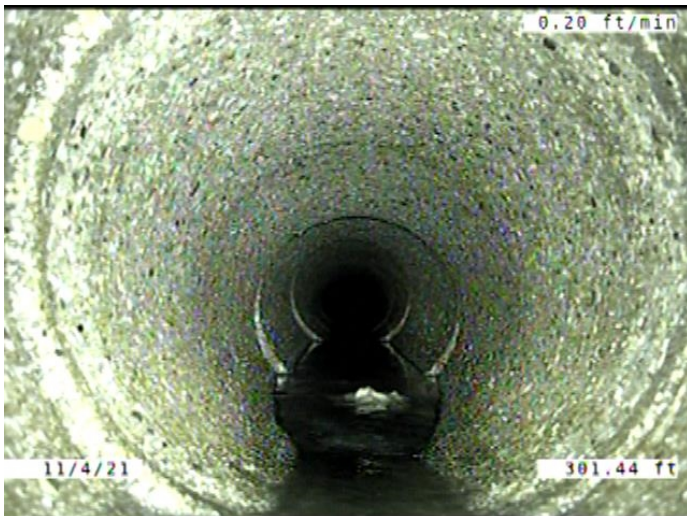
Code: **MWLS**
 Description: **Miscellaneous Water Level Sag**

Distance (ft): **301.4**
 Structural Grade: **2**
 O&M Grade: **0**
 Clock Start/From:
 Clock To:
 1st Value:
 2nd Value:
 Value Percent: **10.000**
 Continuous Index: **F11**
 Within 8" of Joint: **NO**
 Remarks:

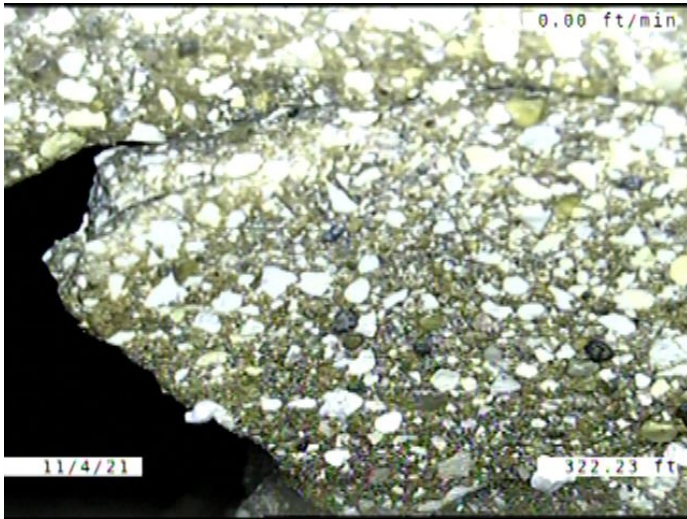
Code: **B**
 Description: **Broken**

Distance (ft): **322.2**
 Structural Grade: **4**
 O&M Grade: **0**
 Clock Start/From: **12**
 Clock To: **12**
 1st Value:
 2nd Value:
 Value Percent:
 Continuous Index:
 Within 8" of Joint: **YES**
 Remarks:

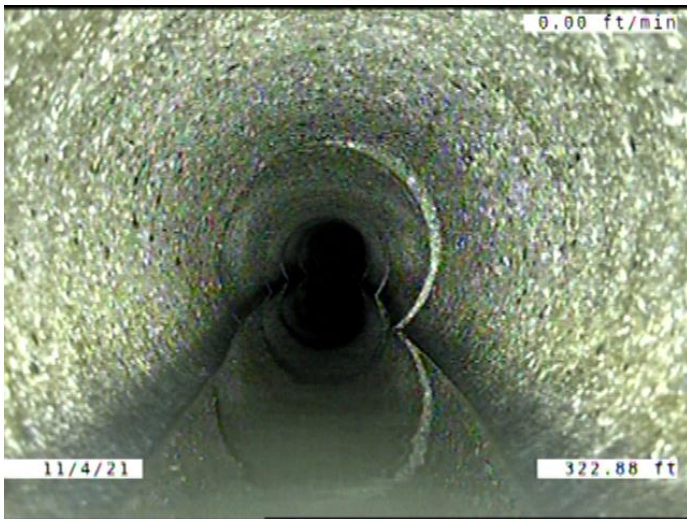
Code: **DSF**
 Description: **Deposits Settled Fine**

Distance (ft): **322.9**
 Structural Grade: **0**
 O&M Grade: **2**
 Clock Start/From: **5**
 Clock To: **7**
 1st Value:
 2nd Value:
 Value Percent: **5.000**
 Continuous Index: **F01**
 Within 8" of Joint: **YES**
 Remarks:
