## Profile/Photo Observation Report

Street:	<b>FOXCROFT STREET</b>	Flow Control:	<b>Not Controlled</b>
City:	<b>Hobart, IN</b>	Year Renewed:	
Location:	<b>Yard</b>	Tape/Media #:	
Purpose:	<b>Routine Assessment</b>	Dia/Height:	<b>10"</b>
Use:	<b>Sanitary</b>	Material:	<b>VCP</b>
Drain Area:	<b>NA</b>	Lining:	
Category:	<b>NA</b>		
Comment:	<b>Flow direction is marked wrong.</b>

Location Details:		Direction of Survey:	<b>Downstream</b>
US MH:	<b>M-406-002</b>	DS MH:	<b>M-406-001</b>
		Total Length Surveyed (ft):	<b>68.4</b>

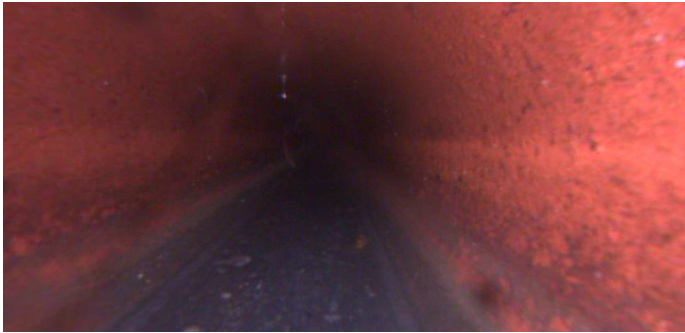
Code:	<b>MWL</b>
Description:	<b>Water Level</b>

Distance (ft):	<b>.0</b>
Structural Grade:	<b>0</b>
O&M Grade:	<b>0</b>
Clock Start/From:	
Clock To:	
1st Value:	
2nd Value:	
Value Percent:	<b>10.000</b>
Continuous Index:	
Within 8" of Joint:	<b>NO</b>
Remarks:

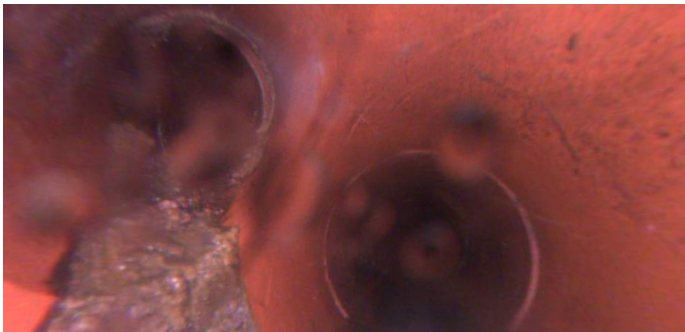
Code:	<b>TF</b>
Description:	<b>Tap Factory</b>

Distance (ft):	<b>45.1</b>
Structural Grade:	<b>0</b>
O&M Grade:	<b>0</b>
Clock Start/From:	<b>10</b>
Clock To:	
1st Value:	<b>4.000</b>
2nd Value:	
Value Percent:	
Continuous Index:	
Within 8" of Joint:	
Remarks:

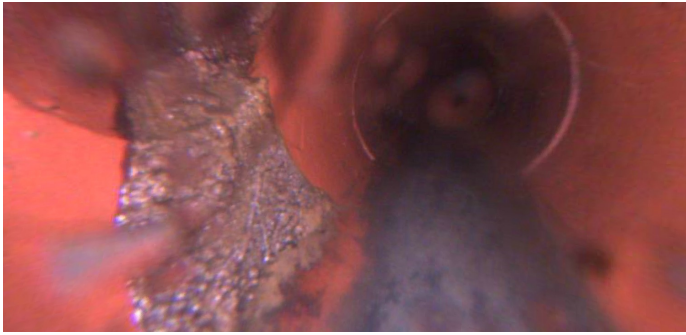
Code: **DAE**  
Description: **Deposits Attached Encrustation**

Distance (ft): **45.1**  
Structural Grade: **0**  
O&M Grade: **2**  
Clock Start/From: **7**  
Clock To: **9**  
1st Value:  
2nd Value:  
Value Percent: **5.000**  
Continuous Index:  
Within 8" of Joint: **NO**  
Remarks:

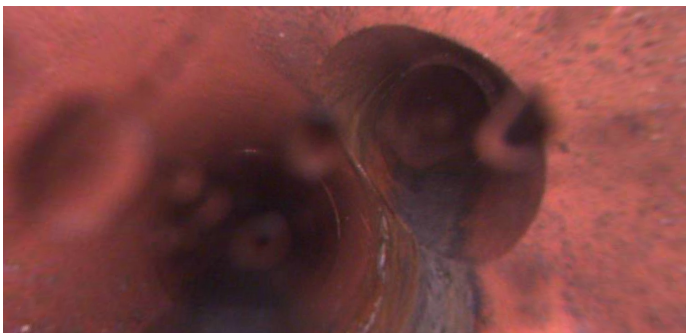
Code: **TF**  
Description: **Tap Factory**

Distance (ft): **46.9**  
Structural Grade: **0**  
O&M Grade: **0**  
Clock Start/From: **2**  
Clock To:  
1st Value: **4.000**  
2nd Value:  
Value Percent:  
Continuous Index:  
Within 8" of Joint:  
Remarks:

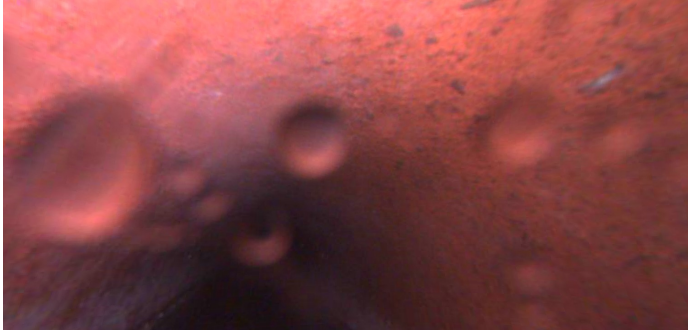
Code:	<b>MSA</b>
Description:	<b>Abandoned Survey</b>
Distance (ft):	<b>68.4</b>
Structural Grade:	<b>0</b>
O&M Grade:	<b>0</b>
Clock Start/From:	
Clock To:	
1st Value:	
2nd Value:	
Value Percent:	
Continuous Index:	
Within 8" of Joint:	<b>NO</b>
Remarks:	<b>unknown</b>
