Profile/Photo Observation Report

Street:	S WABASH PL	Flow Control:	Not Controlled
City:	Hobart, IN	Year Renewed:	
Location:	Yard	Tape/Media #:	
Purpose:	Routine Assessment	Dia/Height:	10"
Use:	Sanitary	Material:	VCP
Drain Area:	NA	Lining:	
Category:	NA		
Comment:

Location Details:		Direction of Survey:	Downstream
US MH:	M-406-002	DS MH:	M-505-089
		Total Length Surveyed (ft):	271.4

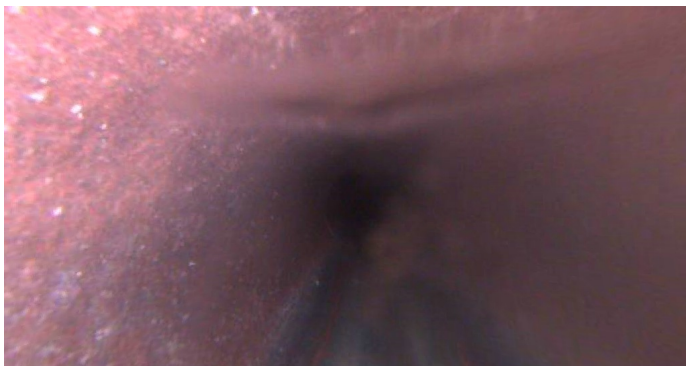
Code: **AMH**
Description: **Manhole**

Distance (ft): **.0**
Structural Grade: **0**
O&M Grade: **0**
Clock Start/From:
Clock To:
1st Value:
2nd Value:
Value Percent:
Continuous Index:
Within 8" of Joint: **NO**
Remarks: **M-406-002**

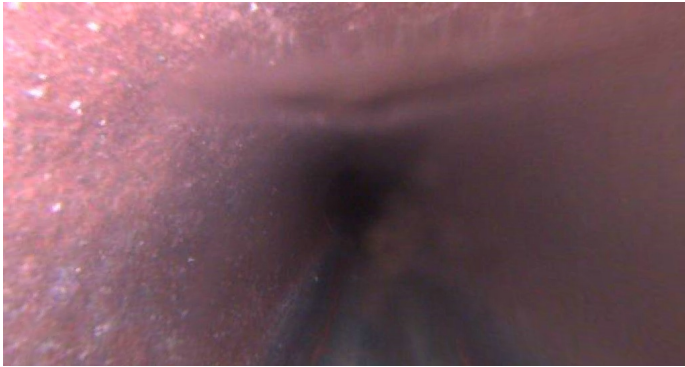
Code:	MWL
Description:	Water Level

Distance (ft):	.0
Structural Grade:	0
O&M Grade:	0
Clock Start/From:	
Clock To:	
1st Value:	
2nd Value:	
Value Percent:	10.000
Continuous Index:	
Within 8" of Joint:	NO
Remarks:

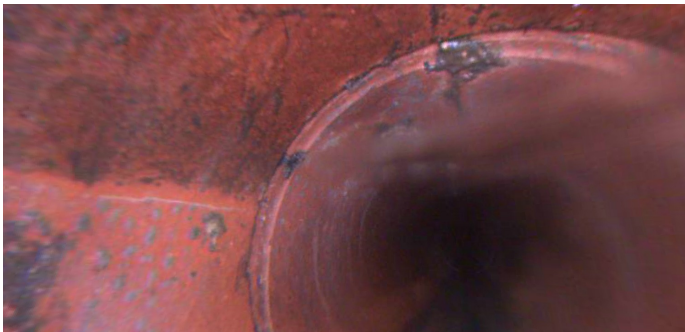
Code:	CL
Description:	Crack Longitudinal

Distance (ft):	18.3
Structural Grade:	2
O&M Grade:	0
Clock Start/From:	9
Clock To:	
1st Value:	
2nd Value:	
Value Percent:	
Continuous Index:	
Within 8" of Joint:	YES
Remarks:

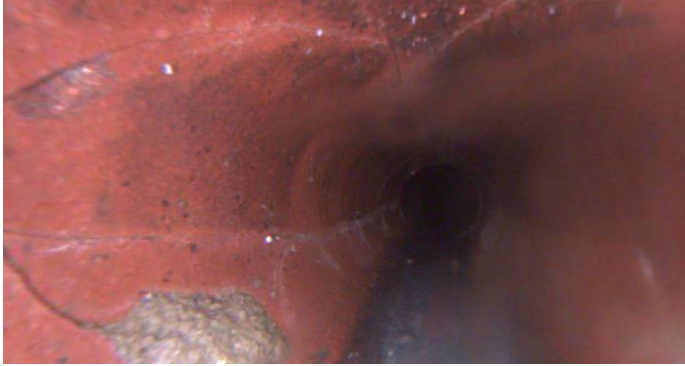
Code: **FM**
Description: **Fracture Multiple**

Distance (ft): **59.4**
Structural Grade: **4**
O&M Grade: **0**
Clock Start/From: **7**
Clock To: **5**
1st Value:
2nd Value:
Value Percent:
Continuous Index:
Within 8" of Joint:
Remarks:

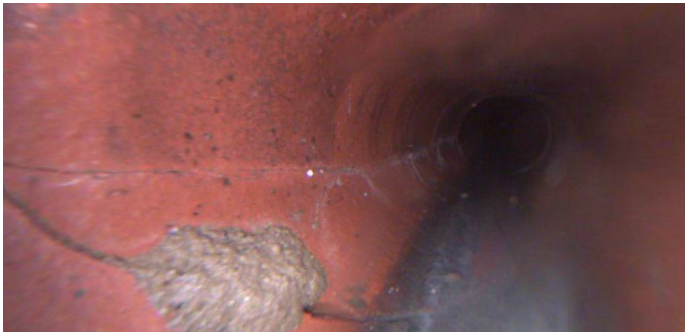
Code: **DAZ**
Description: **Deposits Attached Other**

Distance (ft): **59.5**
Structural Grade: **0**
O&M Grade: **2**
Clock Start/From: **7**
Clock To: **8**
1st Value:
2nd Value:
Value Percent: **5.000**
Continuous Index:
Within 8" of Joint: **NO**
Remarks:

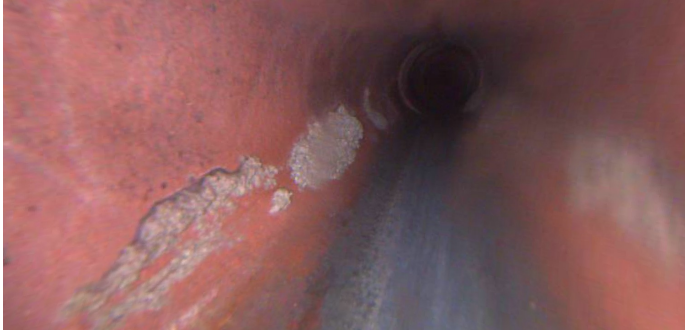
Code: **DAZ**
Description: **Deposits Attached Other**

Distance (ft): **69.3**
Structural Grade: **0**
O&M Grade: **2**
Clock Start/From: **8**
Clock To: **9**
1st Value:
2nd Value:
Value Percent: **5.000**
Continuous Index:
Within 8" of Joint: **NO**
Remarks:

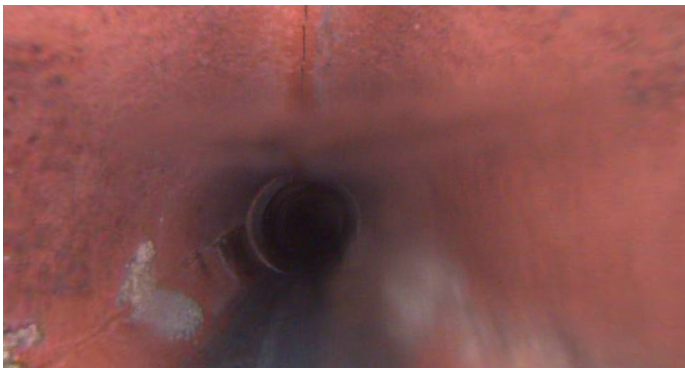
Code: **FM**
Description: **Fracture Multiple**

Distance (ft): **70.2**
Structural Grade: **4**
O&M Grade: **0**
Clock Start/From: **7**
Clock To: **12**
1st Value:
2nd Value:
Value Percent:
Continuous Index:
Within 8" of Joint:
Remarks:

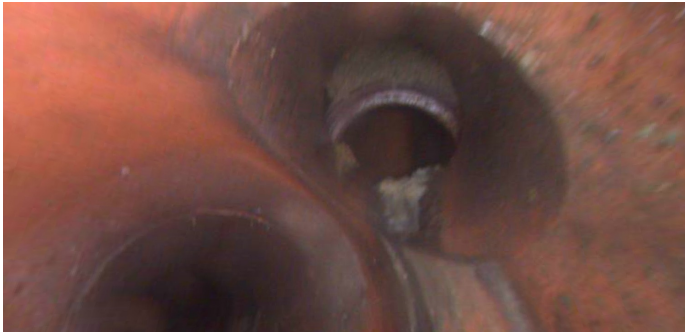
Code: **TF**
Description: **Tap Factory**

Distance (ft): **73.9**
Structural Grade: **0**
O&M Grade: **0**
Clock Start/From: **2**
Clock To:
1st Value: **4.000**
2nd Value:
Value Percent:
Continuous Index:
Within 8" of Joint:
Remarks:

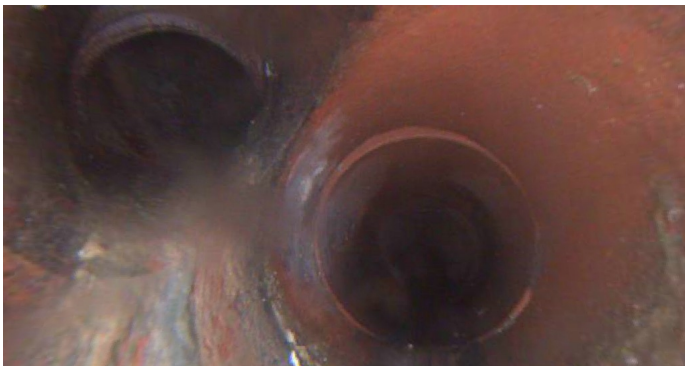
Code: **TF**
Description: **Tap Factory**

Distance (ft): **75.9**
Structural Grade: **0**
O&M Grade: **0**
Clock Start/From: **2**
Clock To:
1st Value: **4.000**
2nd Value:
Value Percent:
Continuous Index:
Within 8" of Joint:
Remarks: **Photo taken from rear camera.**

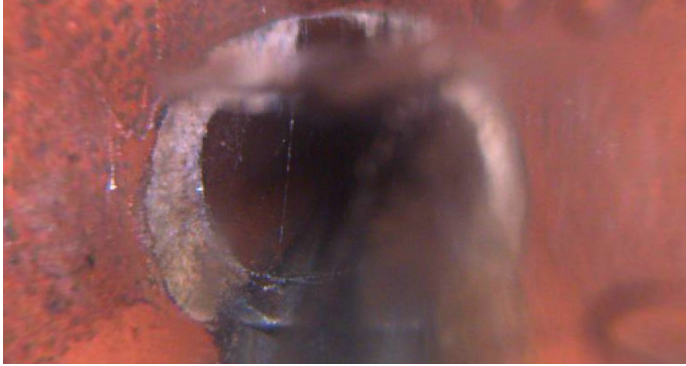
Code: **DAZ**
Description: **Deposits Attached Other**

Distance (ft): **144.4**
Structural Grade: **0**
O&M Grade: **2**
Clock Start/From: **7**
Clock To: **5**
1st Value:
2nd Value:
Value Percent: **5.000**
Continuous Index:
Within 8" of Joint: **YES**
Remarks:

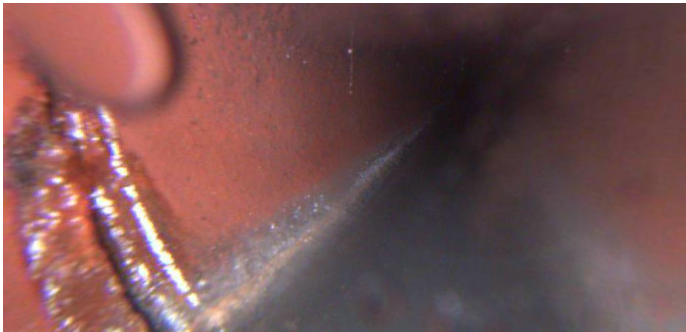
Code: **IW**
Description: **Infil Weeper**

Distance (ft): **184.1**
Structural Grade: **0**
O&M Grade: **2**
Clock Start/From: **7**
Clock To: **9**
1st Value:
2nd Value:
Value Percent:
Continuous Index:
Within 8" of Joint: **YES**
Remarks:

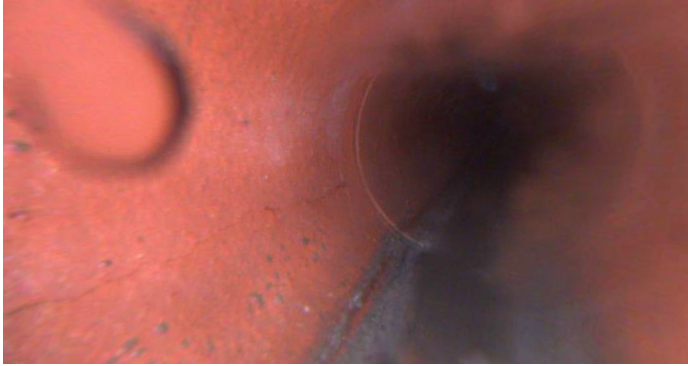
Code: **CL**
Description: **Crack Longitudinal**

Distance (ft): **232.2**
Structural Grade: **2**
O&M Grade: **0**
Clock Start/From: **8**
Clock To:
1st Value:
2nd Value:
Value Percent:
Continuous Index:
Within 8" of Joint:
Remarks:

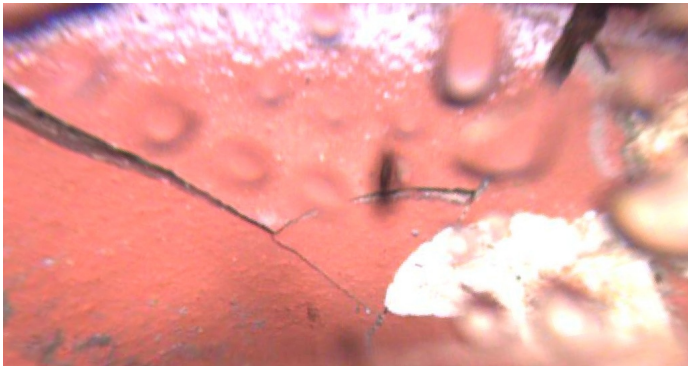
Code: **FM**
Description: **Fracture Multiple**

Distance (ft): **243.1**
Structural Grade: **4**
O&M Grade: **0**
Clock Start/From: **10**
Clock To: **1**
1st Value:
2nd Value:
Value Percent:
Continuous Index:
Within 8" of Joint: **YES**
Remarks:

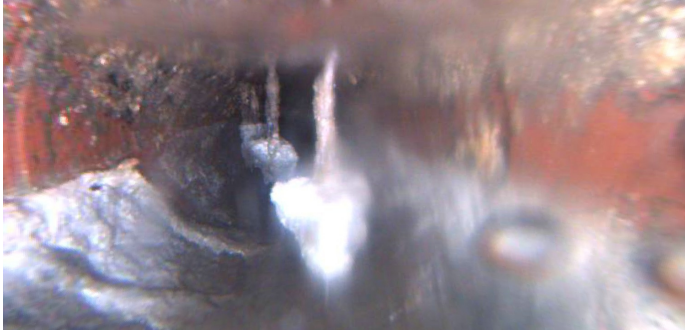
Code: **RMB**
Description: **Roots Medium Barrel**

Distance (ft): **247.5**
Structural Grade: **0**
O&M Grade: **4**
Clock Start/From: **12**
Clock To:
1st Value:
2nd Value:
Value Percent: **5.000**
Continuous Index:
Within 8" of Joint: **NO**
Remarks:

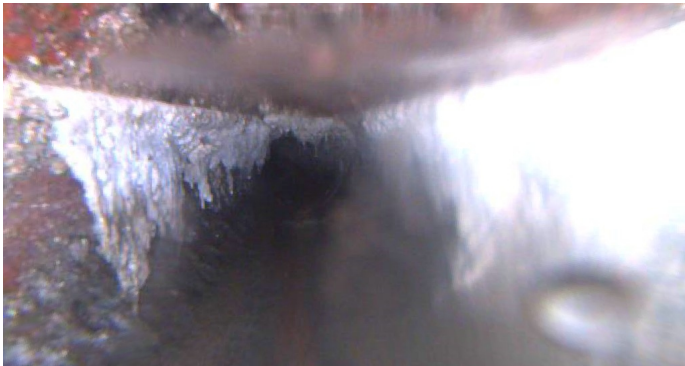
Code: **DAZ**
Description: **Deposits Attached Other**

Distance (ft): **250.1**
Structural Grade: **0**
O&M Grade: **2**
Clock Start/From: **7**
Clock To: **5**
1st Value:
2nd Value:
Value Percent: **10.000**
Continuous Index:
Within 8" of Joint: **NO**
Remarks:

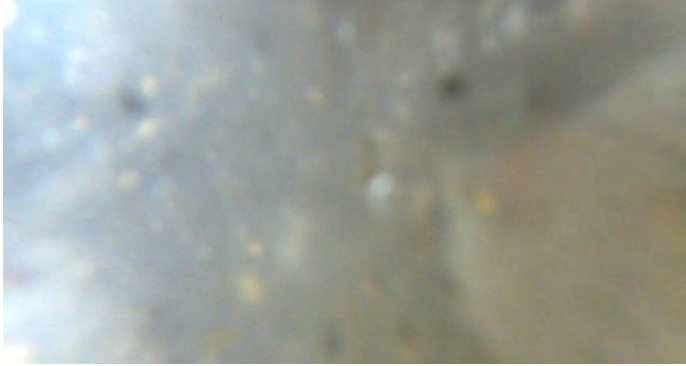
Code: **MCU**
Description: **Camera Underwater**

Distance (ft): **262.6**
Structural Grade: **0**
O&M Grade: **4**
Clock Start/From:
Clock To:
1st Value:
2nd Value:
Value Percent:
Continuous Index: **S01**
Within 8" of Joint: **NO**
Remarks:
