## Profile/Photo Observation Report

Date:	<b>04/10/2018</b>	Weather:		Coding:	<b>PACP 6.0</b>
Pipe Length (ft):	<b>273.2</b>	Owner:	<b>NA</b>	Pre Clean:	<b>No Pre-Cleaning</b>
P.O.#:		Surveyor:	<b>Mark Ruby</b>	PSR:	<b>P-406-002-LS006</b>
Customer:		Clean Date:	<b>01/01/1900</b>	Shape:	<b>C</b>

Street:	<b>FOXCROFT STREET</b>	Flow Control:	<b>Not Controlled</b>
City:	<b>Hobart, IN</b>	Year Renewed:	
Location:	<b>Yard</b>	Tape/Media #:	
Purpose:	<b>Routine Assessment</b>	Dia/Height:	<b>10"</b>
Use:	<b>Sanitary</b>	Material:	<b>VCP</b>
Drain Area:	<b>NA</b>	Lining:	
Category:	<b>NA</b>		
Comment:

Location Details:		Direction of Survey:	<b>Downstream</b>
US MH:	<b>M-406-002</b>	DS MH:	<b>M-505-089</b>
		Total Length Surveyed (ft):	<b>271.4</b>

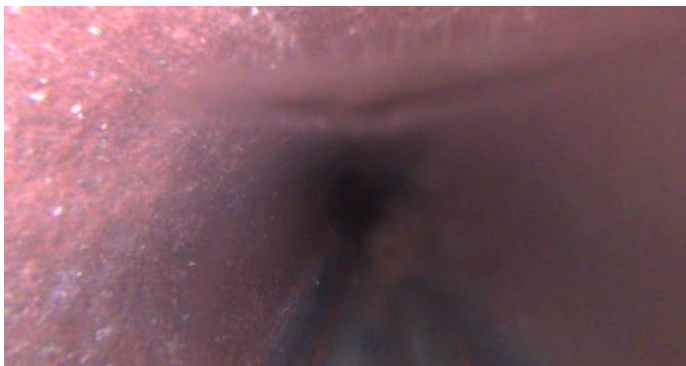
Code: **AMH**  
Description: **Manhole**

Distance (ft): **.0**  
Structural Grade: **0**  
O&M Grade: **0**  
Clock Start/From:  
Clock To:  
1st Value:  
2nd Value:  
Value Percent:  
Continuous Index:  
Within 8" of Joint: **NO**  
Remarks: **M-406-002**

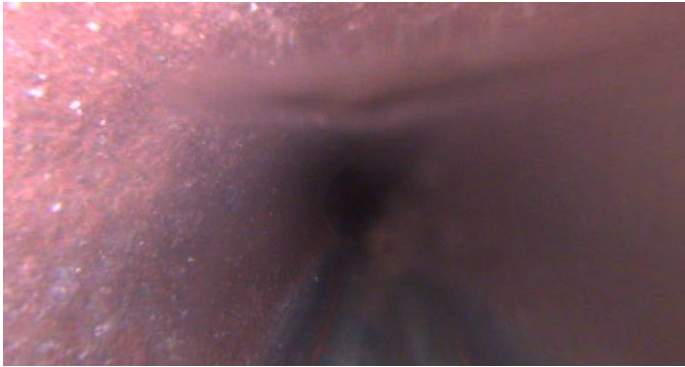
Code:	<b>MWL</b>
Description:	<b>Water Level</b>

Distance (ft):	<b>.0</b>
Structural Grade:	<b>0</b>
O&M Grade:	<b>0</b>
Clock Start/From:	
Clock To:	
1st Value:	
2nd Value:	
Value Percent:	<b>10.000</b>
Continuous Index:	
Within 8" of Joint:	<b>NO</b>
Remarks:

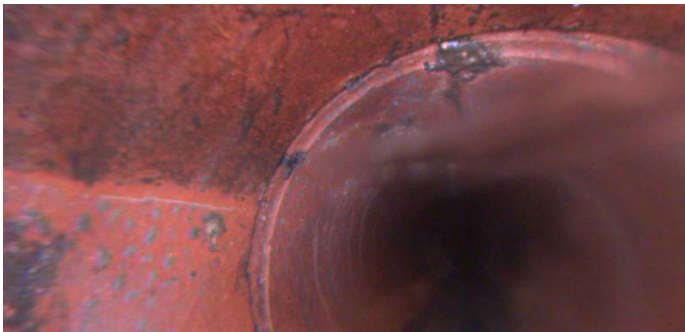
Code:	<b>CL</b>
Description:	<b>Crack Longitudinal</b>

Distance (ft):	<b>18.3</b>
Structural Grade:	<b>2</b>
O&M Grade:	<b>0</b>
Clock Start/From:	<b>9</b>
Clock To:	
1st Value:	
2nd Value:	
Value Percent:	
Continuous Index:	
Within 8" of Joint:	<b>YES</b>
Remarks:

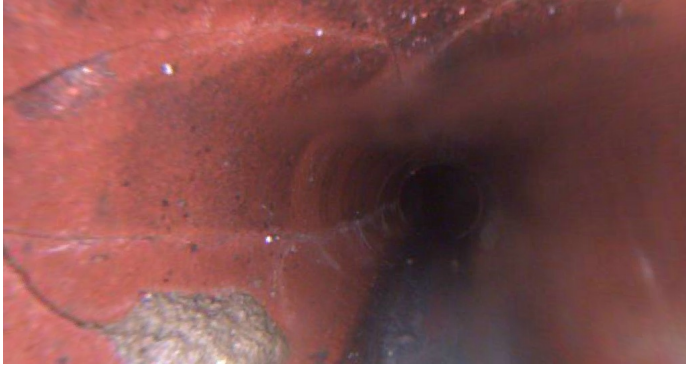
Code: **FM**  
Description: **Fracture Multiple**

Distance (ft): **59.4**  
Structural Grade: **4**  
O&M Grade: **0**  
Clock Start/From: **7**  
Clock To: **5**  
1st Value:  
2nd Value:  
Value Percent:  
Continuous Index:  
Within 8" of Joint:  
Remarks:

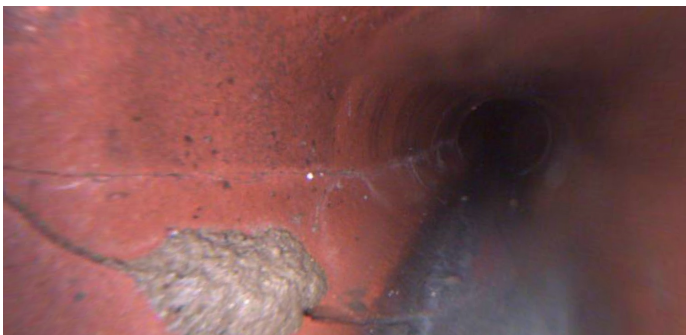
Code: **DAZ**  
Description: **Deposits Attached Other**

Distance (ft): **59.5**  
Structural Grade: **0**  
O&M Grade: **2**  
Clock Start/From: **7**  
Clock To: **8**  
1st Value:  
2nd Value:  
Value Percent: **5.000**  
Continuous Index:  
Within 8" of Joint: **NO**  
Remarks:

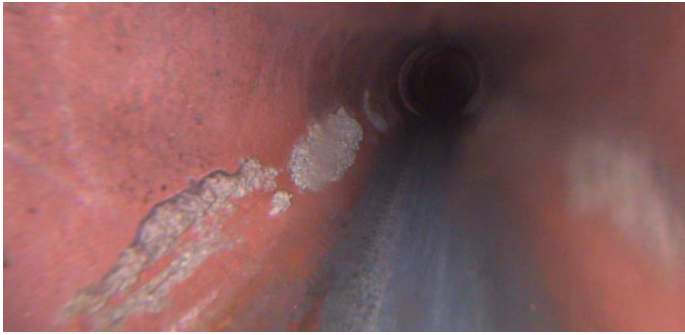
Code: **DAZ**  
Description: **Deposits Attached Other**

Distance (ft): **69.3**  
Structural Grade: **0**  
O&M Grade: **2**  
Clock Start/From: **8**  
Clock To: **9**  
1st Value:  
2nd Value:  
Value Percent: **5.000**  
Continuous Index:  
Within 8" of Joint: **NO**  
Remarks:

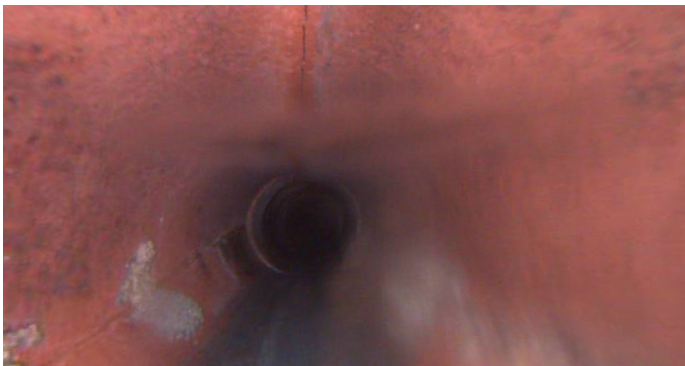
Code: **FM**  
Description: **Fracture Multiple**

Distance (ft): **70.2**  
Structural Grade: **4**  
O&M Grade: **0**  
Clock Start/From: **7**  
Clock To: **12**  
1st Value:  
2nd Value:  
Value Percent:  
Continuous Index:  
Within 8" of Joint:  
Remarks:

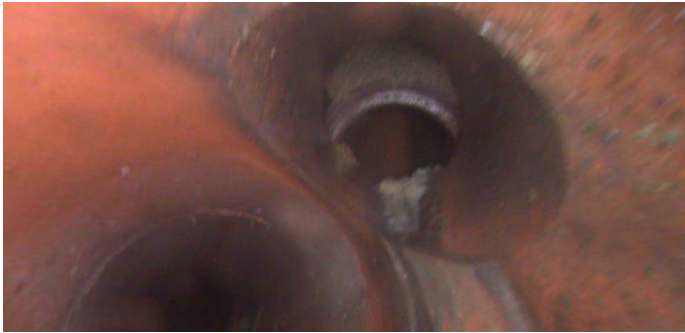
Code: **TF**  
Description: **Tap Factory**

Distance (ft): **73.9**  
Structural Grade: **0**  
O&M Grade: **0**  
Clock Start/From: **2**  
Clock To:  
1st Value: **4.000**  
2nd Value:  
Value Percent:  
Continuous Index:  
Within 8" of Joint:  
Remarks:

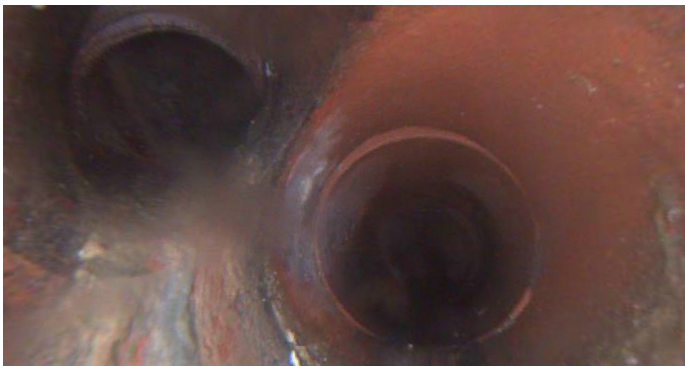
Code: **TF**  
Description: **Tap Factory**

Distance (ft): **75.9**  
Structural Grade: **0**  
O&M Grade: **0**  
Clock Start/From: **2**  
Clock To:  
1st Value: **4.000**  
2nd Value:  
Value Percent:  
Continuous Index:  
Within 8" of Joint:  
Remarks: **Photo taken from rear camera.**

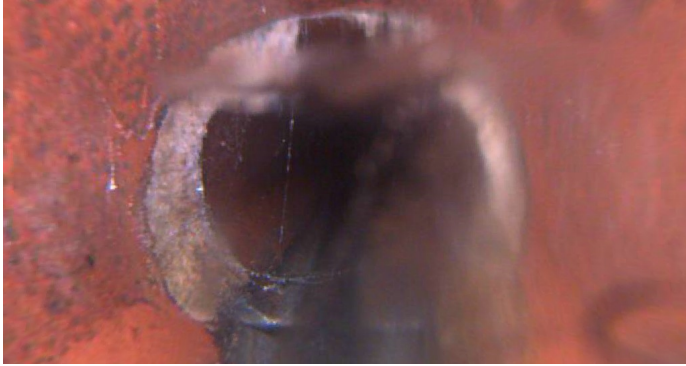
Code: **DAZ**  
Description: **Deposits Attached Other**

Distance (ft): **144.4**  
Structural Grade: **0**  
O&M Grade: **2**  
Clock Start/From: **7**  
Clock To: **5**  
1st Value:  
2nd Value:  
Value Percent: **5.000**  
Continuous Index:  
Within 8" of Joint: **YES**  
Remarks:

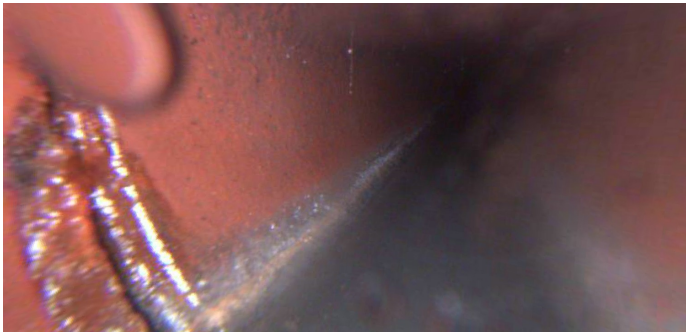
Code: **IW**  
Description: **Infil Weeper**

Distance (ft): **184.1**  
Structural Grade: **0**  
O&M Grade: **2**  
Clock Start/From: **7**  
Clock To: **9**  
1st Value:  
2nd Value:  
Value Percent:  
Continuous Index:  
Within 8" of Joint: **YES**  
Remarks:

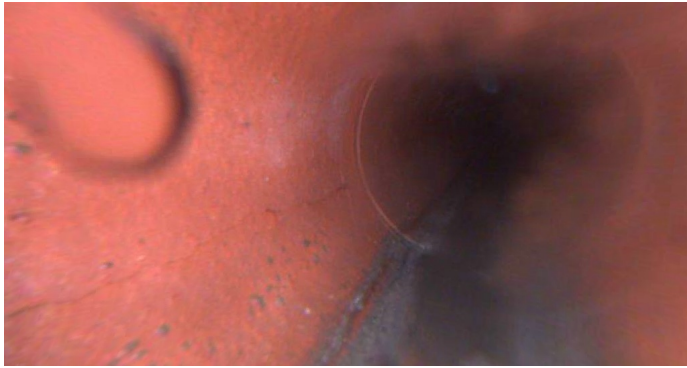
Code: **CL**  
Description: **Crack Longitudinal**

Distance (ft): **232.2**  
Structural Grade: **2**  
O&M Grade: **0**  
Clock Start/From: **8**  
Clock To:  
1st Value:  
2nd Value:  
Value Percent:  
Continuous Index:  
Within 8" of Joint:  
Remarks:

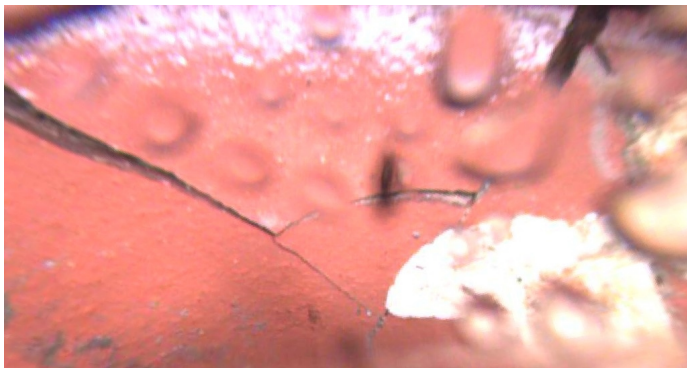
Code: **FM**  
Description: **Fracture Multiple**

Distance (ft): **243.1**  
Structural Grade: **4**  
O&M Grade: **0**  
Clock Start/From: **10**  
Clock To: **1**  
1st Value:  
2nd Value:  
Value Percent:  
Continuous Index:  
Within 8" of Joint: **YES**  
Remarks:

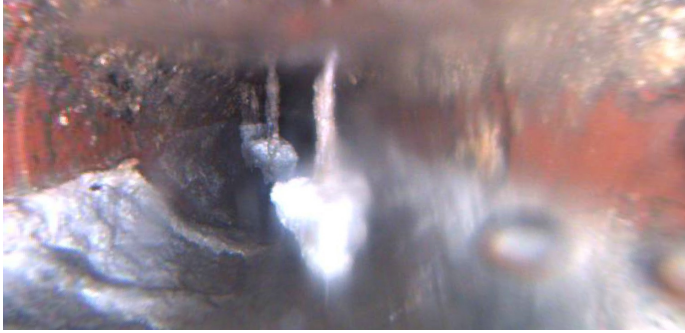
Code: **RMB**  
Description: **Roots Medium Barrel**

Distance (ft): **247.5**  
Structural Grade: **0**  
O&M Grade: **4**  
Clock Start/From: **12**  
Clock To:  
1st Value:  
2nd Value:  
Value Percent: **5.000**  
Continuous Index:  
Within 8" of Joint: **NO**  
Remarks:

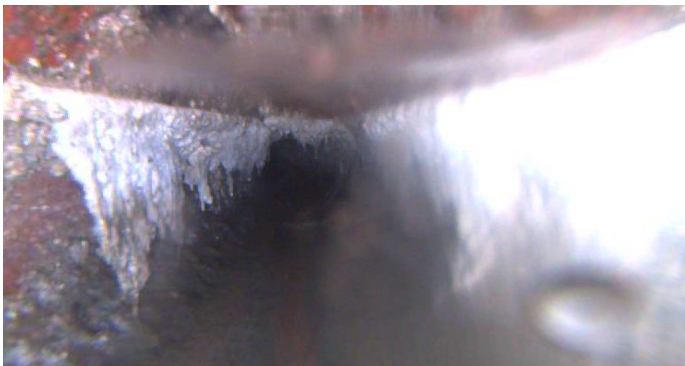
Code: **DAZ**  
Description: **Deposits Attached Other**

Distance (ft): **250.1**  
Structural Grade: **0**  
O&M Grade: **2**  
Clock Start/From: **7**  
Clock To: **5**  
1st Value:  
2nd Value:  
Value Percent: **10.000**  
Continuous Index:  
Within 8" of Joint: **NO**  
Remarks:

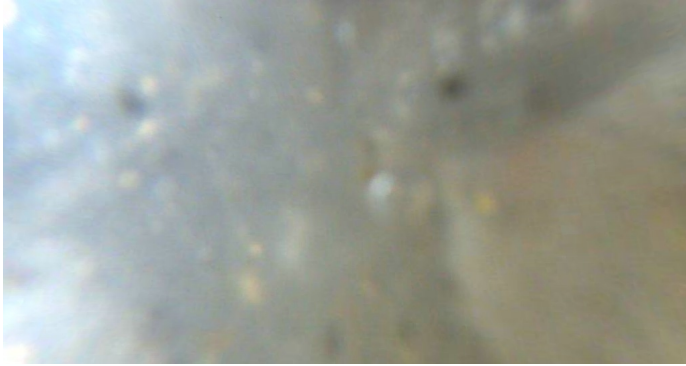
Code: **MCU**  
Description: **Camera Underwater**

Distance (ft): **262.6**  
Structural Grade: **0**  
O&M Grade: **4**  
Clock Start/From:  
Clock To:  
1st Value:  
2nd Value:  
Value Percent:  
Continuous Index: **S01**  
Within 8" of Joint: **NO**  
Remarks:
