## Profile/Photo Observation Report

Street:	<b>FOXCROFT STREET</b>	Flow Control:	<b>Not Controlled</b>
City:	<b>Hobart, IN</b>	Year Renewed:	
Location:	<b>Yard</b>	Tape/Media #:	
Purpose:	<b>Routine Assessment</b>	Dia/Height:	<b>8"</b>
Use:	<b>Sanitary</b>	Material:	<b>PVC</b>
Drain Area:	<b>NA</b>	Lining:	
Category:	<b>NA</b>		
Comment:	<b>Flow direction is marked wrong.</b>

Location Details:		Direction of Survey:	<b>Downstream</b>
US MH:	<b>M-407-002</b>	DS MH:	<b>M-407-001</b>
		Total Length Surveyed (ft):	<b>90.3</b>

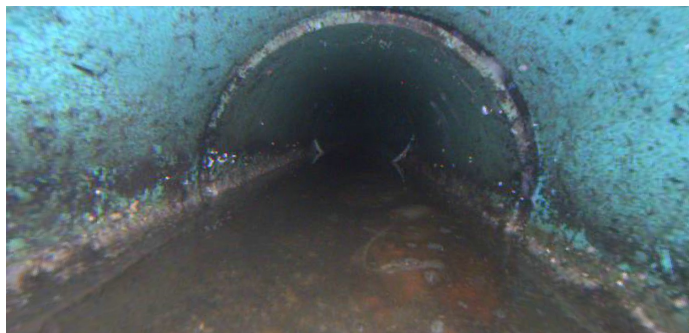
Code: **AMH**  
 Description: **Manhole**

Distance (ft): **.0**  
 Structural Grade: **0**  
 O&M Grade: **0**  
 Clock Start/From:  
 Clock To:  
 1st Value:  
 2nd Value:  
 Value Percent:  
 Continuous Index:  
 Within 8" of Joint: **NO**  
 Remarks: **M-407-002**

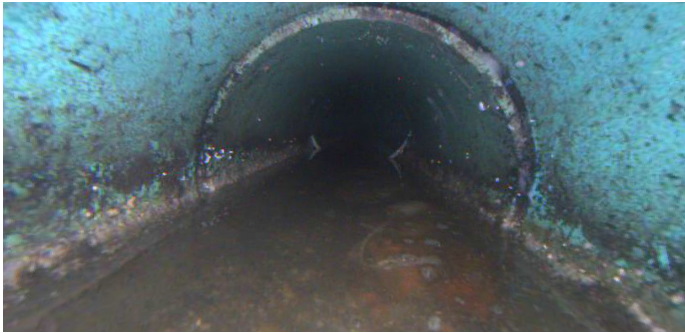
Code:	<b>MWL</b>
Description:	<b>Water Level</b>

Distance (ft):	<b>.0</b>
Structural Grade:	<b>0</b>
O&M Grade:	<b>0</b>
Clock Start/From:	
Clock To:	
1st Value:	
2nd Value:	
Value Percent:	<b>30.000</b>
Continuous Index:	
Within 8" of Joint:	<b>NO</b>
Remarks:

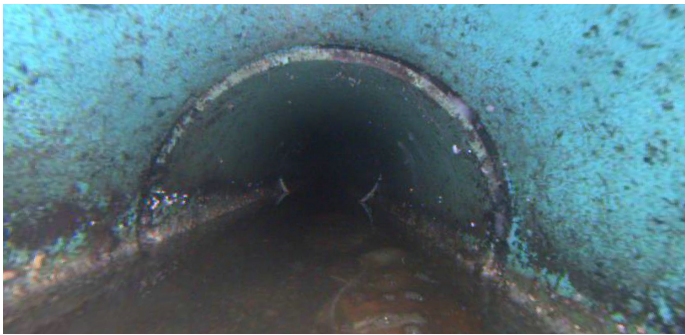
Code:	<b>JOM</b>
Description:	<b>Joint Offset Medium</b>

Distance (ft):	<b>.1</b>
Structural Grade:	<b>1</b>
O&M Grade:	<b>0</b>
Clock Start/From:	
Clock To:	
1st Value:	
2nd Value:	
Value Percent:	
Continuous Index:	
Within 8" of Joint:	<b>NO</b>
Remarks:

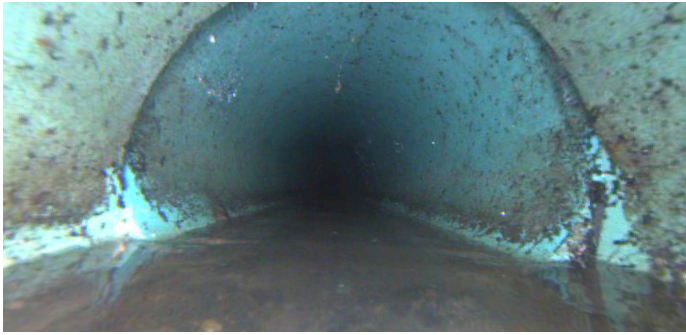
Code: **JOM**  
Description: **Joint Offset Medium**

Distance (ft): **2.8**  
Structural Grade: **1**  
O&M Grade: **0**  
Clock Start/From:  
Clock To:  
1st Value:  
2nd Value:  
Value Percent:  
Continuous Index:  
Within 8" of Joint: **NO**  
Remarks:

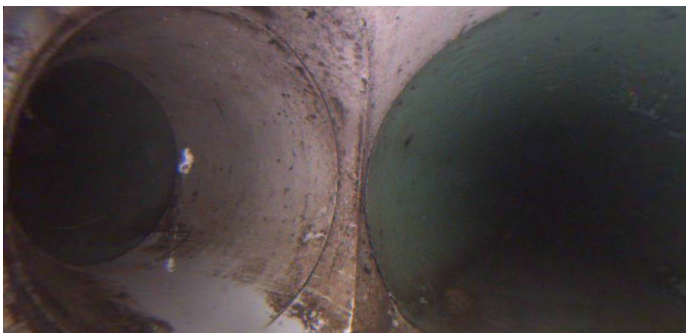
Code: **TF**  
Description: **Tap Factory**

Distance (ft): **8.3**  
Structural Grade: **0**  
O&M Grade: **0**  
Clock Start/From: **9**  
Clock To:  
1st Value: **4.000**  
2nd Value:  
Value Percent:  
Continuous Index:  
Within 8" of Joint:  
Remarks:

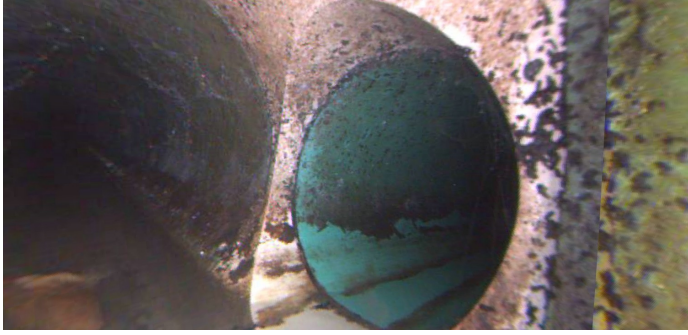
Code: **TFA**  
Description: **Tap Factory Active**

Distance (ft): **34.1**  
Structural Grade: **0**  
O&M Grade: **0**  
Clock Start/From: **3**  
Clock To:  
1st Value: **4.000**  
2nd Value:  
Value Percent:  
Continuous Index:  
Within 8" of Joint:  
Remarks:

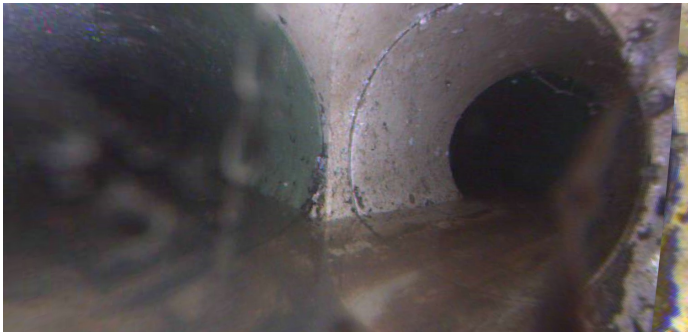
Code: **TFA**  
Description: **Tap Factory Active**

Distance (ft): **85.9**  
Structural Grade: **0**  
O&M Grade: **0**  
Clock Start/From: **3**  
Clock To:  
1st Value: **4.000**  
2nd Value:  
Value Percent:  
Continuous Index:  
Within 8" of Joint:  
Remarks:

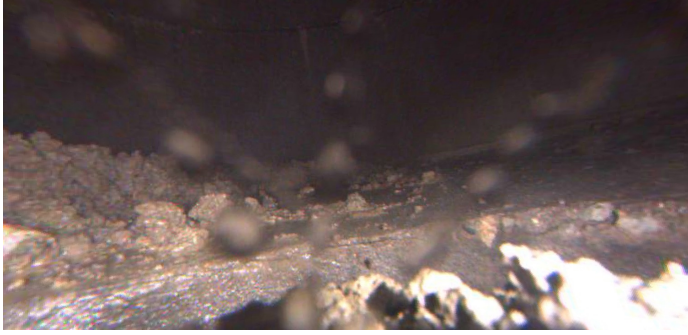
Code:	<b>AMH</b>
Description:	<b>Manhole</b>
Distance (ft):	<b>90.3</b>
Structural Grade:	<b>0</b>
O&M Grade:	<b>0</b>
Clock Start/From:	
Clock To:	
1st Value:	
2nd Value:	
Value Percent:	
Continuous Index:	
Within 8" of Joint:	<b>NO</b>
Remarks:	<b>M-407-001</b>
