Profile/Ph	oto Observation	Report				RedZone
Date:	04/12/2018	Weather:			Coding:	PACP 6.0
Pipe Length (ft): 244.9	Owner:	NA		Pre Clean:	No Pre-Cleaning
P.O.#:		Surveyor:	Jen Costel	lo	PSR:	P-407-003-004
Customer:		Clean Date:	01/01/190	0	Shape:	с
Street:	LAKEVIEW DR		Flow Control:		Not Controlled	
City:	Hobart, IN		Year Renew	ed:		
Location:	Yard		Tape/Media	#:		
Purpose:	Routine Assessment	t i	Dia/Height:		10"	
Use:	Sanitary		Material:		PVC	
Drain Area:	NA		Lining:			
Category:	NA					
Comment:						
Location Detail	ls:		Direction of	Survey:	Upstream	
US MH:	M-407-003	DS MH:	M-407-004	-	Total Length Surveyed (ft):	31.5
0&M Index:	0.00	O&M Quick:		0000	O&M Rating:	0.00
tructural Index:	0.00	Structural Qu	uick:	0000	Structural Rating:	0.00
Overall Index:	0.00	Overall Quick	<:	0000	Overall Rating:	0.00

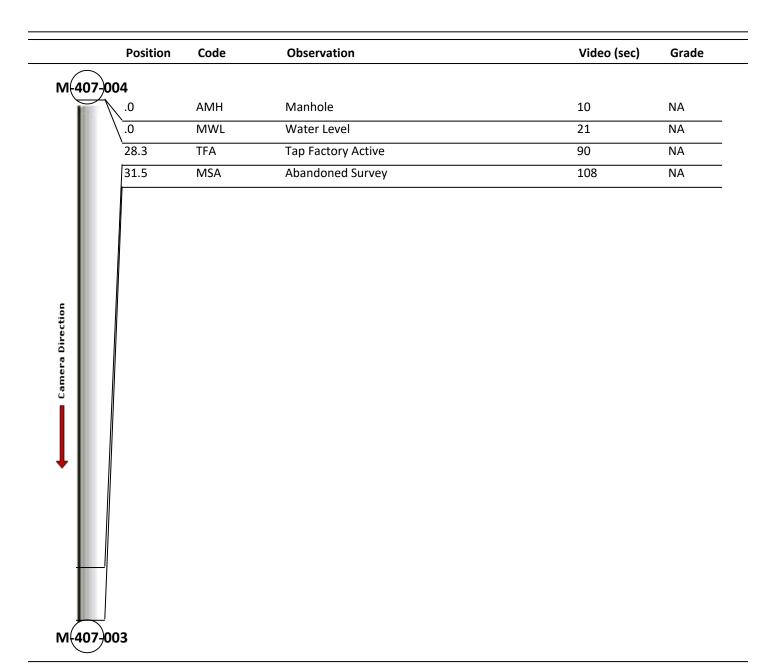
Code: Description:	AMH Manhole
Distance (ft):	.0
Structural Grade:	0
O&M Grade:	0
Clock Start/From:	
Clock To:	
1st Value:	
2nd Value:	
Value Percent:	
Continuous Index:	
Within 8" of Joint:	NO
Remarks:	M-407-004

Code: MWL Description: Water Level

Distance (ft): .0 Structural Grade: 0 O&M Grade: 0 Clock Start/From: Clock To: 1st Value: 2nd Value: Value Percent: 5.000 Continuous Index: Within 8" of Joint: NO Remarks:

Code: Description:	TFA Tap Factory Active
Distance (ft):	28.3
Structural Grade:	0
O&M Grade:	0
Clock Start/From:	9
Clock To:	
1st Value:	4.000
2nd Value:	
Value Percent:	
Continuous Index:	
Within 8" of Joint:	
Remarks:

Code:MSADescription:Abandoned Survey

Distance (ft):	31.5
Structural Grade:	0
O&M Grade:	0
Clock Start/From:	
Clock To:	
1st Value:	
2nd Value:	
Value Percent:	
Continuous Index:	
Within 8" of Joint:	NO
Remarks:	DEBRIS UN

NO DEBRIS UNDER WATER
