Profile/Photo Observation Report

Street:	LAKEVIEW DR	Flow Control:	Not Controlled
City:	Hobart, IN	Year Renewed:	
Location:	Yard	Tape/Media #:	
Purpose:	Routine Assessment	Dia/Height:	8"
Use:	Sanitary	Material:	PVC
Drain Area:	NA	Lining:	
Category:	NA		
Comment:	False P_C, MH_F. Flow direction is marked wrong.		
Location Details:		Direction of Survey:	Upstream
US MH:	M-407-005	DS MH:	M-407-002
		Total Length Surveyed (ft):	196.7

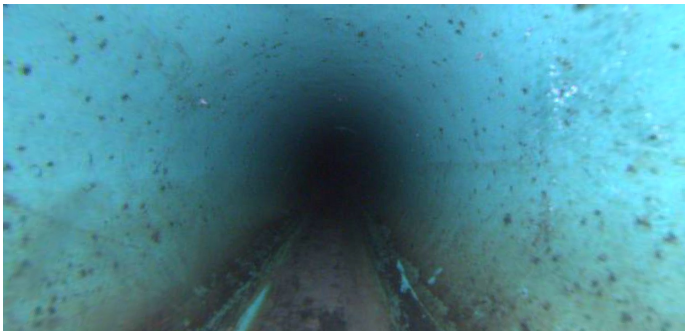
Code: **AMH**
Description: **Manhole**

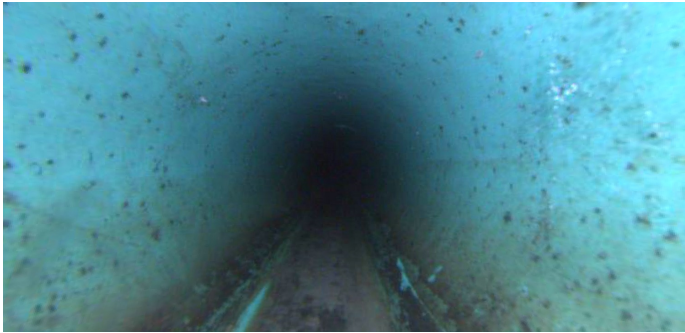
Code:	MWL
Description:	Water Level

Distance (ft):	.0
Structural Grade:	0
O&M Grade:	0
Clock Start/From:	
Clock To:	
1st Value:	
2nd Value:	
Value Percent:	5.000
Continuous Index:	
Within 8" of Joint:	NO
Remarks:

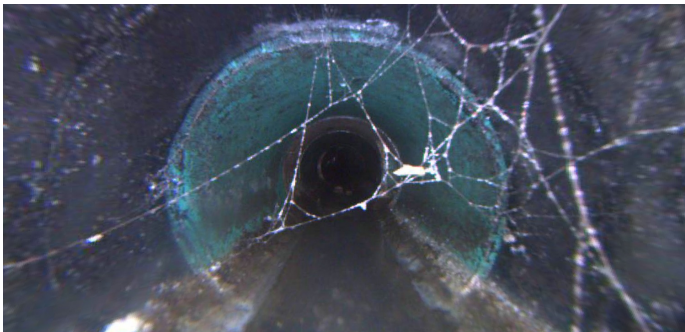
Code:	RPP
Description:	Repair Patch

Distance (ft):	65.2
Structural Grade:	0
O&M Grade:	0
Clock Start/From:	12
Clock To:	12
1st Value:	
2nd Value:	
Value Percent:	
Continuous Index:	
Within 8" of Joint:	NO
Remarks:	rubber

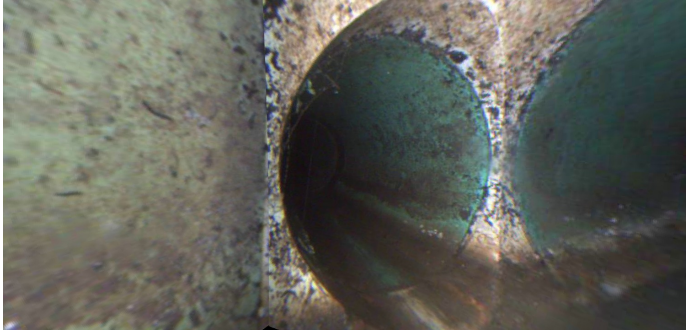
Code: **TFA**
Description: **Tap Factory Active**

Distance (ft): **66.9**
Structural Grade: **0**
O&M Grade: **0**
Clock Start/From: **3**
Clock To:
1st Value: **4.000**
2nd Value:
Value Percent:
Continuous Index:
Within 8" of Joint:
Remarks:

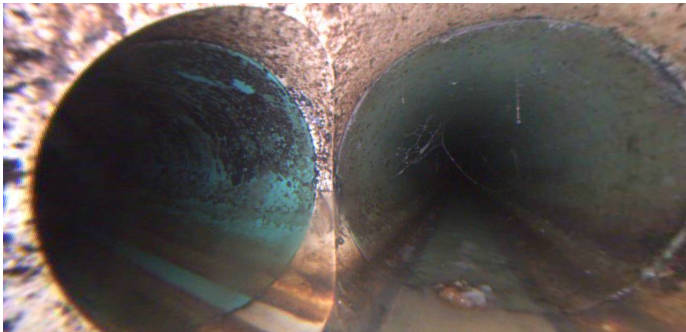
Code: **TFA**
Description: **Tap Factory Active**

Distance (ft): **68.3**
Structural Grade: **0**
O&M Grade: **0**
Clock Start/From: **9**
Clock To:
1st Value: **4.000**
2nd Value:
Value Percent:
Continuous Index:
Within 8" of Joint:
Remarks:

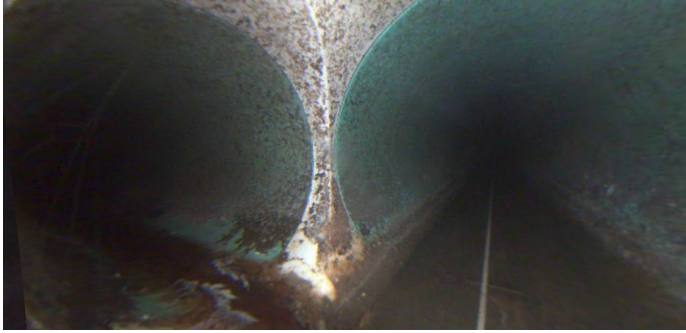
Code: **TFA**
Description: **Tap Factory Active**

Distance (ft): **144.7**
Structural Grade: **0**
O&M Grade: **0**
Clock Start/From: **3**
Clock To:
1st Value: **4.000**
2nd Value:
Value Percent:
Continuous Index:
Within 8" of Joint:
Remarks:

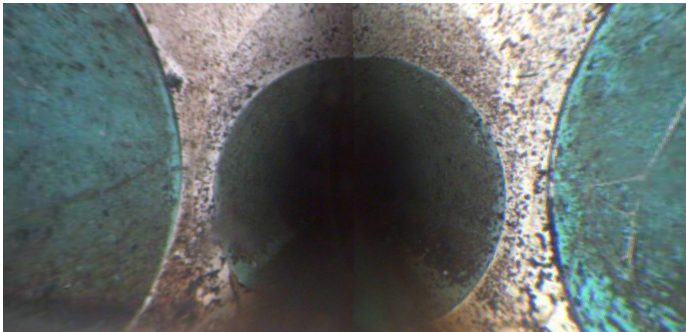
Code: **TFA**
Description: **Tap Factory Active**

Distance (ft): **191.4**
Structural Grade: **0**
O&M Grade: **0**
Clock Start/From: **3**
Clock To:
1st Value: **4.000**
2nd Value:
Value Percent:
Continuous Index:
Within 8" of Joint:
Remarks:

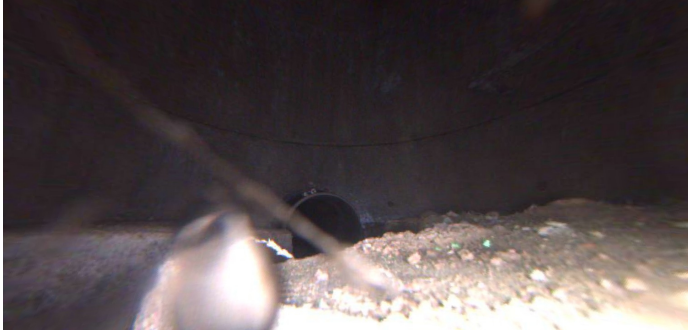
Code:	AMH
Description:	Manhole
Distance (ft):	196.7
Structural Grade:	0
O&M Grade:	0
Clock Start/From:	
Clock To:	
1st Value:	
2nd Value:	
Value Percent:	
Continuous Index:	
Within 8" of Joint:	NO
Remarks:	M-407-005
