## Profile/Photo Observation Report

Date:	<b>04/12/2018</b>	Weather:		Coding:	<b>PACP 6.0</b>
Pipe Length (ft):	<b>203.8</b>	Owner:	<b>NA</b>	Pre Clean:	<b>No Pre-Cleaning</b>
P.O.#:		Surveyor:	<b>Jen Costello</b>	PSR:	<b>P-407-002-005</b>
Customer:		Clean Date:	<b>01/01/1900</b>	Shape:	<b>C</b>

Street:	<b>FOXCROFT STREET</b>	Flow Control:	<b>Not Controlled</b>
City:	<b>Hobart, IN</b>	Year Renewed:	
Location:	<b>Yard</b>	Tape/Media #:	
Purpose:	<b>Routine Assessment</b>	Dia/Height:	<b>8"</b>
Use:	<b>Sanitary</b>	Material:	<b>PVC</b>
Drain Area:	<b>NA</b>	Lining:	
Category:	<b>NA</b>		
Comment:	<b>False P_C, MH_F. Flow direction is marked wrong.</b>		
Location Details:		Direction of Survey:	<b>Upstream</b>
US MH:	<b>M-407-005</b>	DS MH:	<b>M-407-002</b>
		Total Length Surveyed (ft):	<b>196.7</b>

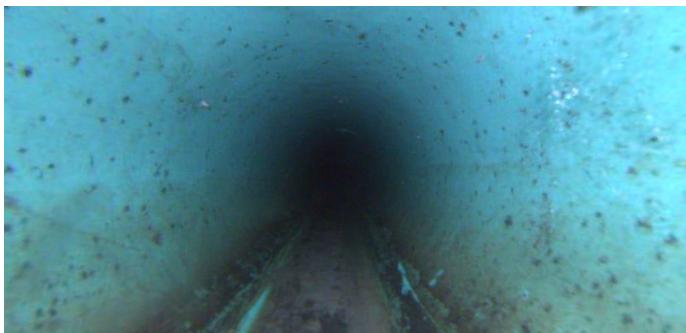
Code: **AMH**  
Description: **Manhole**

Distance (ft): **.0**  
Structural Grade: **0**  
O&M Grade: **0**  
Clock Start/From:  
Clock To:  
1st Value:  
2nd Value:  
Value Percent:  
Continuous Index:  
Within 8" of Joint: **NO**  
Remarks: **M-407-002**

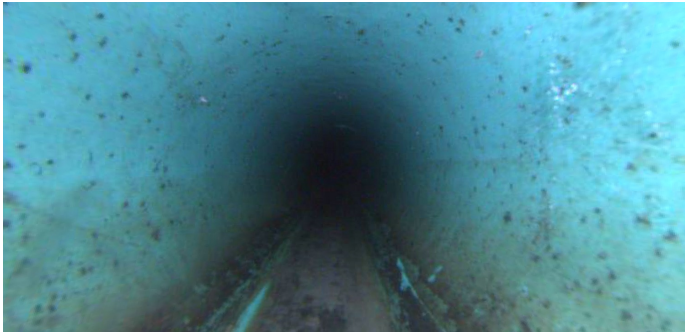
Code:	<b>MWL</b>
Description:	<b>Water Level</b>

Distance (ft):	<b>.0</b>
Structural Grade:	<b>0</b>
O&M Grade:	<b>0</b>
Clock Start/From:	
Clock To:	
1st Value:	
2nd Value:	
Value Percent:	<b>5.000</b>
Continuous Index:	
Within 8" of Joint:	<b>NO</b>
Remarks:

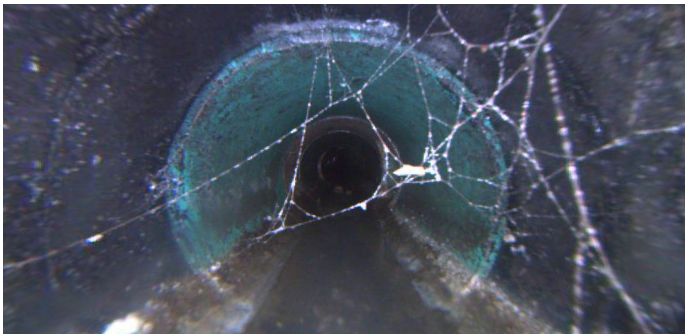
Code:	<b>RPP</b>
Description:	<b>Repair Patch</b>

Distance (ft):	<b>65.2</b>
Structural Grade:	<b>0</b>
O&M Grade:	<b>0</b>
Clock Start/From:	<b>12</b>
Clock To:	<b>12</b>
1st Value:	
2nd Value:	
Value Percent:	
Continuous Index:	
Within 8" of Joint:	<b>NO</b>
Remarks:	<b>rubber</b>

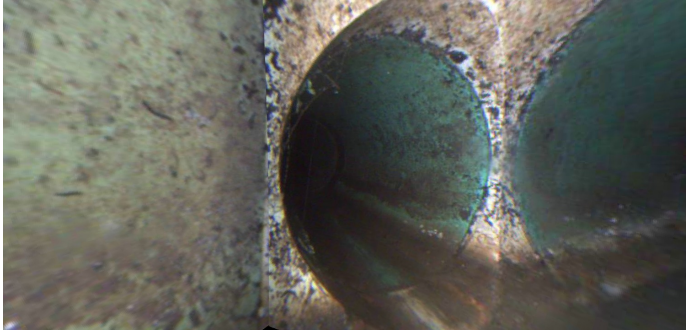
Code: **TFA**  
Description: **Tap Factory Active**

Distance (ft): **66.9**  
Structural Grade: **0**  
O&M Grade: **0**  
Clock Start/From: **3**  
Clock To:  
1st Value: **4.000**  
2nd Value:  
Value Percent:  
Continuous Index:  
Within 8" of Joint:  
Remarks:

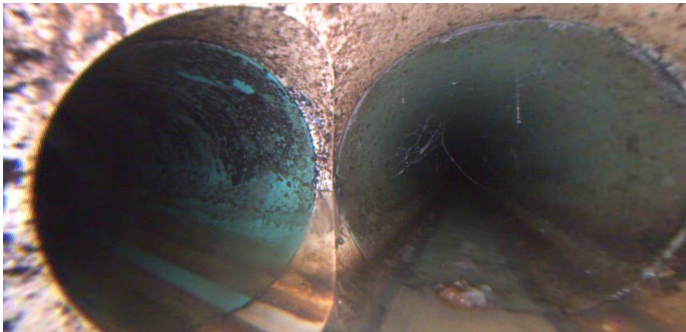
Code: **TFA**  
Description: **Tap Factory Active**

Distance (ft): **68.3**  
Structural Grade: **0**  
O&M Grade: **0**  
Clock Start/From: **9**  
Clock To:  
1st Value: **4.000**  
2nd Value:  
Value Percent:  
Continuous Index:  
Within 8" of Joint:  
Remarks:

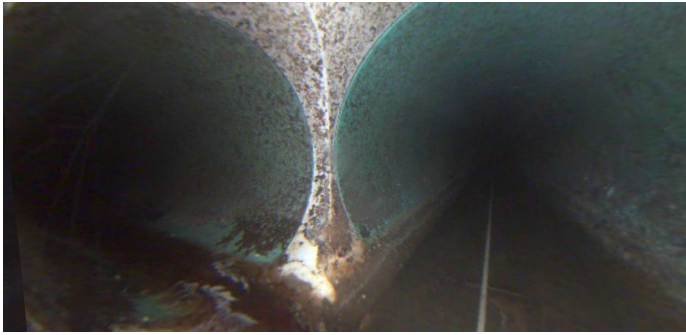
Code: **TFA**  
Description: **Tap Factory Active**

Distance (ft): **144.7**  
Structural Grade: **0**  
O&M Grade: **0**  
Clock Start/From: **3**  
Clock To:  
1st Value: **4.000**  
2nd Value:  
Value Percent:  
Continuous Index:  
Within 8" of Joint:  
Remarks:

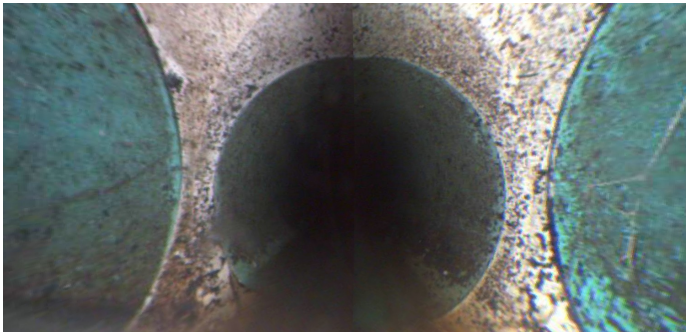
Code: **TFA**  
Description: **Tap Factory Active**

Distance (ft): **191.4**  
Structural Grade: **0**  
O&M Grade: **0**  
Clock Start/From: **3**  
Clock To:  
1st Value: **4.000**  
2nd Value:  
Value Percent:  
Continuous Index:  
Within 8" of Joint:  
Remarks:

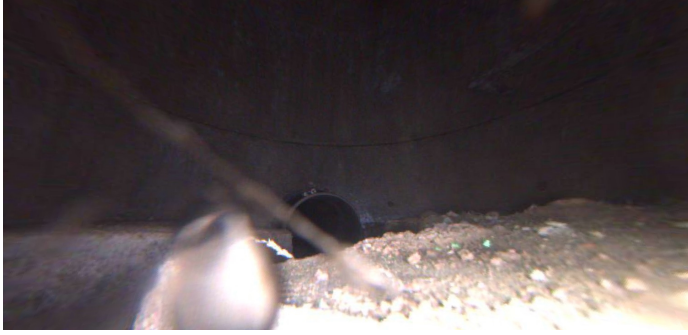
Code:	<b>AMH</b>
Description:	<b>Manhole</b>
Distance (ft):	<b>196.7</b>
Structural Grade:	<b>0</b>
O&M Grade:	<b>0</b>
Clock Start/From:	
Clock To:	
1st Value:	
2nd Value:	
Value Percent:	
Continuous Index:	
Within 8" of Joint:	<b>NO</b>
Remarks:	<b>M-407-005</b>
